# Monitoring the impacts of on-site wastewater treatment systems, Bay of Plenty

Bay of Plenty Regional Council  
Environmental Publication 2018/01  
February 2018

Prepared by Paul Scholes (Science Team Leader - Water Quality)

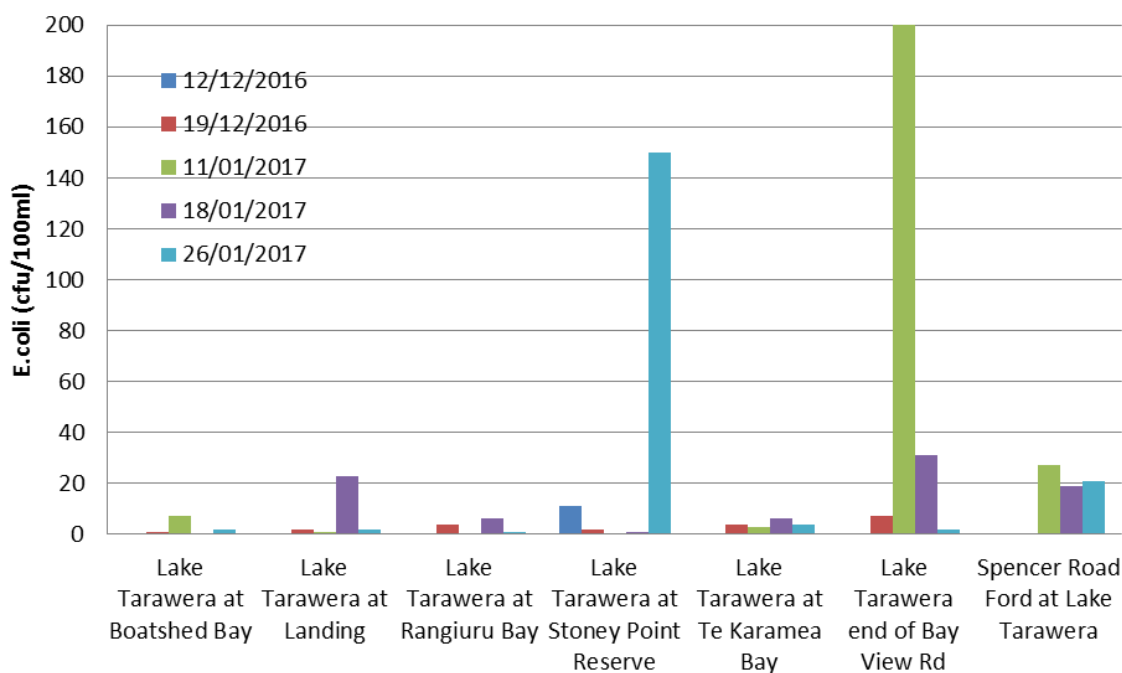
Figure 3.1.2 *E.coli* concentrations in lake Tarawera, 2016/17. For comparison microbiological water quality guideline, the orange alert guideline, is 260 cfu/100 ml.

*E.coli* concentrations in the lake over the summer were on the whole very low (see median results in Figure 3.1.2, with the exception of an elevated result at the lake at the end of Bay View Road. As no runoff due to rain or other sources was noted and the Spencer Road Ford stream was at a low *E.coli* concentration, it is likely that this sample was elevated due to inclusion of contamination from a recent wildfowl scat.

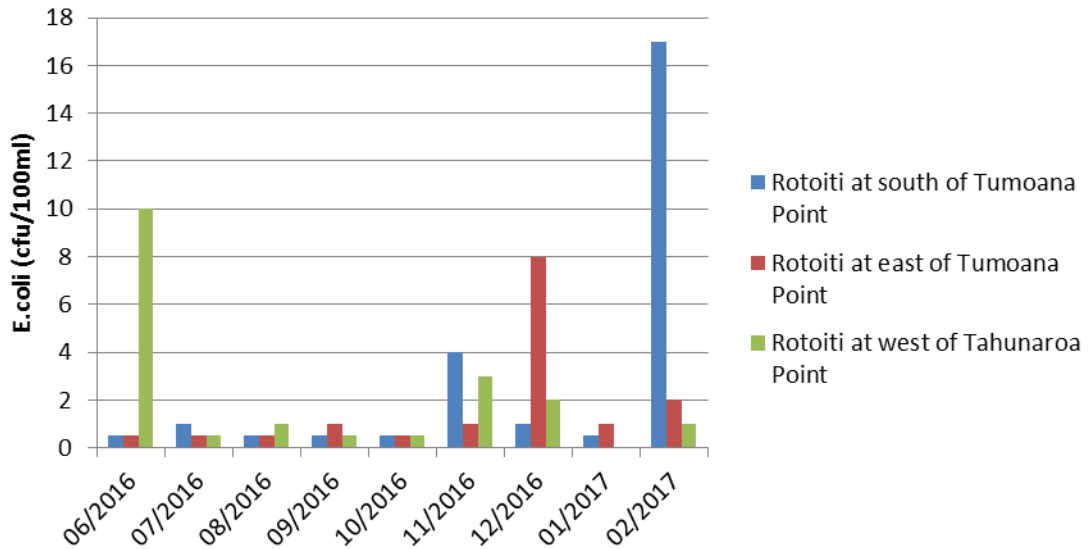
*E.coli* concentrations around the foreshore were found to be low, with regards to recreational use water quality (Figure 3.2.2). The highest result of 17 cfu/100 ml is well below the first alert level of 260 cfu/100 ml for microbiological water quality guidelines.

Figure 3.2.2 E.coli concentrations at Tumoana Point.

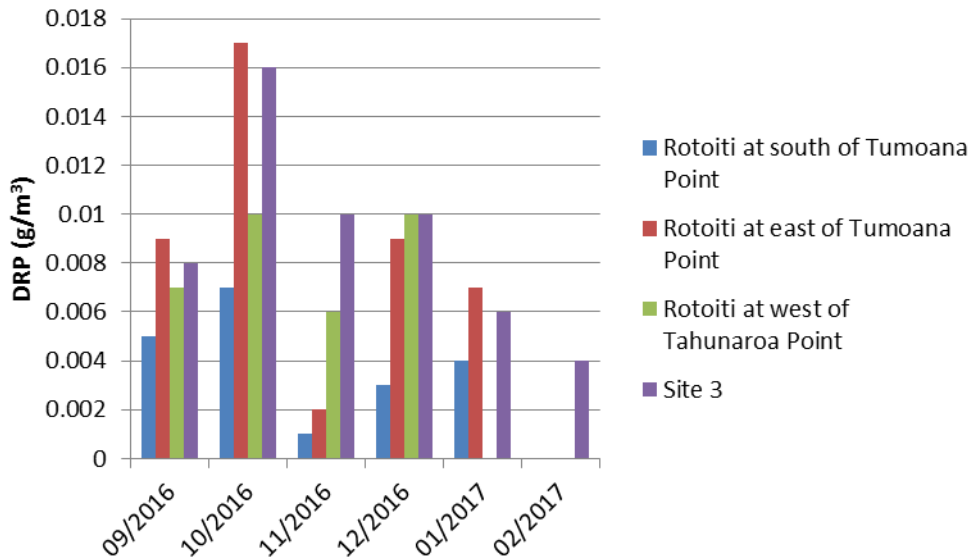
Dissolved reactive phosphorus (DRP) was also analysed to observe if there were any increased fluxes as a result of leaching from septic tanks. Low DRP concentrations were observed (Figure 3.2.3) with concentrations similar and generally lower than those found at the adjacent lake monitoring sites (site 3).

Figure 3.2.3 Dissolved reactive concentrations at Tumoana Point.

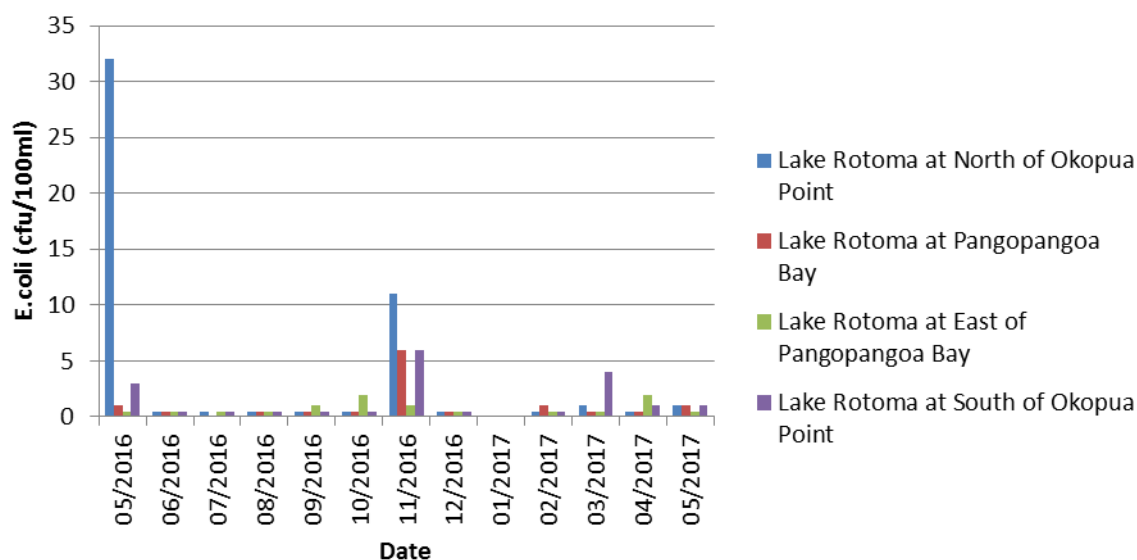
*E.coli* concentrations around the foreshore were found to be low with regards to recreational use water quality (Figures 3.3.2 and 3.3.3). The highest *E.coli* result of 32 cfu/100 ml is well below the first alert level of 260 cfu/100 ml for microbiological water quality guidelines.

Figure 3.3.2 *E.coli* concentrations at Tumoana Point.

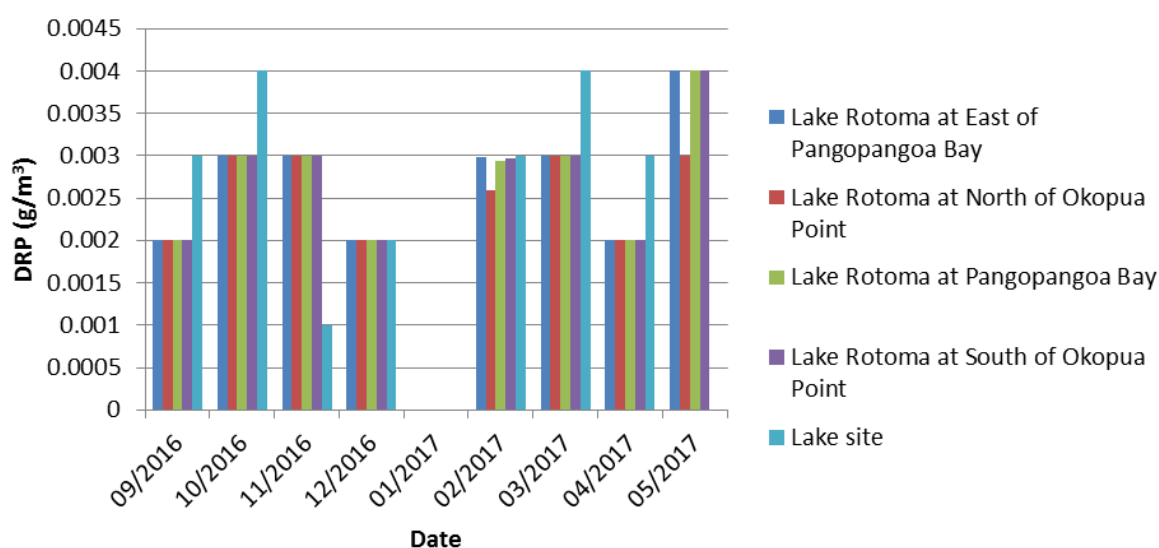
Dissolved reactive phosphorus (DRP) was also analysed to observe if there were any increased fluxes as a result of leaching from septic tanks. Low DRP concentrations were observed (Figure 3.3.3) with concentrations similar and generally lower than those found at the lake monitoring site.

Figure 3.3.3 Dissolved reactive concentrations at Tumoana Point.

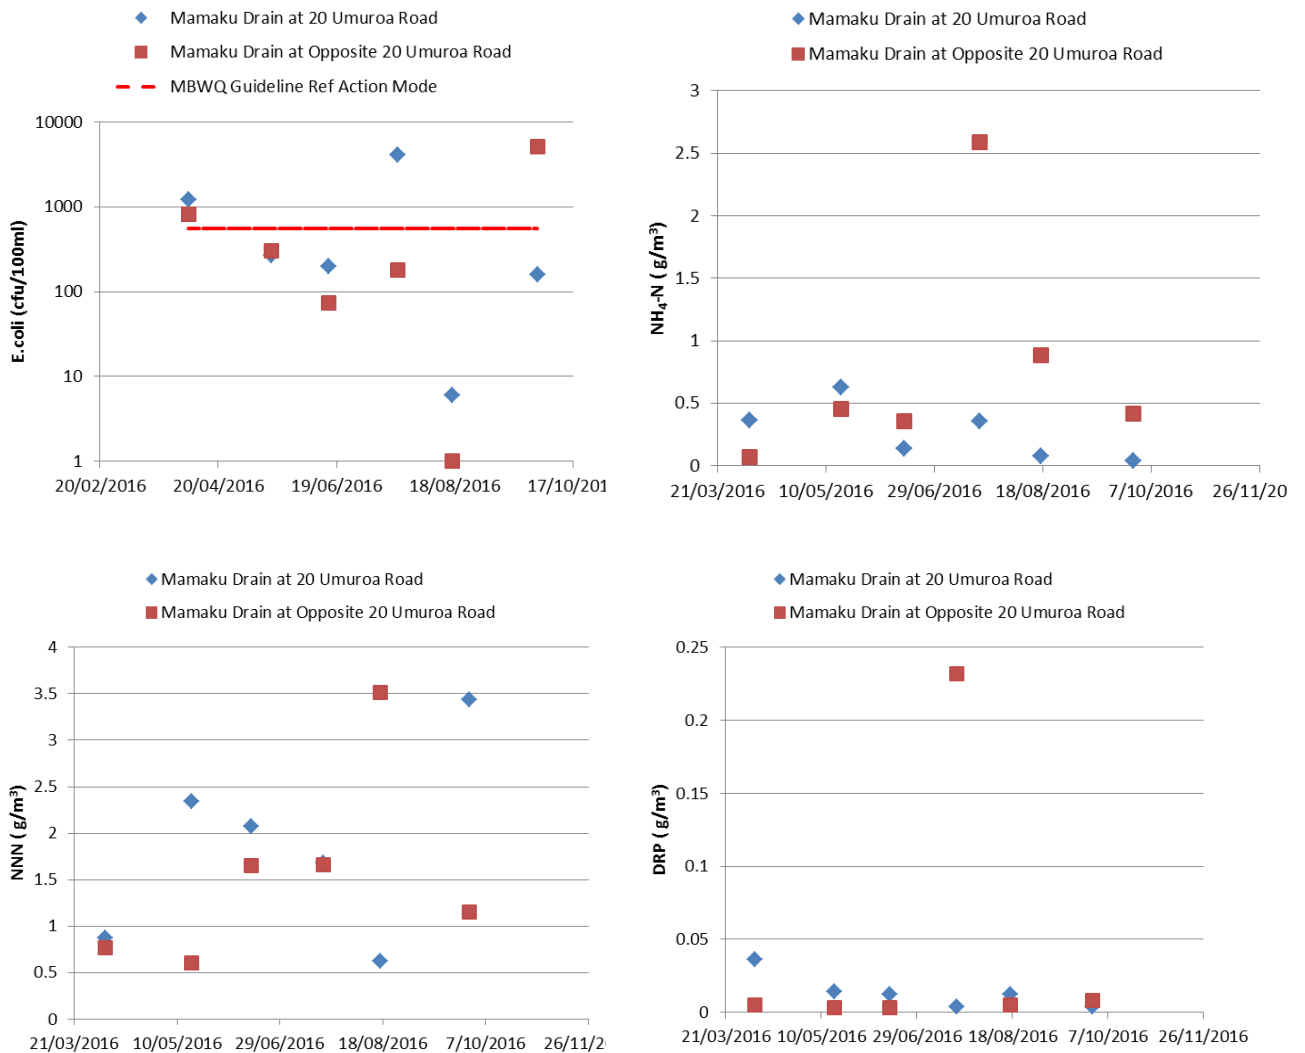
Nutrient concentrations would indicate the possibility of contamination of the drains from septic tanks at only a low-moderate level. Ammonium-nitrogen ( $\text{NH}_4\text{-N}$ ) concentrations (Figure 3.4.2) are slightly elevated above what might be expected in these spring fed streams, but with only one sample in the drain opposite 20 Umuroa Road being more indicative of concentrations that might be emanating from septic tanks. Nitrate-nitrite-nitrogen (NNN) concentrations are generally higher than ammonium-nitrogen concentrations, possibly due to denitrification processes as septic effluent moves through the soils. Further evidence that the soils are treating effluent leaking into the drains is the low DRP, with the exception of one result which coincides with the highest  $\text{NH}_4\text{-N}$  result.

Figure 3.4.2 *E. coli* and Nutrient concentrations.

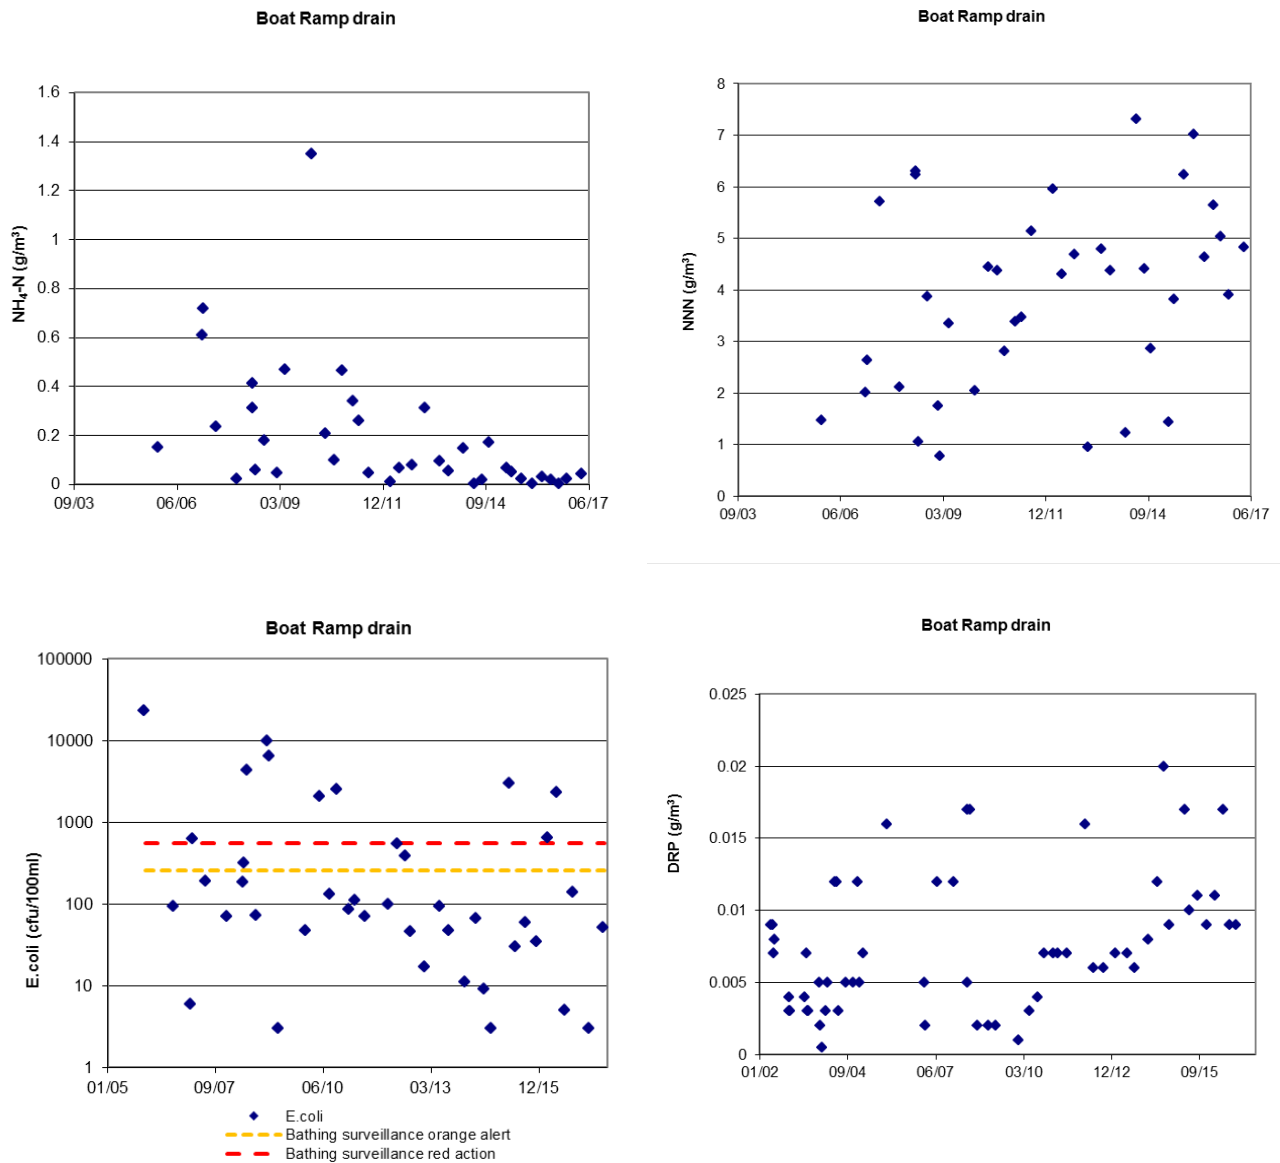
The permanently flowing drain adjacent to the boat ramp at Tanners Point has been the most often sampled flow on the peninsula. Figure 3.5.2 shows that NNN results remain elevated, indicating that septic tank contamination is likely to be occurring as ammoniacal-nitrogen is converted to nitrate-nitrite-nitrogen. High NNN results have also been found in the waters emanating from the sub-surface drains. Ammoniacal-nitrogen does show a declining trend ( $p < 0.05$ ), however, dissolved reactive phosphorous (DRP) concentrations have an increasing trend ( $p < 0.05$ ) with minimum observed concentration increasing. This may be a sign that soils have become saturated with respect to phosphorous and are not readily adsorbing phosphorous.

The drain has occasional elevated *E. coli* levels at times above contact recreational limit of 550 cfu/100 ml. Concentrations of this faecal indicator bacteria have been declining possibly in part, due to an improved treatment system installed to service the public toilets.

Figure 3.5.2 Faecal coliform and nutrient concentrations, Boat Ramp Drain, Tanners Point.

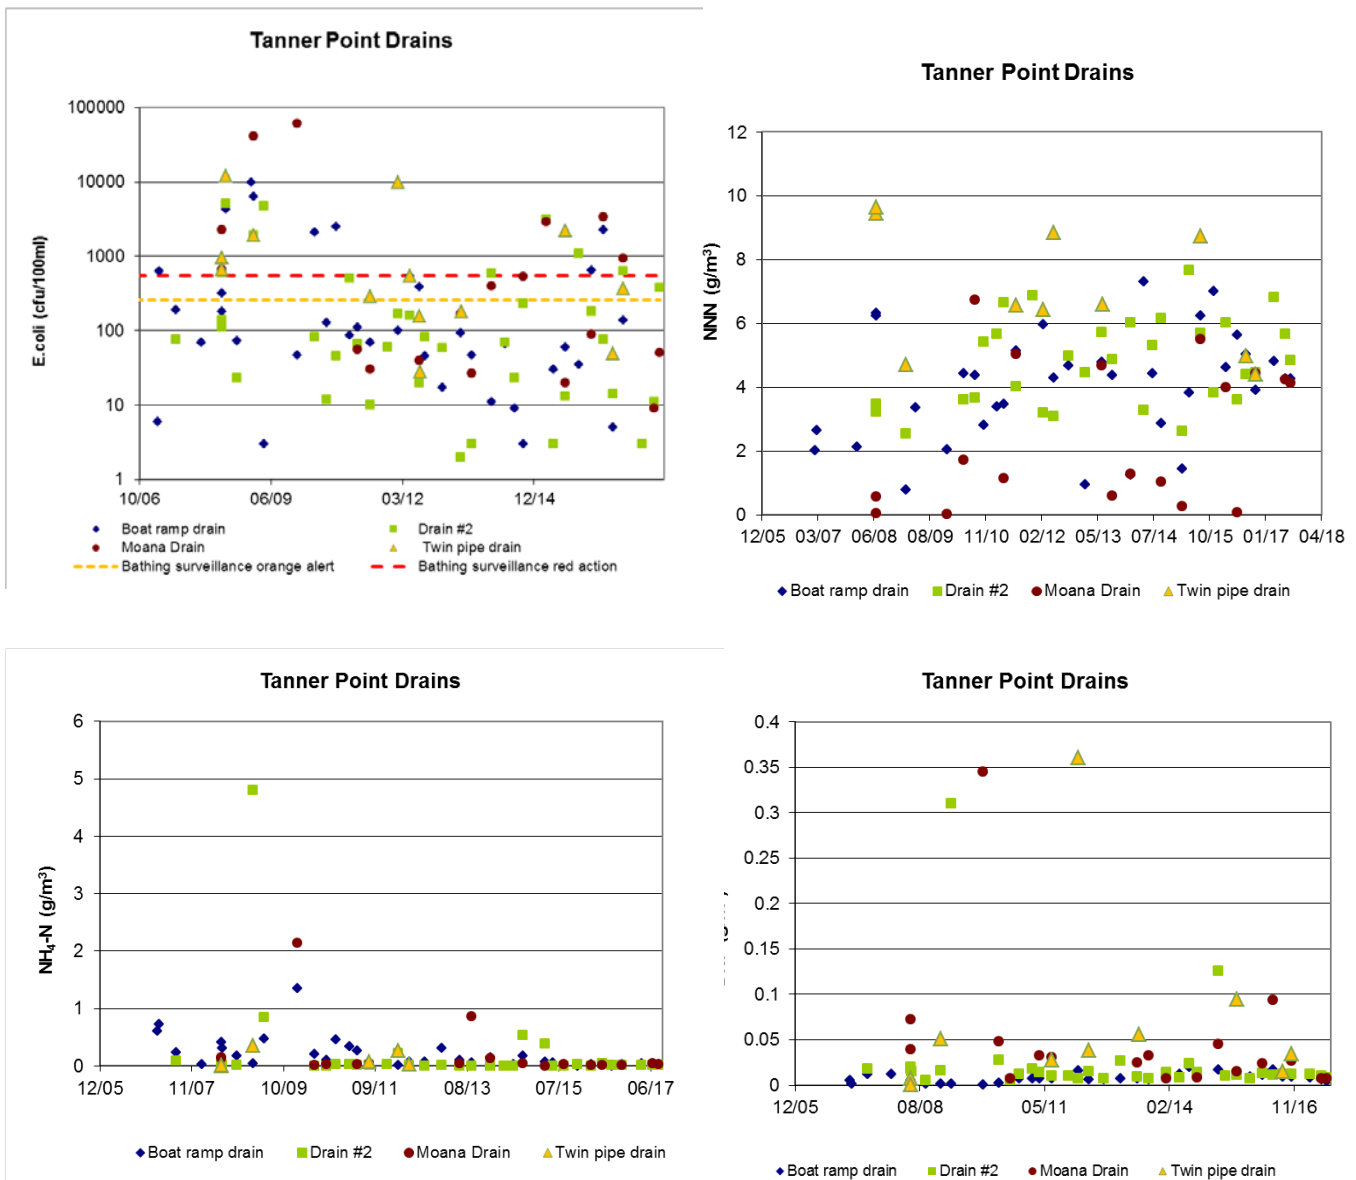
Ammoniacal-nitrogen levels have remained relatively low in all drains potentially indicating better renovation of ammoniacal-nitrogen to nitrate-nitrite-nitrogen in the tanks and soils.

Figure 3.5.3 *E.coli* and nutrient concentrations, Tanners Point drains.

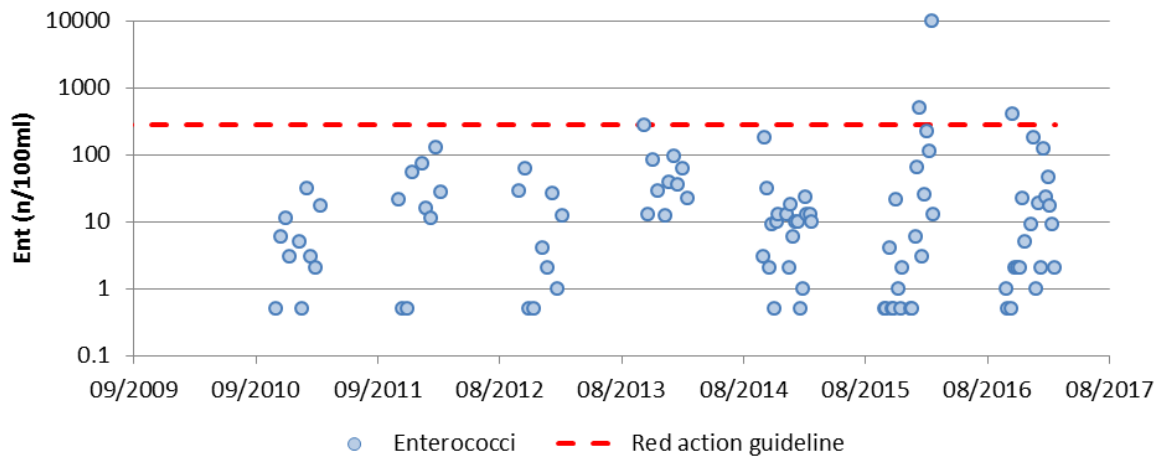
Bathing surveillance monitoring undertaken at the boat ramp in summer has shown an increase in concentrations over the past two seasons. Three results in the past two seasons have been over the red action guideline for swimming water quality, although these were driven by intensive rainfall events. Impact of septic tanks on such events has not been discriminated.

Figure 3.5.4 Indicator bacteria concentrations, Tanners Point Jetty.

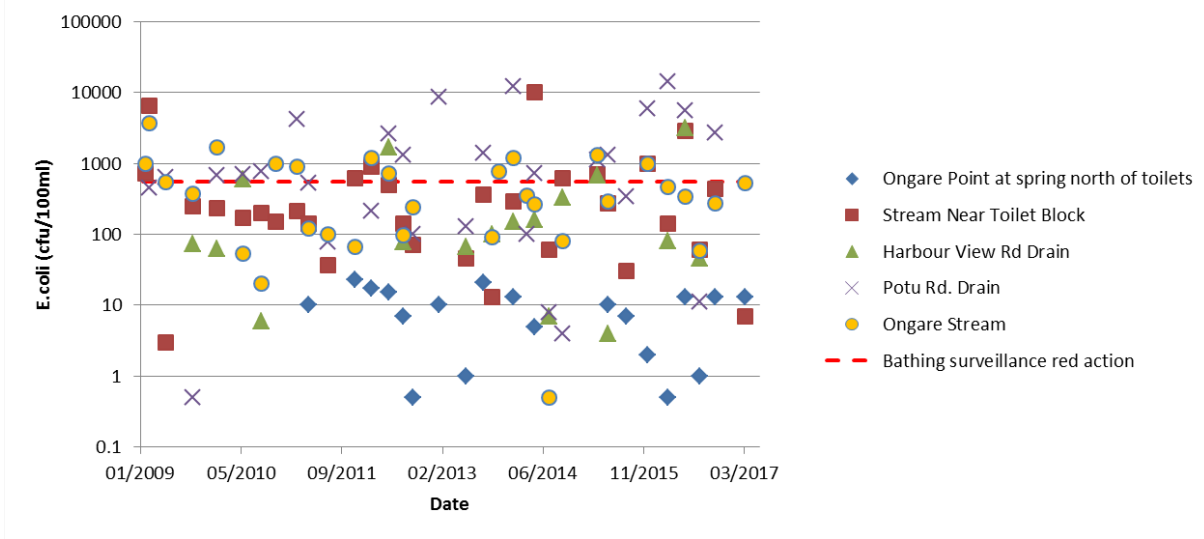
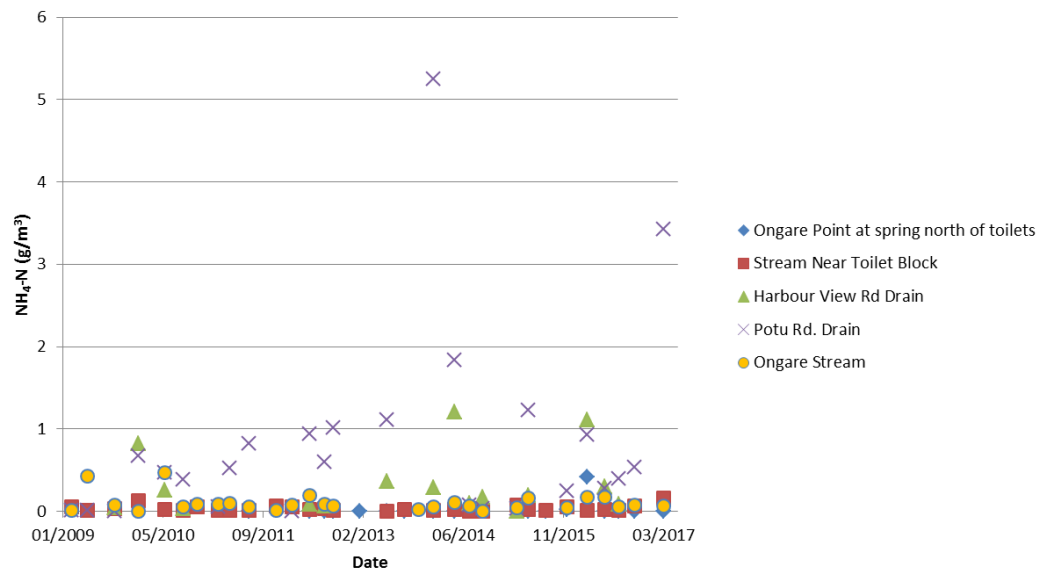
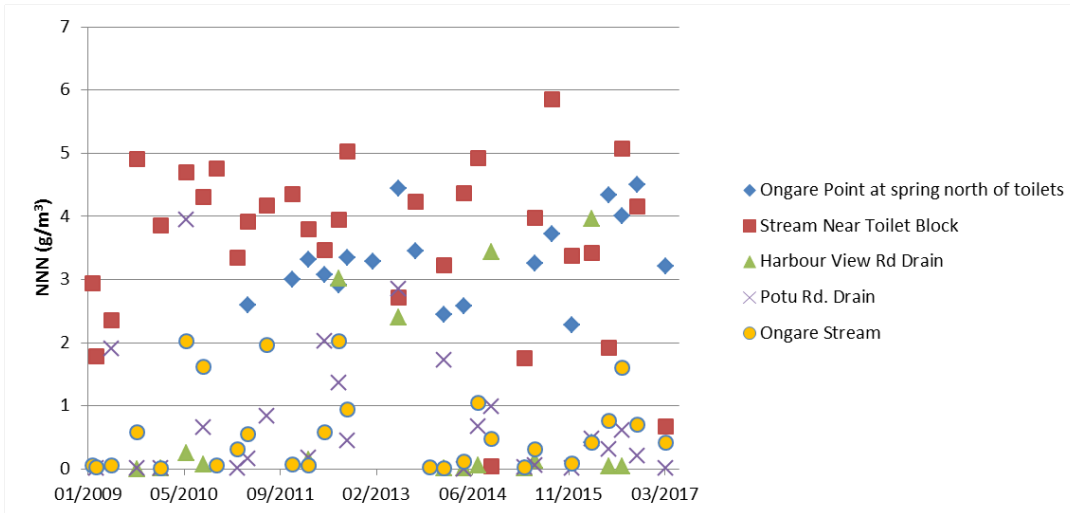
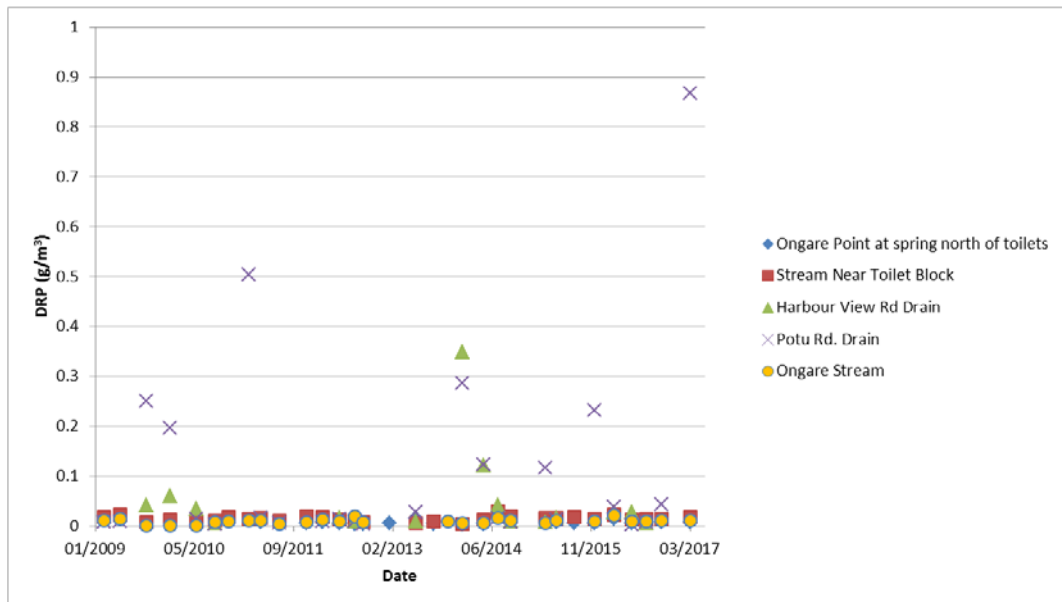
Harbour View Drain has to a lesser extent, also been found to have occasional higher levels of indicator bacteria and nutrients that would be expected in an uncontaminated stormwater seep. Flow from the Potu Road Drain is almost year round while the Harbour View drain experiences only intermittent flow and is therefore influenced by rainfall and water table levels.

Nitrate-nitrite-nitrogen (NNN) at the spring north of toilet block and the stream near the toilet block often have concentrations above 3 g/m<sup>3</sup>. Similar concentration of these mobile nitrogen species through groundwater are also observed in the rurally influenced Site 1 (Figure 3.7.2), indicating nitrogen input from rural sources as well as from septic tanks. Other drains monitored have lower NNN concentrations on average but higher NNN to NH<sub>4</sub>-N ratio.

Ongare Stream does show signs of contamination from rural sources and has predominantly cattle grazing around its lower extent. *E.coli* concentrations have been above the contact recreational guideline and elevated NH<sub>4</sub>-N concentrations have been recorded. High NH<sub>4</sub>-N concentrations may have been a result of reduced flow and stagnation caused by the build-up of sea lettuce and the configuration of the culverts. This has dropped off recently with the installation of a new culvert.

Figure 3.6.2 *E.coli* and nutrient concentrations, Ongare Point.

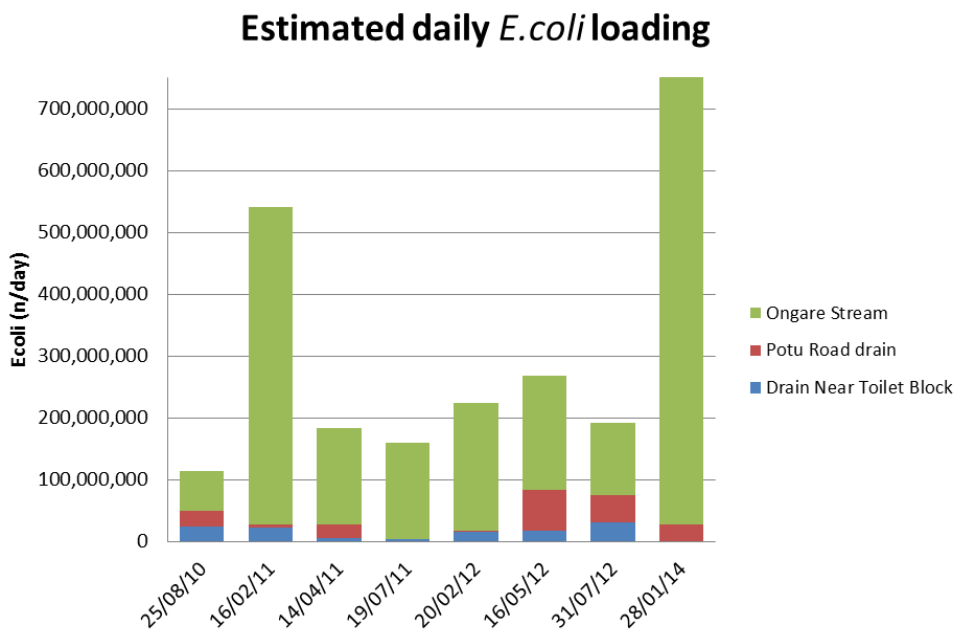
The greatest contribution of faecal contamination to the harbour is from the stream, primarily due to its much greater flow. However, the input from the relatively small drain flows is not insignificant and represents a localised health risk to the foreshore if infectious material is present.

Figure 3.6.3 Percentage representation of *E.coli* loads to harbour (cfu/day) for Ongare Point drains and stream.

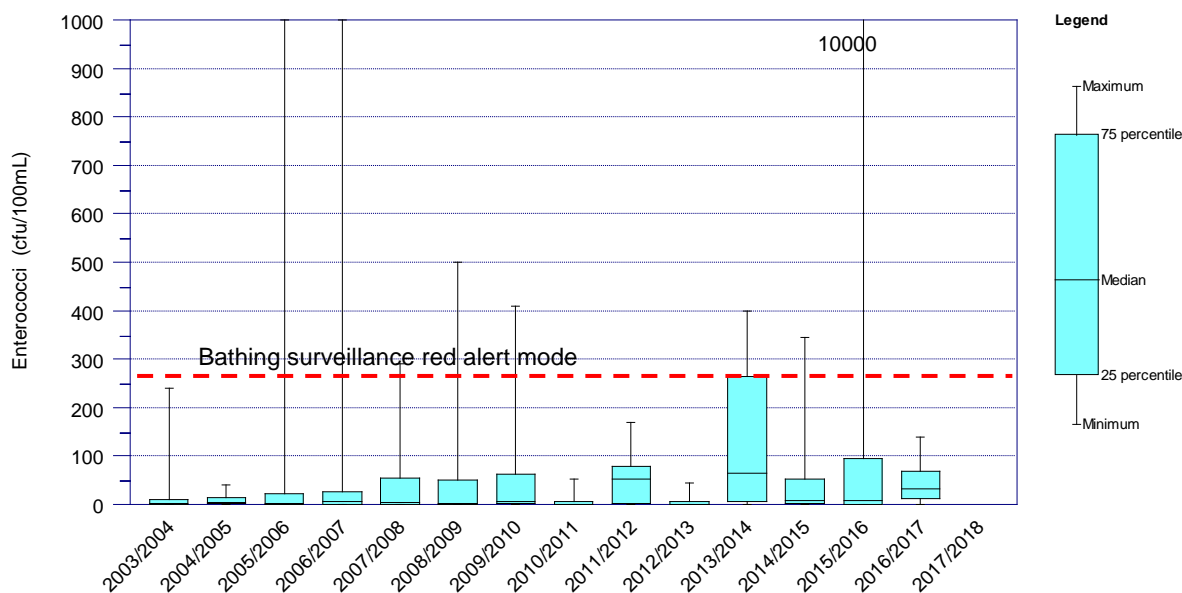
Bathing water quality around Ongare Point is generally good. Only once has the water quality exceeding the Microbiological Water Quality Guidelines (2003) red action mode of 260 enterococci per 100 ml (requires two consecutive samples to be over this threshold). Results of 1000 enterococci per 100 ml occurred in 2006 (Figure 3.7.4) and 2007, and a result of 10000 enterococci per 100 ml occurred in 2016. All of these samples were taken after substantial rain had fallen.

Figure 3.6.4 Bathing surveillance monitoring results, Enterococci, Ongare Point.

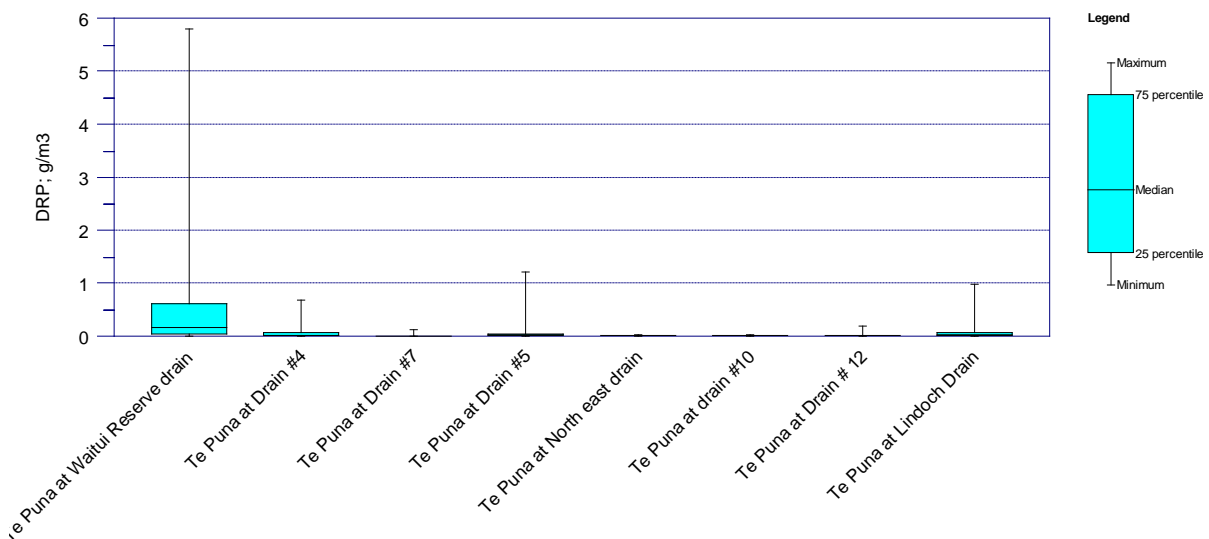
Several of these west side drains have elevated ammoniacal-nitrogen ( $\text{NH}_4\text{-N}$ ) concentrations, indicating septage contamination. Drains on the eastern side have lower ammoniacal-nitrogen concentrations. Two drains on the eastern side have higher NNN concentrations than their western counterparts. This could be a result of nutrient renovation of septic tank effluent as well as rural land use impacts. High NNN concentrations at the two western drains also indicate influence of septic tanks. Elevated phosphorus levels on the eastern side also indicate some potential effluent influence (Figure 3.7.5).

Figure 3.7.5 Box-whisker plots of DRP concentrations, Te Puna drains, 2010 to 2017.

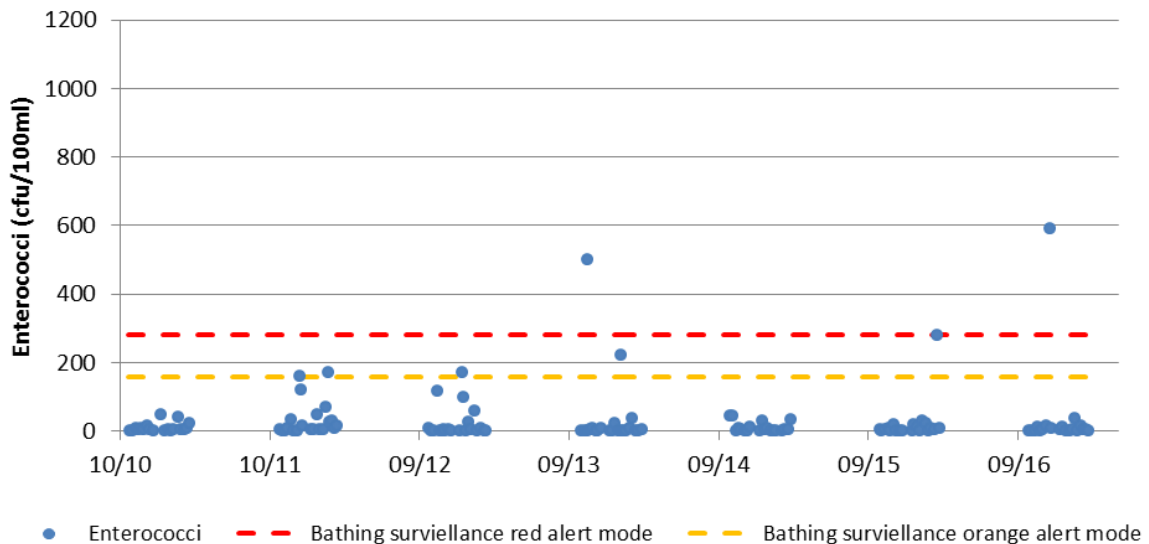
The microbiological swimming water quality of the Te Puna Estuary is good, based on monitoring of the indicator bacteria enterococci (Figure 3.7.7). Only two results have been above the bathing surveillance red alert threshold (280 cfu/100 ml) over the past seven seasons.

Figure 3.7.7 Bathing surveillance monitoring results, *Enterococci*, Te Puna.

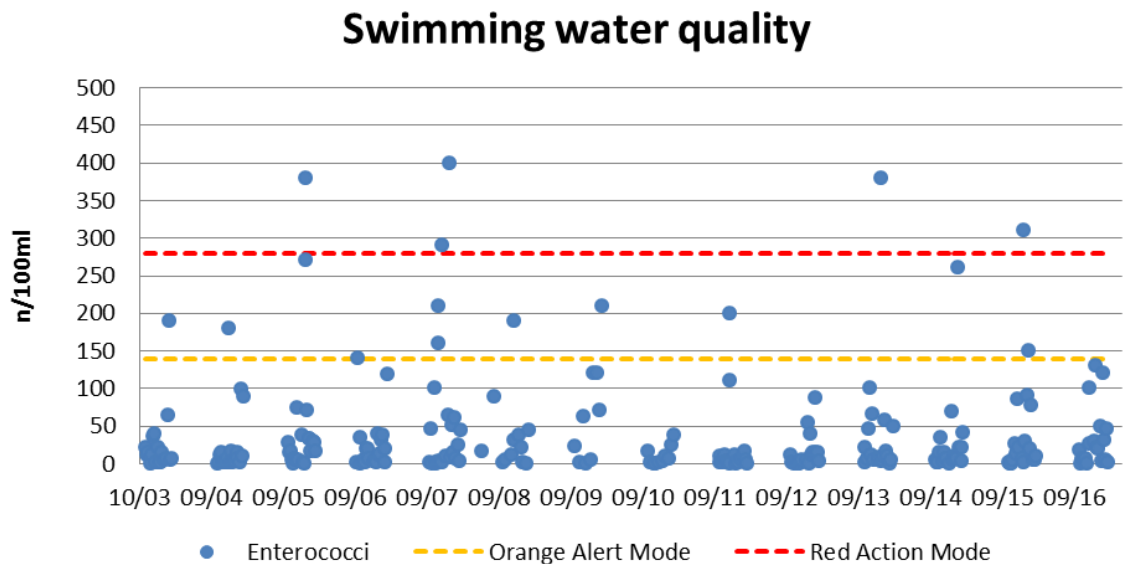
Bathing surveillance monitoring at Pukehina Beach (coastal waters), shows these waters to be excellent for contact recreation purposes. Waihi Estuary has lower water quality due predominantly to rural freshwater inputs. Only very small intermittent flows of some contaminants originate from the Pukehina community. Figure 3.8.4 shows monitoring results for the lower estuary from 2003 to 2017. Results are generally below bathing surveillance alert levels for marine waters, with four seasons in the last ten having had occasional results above the bathing surveillance red alert level.

Figure 3.9.4 Swimming water quality and recreational guideline levels. Waihi Estuary.

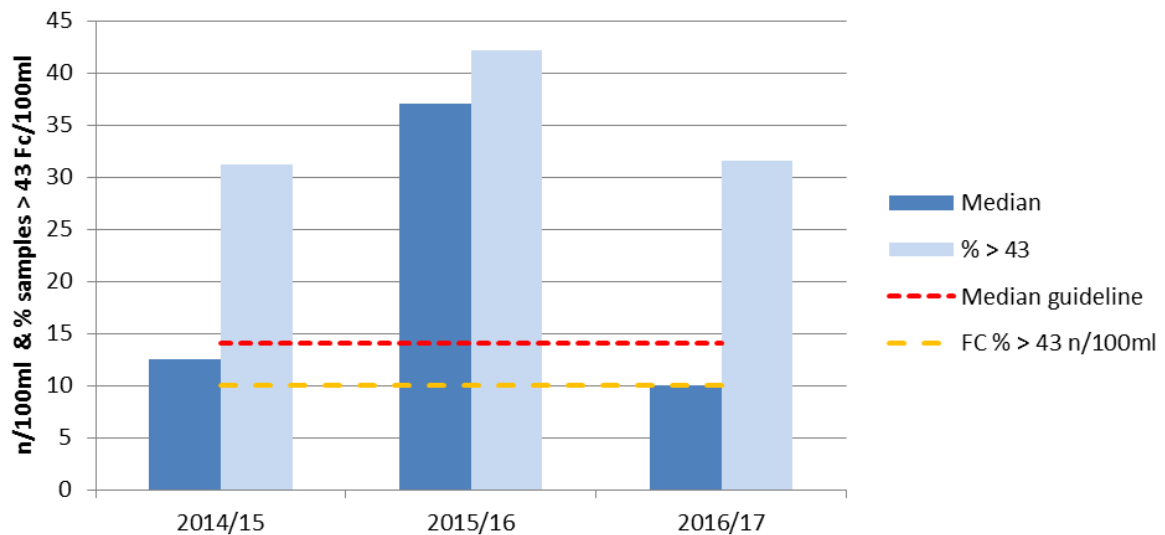
Indicator bacteria results for shellfish waters in the Waihi Estuary have been variable, with some elevated faecal coliform results found in the water on occasion. These are usually associated with rainfall events. Faecal coliform results for main channel pipi indicate, that on occasion, pipi would not be considered safe for human consumption. Results for shellfish waters over the past three years (Figure 3.8.5) show that in 2015/16 the two shellfish water guidelines were exceeded, showing shellfish water were unsafe for human consumption.

Figure 3.8.5 Shellfish water quality and shellfish water guideline levels based on faecal coliform concentrations. Waihi Estuary.

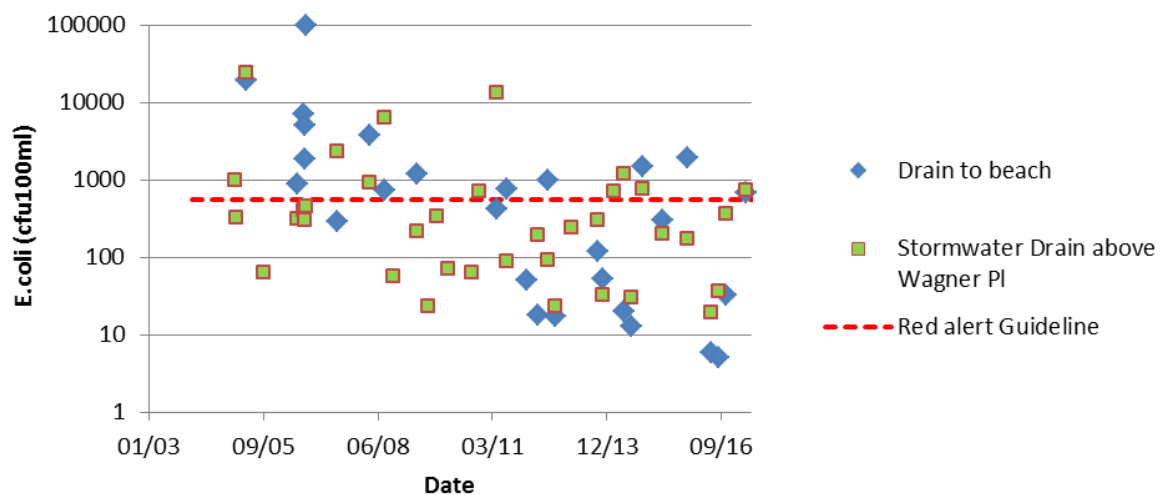
The *E.coli* data from the stream shows fewer results over the Microbiological Water Quality Guideline red alert level (Figure 3.10.2) in the past few years. *E.coli* concentrations from the stormwater drains have been higher than the stream results, with the drain to beach showing indications of a downward trend. The highest health risk to the community will be due to potential contact with the drain waters at the beach.

Figure 3.10.4 *E.coli* concentrations from stormwater drains, 2003 to 2017, Bryans Beach.

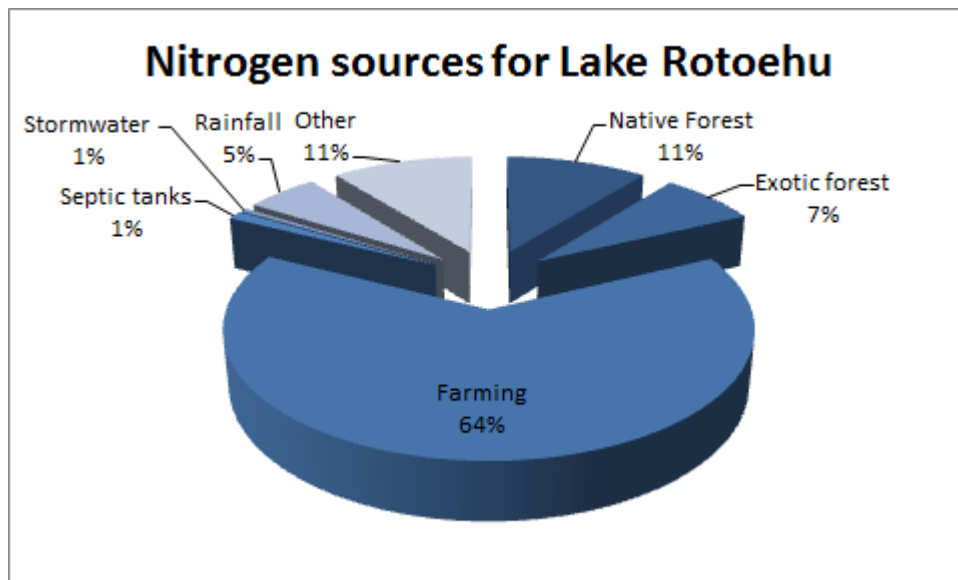
Nutrient loading has been estimated in the context of the lake loading budget at around 1% of the total nitrogen and phosphorus budget (Figure 3.12.3). Hence, the contribution and impact from septic tanks on lake eutrophication is very minor.

Figure 3.11.3 Nitrogen sources for Lake Rotoehu, from Lake Rotoehu Action Plan, 2007.
