1 Introduction

The Bay of Plenty Regional Council and has contracted Sustainable Forest and Land Management Limited to provide a present day assessment of the Awatarariki catchment to the North of the Matata township on state highway 2. The purpose of the investigation is to advise and support Bay of Plenty Regional Council in its assistance of Whakatāne District Council in the preparation and consideration of district and regional plan changes to reduce debris-flow risk at the Awatarariki fanhead, Matatā.

The report will also provide my own and others' inspections of the upper catchment from 1993 until 18 May 2005. The report will also provide and insight into maintenance activities which were carried out by the Bay Of Plenty Regional council in support of a Whakatane district council request.

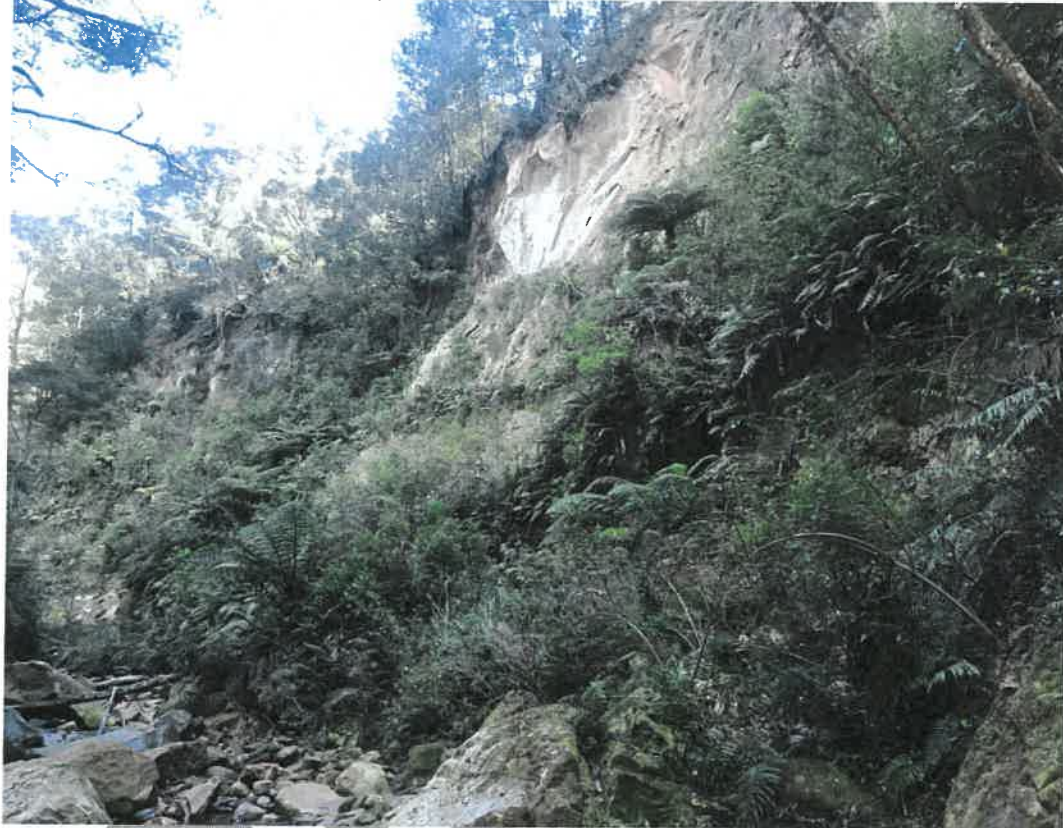
Large boulders, large fallen trees and hill-slopes of mudstone have fallen into the streambed either during or in the years following the 2005 event. This material is stored in the streambed, in large volumes, near the upper third of the Awatarariki catchment. Aerial photography comparisons show that the erosion scars, which now dominate this part of the catchment, were not as evident when the 1993 catchment investigation was undertaken.

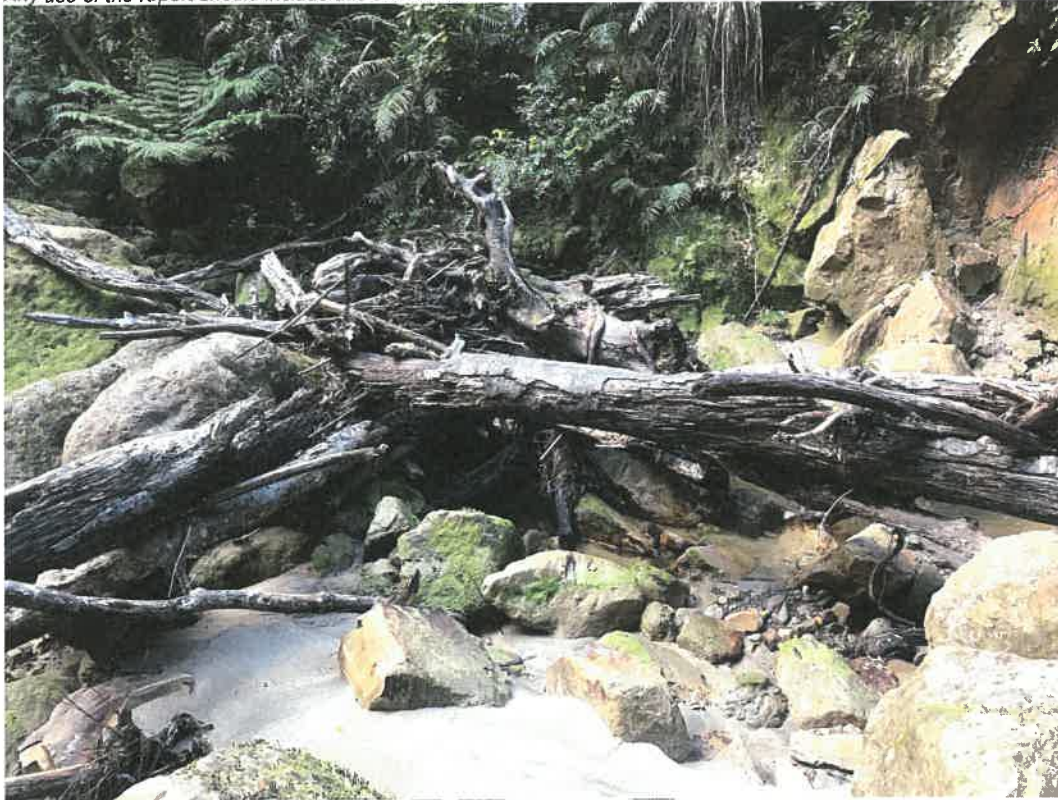
The Awatarariki stream has cut down significantly in the lower third of the catchment. The stream is clear of any major blockages but does show signs that blockages are starting to occur especially where logs or extremely large boulders are jammed in narrow valleys. Soil, rock, trees and vegetation is being washed into these steep narrow blockages and are stored there until there is enough force to dislodge them. There is sufficient eroded loose material in the upper catchment to supply numerous blockages throughout the 5km catchment tributaries. However the energy or rainfall event required to mobilise these blockages needs to be of the same magnitude as the May 18, 2005 event.
