Mamaku On-Site Effluent Treatment System Study

Bay of Plenty Regional Council

September 2019

Ormiston Associates Ltd.

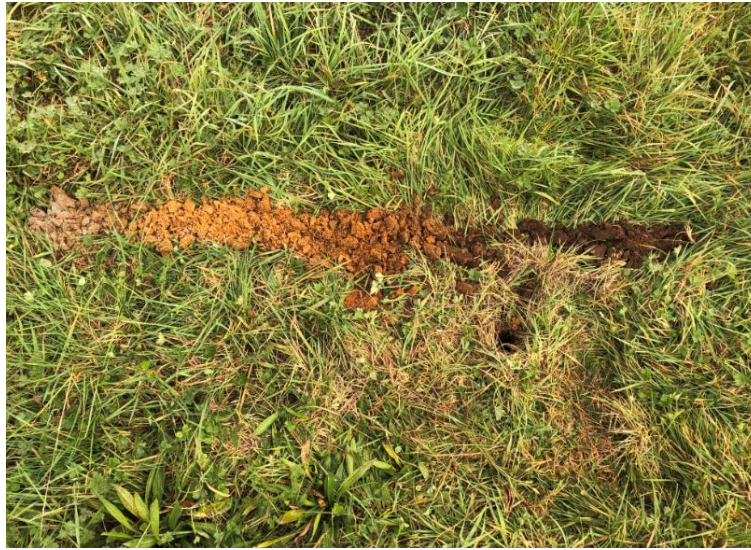
BH1

BH No.	Topsoil (mm)	Red-Brown Silt/Ash (mm)	Orange Ash/Gravelly Silt (mm)	Silt/weathered ignimbrite (mm)	EOH = unweathered ignimbrite (mm)
1	0-500	500-1400	1,400-1,900	1,900-2,150	2,150
2	0-300	300-850	Not present	Inclusions	850
3	0-300	300-900	900-1,500	1,500-1,550	1,550
4	0-400	400-1,600	1,600-2,300	2,300-2,650	2,650
5	0-300	300-1,200	1,200-1,650	1,650-1,700	1,700
6	0-300	300-1,600	1,600-2,400	2,400-2,500	2,500
7	0-500	500-1,100	1,100-1,750	1,750-2,100	2,100
8	0-300	300-1,200	1,200-2,150	2,150-2,300	2,300
9	0-500 (F)	500-1,350	1,350-2,100	2,100-2,150	2,150

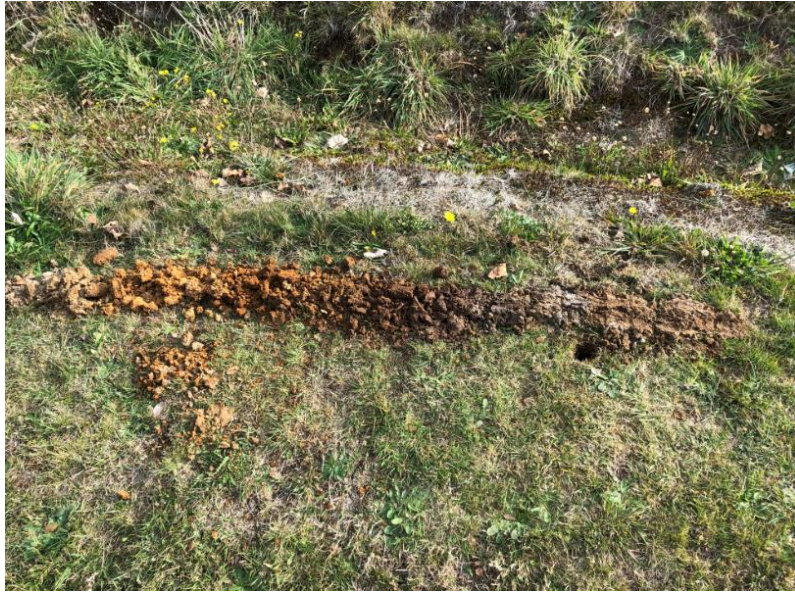
BH10

BH No.	Topsoil (mm)	Red-Brown Silt/Ash (mm)	Orange Ash/Gravelly Silt (mm)	Silt/weathered ignimbrite (mm)	EOH = unweathered ignimbrite (mm)
10	0-500 (F)	500-1,650	1,650-2,200	2,200-2,700	2,700
11	0-400	400-900	900-1,950	1,950-2,000	2,000
12	0-500	500-1,050	1,050-1,350	1,350-1,550	1,550
13	0-300	300-1,100	1,100-2,300	2,300-2,500	2,500
14	0-100	100-1,400	1,400-2,550	2,550-2,750	2,750
Average Unit Thickness Rounded to 50mm	400	850	750	200	2,100

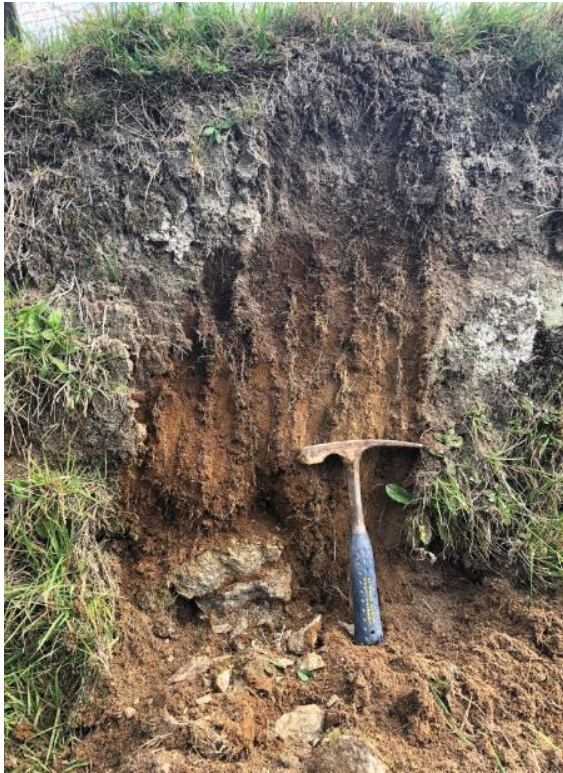
Exposed profile in Road Cut

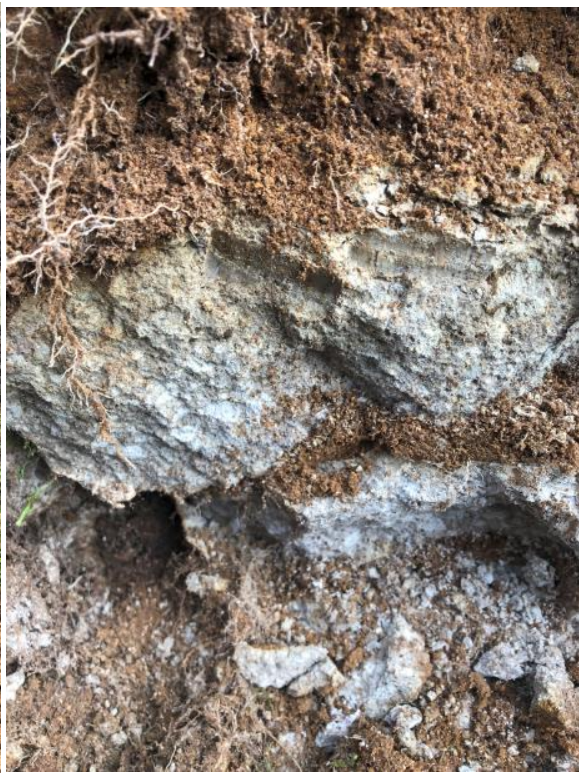
The geological sequence has implications regarding the effectiveness and sustainability of OSET systems operation in Mamaku. The main concern is the presence of the unweathered ignimbrite at around 2 metres depth across the village. This unit will impede the progress of discharged wastewater into the ground, as it will not be able to soak through the rock layer and perch on this low permeability surface. The orange gravelly silt/ash layer overlying ignimbrite was always noted as wet, even after a long dry summer season. This confirms that water in the soil, both natural groundwater and wastewater, perches on the top of the low permeability ignimbrite potentially saturating overlying soils and resulting in surface breakout.

Close up of Mamaku Ignimbrite

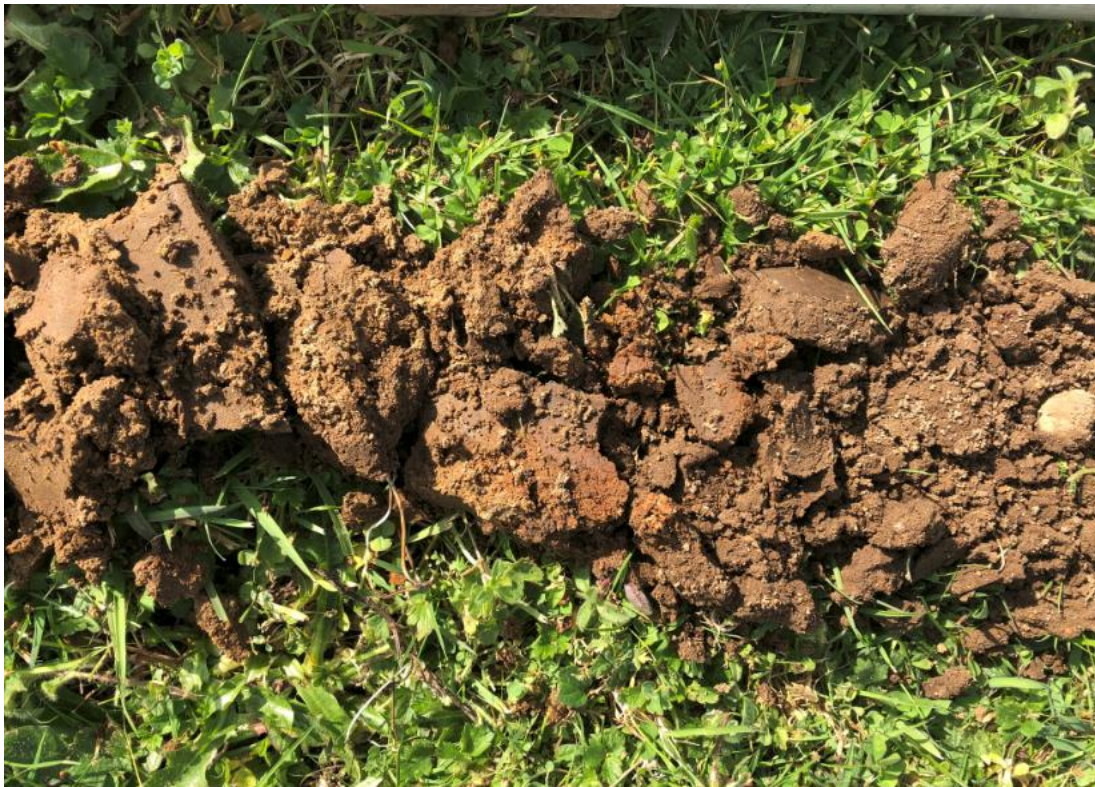
Topsoil and Red-Brown Silty Ash (Dark or-br and red-br, moist, very sticky)

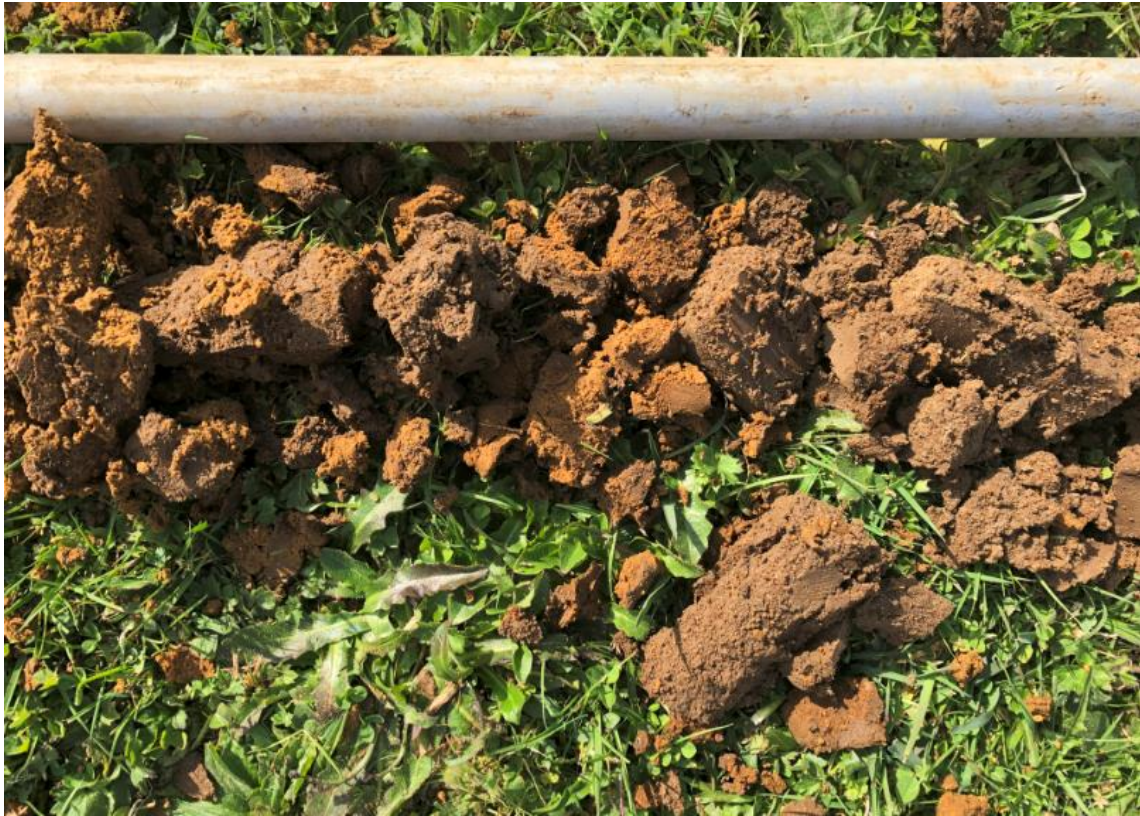
Red Brown Silty Ash transitioning to Orange Gravelly Silt Ash (Orange-brown, wet)

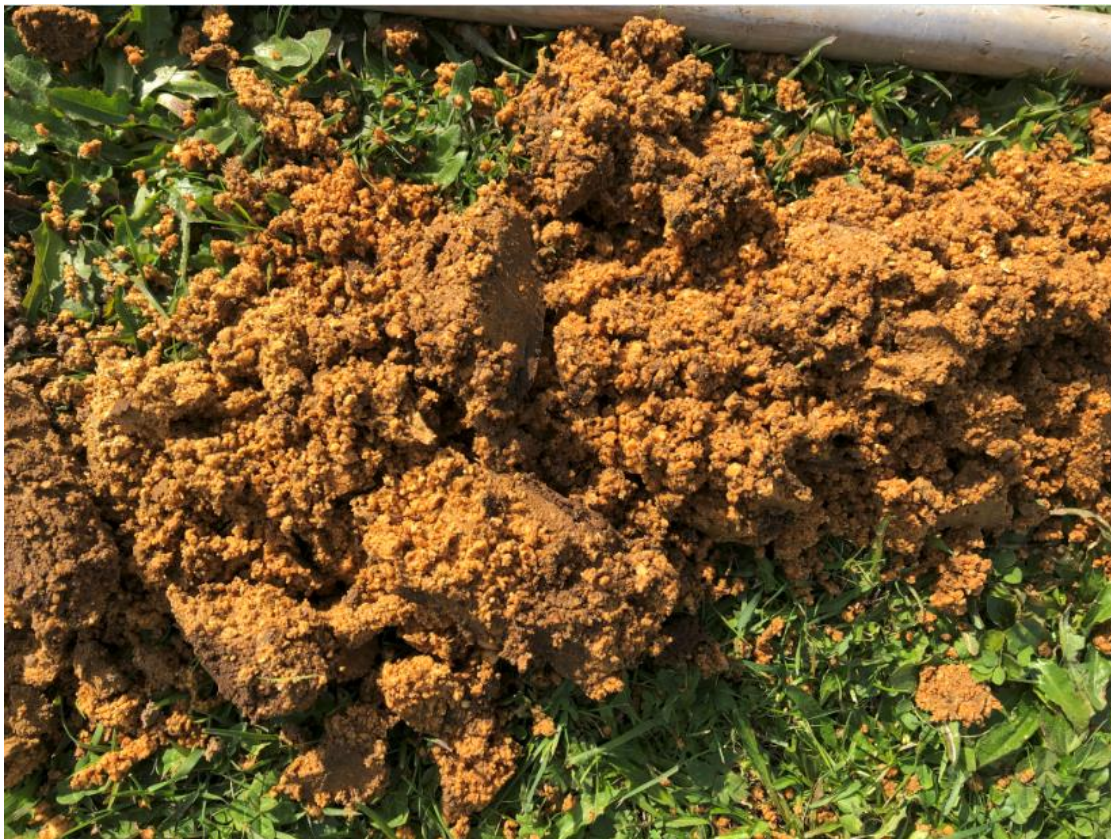
Close up of Orange Gravelly Silt Ash

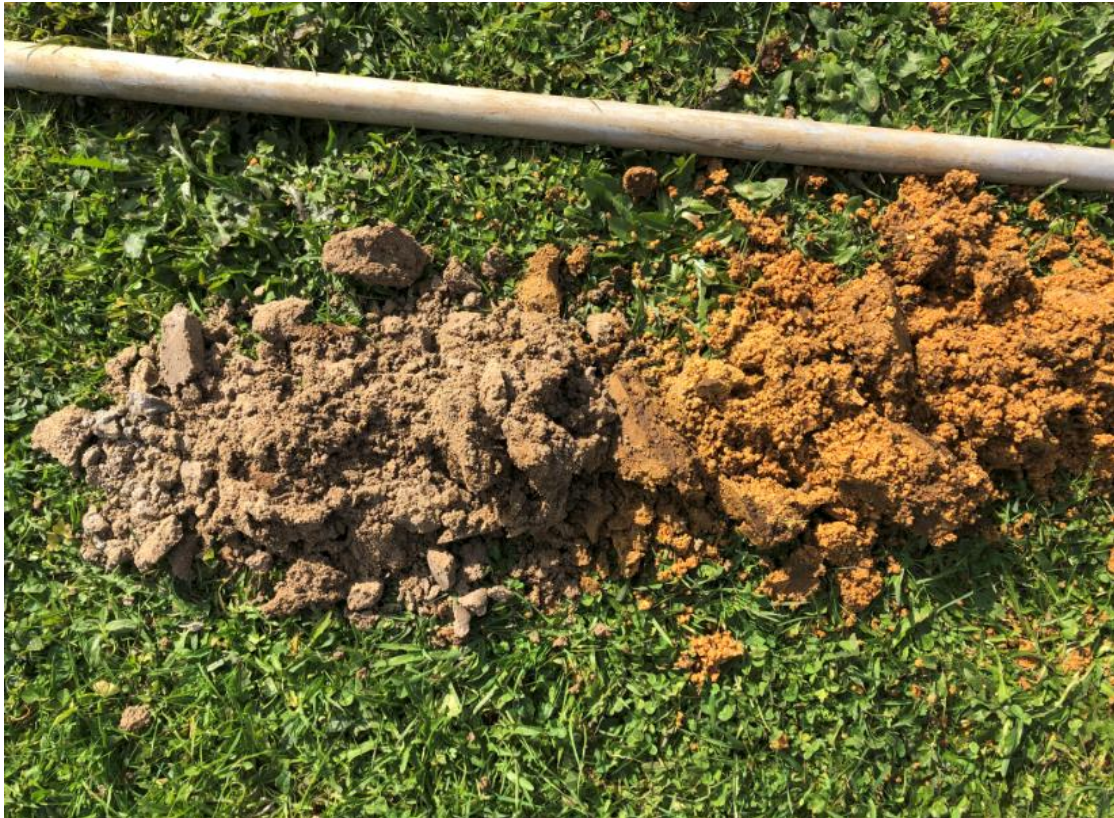
Transition between Gravelly Silt Ash and Weathered Ignimbrite (Silt, light grey, stiff, moist)

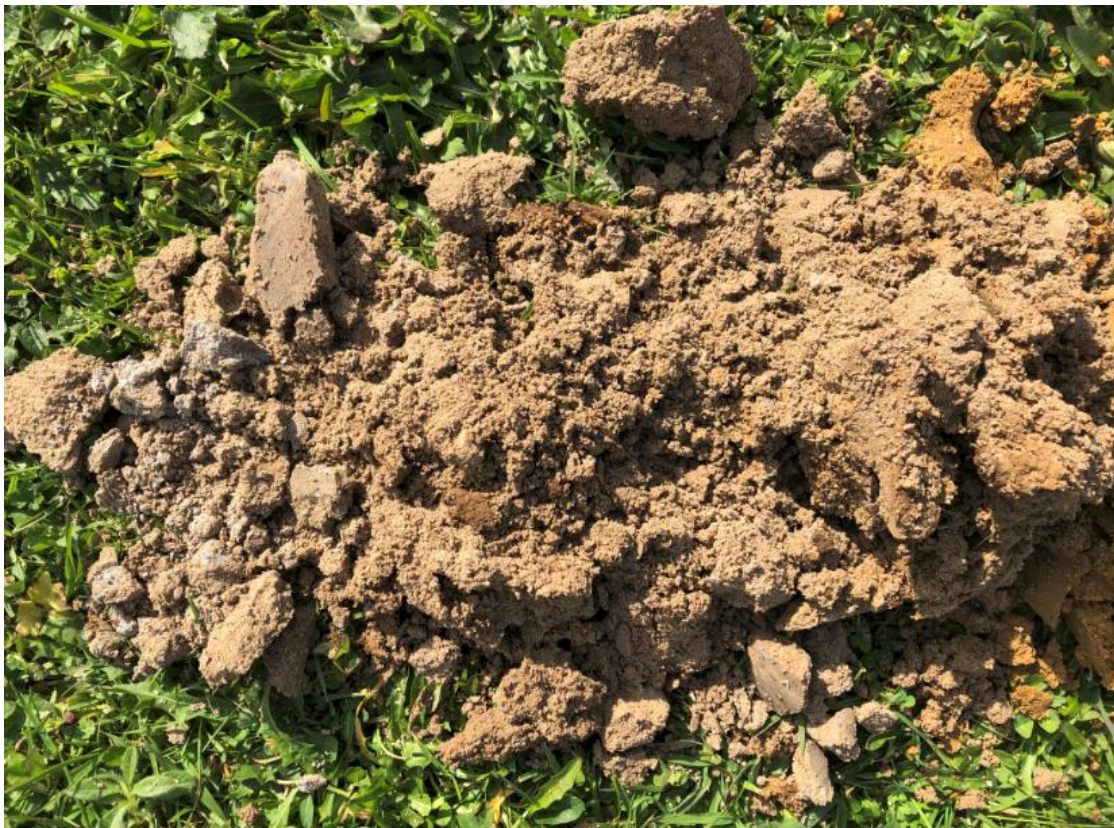
Close up of Weathered Ignimbrite with fragments of unweathered rock (light grey-white) at left
