Investigation into the role of jet boating on bank erosion in the Kaituna River

Prepared for Bay of Plenty Regional Council

February 2012

NIWA Client Report No: CHC2011-088
Report date: February 2012
NIWA Project: EBP10501

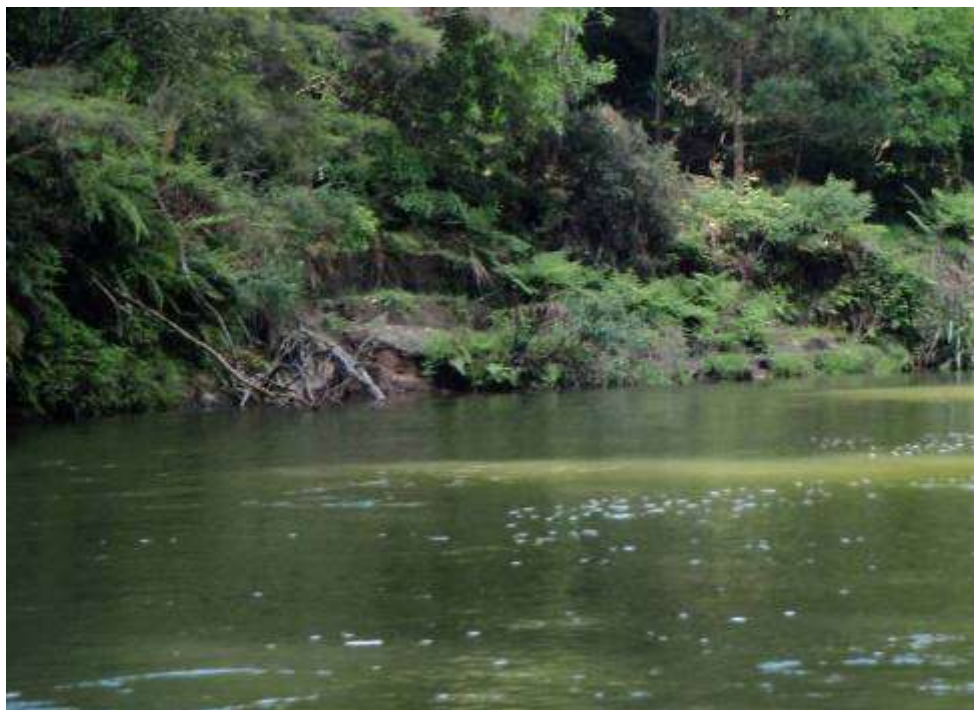
- Slips – Also known as slab failures or gravity collapses. They typically occur on steep banks where blocks of bank material slip vertically into the river (e.g. Figure 1-2).

Figure 1-2: Typical 'slip' type of erosion. Blocks of bank material have slid into the river.

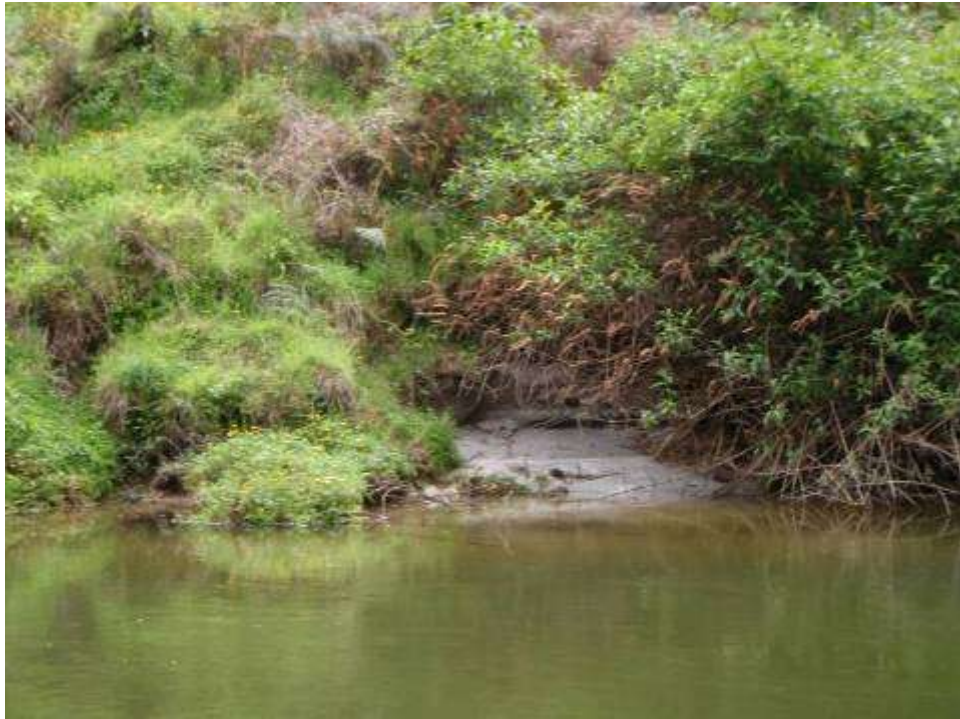
- Slumps – These are mass-failures that occur by rotational collapse; typical of water-logged hillslopes or banks that are high but not particularly steep (e.g. Figure 1-3).

Figure 1-3: Typical 'slump' type of erosion. The same type of erosion was recorded at this site in 2004. This slump extends at least 15 m up the bank.

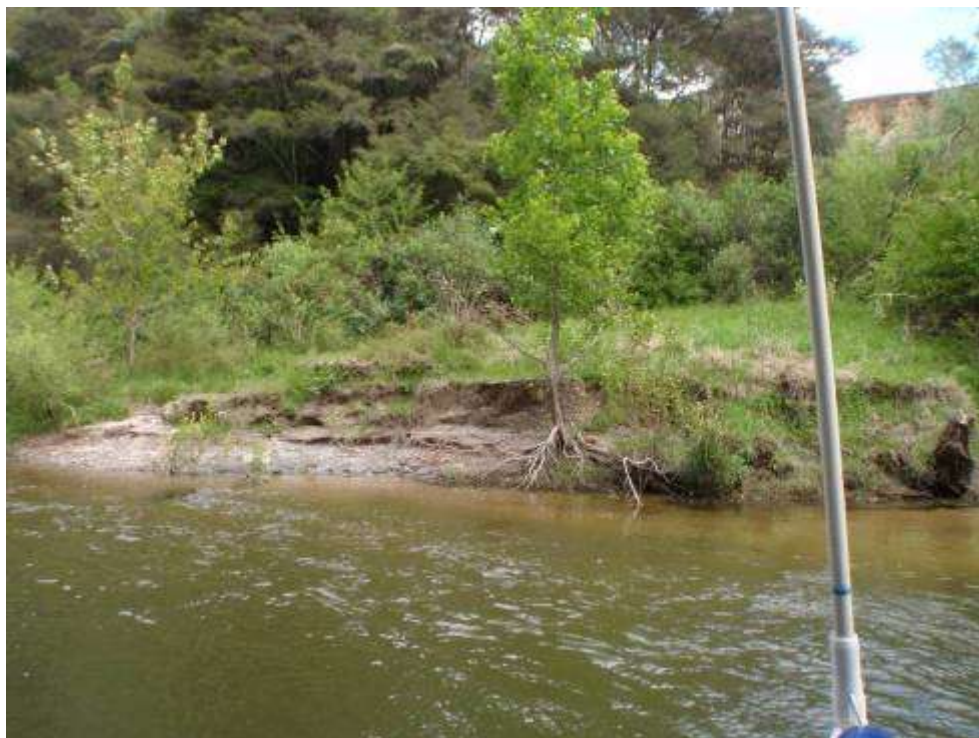
Figure 1-4: Typical erosion of 'gully' material. The head of the gully can be seen in the top right of the photo.

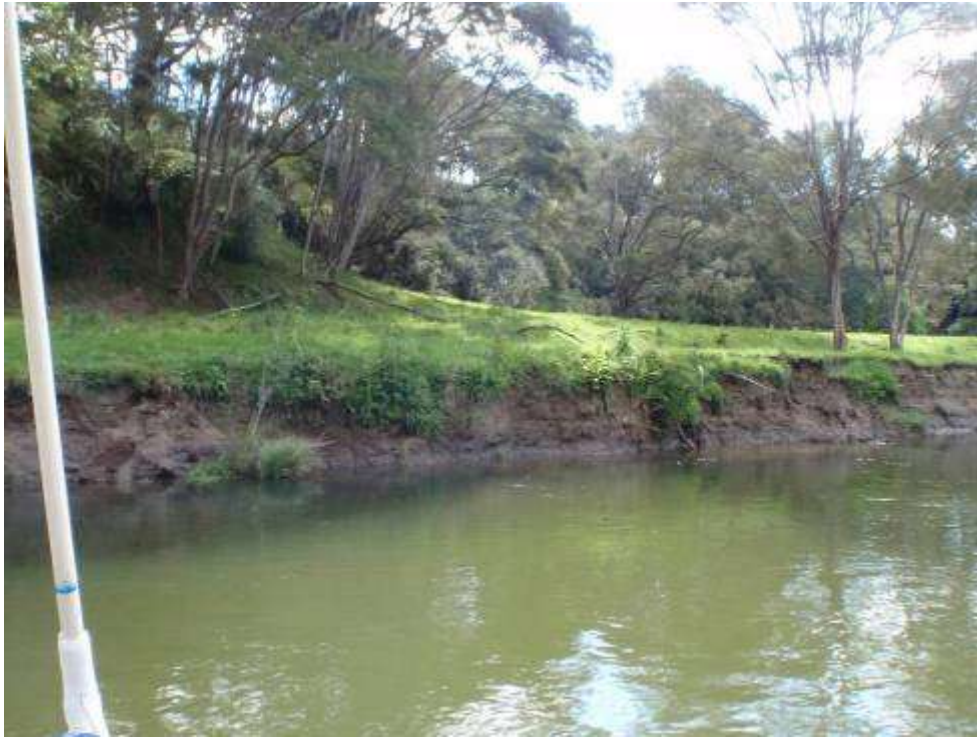
Figure 1-5: Typical 'current scour' type erosion.

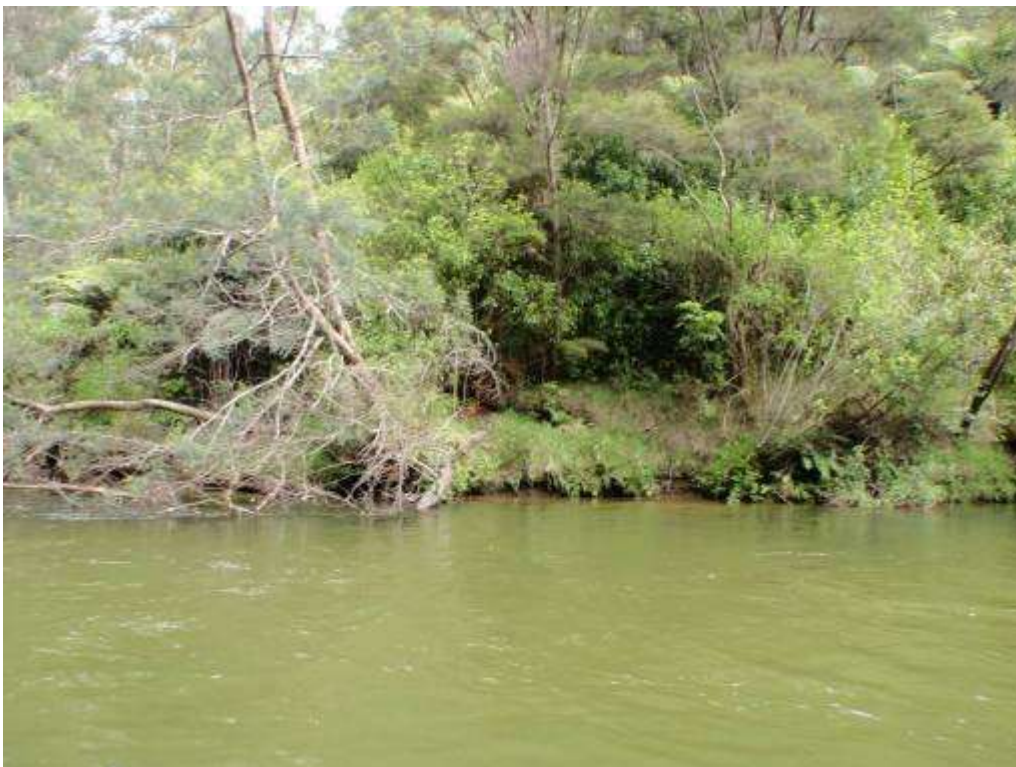
Figure 1-6: Typical 'undercut' bank. Erosion has occurred to the point that a tree has toppled into the river.

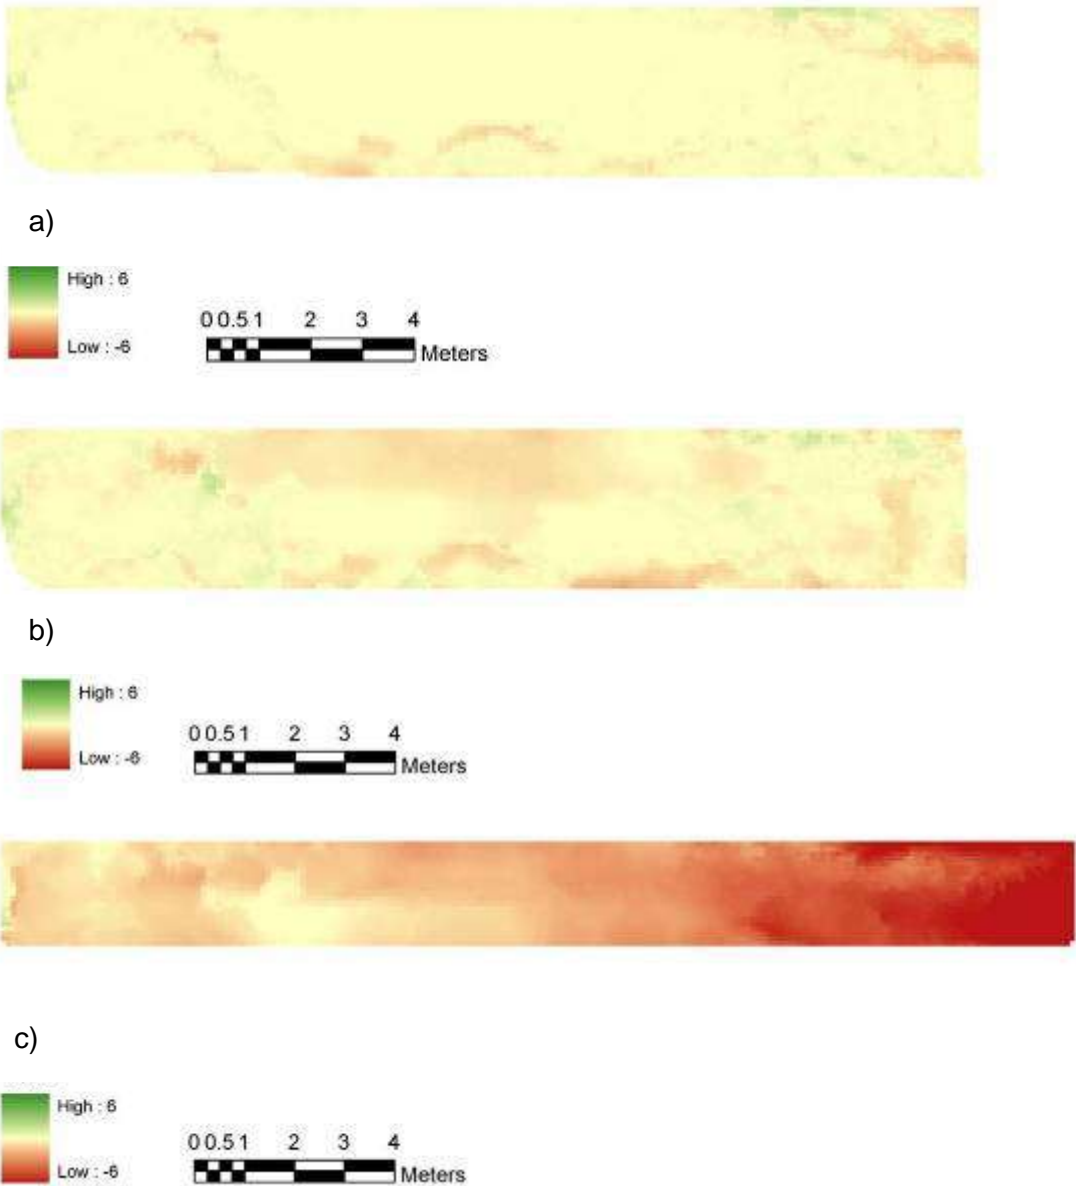
The large section of bank at the downstream end of this site eroded into the river during the January 2011 flood. This can clearly be seen in Figure 3-2 c). This was the section of bank that the surveillance camera was attached to.

Figure 3-2: DEM of difference images for Site 1. a) between scan 1 (December 2009) and scan 2 (March 2010); b) between scan 1 and scan 3 (December 2010); c) between scan 1 and scan 4 (May 2011). Note flow is from left to right.

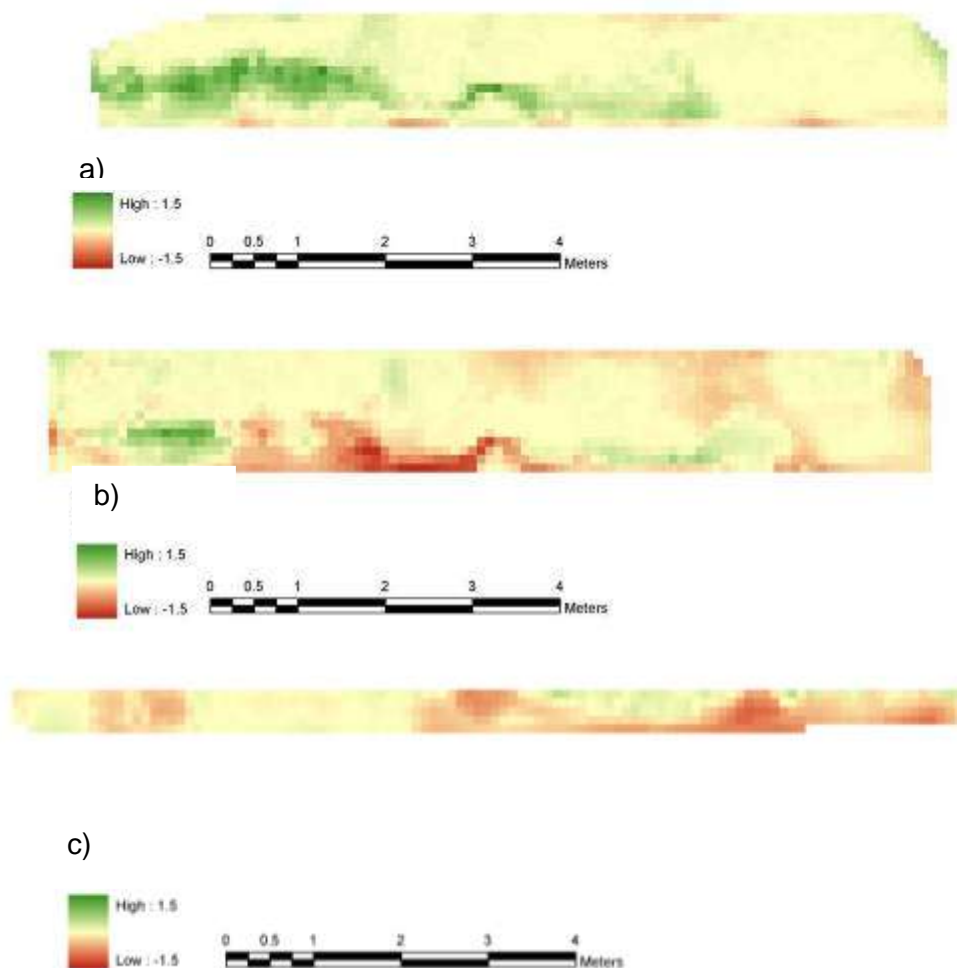
The DEM of difference images for Site 2 are presented in Figure 3-4 and the histograms are presented in Figure 3-5. Mean change over the full area scanned between the first two scans was 14 cm of deposition. This change is more likely vegetation growth than accretion, as a significant increase in vegetation cover was noted at the time of the second scan. Between Scans 1 and 3 the mean change over the area scanned was 8 cm of erosion. Figure 3-4 b) shows that much of this occurred along the toe of the bank. Areas of the previous vegetation growth, particularly at the upstream end of the scan area, clearly remained at the time of the third scan. Between the first and last scan mean change over the area scanned was 19 cm of erosion. The height of bank that was able to be captured during Scan 4 was less than the previous scans, as water level was higher at this time. As a result, the DEM of difference shown in Figure 3-4 c) is a narrower strip of bank. This also means that any further changes along the toe of the bank are obscured.

Figure 3-4: DEM of difference images for Site 2. a) between scan 1 (December 2009) and scan 2 (March 2010); b) between scan 1 and scan 3 (December 2010); c) between scan 1 and scan 4 (May 2011). Note flow is from left to right.

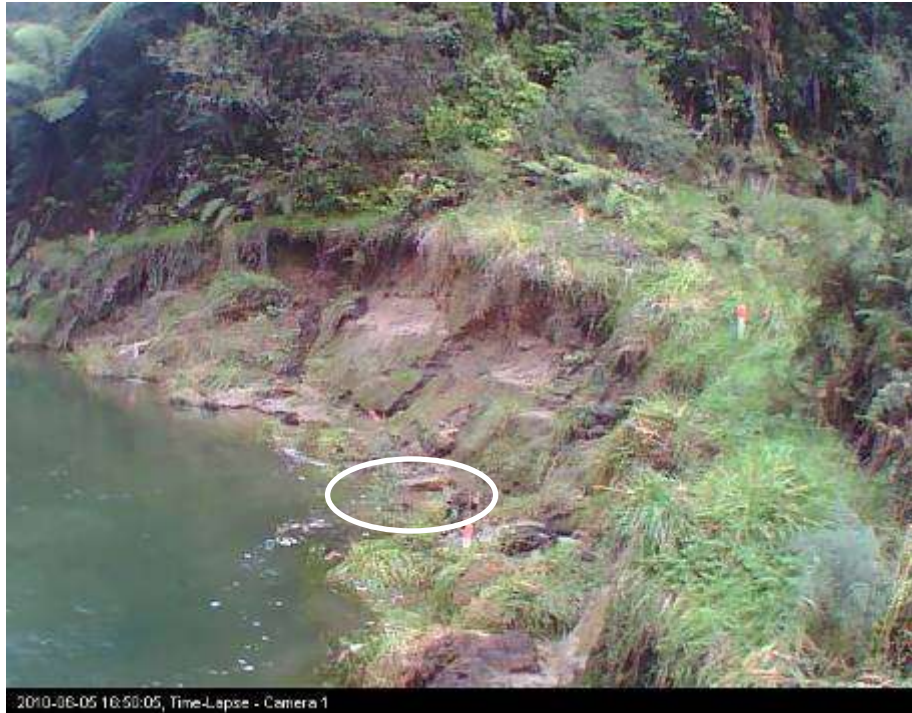
Figure 3-19: Active erosion at waters edge at Site 1 on 5/6/10. 10 mins after previous photo.

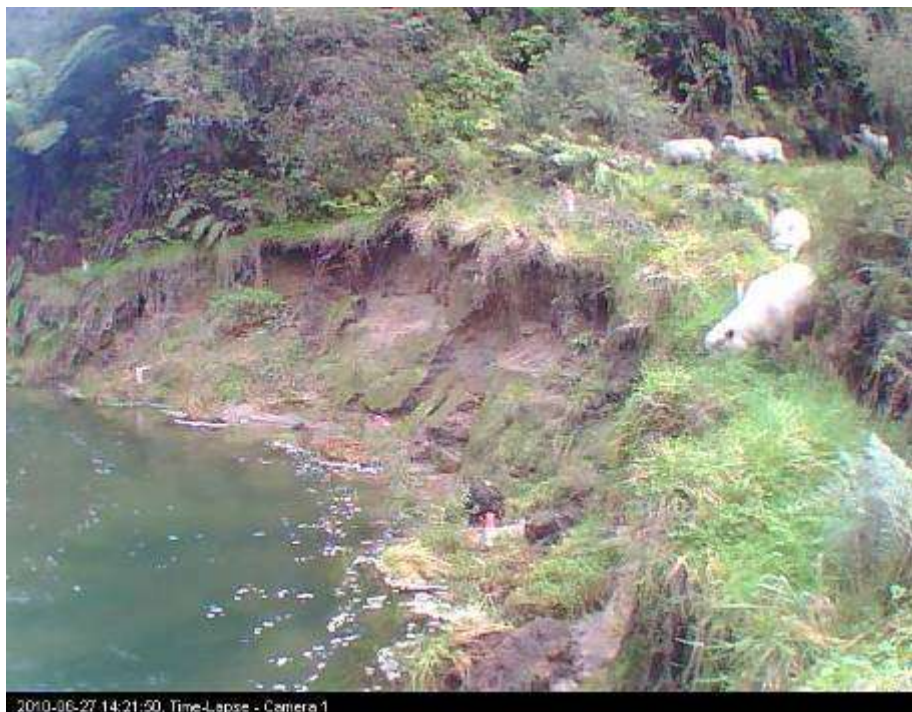
Figure 3-20: Stock access at Site 1 on 27/6/10.

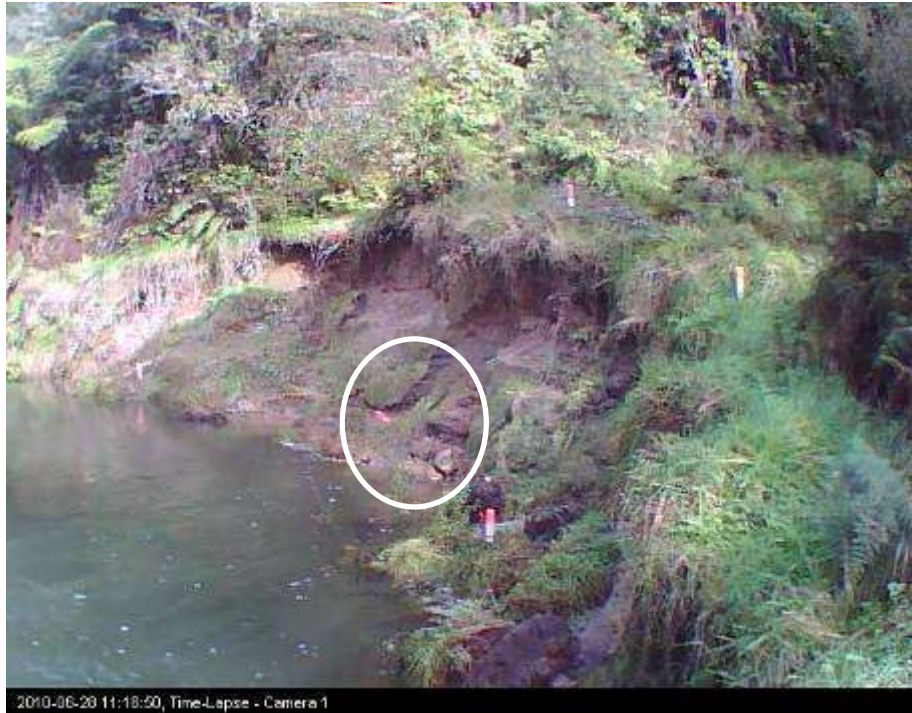
Figures 3-21 and 3-22 are taken 2 hours apart and show a section of bank in the middle of the site slumping into the river. The water at the toe of the bank is also discoloured on Figure 3-22, showing that sediment is being mobilised. This slump may have been caused by jet boating and/or by bank saturation, as this period was preceded by rain. Figure 3-23 shows a wave hitting the toe of the bank and spilling over the vegetation in the foreground. This wave is clearly viewed on the time-lapse movie and is believed to be from a jet boat wake. The following figure (Figure 3-24) is taken 5 minutes later and shows no apparent change. However, Figure 3-25 is taken 25 minutes later and clearly shows that the water is discoloured. During the remaining part of this day, the water cleared and became murky again. This is believed to be the result of a jet boat passing up and down the river. Figures 3-26 and 3-27 show further slumping in the middle part of the bank on 8 August 2010. This corresponds with a flow peak apparent on the hydrograph in Figure 3-15.

Figure 3-21:Area of erosion at waters edge at Site 1 on 28/6/10. See following figure for same site 2 hrs later.

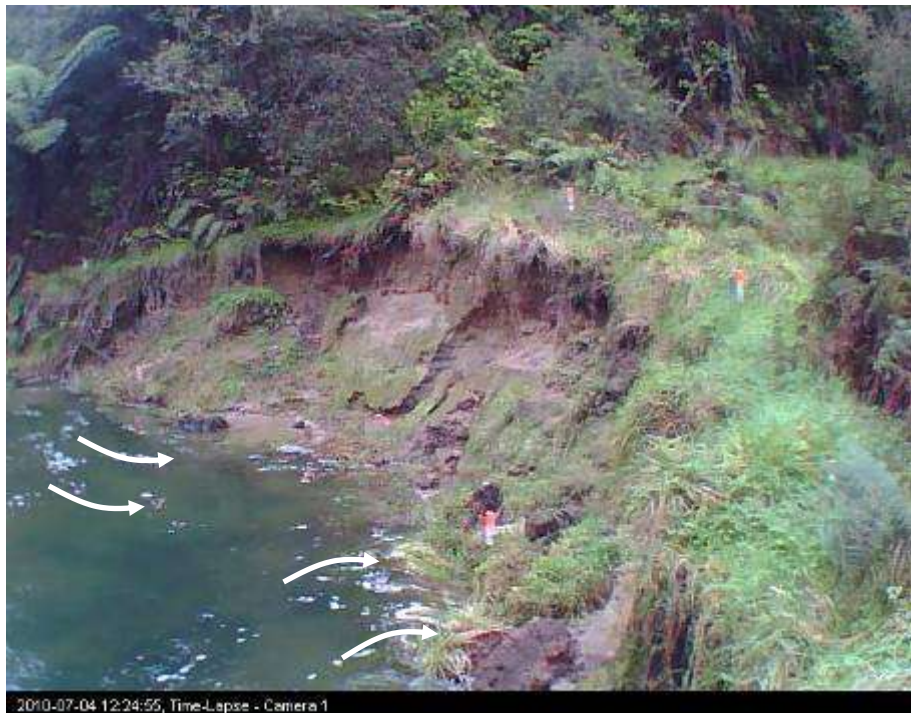
Figure 3-23:Site 1 on 4/7/10 at 12:25, just as a small wave is hitting the bank. It is assumed that this wave has been generated by a jet boat.

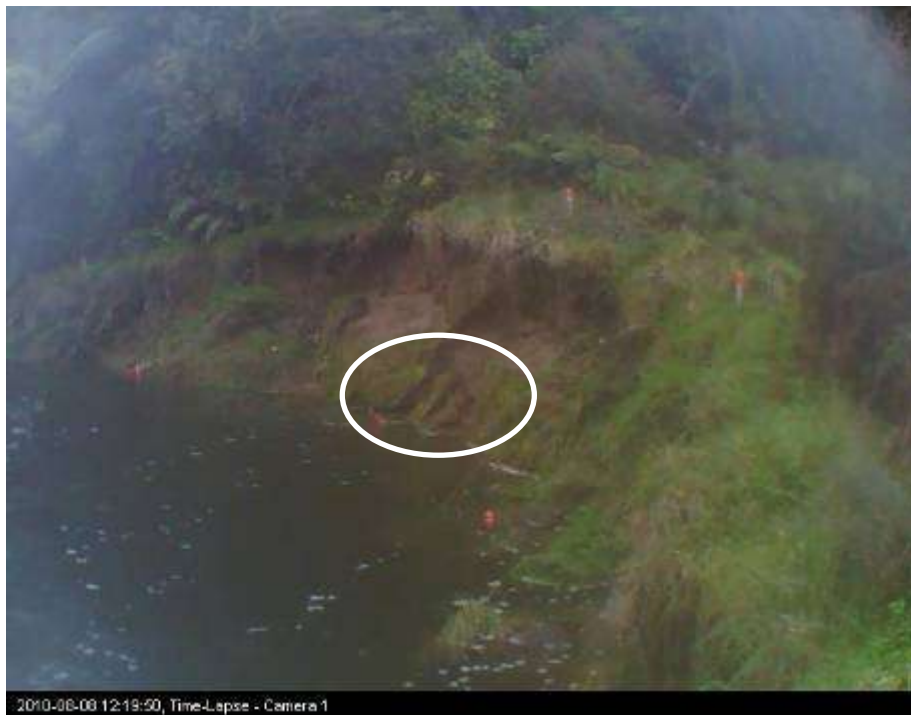
Figure 3-26: Active erosion at waters edge at Site 1 on 8/8/10 at 12:20. See the following figure for the same site 5 mins later.

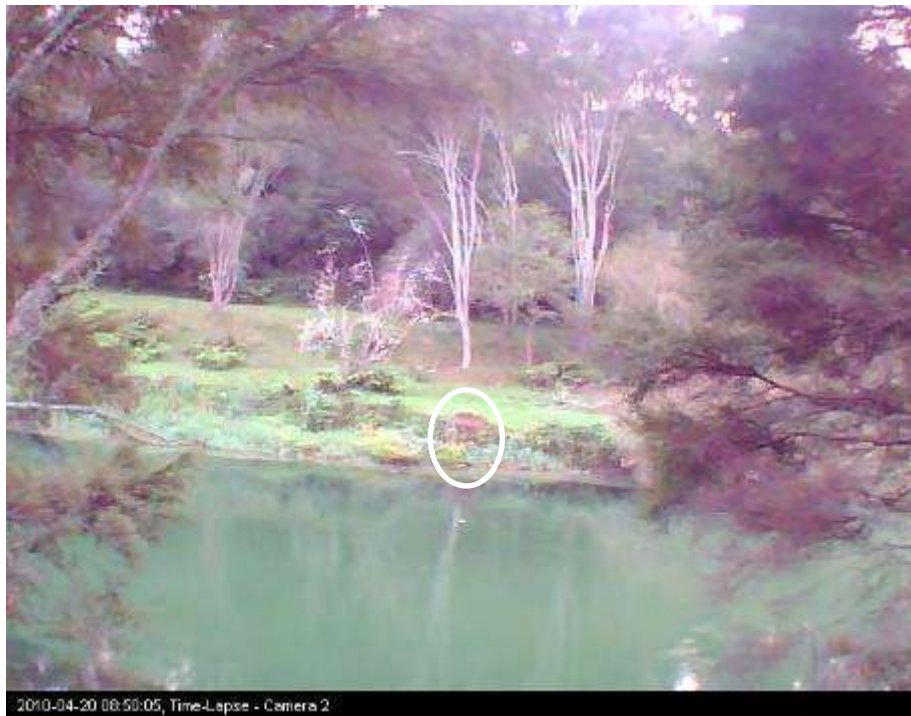
Figure 3-30:The first clear photo of Site 2 on the morning of 20/4/10 showing an area of new erosion (circled).

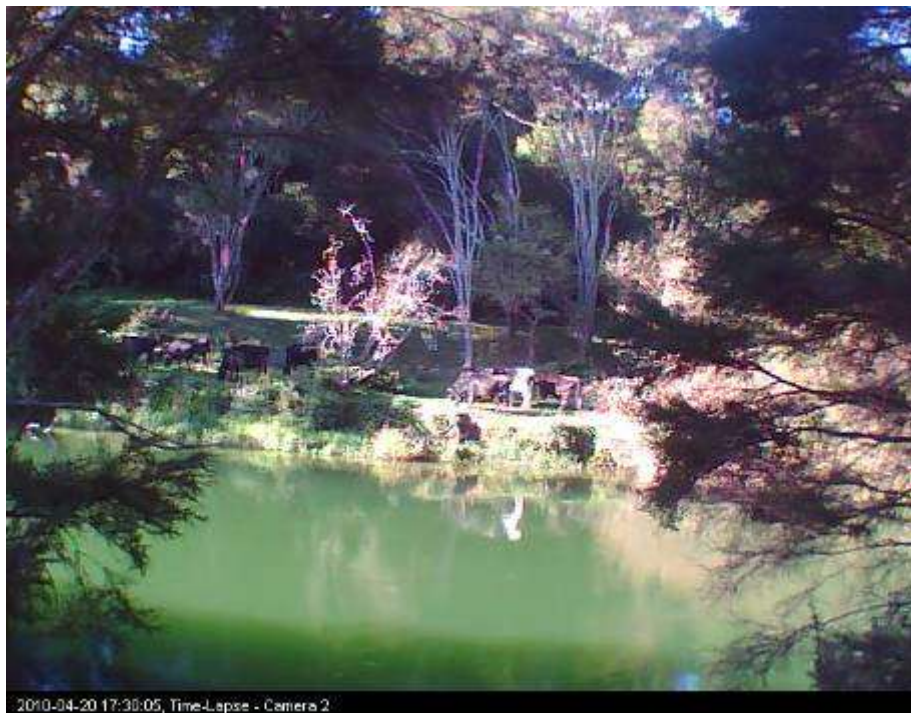
Figure 3-31:Cows grazing at Site 2 later on 20/4/10 (17:30).

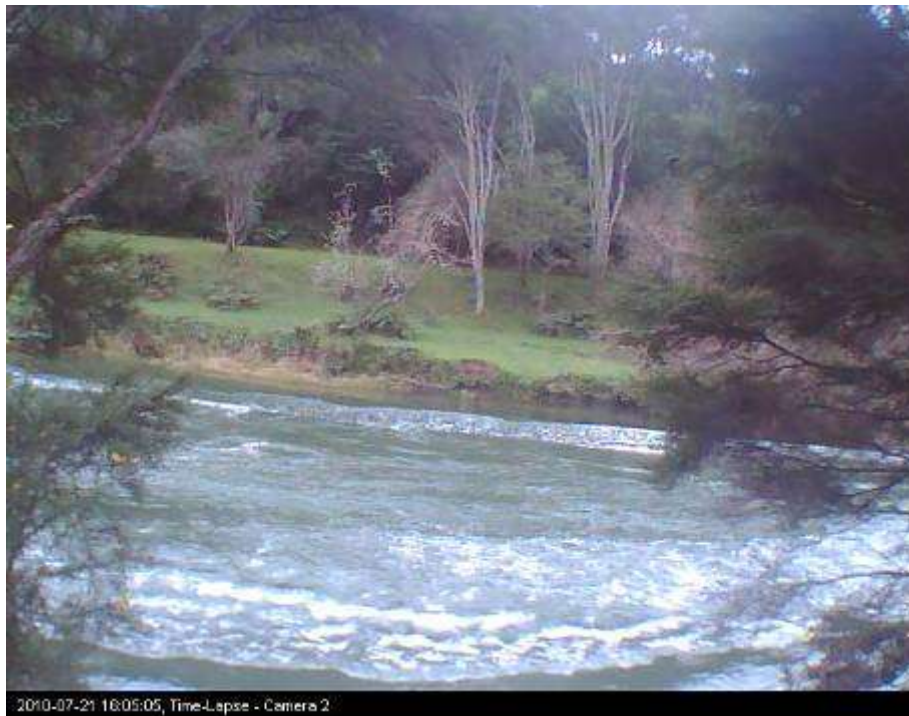
Figure 3-34:Site 2 showing the wake of a boat (presumably the commercial jet boat) just prior to it hitting the bank on 21/7/10.

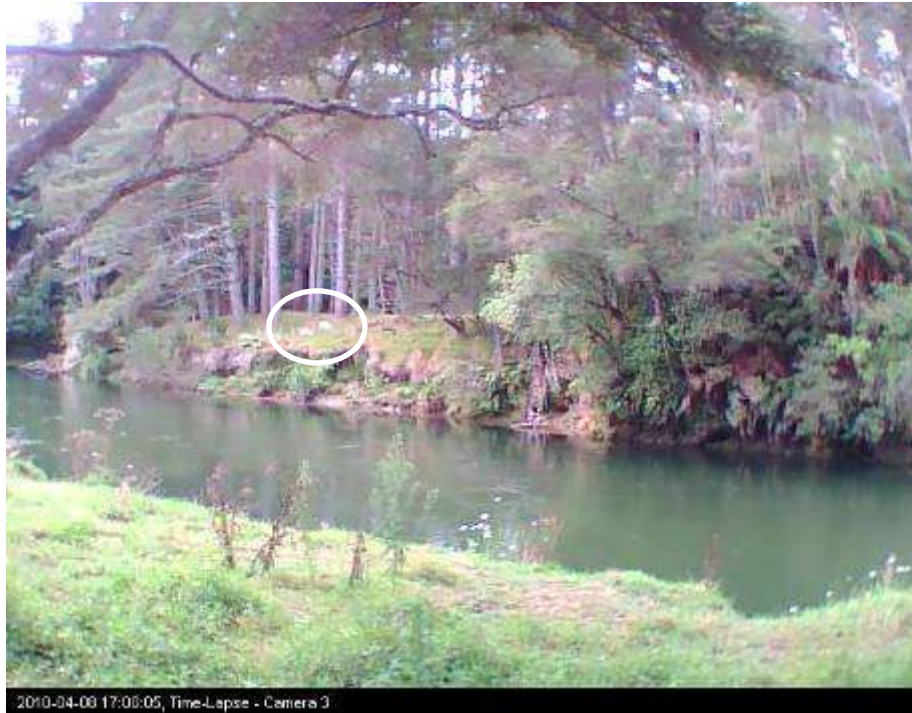
Figure 3-37: Stock access at Site 3 on 8/4/10.

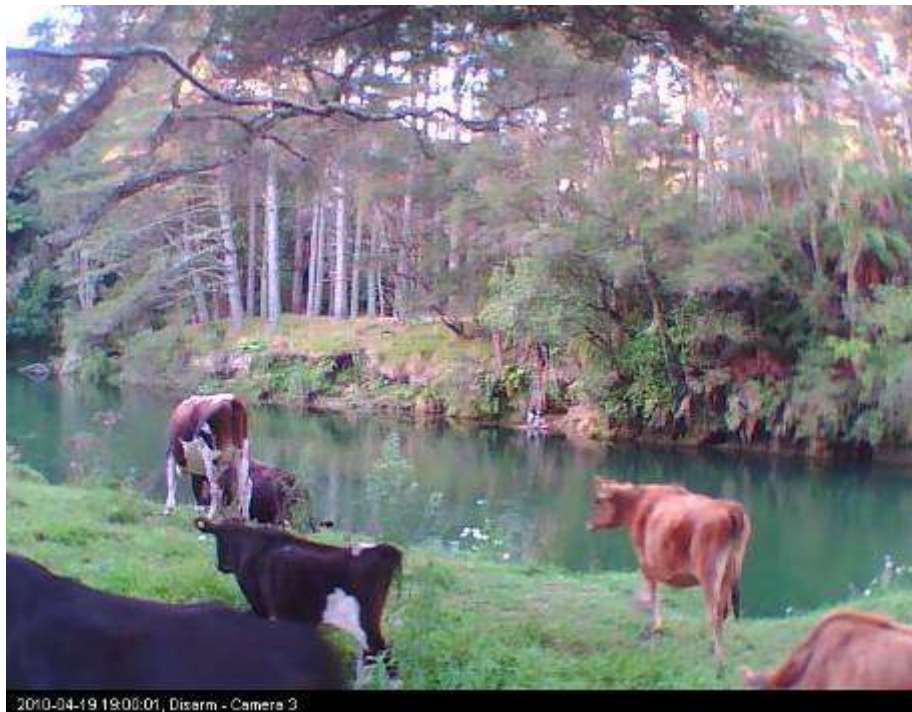
Figure 3-38: Stock access opposite Site 3 on 19/4/10 at camera set up location.

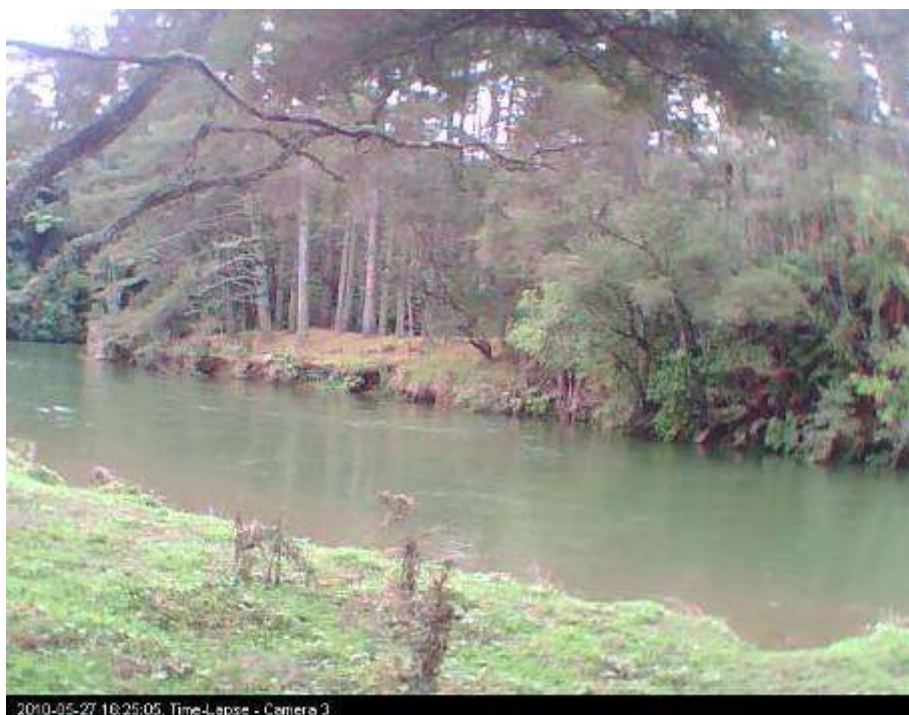
Figure 3-45:Site 3 on 27/5/10 at 16:25. Taken 5 mins after jet boat passes. Although not as extreme as the photo taken at 12:15, this photograph also shows suspended sediment along the bank opposite Site 3.

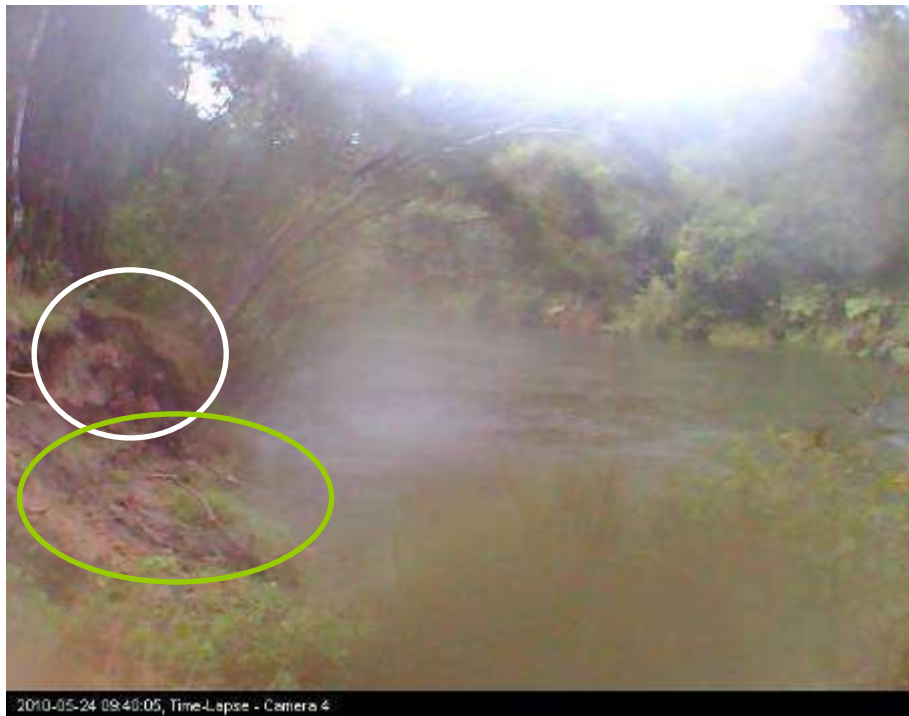
Figure 3-51: Site 4 on 24/5/10 immediately prior to flood of 25/5/10. Circled area is the site of soil loss (white) and vegetation removal (green) apparent after flood waters recede.

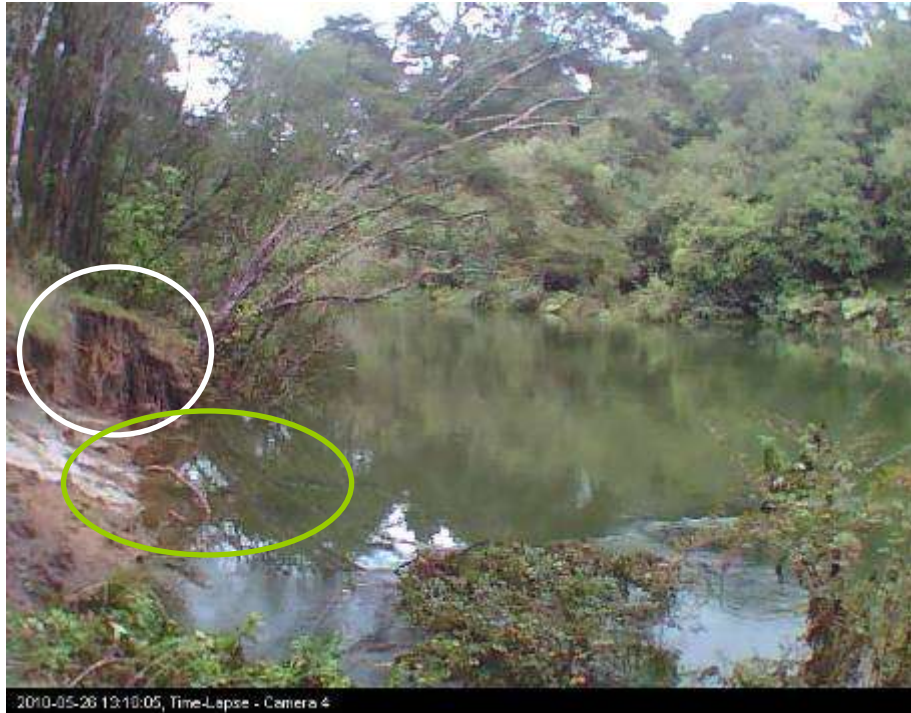
Figure 3-53: Site 4 after flood waters had receded on 26/5/10. Circed areas show site of soil loss (white) and vegetation removal (green) in comparison with photo taken on 24/5/10.

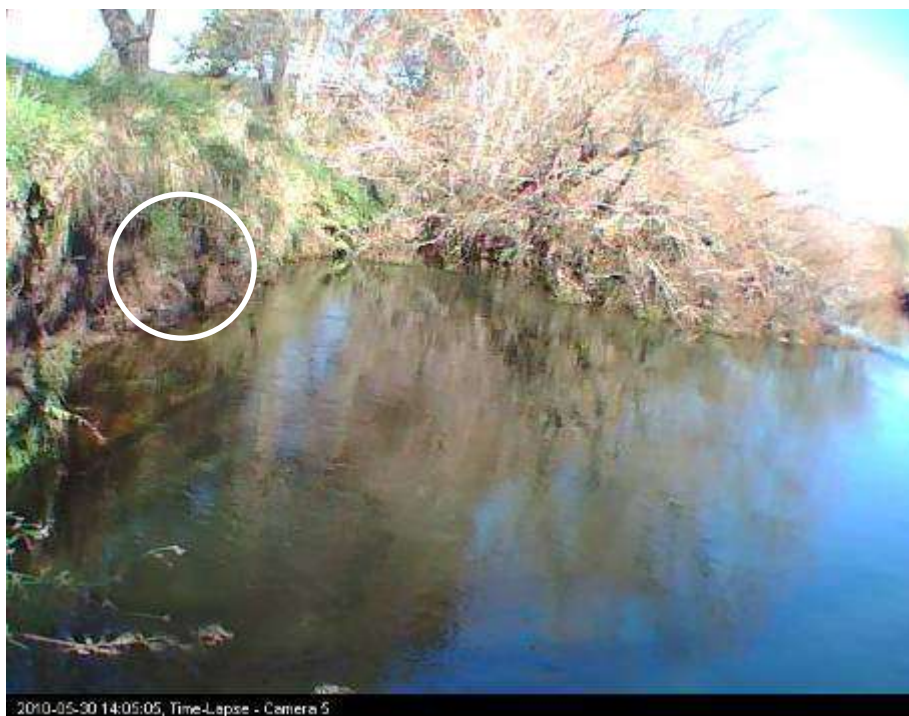
Figure 3-58:Site 5 on the 30/5/10. This is the first clear photo of the bank after floodwaters receded. Note some vegetation removal is circled.

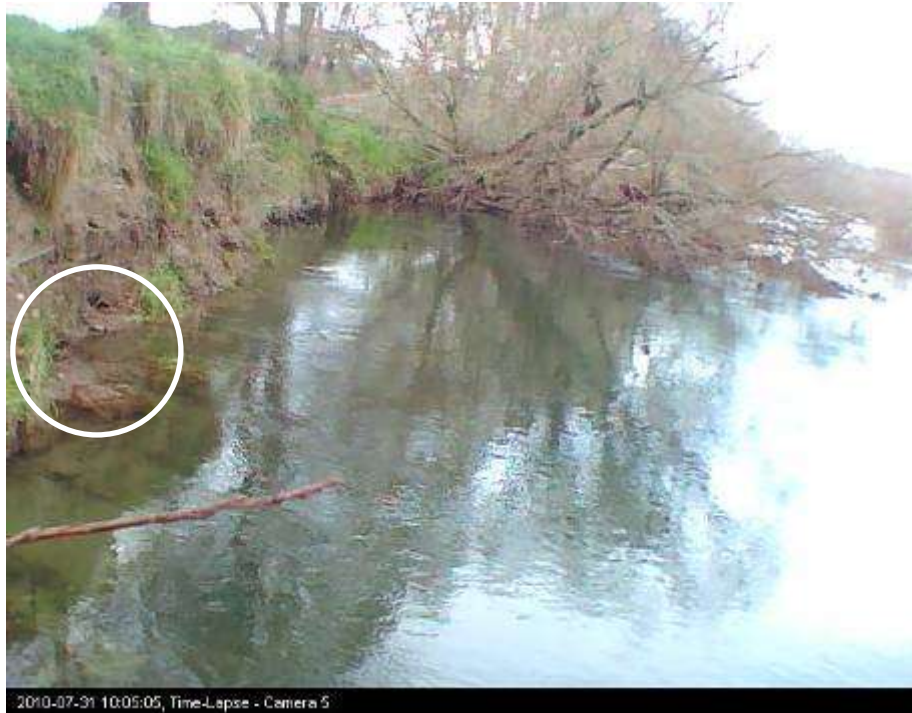
Figure 3-59:Erosion at waters edge of Site 5 on 31/7/10. Compare with following photo.

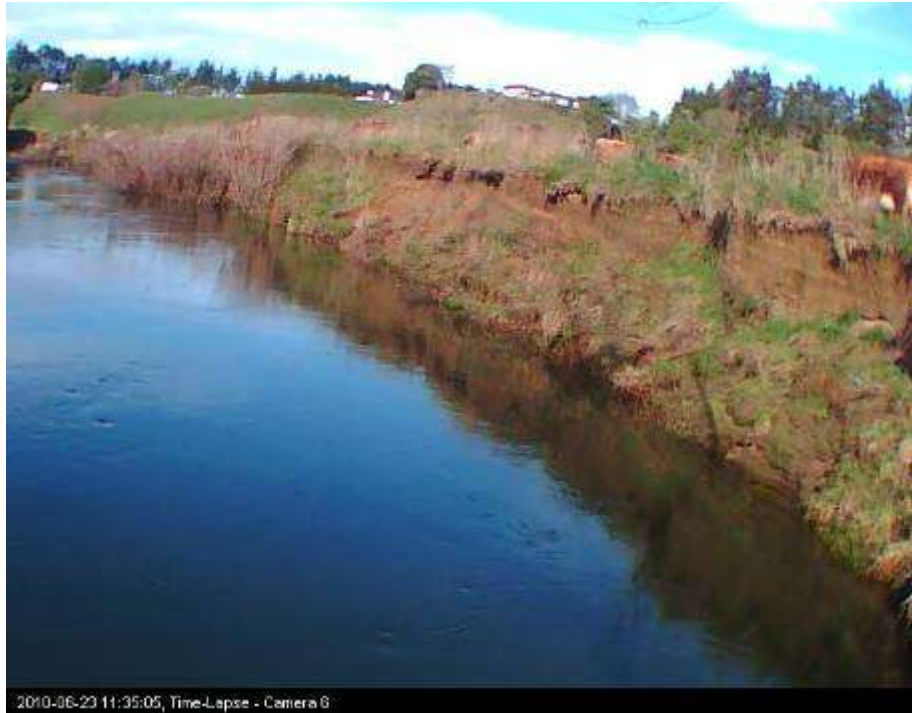
Figure 3-68:Cows at Site 6 on 23/6/10.

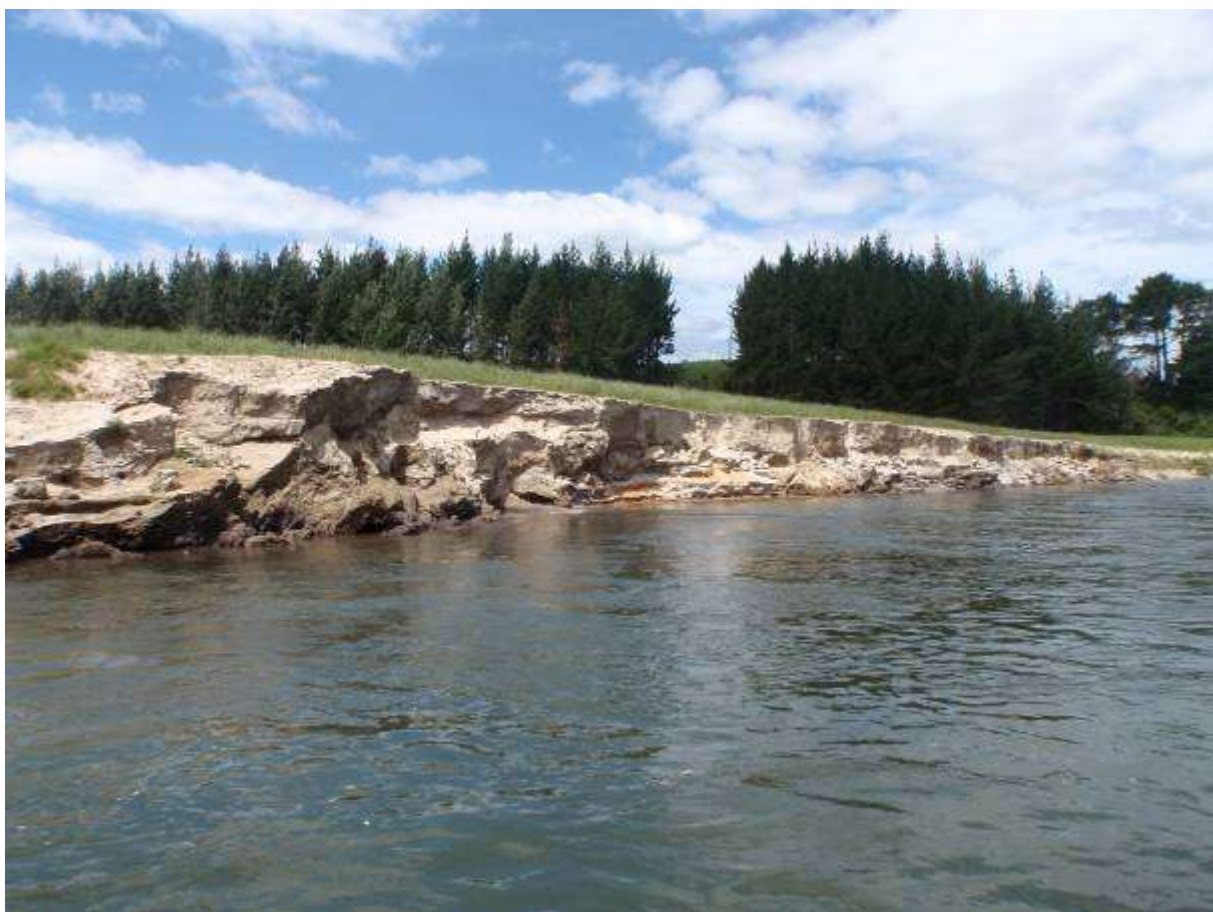
Figure 3-74:Photograph taken at Site 7 on 6/12/10 showing erosion following engineering works.
