1 Introduction

A breach occurred in the Rangitiaki River stopbank adjacent to Hydro Road, just upstream of Edgecumbe, at approximately 10am on Sunday 18th July 2004. The river was flowing very high at the time and water poured through the breach causing serious flooding of farmland, the railway, roads, and buildings downstream. The breach in the stopbank widened to about 100m and water flowed through for several days. Photograph 1 shows the breach from the air and Figure 1, prepared by Environment Bay of Plenty (EBOP), shows the extent of the flooding which resulted. As the breach occurred on Sullivan's farm it is referred to as Sullivan's Breach.

Ice Geo and Civil has been commissioned by EBOP to investigate the causes of Sullivan's Breach. This report discusses the following:

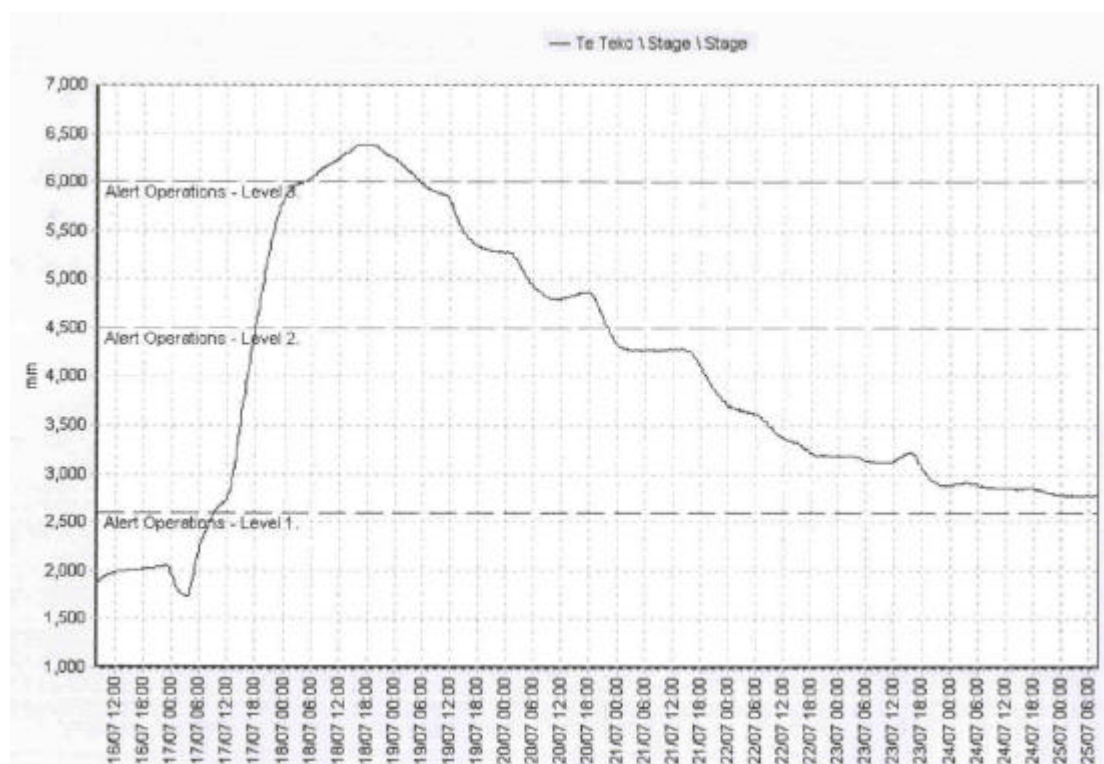
The high rainfall caused a rapid rise in the Rangitaiki River. Figure 2 shows the hydrograph measured in the river at Te Teko, about 11km upstream from the breach site. Fortunately the upper catchment of the Rangitaiki River received only about 120mm of rain and not nearer the 300mm experienced in the rest of the catchment.

Figure 2: Flood hydrograph measured at Te Teko (EBOP)

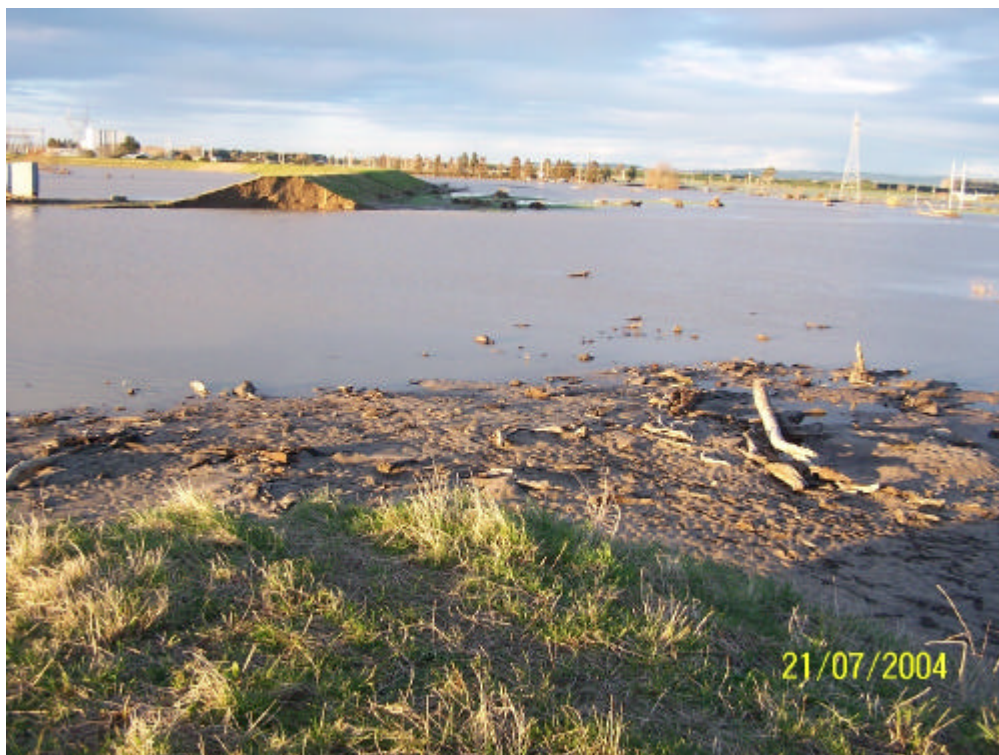
collapse into the flow. Photograph 2 shows the opening three days after the breach when the river level had dropped significantly.

Photograph 2: Looking downstream three days after the initial breach

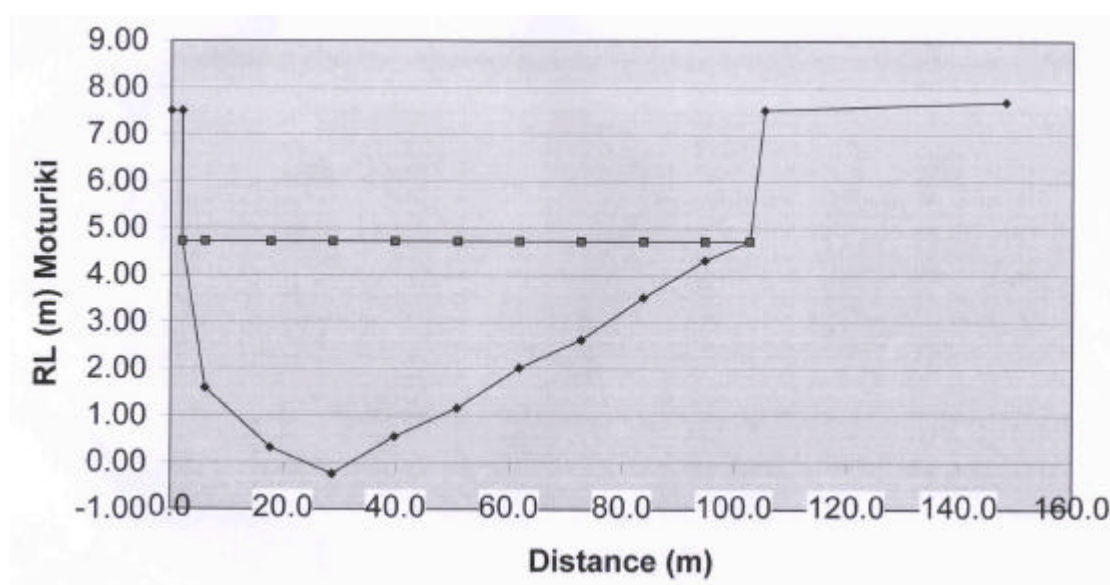
The large volume of water which flowed through the breach scoured out a hole nearly 5m deep where the stopbank had been (Figure 3). The scour hole extended inland about 150m from the stopbank centreline, typically reducing in depth with increasing distance from the stopbank (Figure 4, Photograph 3). About 5m beyond the end of the scour hole was a shallow depression which was later found to be an old abandoned stream channel.

Figure 3: Cross section of scour hole along line of stopbank (EBOP)

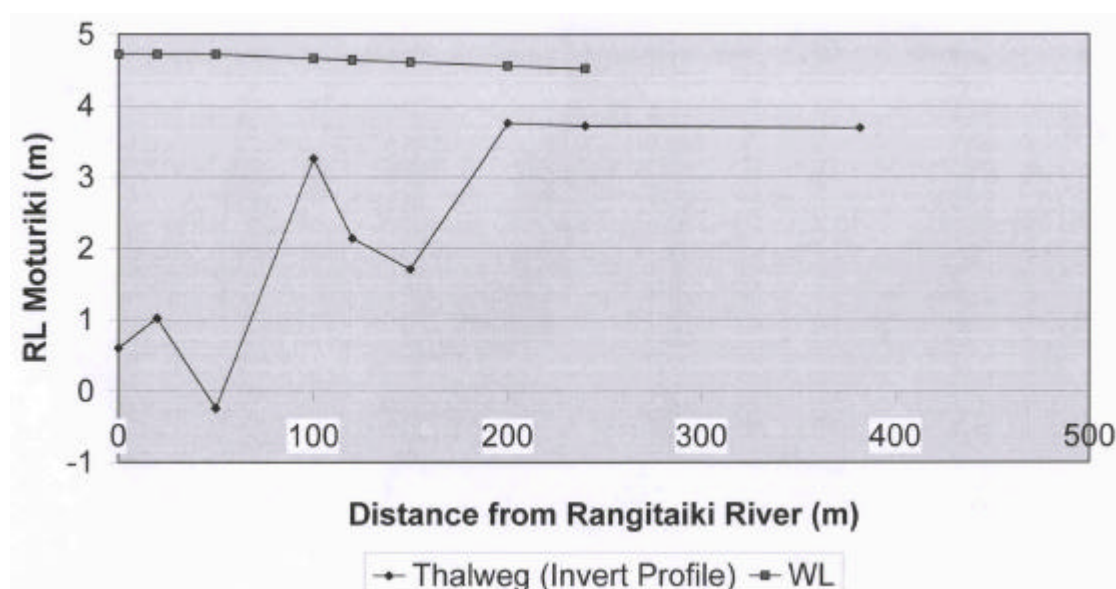
Figure 4: Long section along scour hole from river to Hydro Road (EBOP)

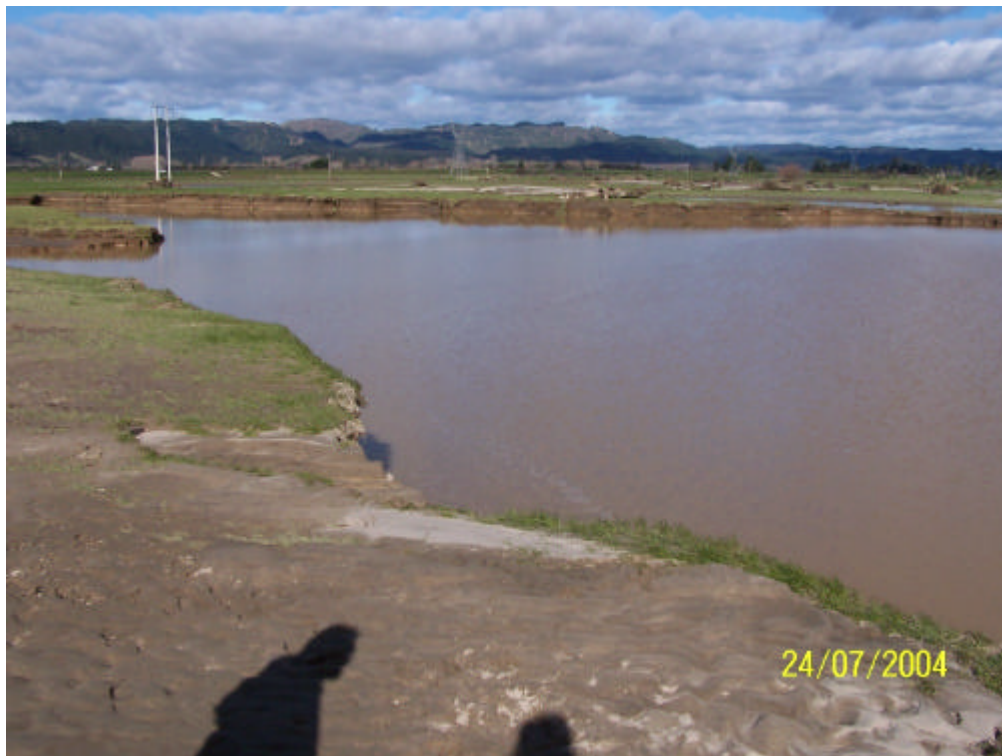
There were large tree stumps and slabs of peat within the scour hole when the water level dropped. These slabs of fibrous peat were up to 2m across and 300mm thick. There were no signs of peat around the edges of the hole and none was found in the later subsurface investigations. It is assumed that the peat and stumps came from further upstream, possibly where the earthquake faultline crosses the river and stumps are exposed in the river bed.

Photograph 3 : Scoured hole

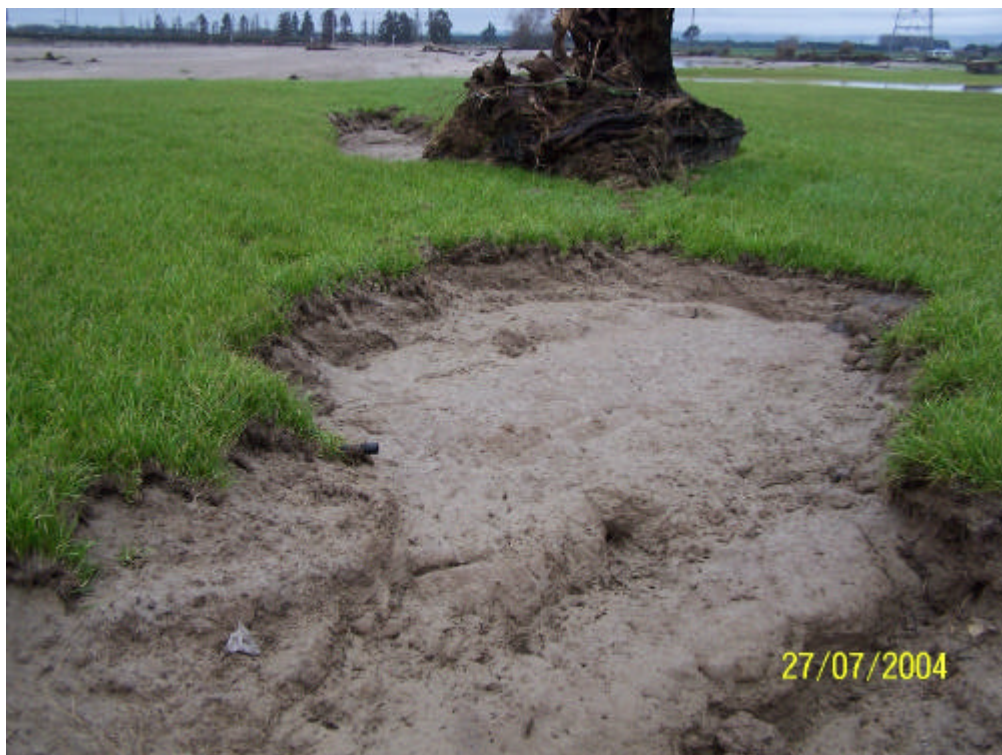
Around the edges of the hole there were fingers of ground where approximately the upper 200mm of soil had been removed. The paddock had been ploughed, rotary hoed and re-sown in February 2004 following its use for growing water melons. The grass roots were not well established and the sown rows of grass were obvious. It is considered that the depth of soil lost in these fingers coincides with the depth of ploughing (Photograph 4).

Photograph 4: Loss of upper soil layer

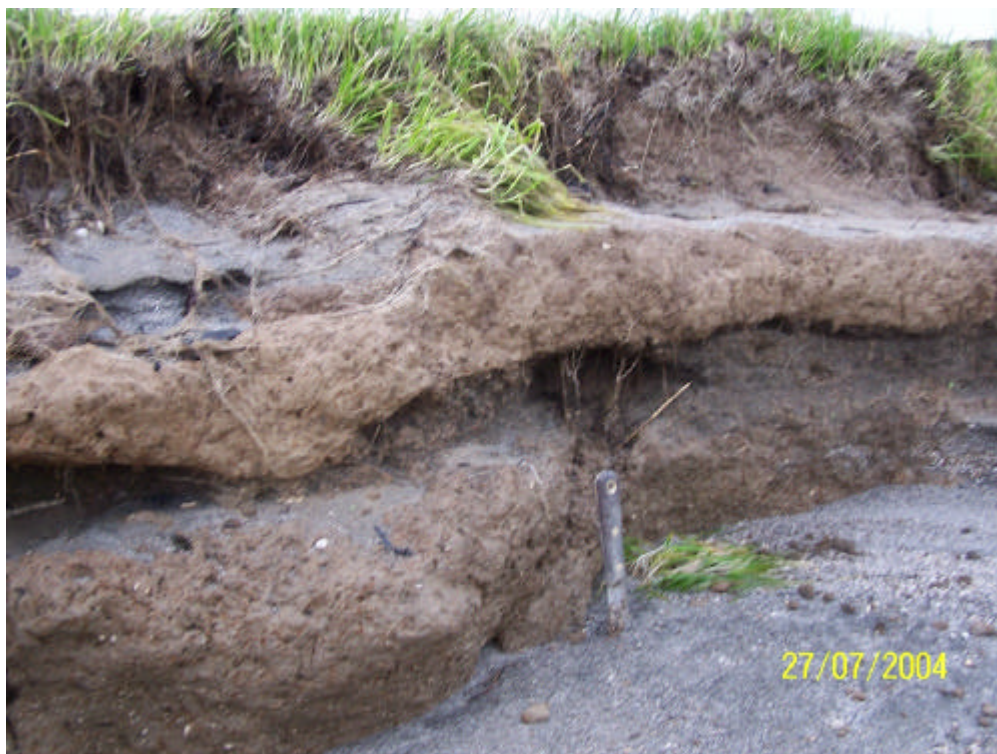
There was often another step in the depth of soil lost from the ploughed depth to about 300 to 400mm below the original ground level. This coincided with a layer of Tarawera Ash across the site. This ash was airfall deposited in 1886 and consists of a coarse abrasive black basaltic sand. It could be seen all around the edges of the scour hole and under the exposed end of the stopbank (Photographs 5 and 6). The thickness of the ash layer varies from about 70mm to 200mm. In some small areas there was a thin layer of fine sand within the predominantly silty soil above the Tarawera Ash.

Photograph 5: Ploughed depth and Tarawera Ash layer

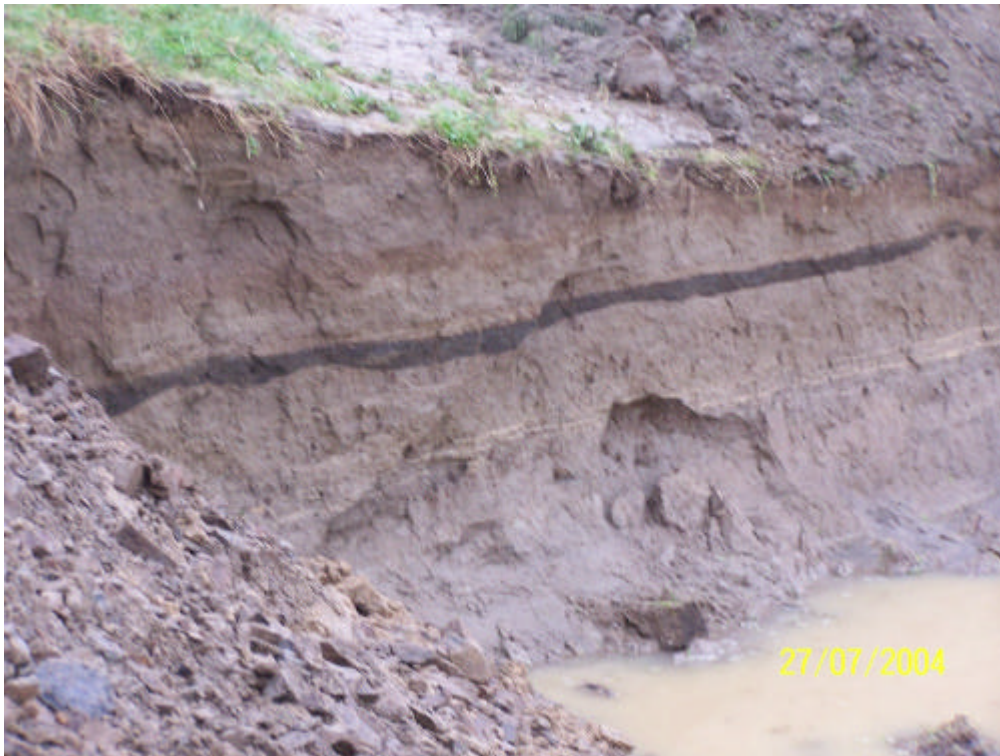
At the toe of the stopbank on the downstream side of the breach it was observed that the surface soils consisted of about 300mm of silty fine sand overlying 75mm of Tarawera Ash and more silty fine sand (Photograph 6).

About 6m from the toe of the breach the combined thickness of these three layers was only about 600mm and they were underlain by a loose fine to medium grained sand. Around the scour hole it could be seen that this sand layer had been removed by water flow causing overhangs and cracks in the slightly cohesive layers above (Photograph 7). Eventually the sand removal would cause collapse of the upper layers. Further out from the stopbank toe the fine to medium sand layer was only about 400mm below the ground surface.

Photograph 6: Exposure at landward toe of stopbank, downstream end of breach showing black Tarawera Ash layer

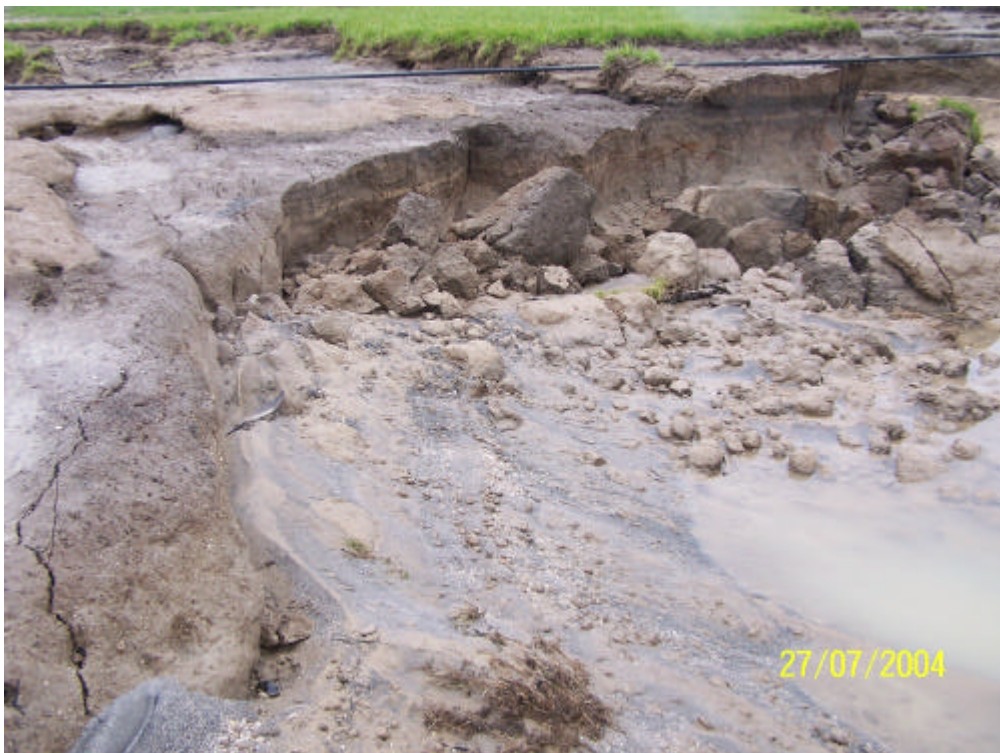
Photograph 7: Cracking and collapse of slightly cohesive upper soil layers at the far end of the scour hole

At the far end of the scour hole (Photograph 7) where about 200mm of the upper soil had been removed, pieces of broken glass, a large diameter steel rod and a piece of wire cable were found. It was thought these may have come from an old rubbish hole on the farm. Neither the present farmer or the previous owner can recall a rubbish hole in this vicinity. The previous owner did recall a spongy area in the paddock "50 to 80 yards" from the stopbank toe when the river was in flood. An alkathene pipe had been exposed at the end of the breach.

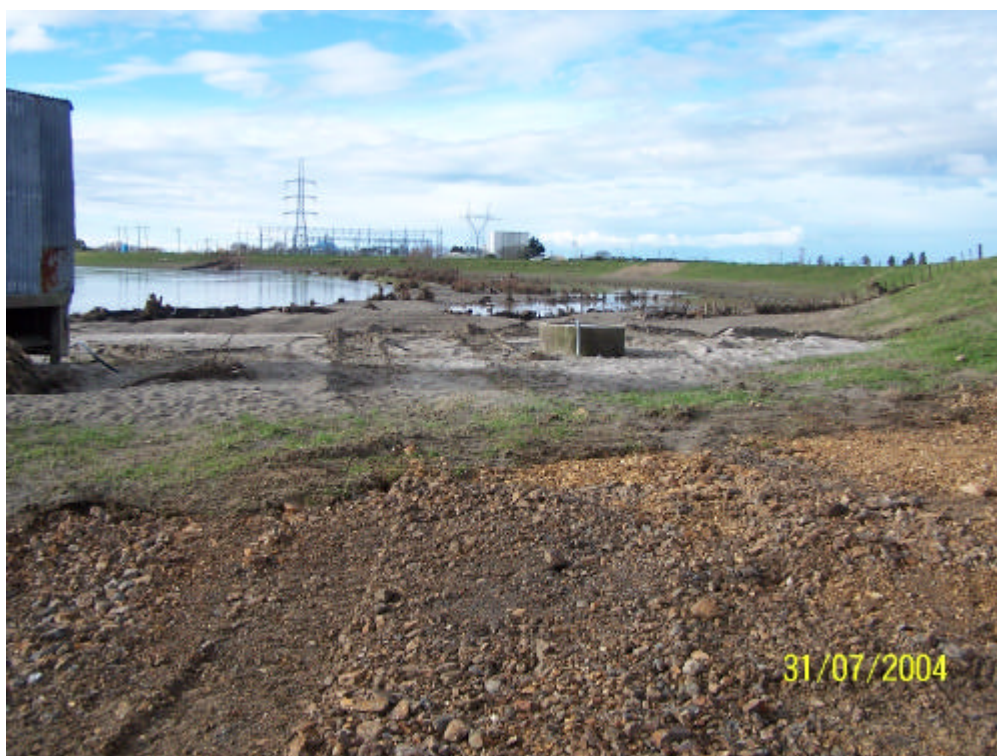
After the water had receded it could be seen that the small pump shed on the berm just to the downstream side of the breach was on a mound 1 to 2m higher than the berm further downstream or upstream. It was later found that this is because there was an old bend in the river downstream from the pump shed and the berm upstream had been used as a borrow area (source of fill) during stopbank construction. The berm between the river and the stopbank widens downstream from the breach site (Photograph 8).

Photograph 8: Pump shed and river berm

Near the pump shed were pieces of steel intake pipe and alkathene pipe. Improperly installed pipes passing through stopbanks can cause stopbank failures. It was later found that the pipe from this pump shed crosses towards the top of the stopbank downstream from the breach.

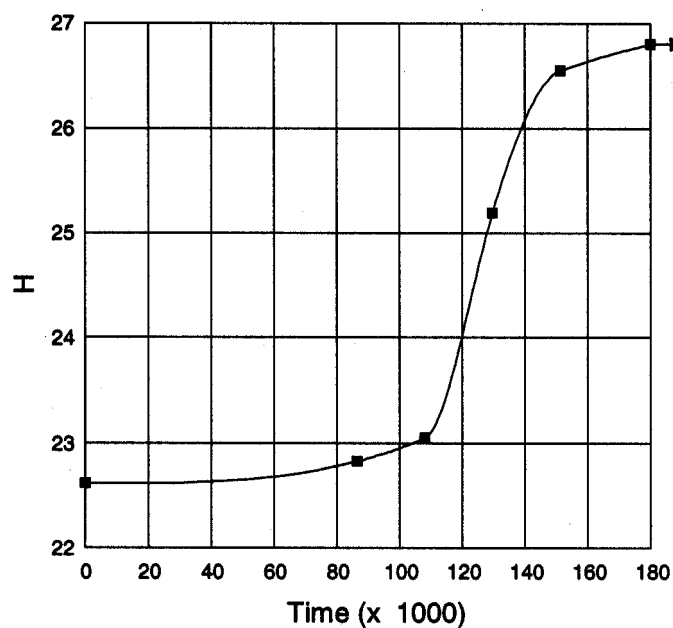
Figure 10: Flood Flow Hydrograph
(time in seconds from 8am 16 July 2004, stopbank crest 27.5m)

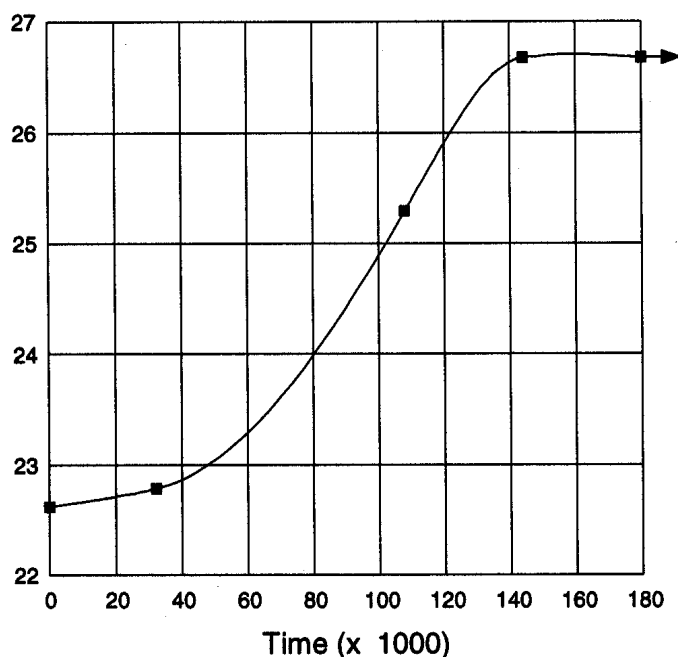
It can be seen by comparing the Trustpower modified hydrograph (Figure 11) to the recorded hydrograph (Figure 10) that modification would have resulted in higher river flows on 16 and 17 July. The seepage model was analysed using this hydrograph and it was found that the phreatic surface would have reached ground level in the paddock at 11.00pm on 17 July, compared to 6.00am on 18 July with the measured hydrograph. Heave of the top three soil layers in the paddock could have occurred at about 2.00am.

Figure 11: Trustpower modified flood flow hydrograph
(time in seconds from 8am 16 July 2004, stopbank crest 27.5m)
