**ENVIRONMENT BAY OF PLENTY  
REGIONAL COUNCIL AND WHAKATANE DISTRICT  
COUNCIL**

**EASTERN BAY OF PLENTY HARBOURS  
NAVIGATIONAL RISK ASSESSMENT**

Prepared For : Environment Bay of Plenty Regional Council and  
Whakatane District Council  
Report Number : 06NZ123  
Issue : Issue 1  
: July 2006

**MARICO MARINE NZ LIMITED**

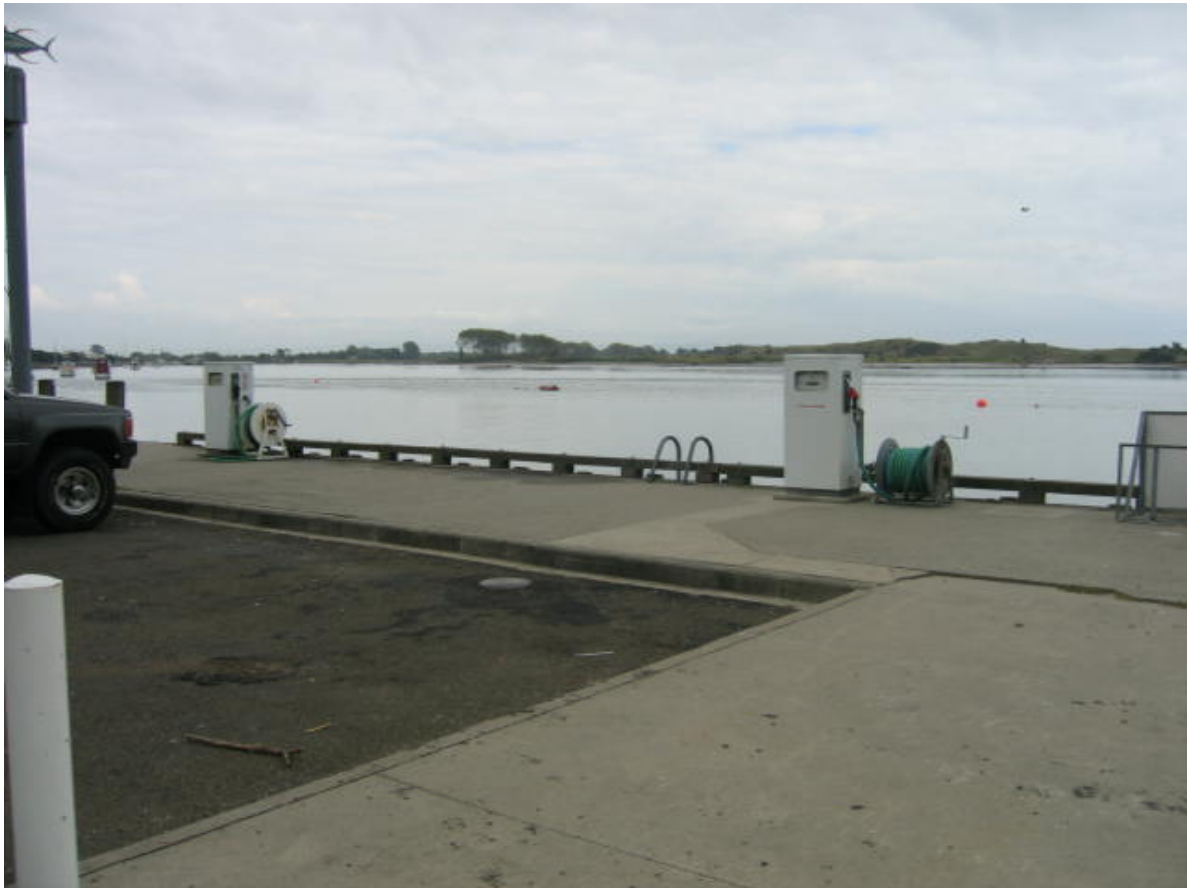
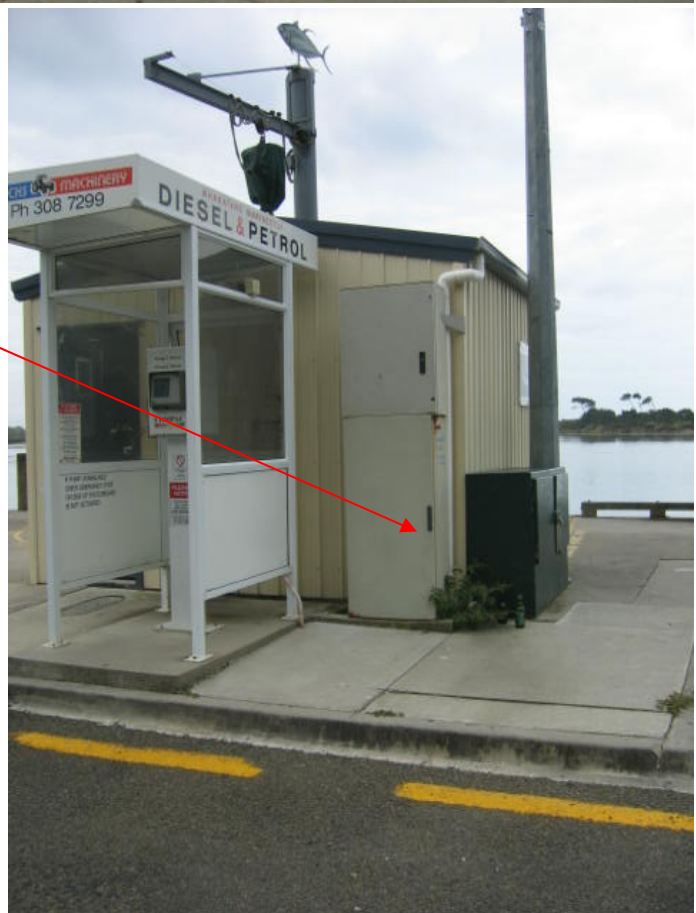
**Figures 1 and 2 : Views of the fuel supply station at Whakatane.**

**Entry of fuel into the water following even a minor spill is inevitable unless some form of drip-trays are considered. Emergency Shutoff is remote from the fuel delivery. Electrical Cabinet (arrowed) was unlatched and open – a notable public safety hazard. It was latched on inspection, but remained unlocked.**

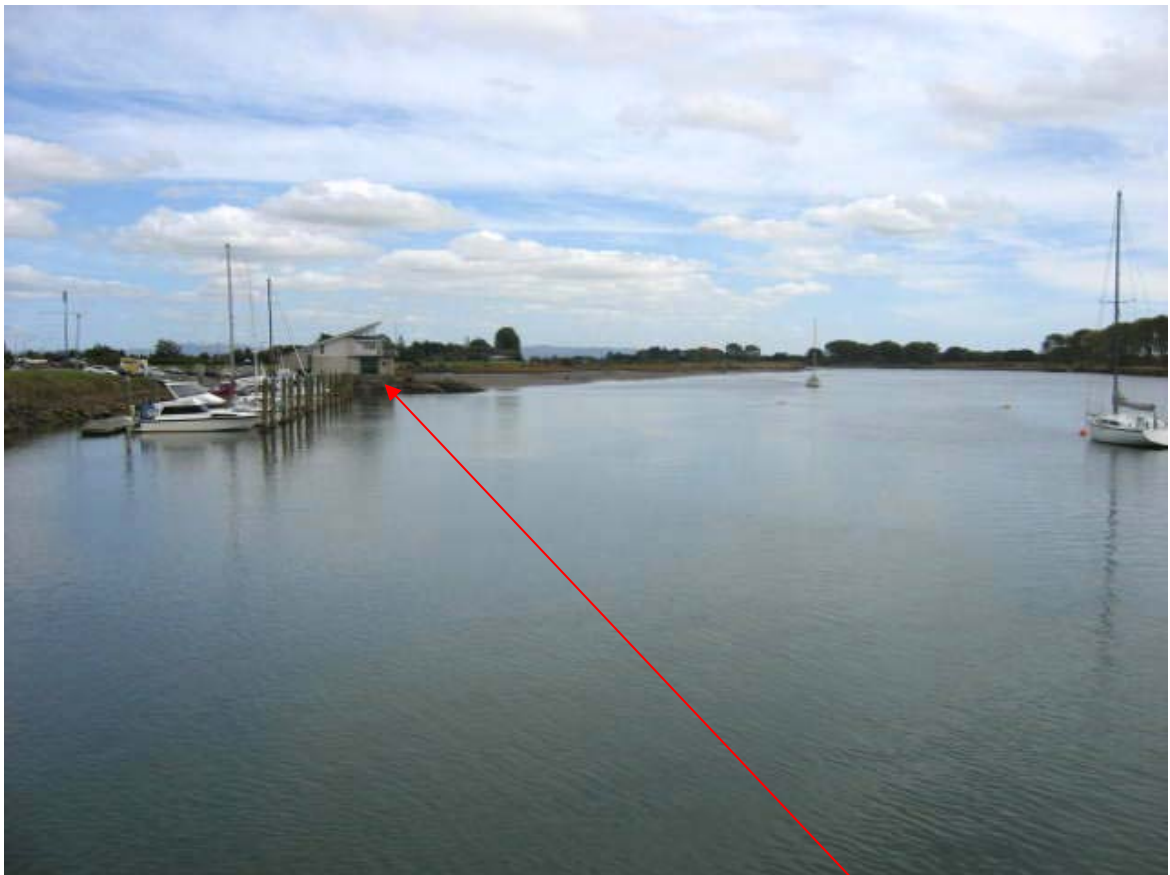
**Figure 4:** View of Yacht Club Area and adjacent Pontoons (Yacht Club Arrowed). Yacht Club Stakeholders reported a difficulty of accessing pontoon berths and moorings in the area due to accretion on one side and rocks on the other.

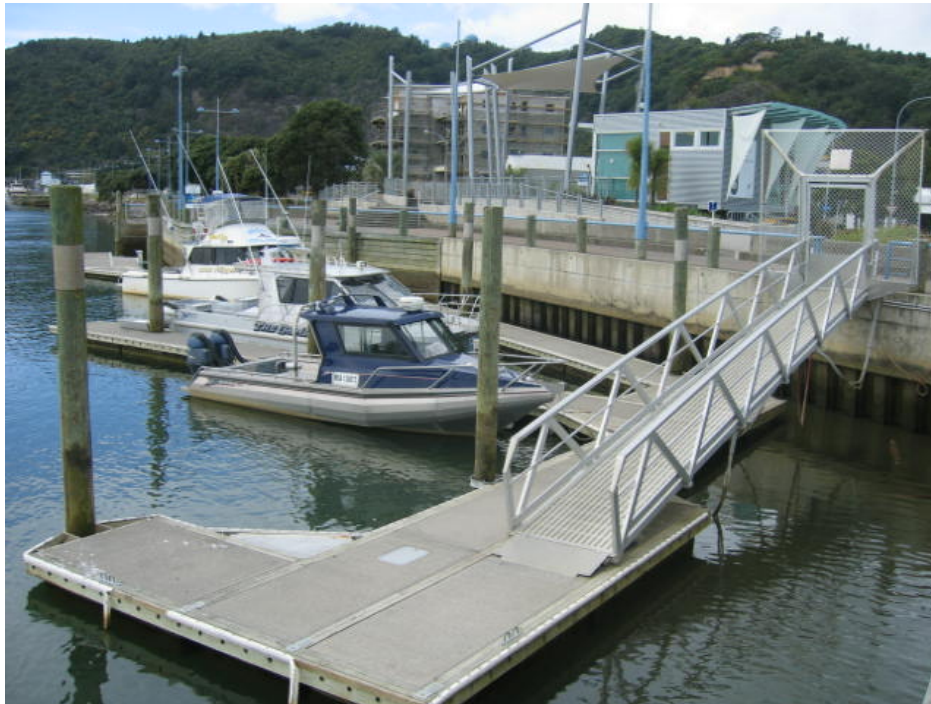
**Figure 5:** Otuawhaki jetty, whose piles have been extended to prevent it lifting off during a flood event.

Jetties were designed to withstand what at the time was a 100 year flood event. Data following a series of flood events determined that designs reflected an event with only a 30 year return period.

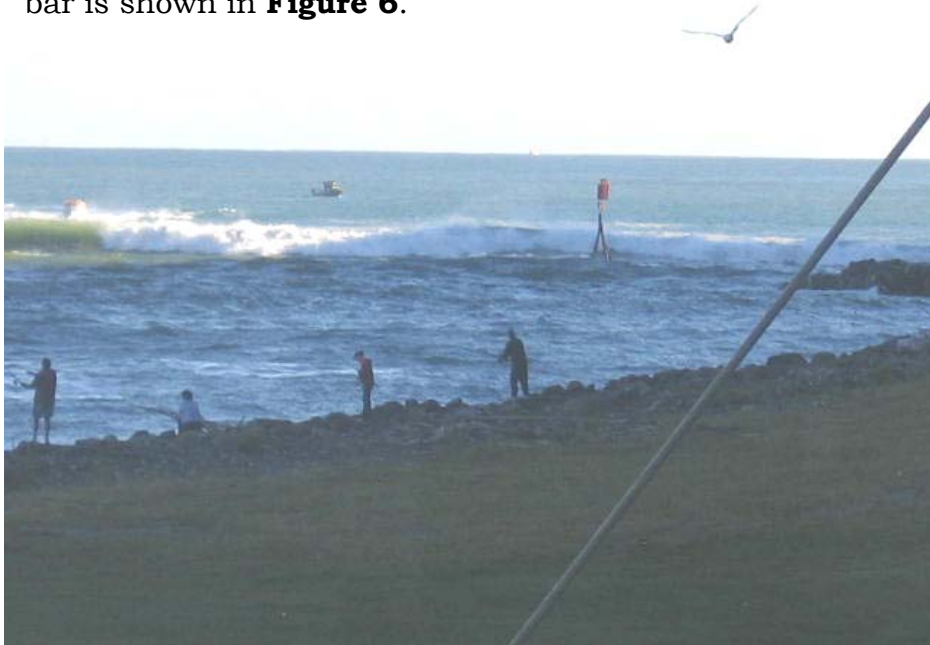
**Figure 6:-**  
A view of surf breaking over the Whakatane Bar

In the summer of 2006, the Whakatane Bar was the shallowest it had been in five years, with at one stage only 0.3m depth above chart datum being available at low tide. Around 2.5 metres was available at high tide (2006). The Whakatane Bar has always been a single Bar and its location can range from the entrance to 50m or more beyond. A significant flood can move the Bar overnight from an entrance location up to 80m from the entrance.

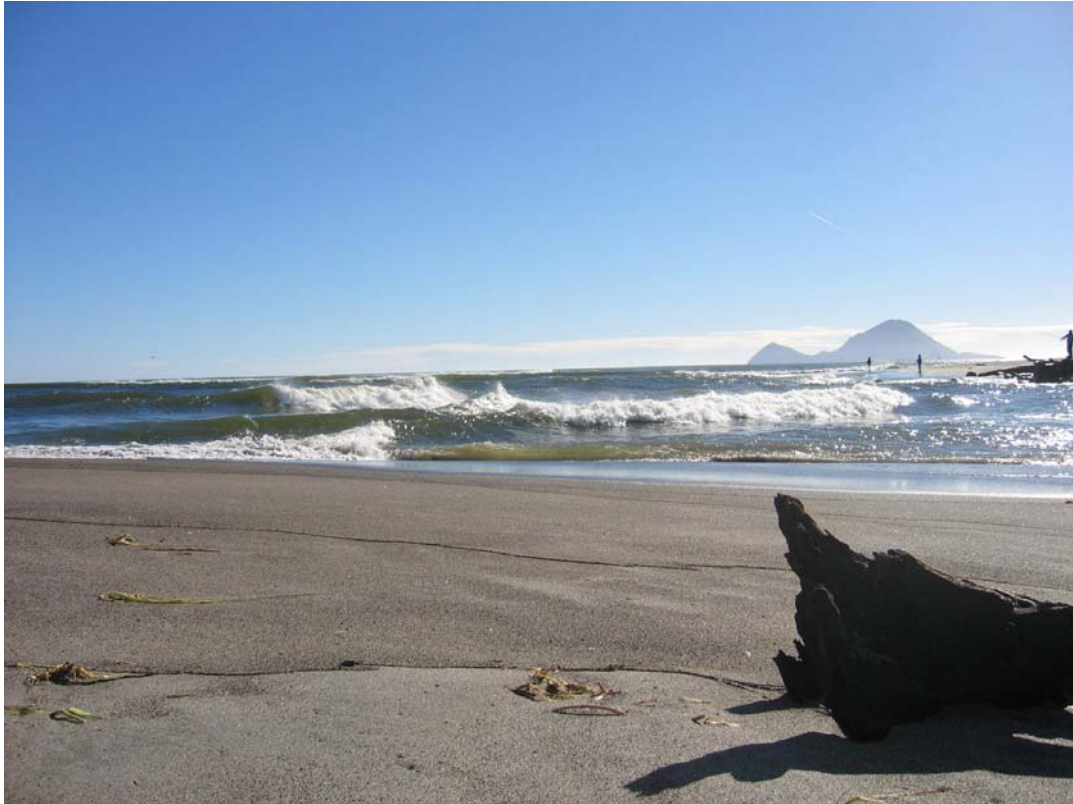
The Thornton entrance appears to run particularly fast as the Groyne on the eastern bank produces a shallow bend, with a well defined and deep channel at the river mouth. In heavy swell conditions, the Bar can be particularly rough and conditions change rapidly with the state of the tide. Loss of life is reported to have occurred on a number of occasions. The Bar is said to be located at the mouth of the river and craft are propelled from the fast flowing water stream immediately into rolling swells and confused water.

**Figure 11:-**  
A view of Thornton Bar, which commences immediately adjacent to the river mouth.
