# Impact of Septic Tank Contamination at Te Puna

Prepared by Paul Futter, Project Implementation Officer

Environment Bay of Plenty  
Environmental Publication 2003/10  
June 2003 Update

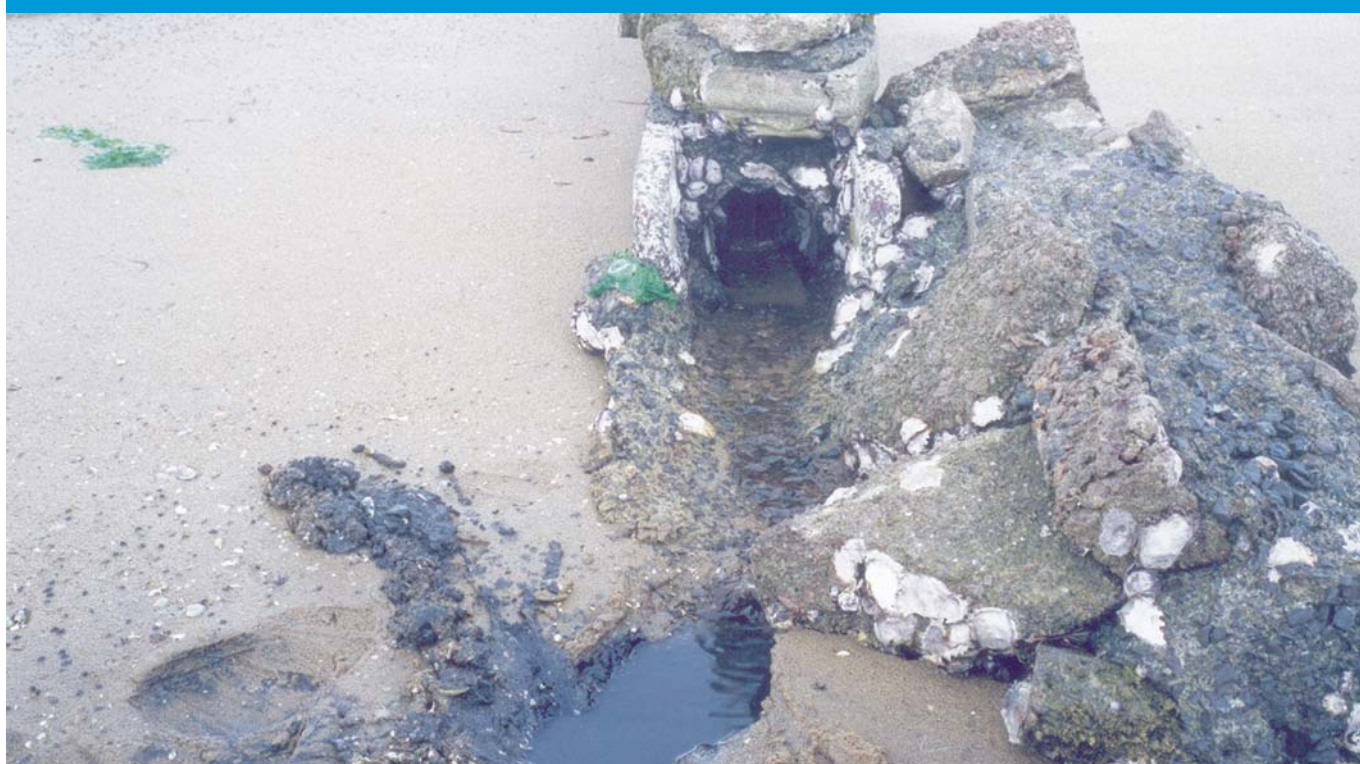
Cover photo: One of the drains (No.9) that discharge to Te Puna Estuary

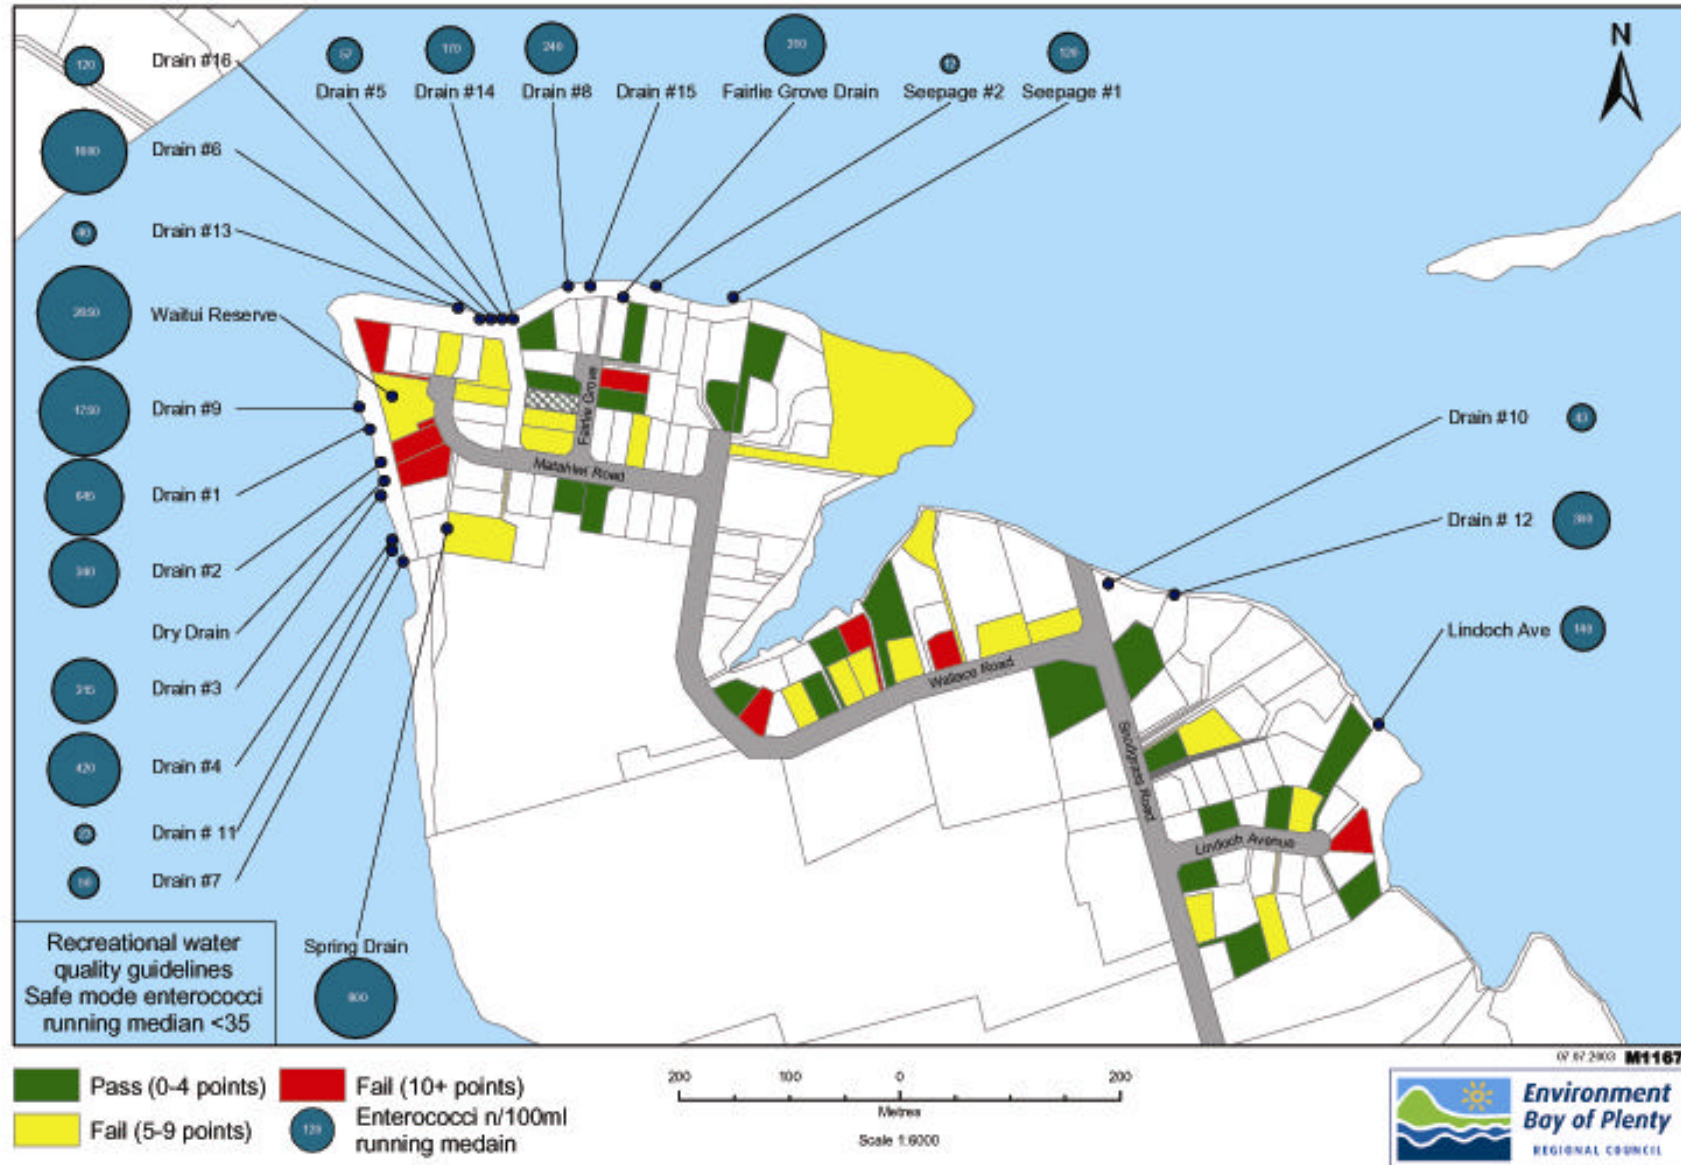
Figure 1: Te Puna Sampling Sites

The median enterococci numbers for each sample point during the period covered by this report compared with Recreational Water Quality guidelines are shown in Figure 1.

A dramatic increase in the bacterial number was observed in the discharges from the drains entering the estuary around the community, and in particular the discharge from the Waitui Drain, in May 2002. The results for the following 12 months indicate that there has been little change to the bacterial numbers since then. There was an initial decline in bacteria counts in January, February and March of this year, but this may be due the dry weather experienced over those months. The higher counts since then may be a result of increased rainfall events.
