Tauranga Harbour Sediment Source Survey

Report prepared by Matthew Surman, Design Engineer
Richard Clarke, Student - Lincoln University
Meredith Carter, Student - Waikato University

Environment B·O·P
Quay Street
P O Box 364
Whakatane
NEW ZEALAND

The report provides an order of magnitude estimate of sediment transported from stream bank erosion into Tauranga Harbour from the harbour catchments. The report describes and costs possible stream improvement works and estimates the reduction of sediment yields such works may achieve.

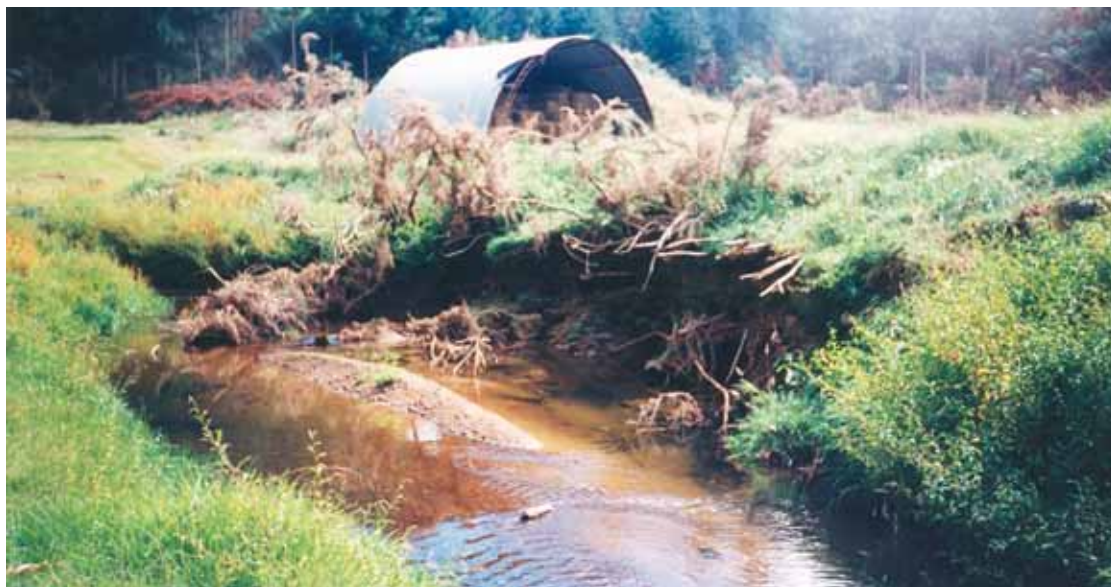
The stopbanks are all in good condition with adequate berm width, with the exception of one location at the upstream end of the southernmost bank, which is eroding. There are no trees at this location, refer Figure 3.7.

Figure 3.7 An eroding stopbank at 3.45km

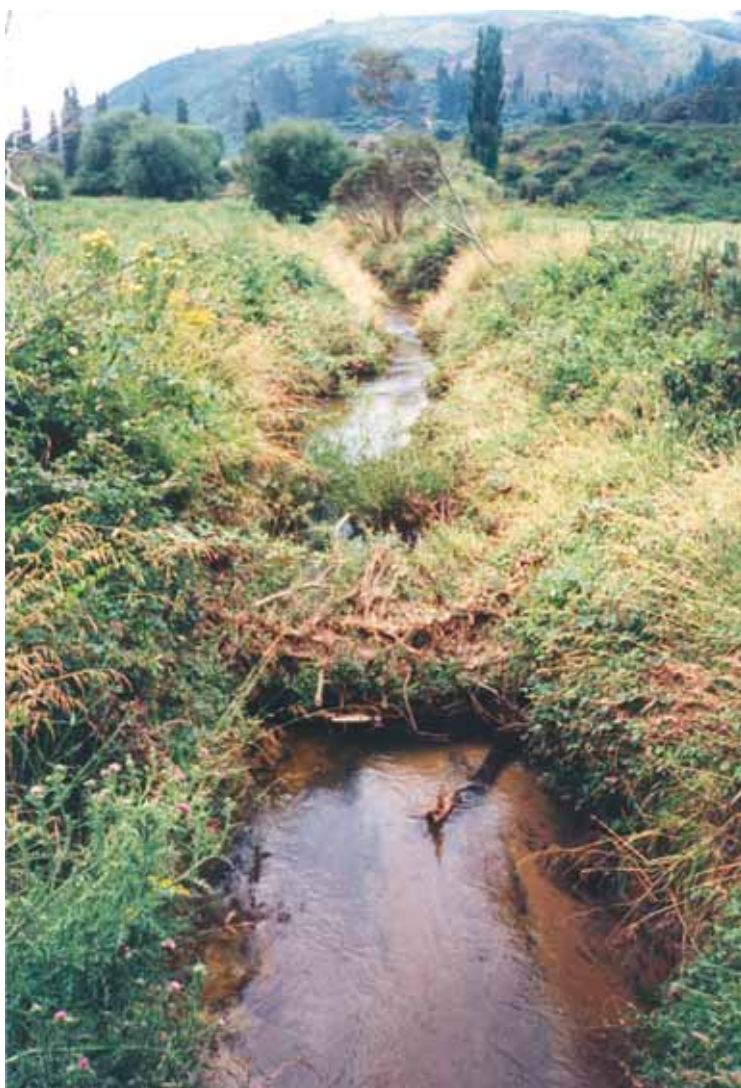
Moderate erosion is present at some locations. The plains are mostly grass covered. A quarry is as close as 30m from the stream near Waitao road; a pond beside the quarry reveals the potential for high sediment input to the stream with rainfall. Further upstream are more blockages that, while small, fully dam the stream. Little water is held behind them at normal flows, but during high flow would cause significant restrictions to flow.

Figure 4.1 Partial blocking of the Kaiate Stream

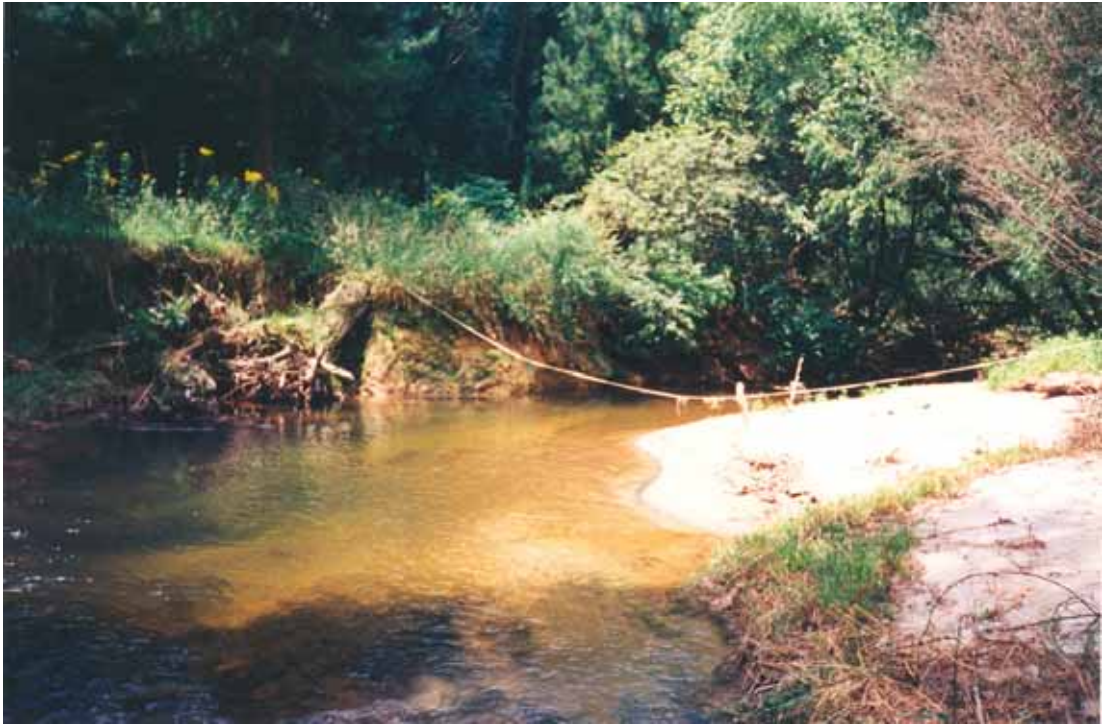
Figure 4.2 Near the top of the flood plains, large willows span the river, partially blocking it (seen to the right). Flooding is evident to 2m above the water level and some minor erosion is noted.

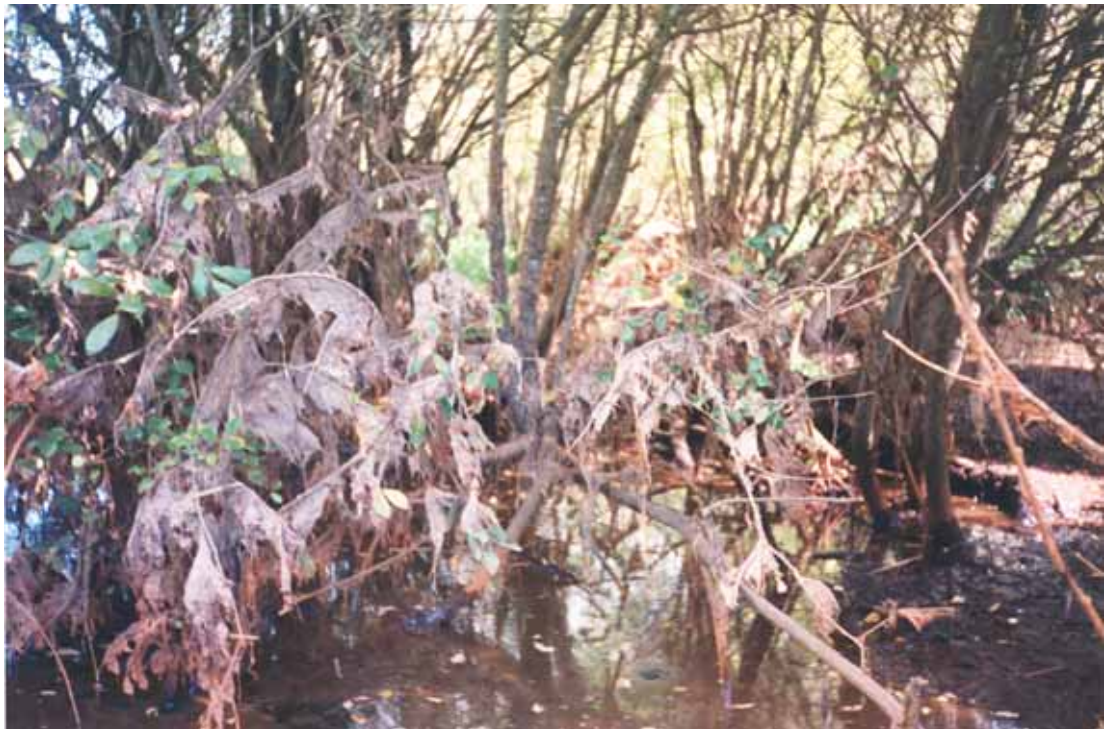
Figure 5.2 Debris draped on a willow tree above the normal flow does not presently choke the stream at 1km.

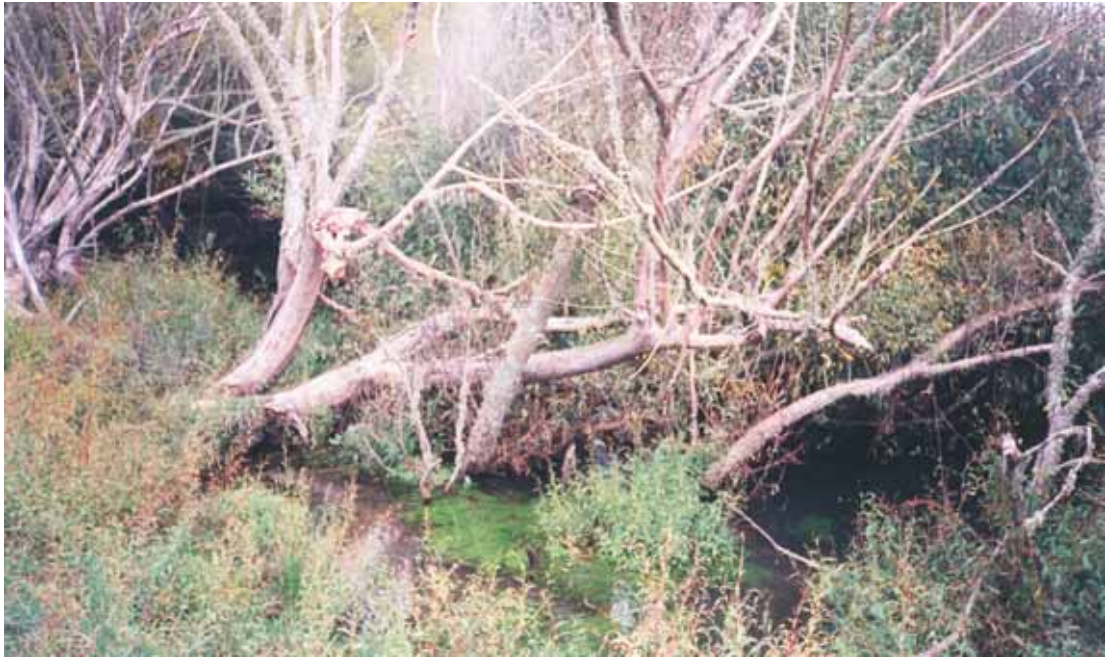
Figure 6.3 Here, 700m above its confluence with the Waimapu, willows strain the Waiorahi Stream. There is potential for increased blocking.

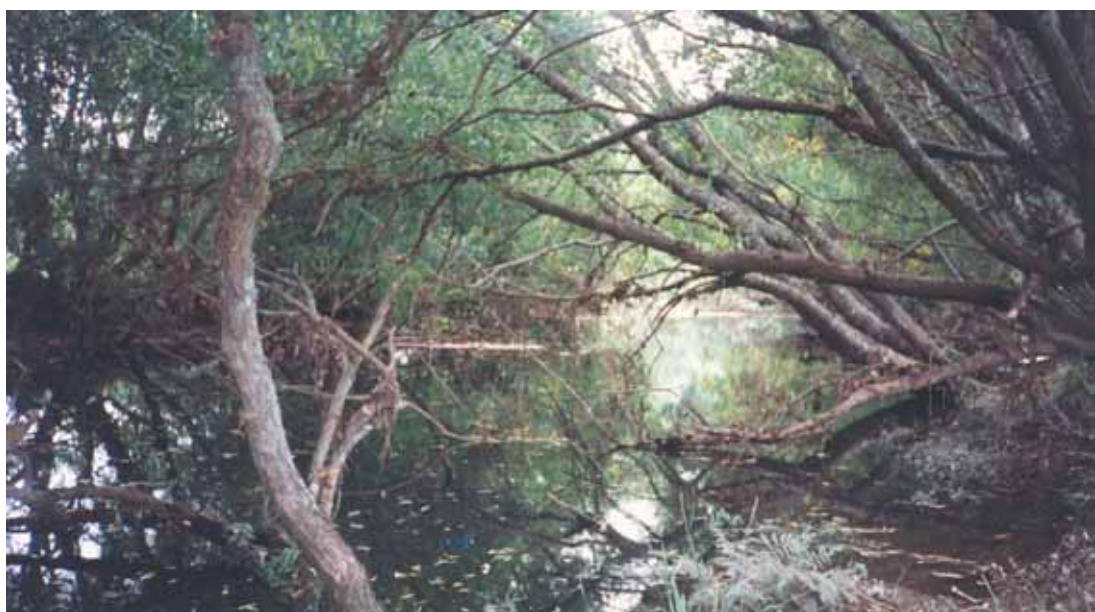
Figure 6.8 Overhanging willows are potential blockages.

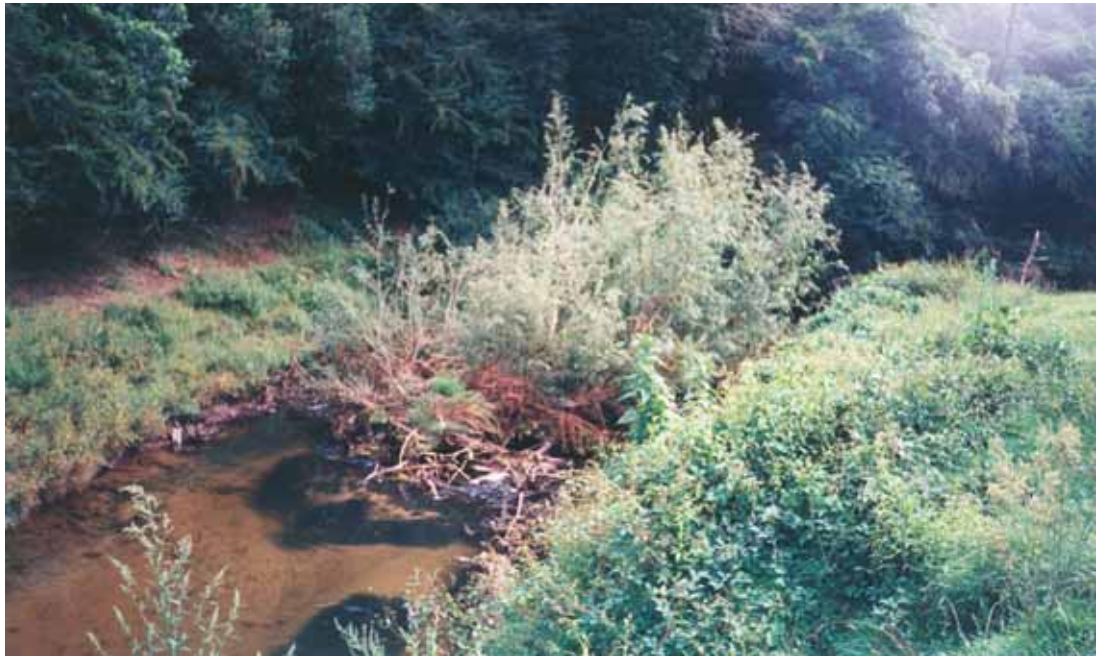
Figure 6.11 A mid-stream willow collects small debris making an effective barrier at the mouth of the gorge.

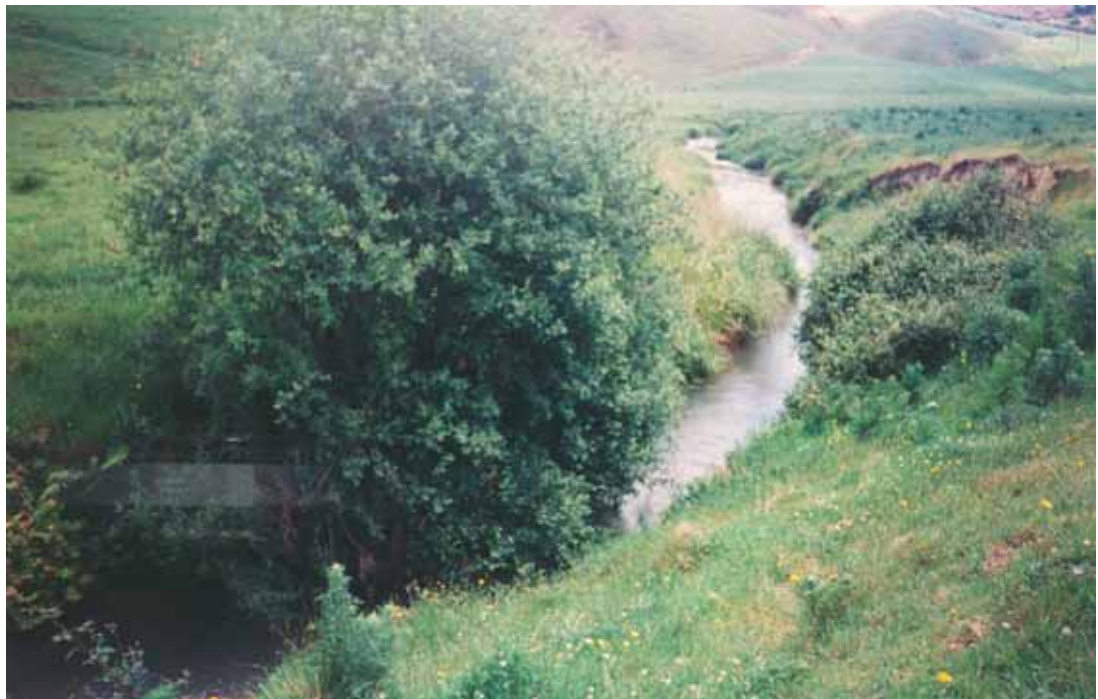
Over 1km upstream to 3.9km above the SH29 bridge, the thick bank cover vanishes. About ten trees were noted as rooted within or dragging in the river (refer Figure 7.6), and erosion (more easily visible) of banks (from 1 to 2.5m height) was apparent particularly on the outside of a bend.

Figure 7.6 Lone tree rooted on the edge of the stream, erosion on a nearby downstream bank.

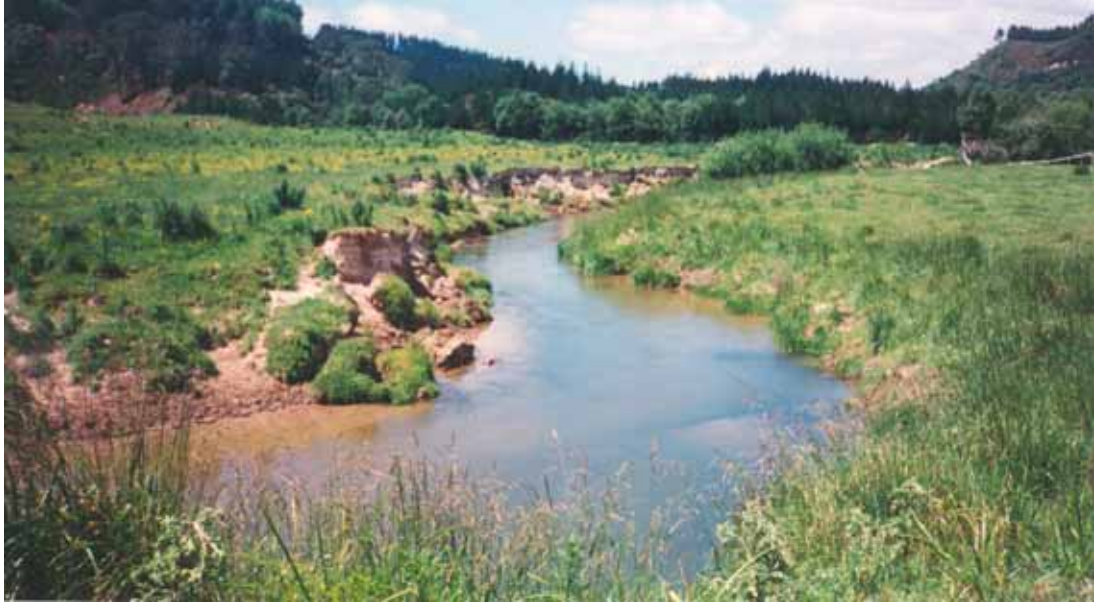
The next part of the stream is an open section with farmed land to the river's edge. Banks here have been eroded over a continuous 400m length (to 4.3km from SH29), refer Figure 7.7; there are no obstructions in the river over this section. Although bank heights commonly impede access to the river, hoof prints are occasionally found at the water's edge. Downstream of this, fencing which borders the river begins.

Figure 7.7 The true right bank is significantly eroded at 4km from the mouth.

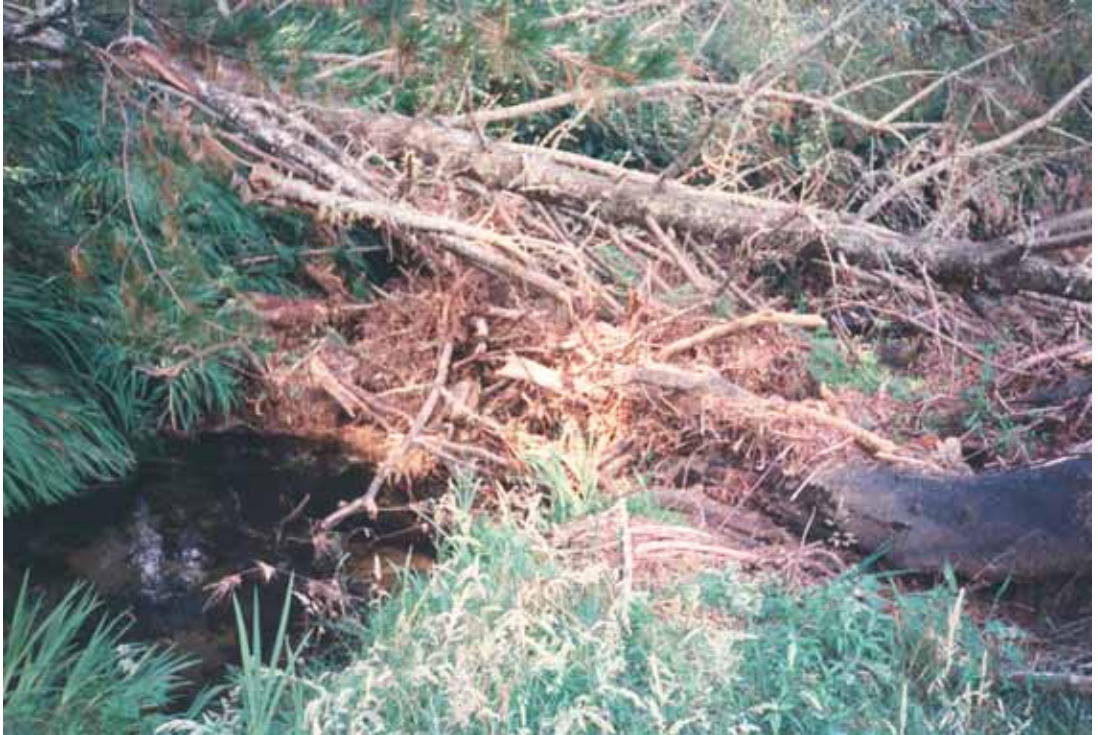
At 3.55km, there is a partial dam consisting of apparently planted trees (10cm diameter); there is a steady flow of water through the dam. Only 20m downstream of this there is another dam, however this is more significant (refer Figure 11.3). Stream banks are low and there is barely any evidence of erosion. A large rock shelf waterfall signals the end of this more open section.

Figure 11.3 The second debris dam, low flows pass through the blockage.

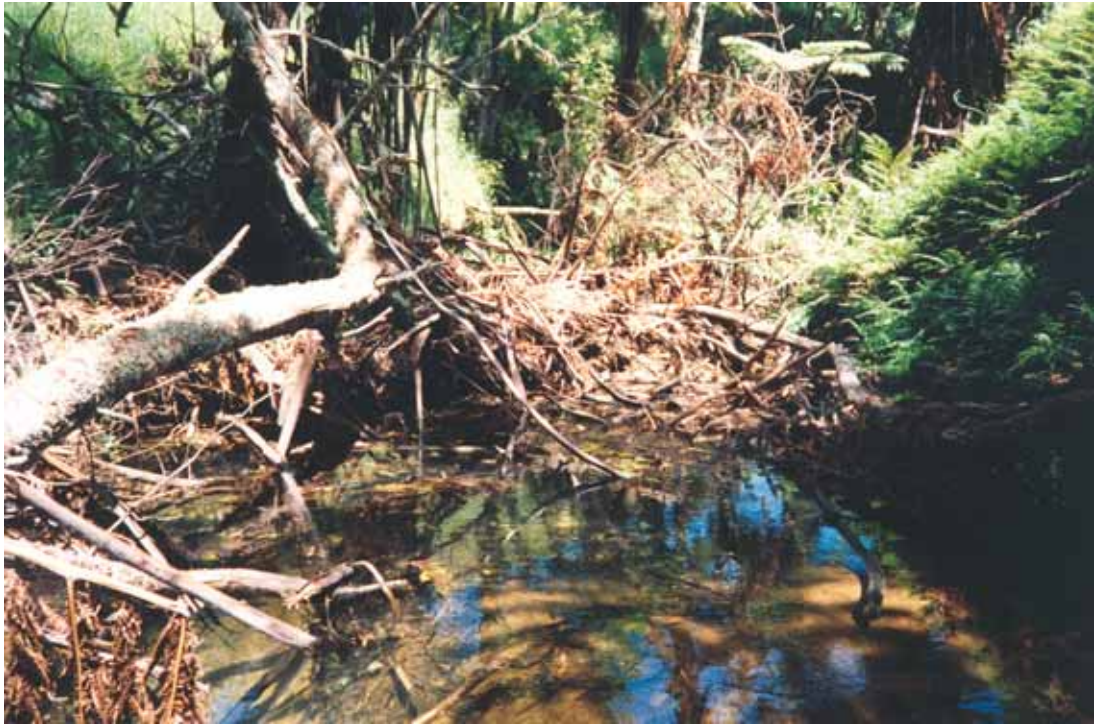
Figure 13.3 This second, larger dam catches much debris and fully blocks the stream flow.

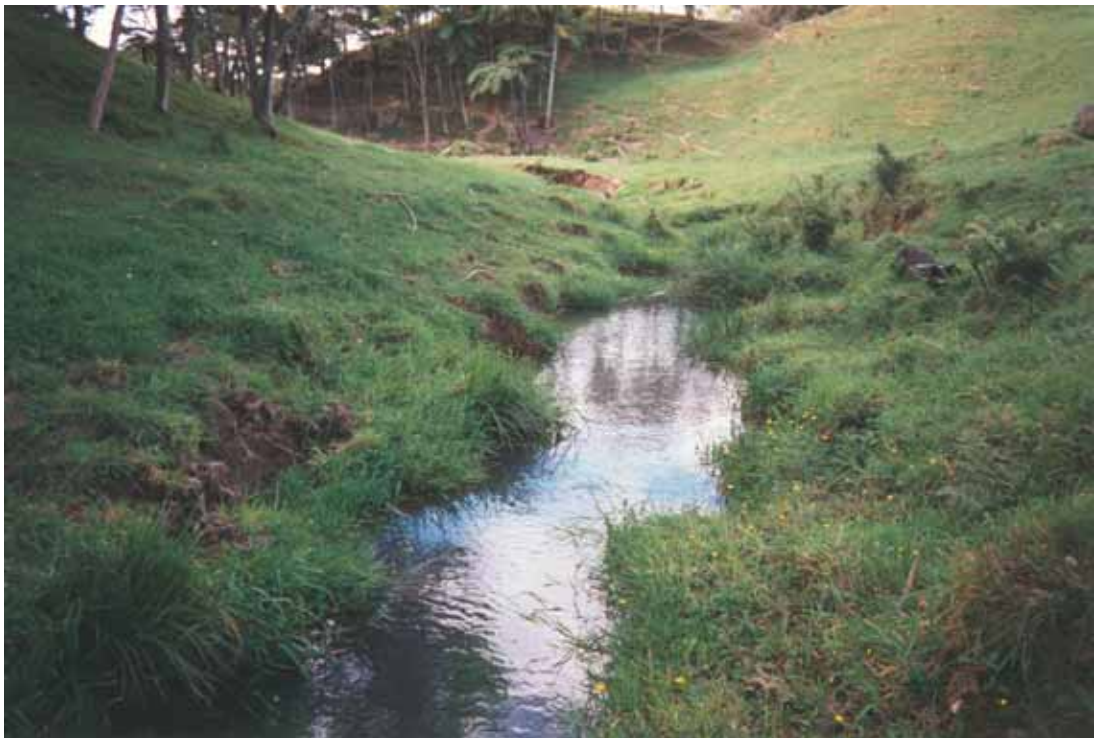
2.4km above SH2, the surrounding area opens out, with farmed land to the streams edge. A floodplain of 10m is available for floodable waters. The banks have a vegetation cover of grass and appear more prone to erosion. Approximately 12 isolated patches of erosion were noted.

Figure 13.4 Grass banks are prone to erosion and slumping.

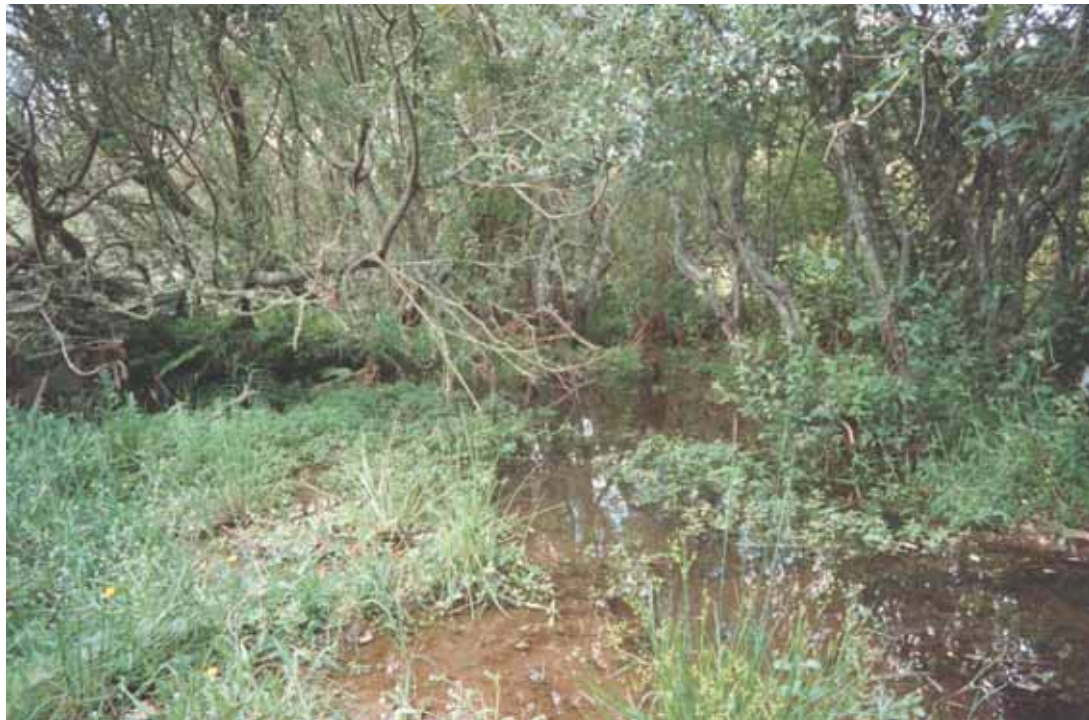
Figure 13.5 At 1.9km above SH2, willows congest the stream, with potential for increased blockages.

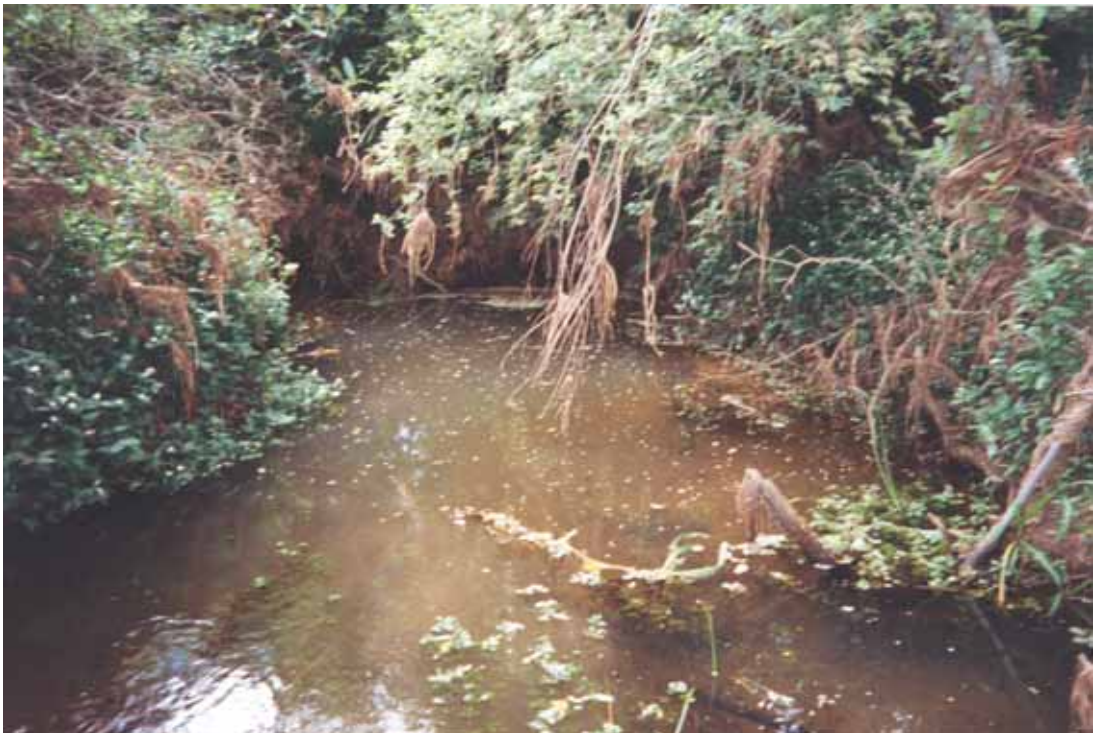
1.3km above SH2 the stream becomes surrounded with vegetation for 100m, and as a result, dead wood lies on the streambed at several sites. In this stretch a large tree lies across the stream collecting debris and blocking the flow (refer Figure 13.6). Downstream smaller branches are found overhanging the stream.

Figure 13.7 A large tree blockage dams the channel at 1.24km above SH2.

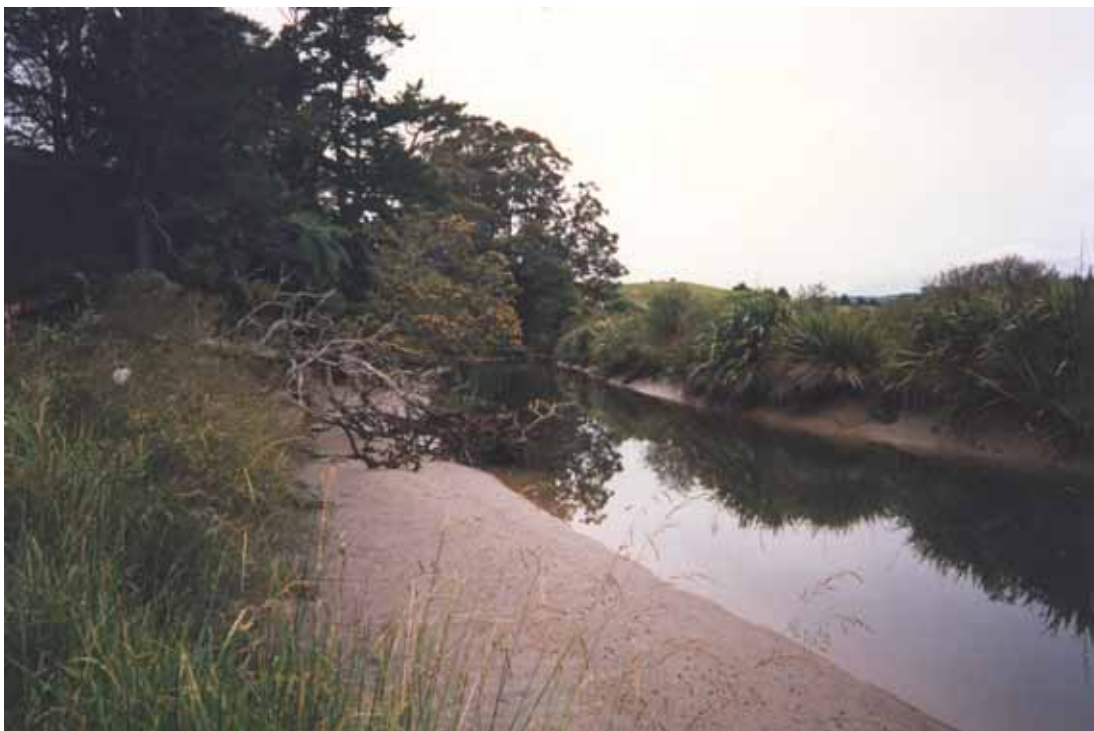
Figure 14.4 Slumping occurs in the tidal areas of the river, with some dead wood in the channels.

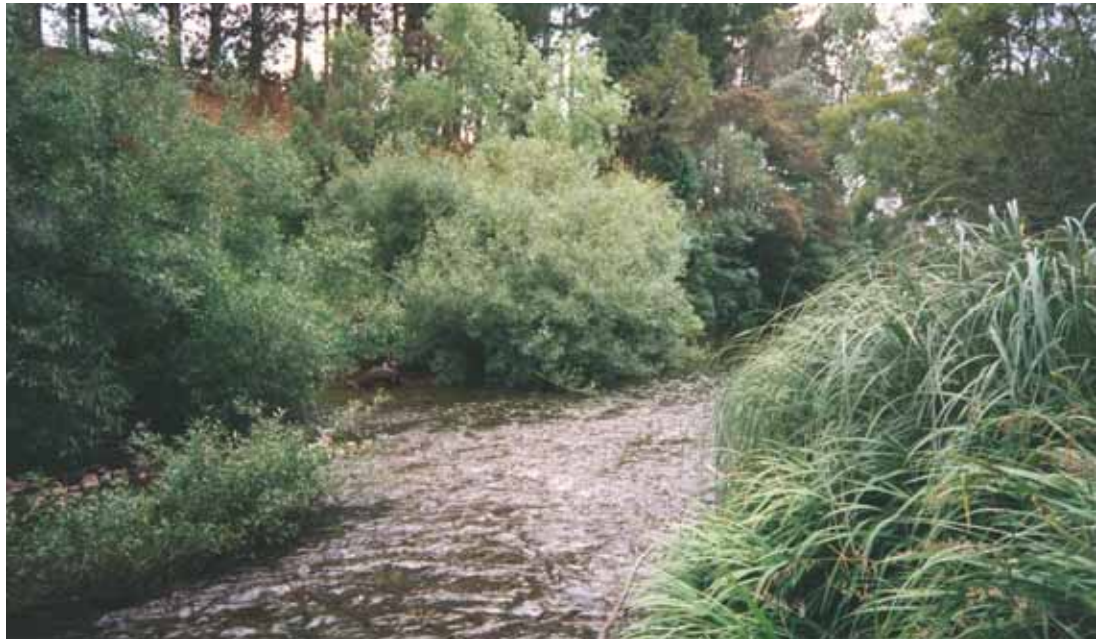
Figure 15.5 Willows overhang up to 3m across the main flow.

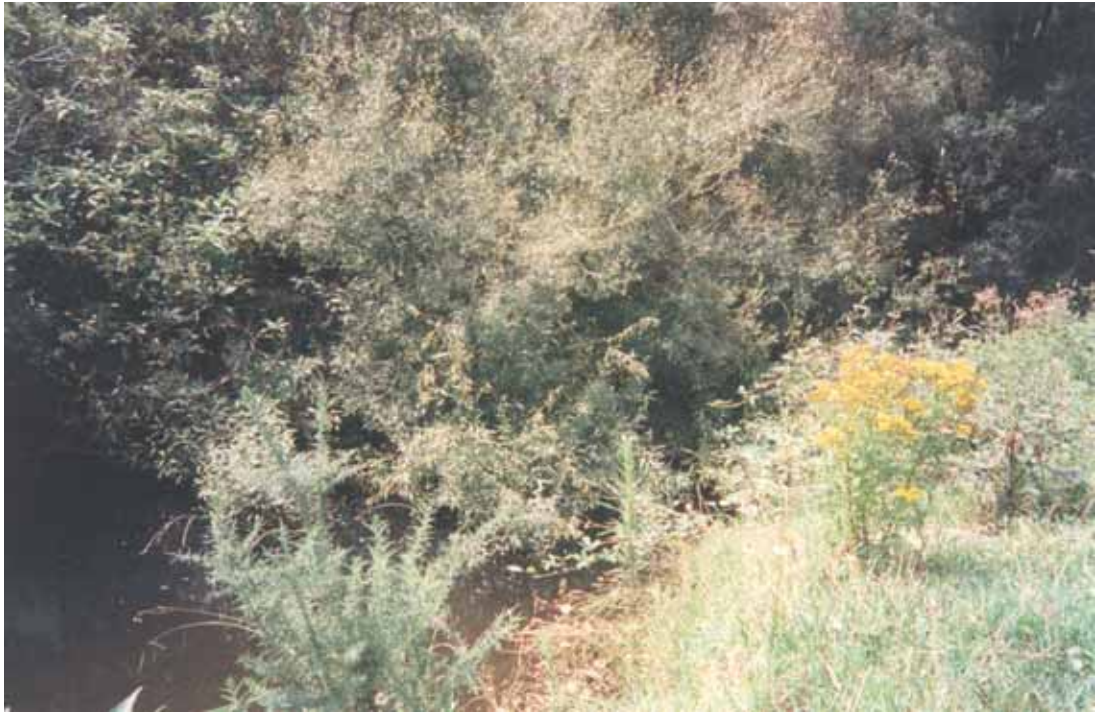
Figure 17.5 Typical willow blockage at 3.8km above SH2. The 1-2m high banks have a good vegetation cover of blackberries and other vegetation.

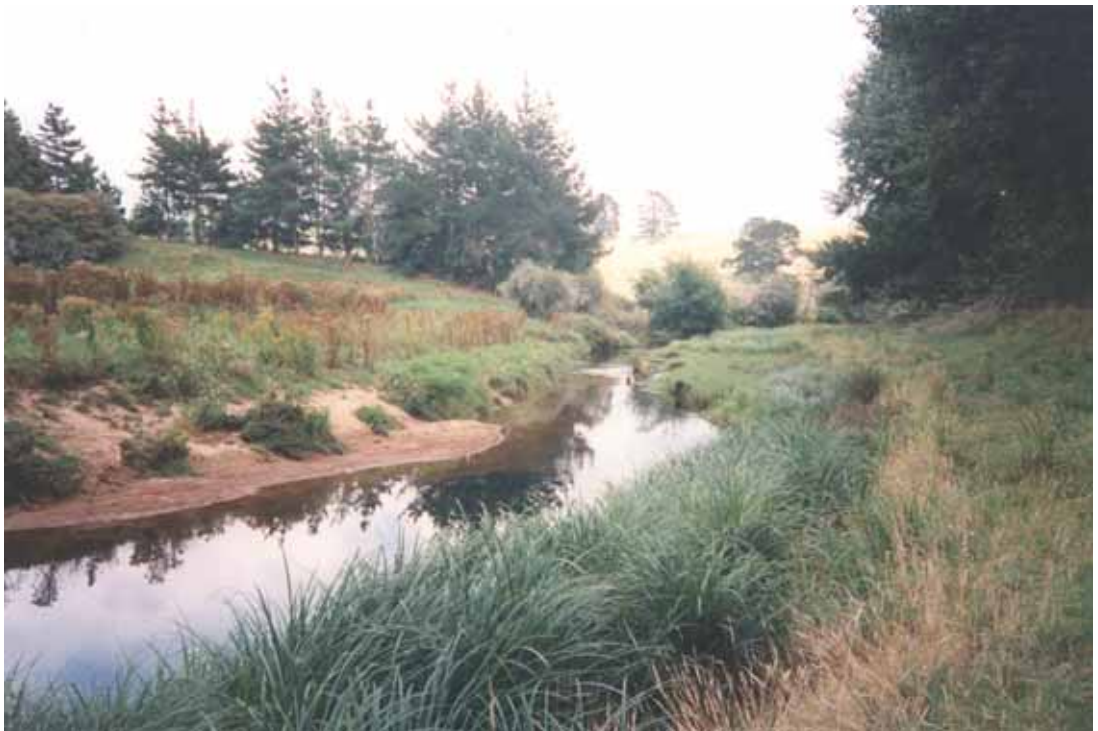
Figure 17.6 Minor erosion of the low grassy banks at 3.2km. Downstream a willow can be seen overhanging the stream.

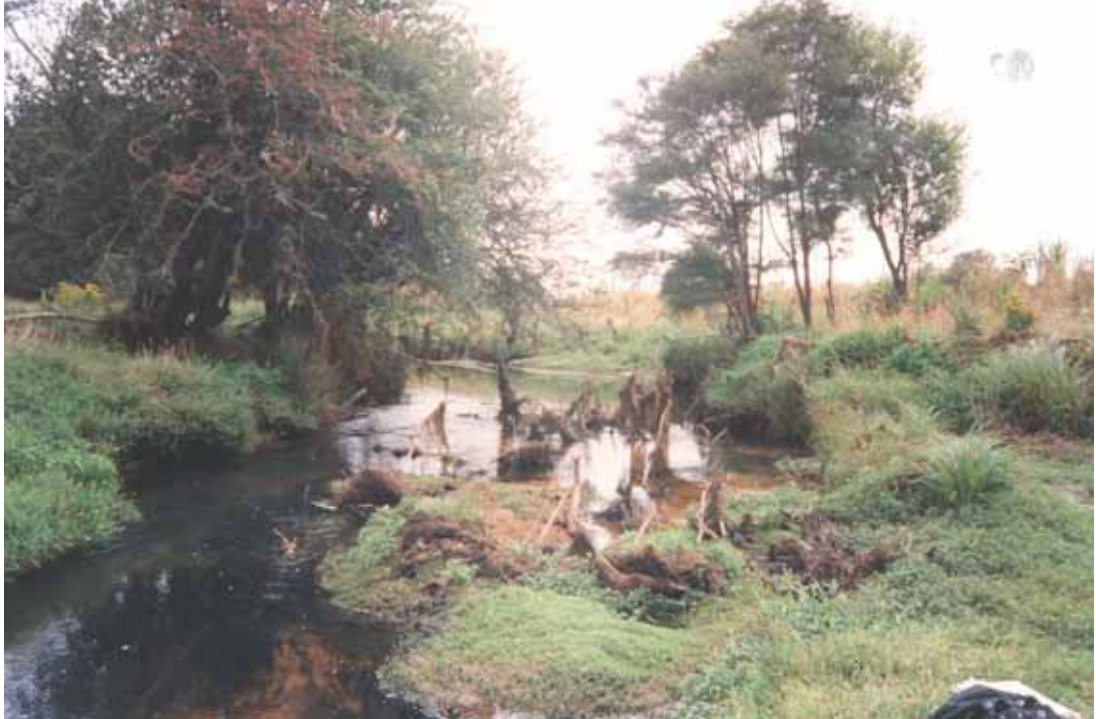
Figure 17.7 At 2.6km debris catches on branches in the stream and on vegetation on the banks.

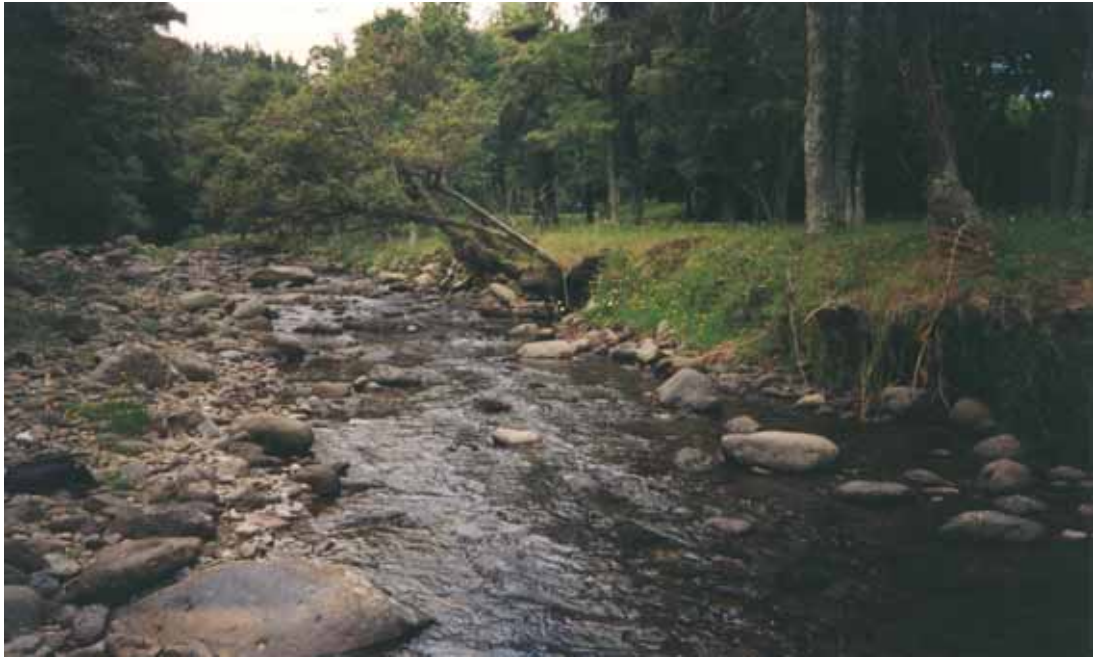
Figure 18.1 Undermining of trees at 2.35km.

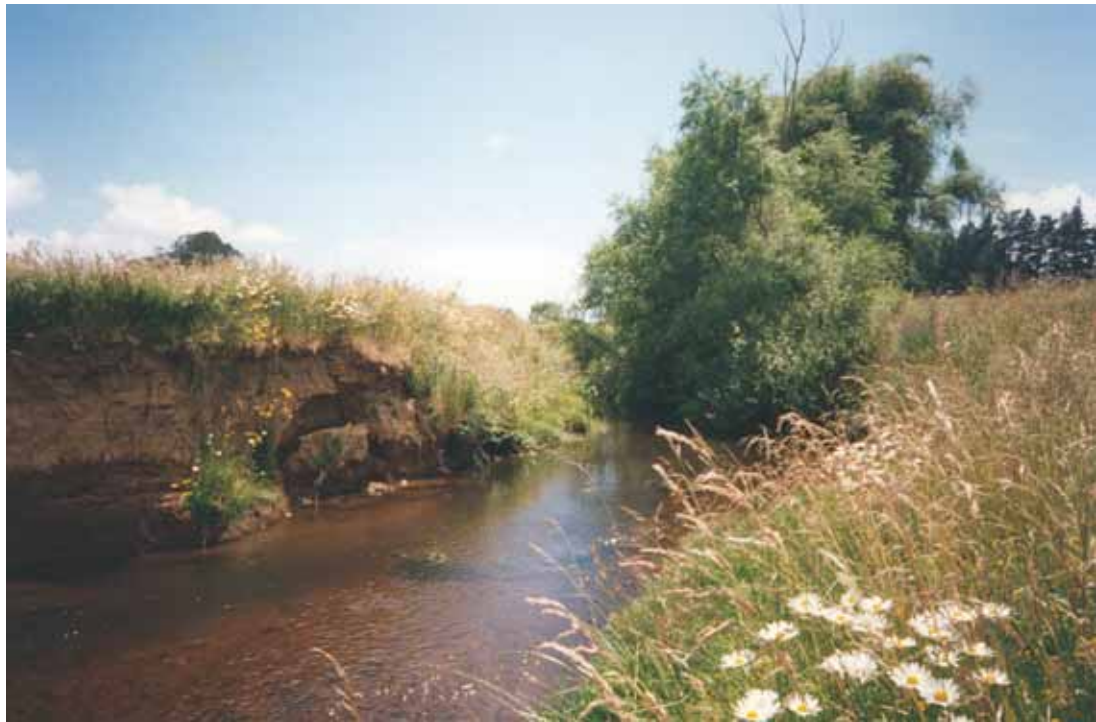
Figure 18.10 Typical willow blockage and bank erosion at 1.5km.

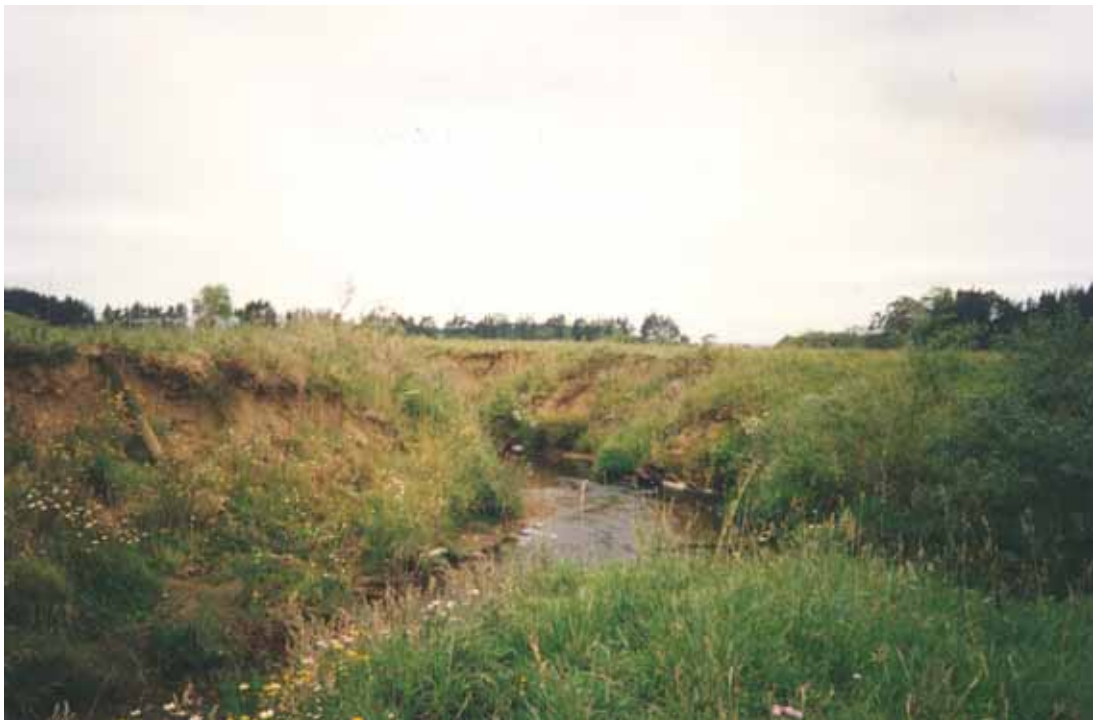
Figure 18.12 Bank erosion and slumping is frequent in this open section.

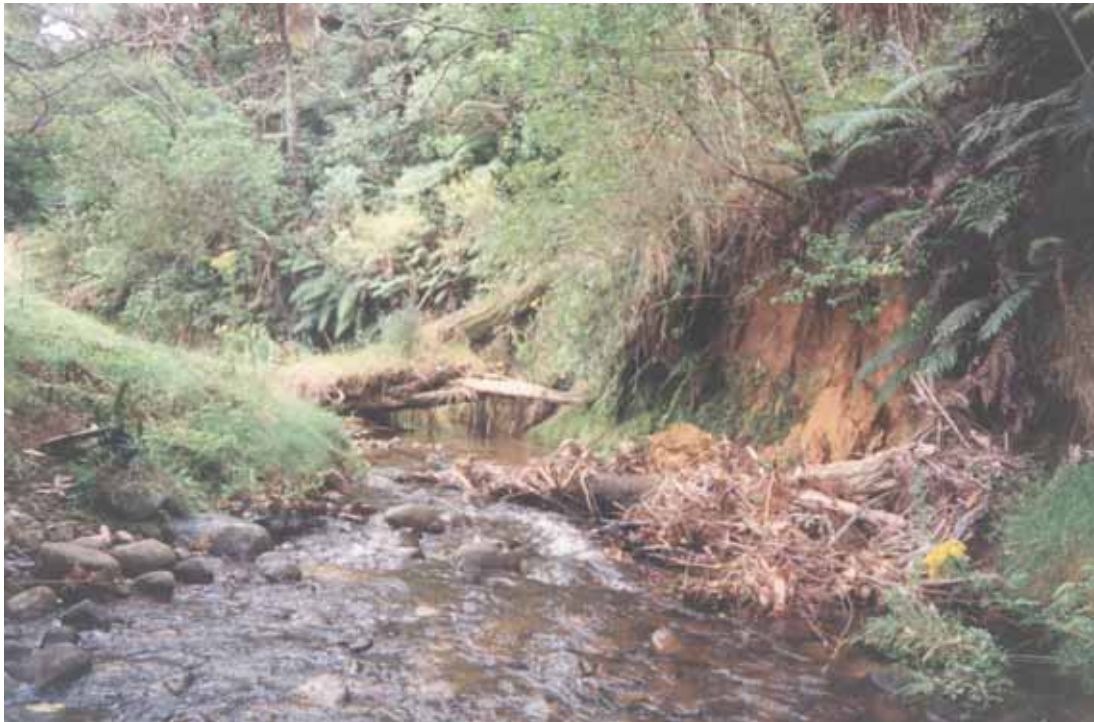
Figure 19.1 Bank erosion at 4.7km. Debris collects on a fallen tree, downstream of this is another partial blockage.

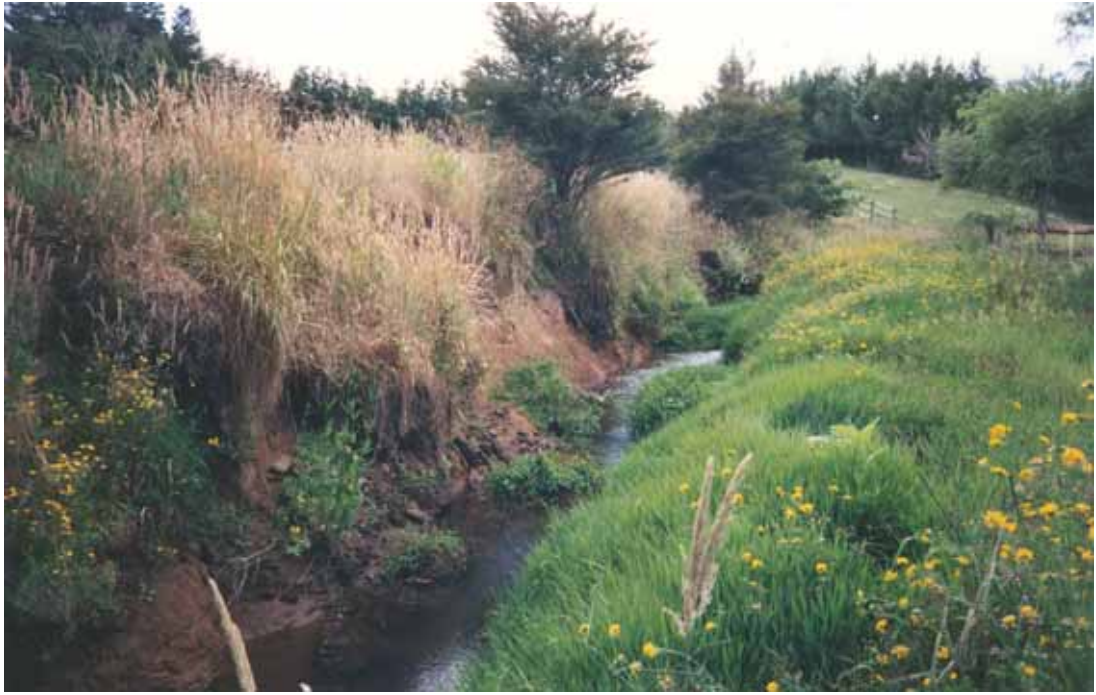
Figure 20.8 Looking upstream at 400m, the true right bank has areas of erosion. The left bank has a good vegetation cover of grass.

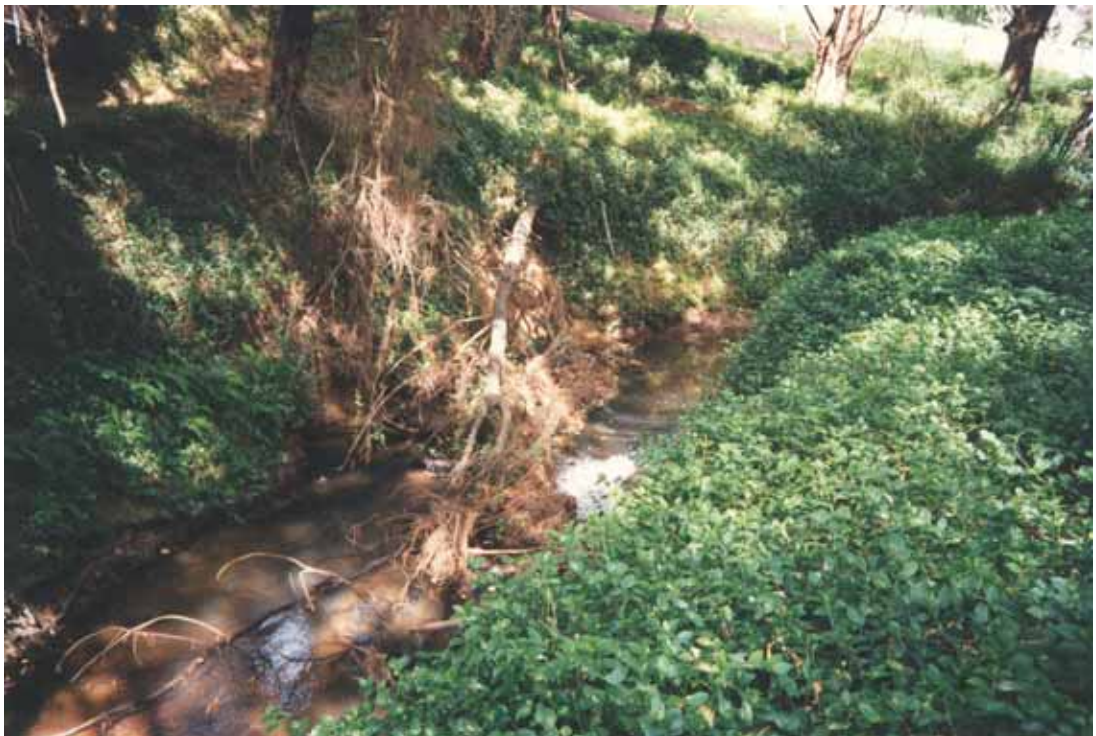
Figure 20.9 Debris collects in the stream and partially blocks the flow. Downstream to the SH2 bridge banks are well vegetated.

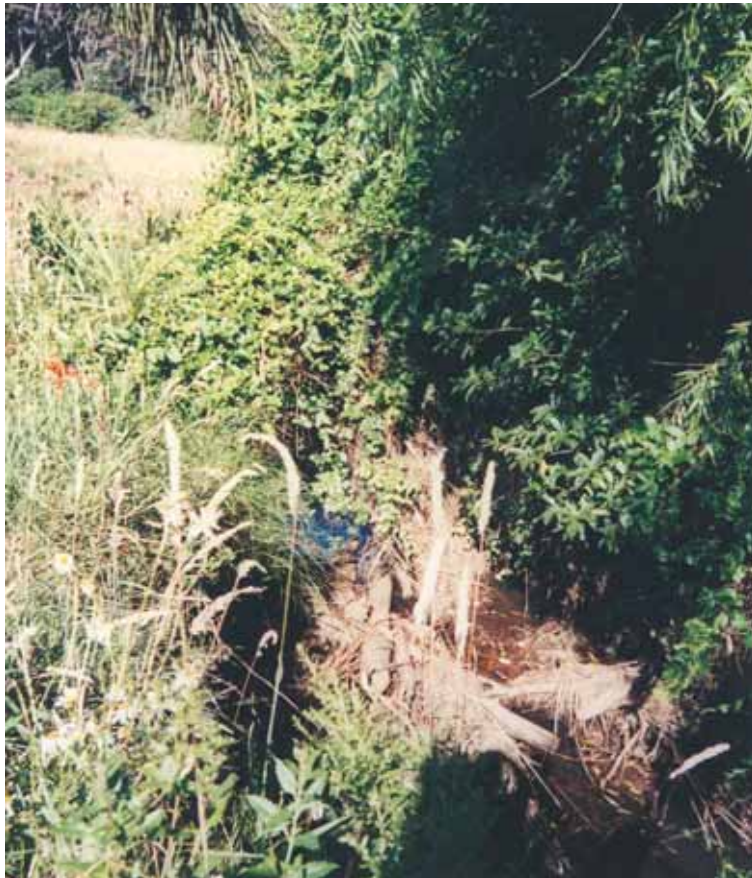
*Figure 20.11
Sawn logs and
debris collect at
300m below SH2*

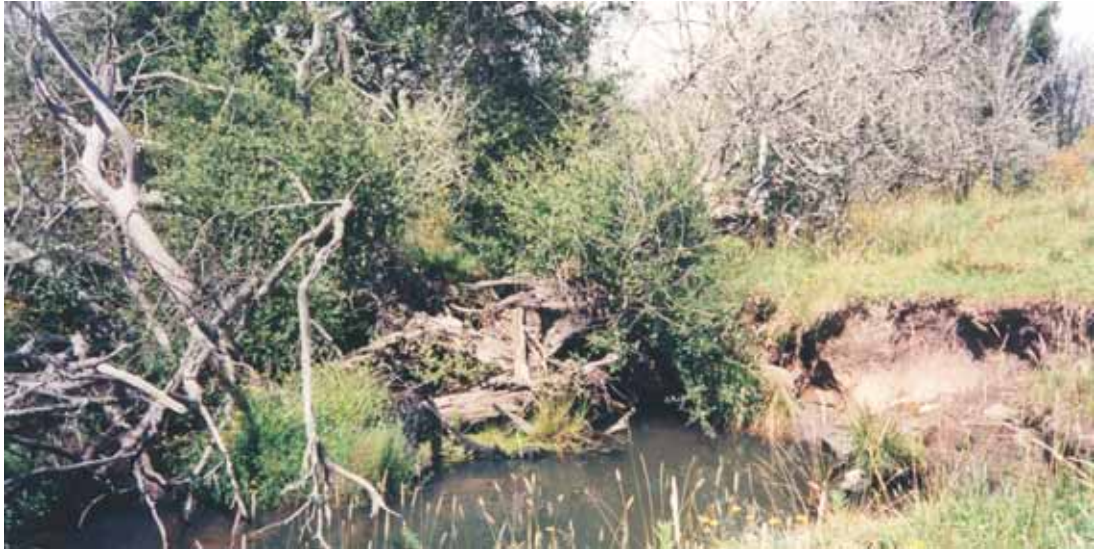
Figure 20.12 Full blockage at 1.1km below SH2.

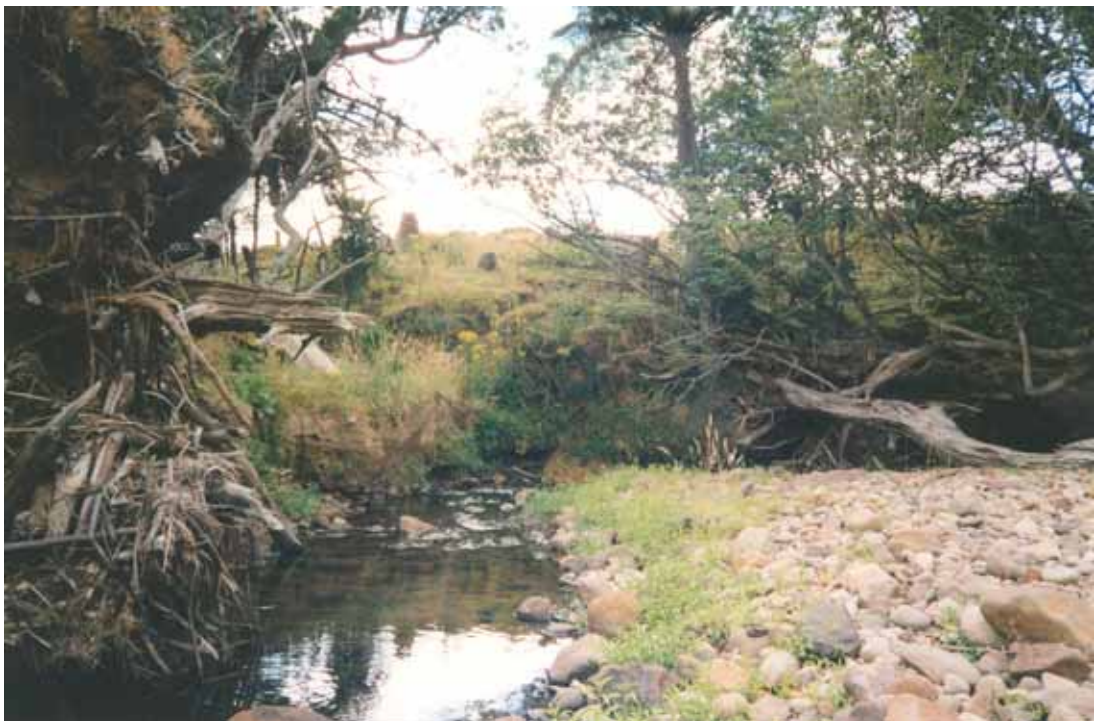
Figure 22.4 At 3.3km, two large trees have been uprooted and collect debris.
