Tauranga Harbour Sediment Source Survey

Report prepared by Matthew Surman, Design Engineer
Richard Clarke, Student - Lincoln University
Meredith Carter, Student - Waikato University

Environment B·O·P
Quay Street
P O Box 364
Whakatane
NEW ZEALAND

The report provides an order of magnitude estimate of sediment transported from stream bank erosion into Tauranga Harbour from the harbour catchments. The report describes and costs possible stream improvement works and estimates the reduction of sediment yields such works may achieve.

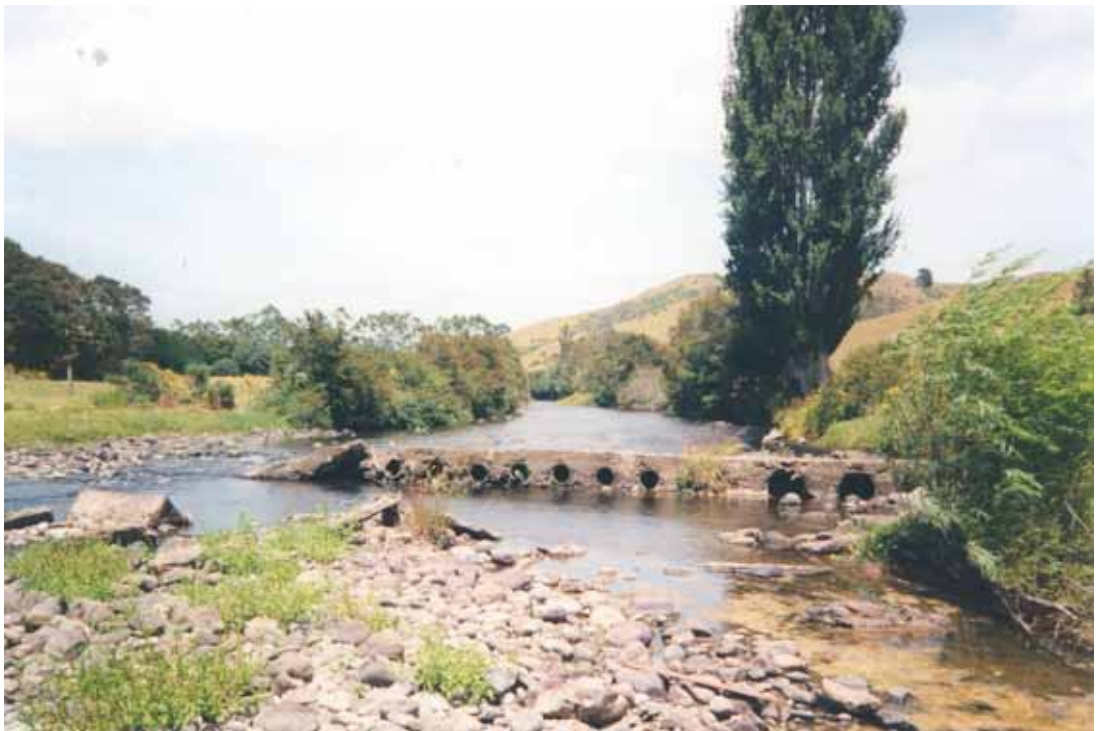
Figure 24.10 At 1.9km a broken causeway lies across the stream..

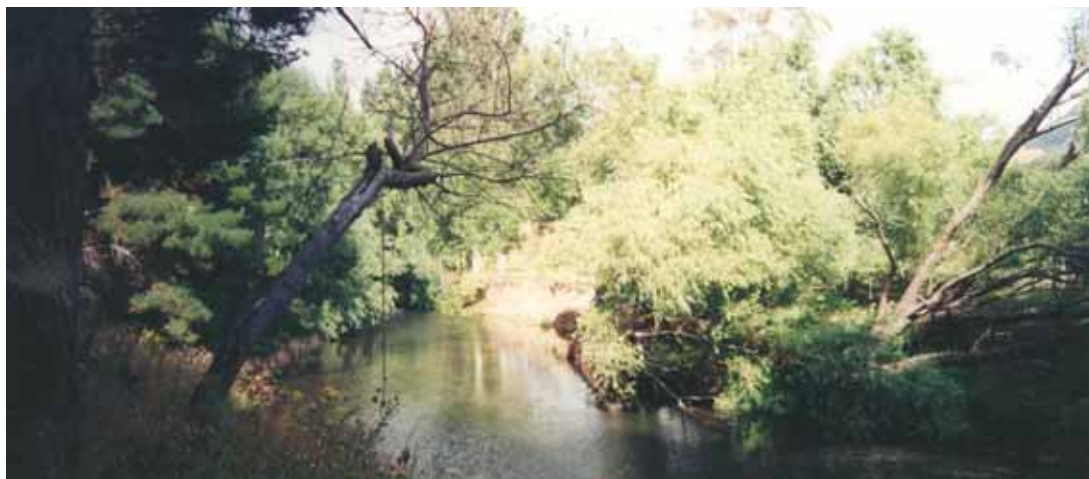
Figure 24.11 Looking upstream, willows overhang the main flow at 650m. Erosion of the true left bank extends for 10m.
