Ngapuna Industrial Area Dust Survey 2010

Bay of Plenty Regional Council
Environmental Publication 2010/17

Ngāpuna Industrial Site Dust Survey

August 2010

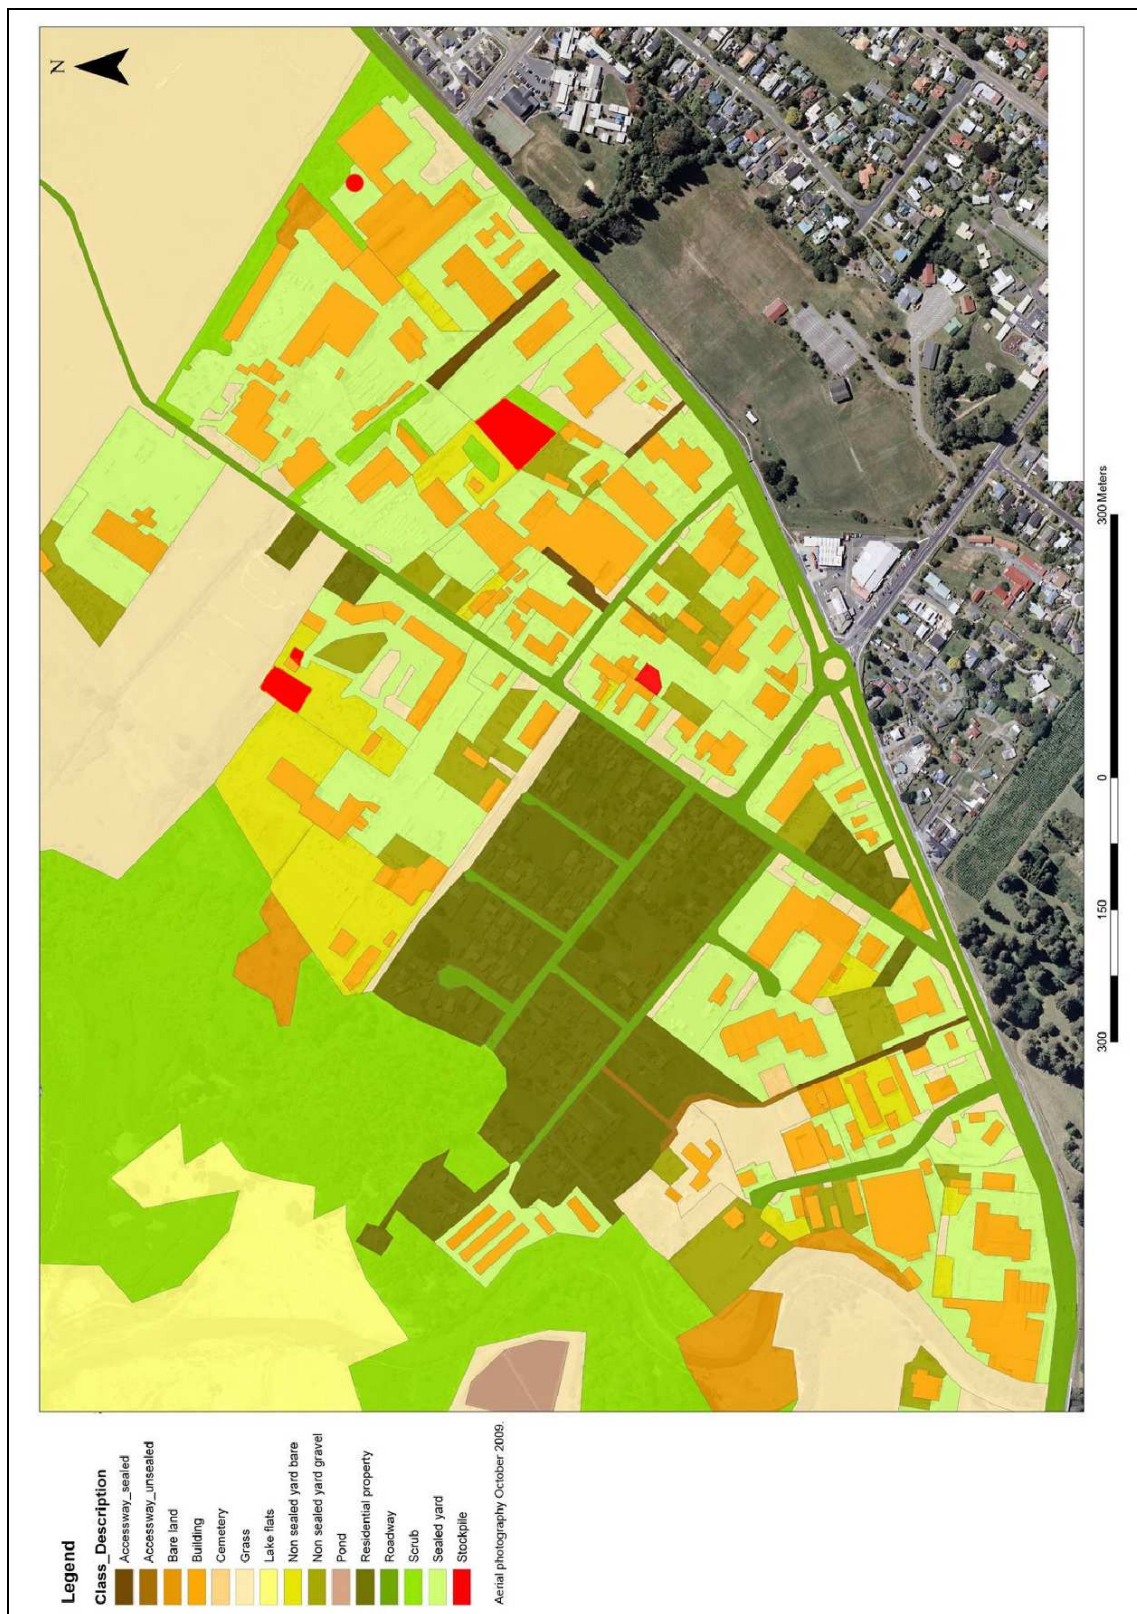
Spatially (Figure 5.12) represented these classes show a pattern in relation to anticipated dust potential and the location of the regional councils monitoring caravan.

Figure 5.12 Land cover type for Ngāpuna subdivision (red dot – air quality monitoring site).

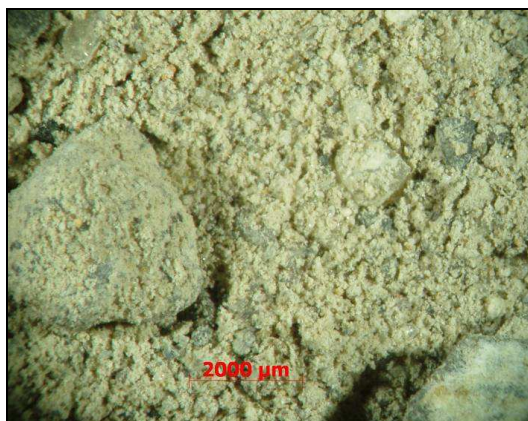
Under the microscope individual minerals of volcanic origin could be identified. Accompanying these larger minerals is a finer fraction (<20µm) of pumiceous material (Figure 5.14).

Figure 5.14 Sample from Godfrey Haulage Ltd. 10x mag.

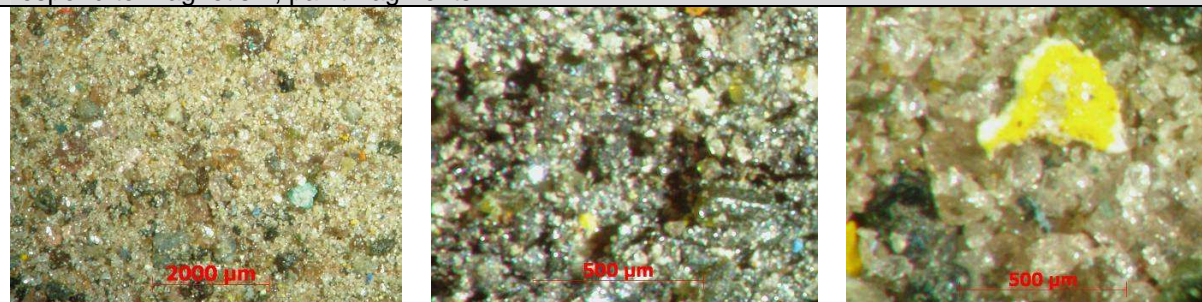
In addition to this background profile some sites has additional components associated with their activity. The spray painting/sandblasting sites had paint fragments and particles which responded to magnetism. The timber processing and handling sites had wood fragments present in the sample.

L to R: Sample showing underlying particle profile along with sandblasting medium, particles that respond to magnetism, paint fragments.

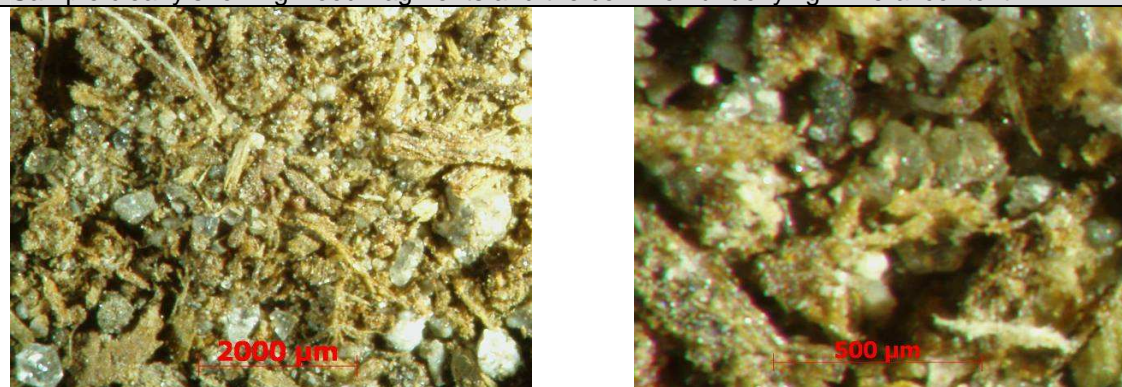
Sample clearly showing wood fragments and the common underlying mineral content.

Figure 5.15 Photomicrography examples of the grab samples collected from two sites in the Ngāpuna subdivision.

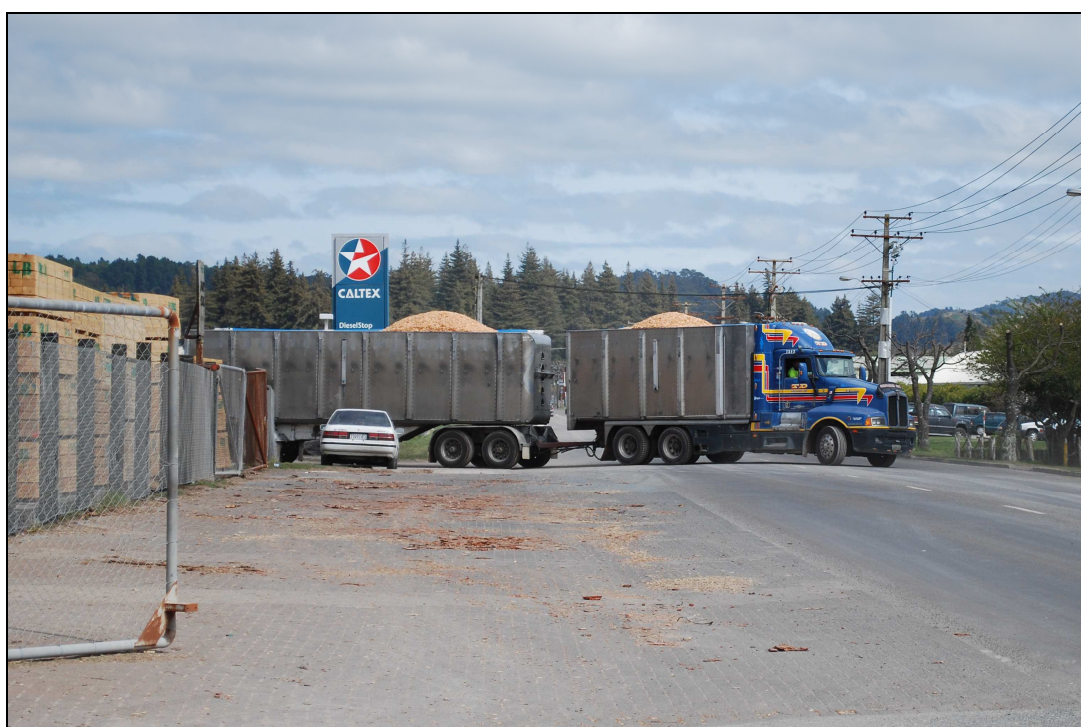
Load covering (where applicable) was discussed as largely being addressed during the survey responses (Figure 6.3), but signage or the like may be necessary as a reminder. This should be addressed and reinforced in a site specific management plan.

Figure 6.3 Uncovered truck, Vaughan Road, looking south, 9 October 2009.

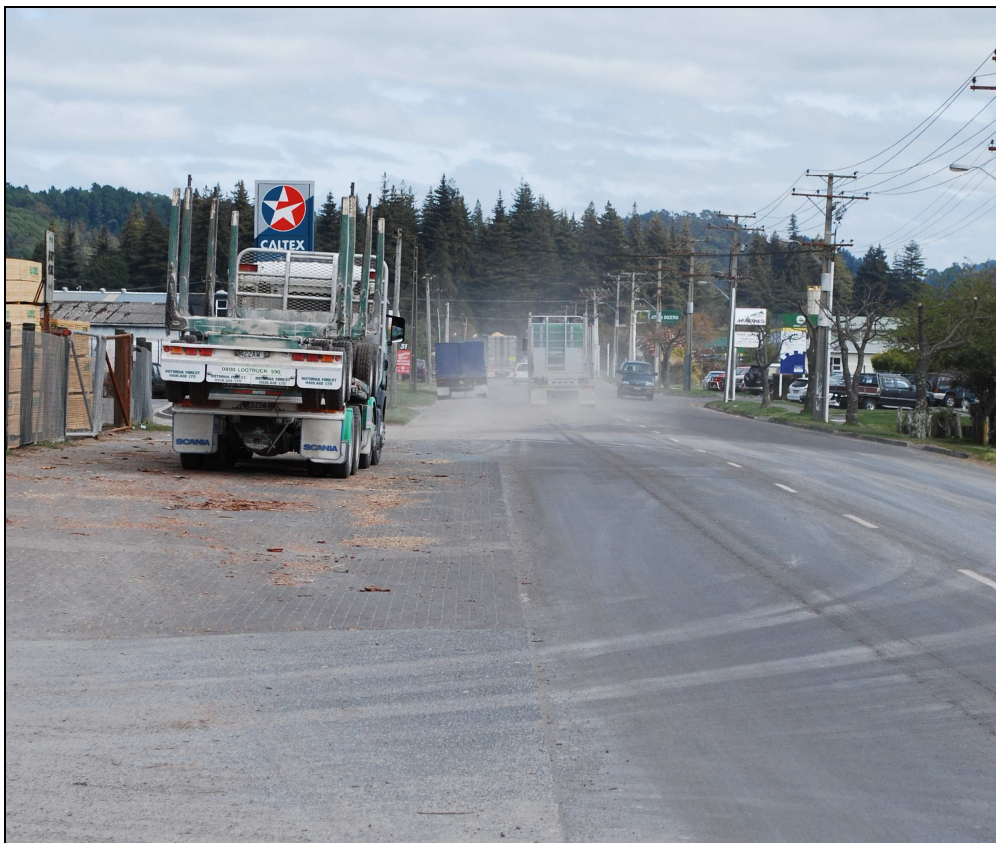
Figure 6.4 Vaughan Road, looking south, 9 October 2009.

Road sweeping frequency by the Rotorua City Council may need to be readdressed (and may require the entire road width rather than the traditional kerbside), fortnightly seems too infrequent when considering the level and type of activities (Figure 6.4) within the subdivision. Tauranga City Council for example has daily and twice weekly road sweeping schedules for areas around Mt Maunganui and the Port of Tauranga. The option of including private business within the schedule could also be investigated.
