**340E Pahoia Road, Whakamarama**

Coastal Processes Impact Assessment

July 2020

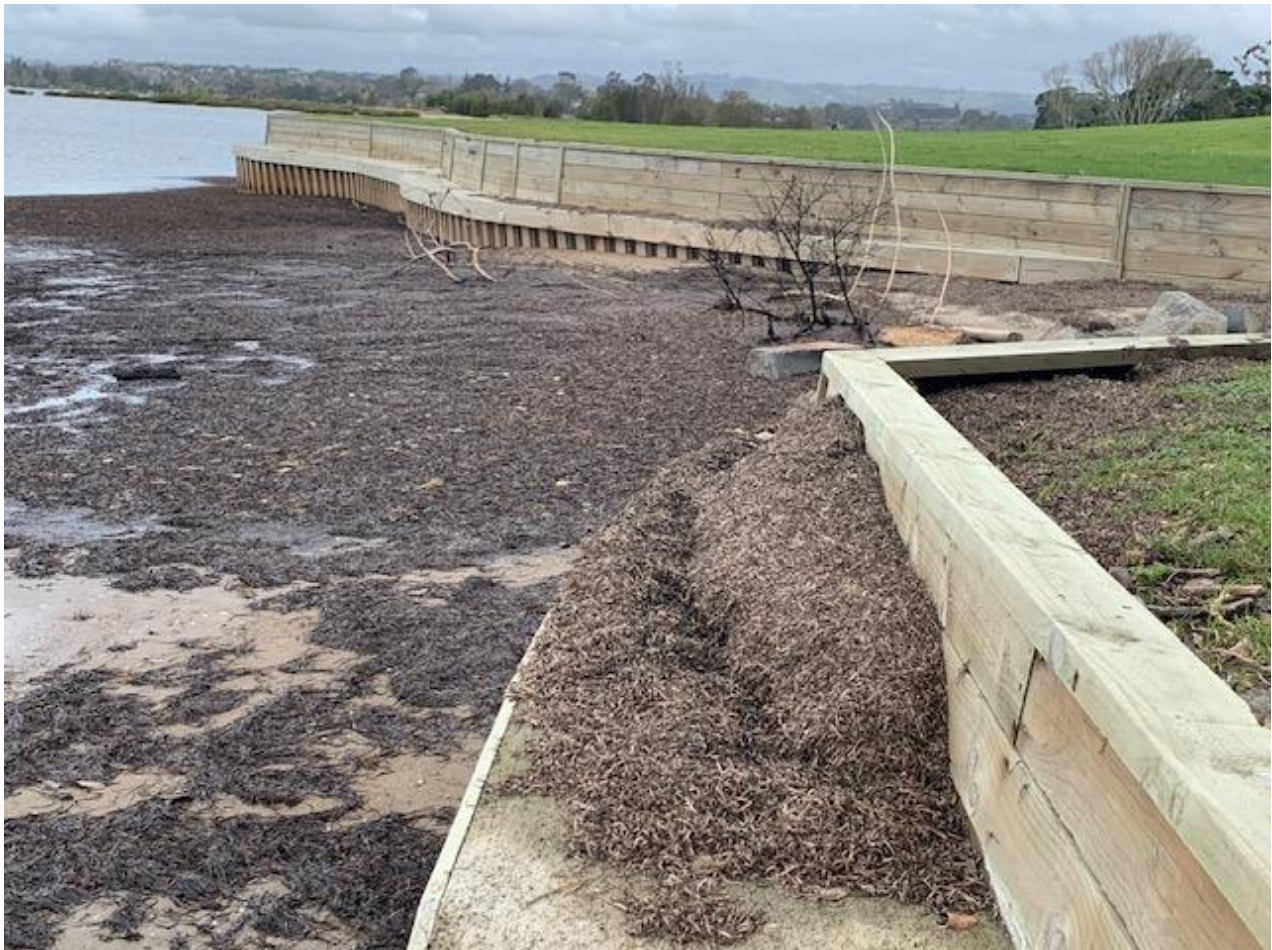
It is understood that the original uPVC plastic sheet pile wall was constructed approximately 12 years ago. The height of this wall varies between 0.6-1m above the sand. A structural assessment undertaken by Kirk Roberts Consulting considered the uPVC sheet pile wall to be in a reasonable condition from a durability perspective with no apparent chalking, which can indicate UV damage and degradation to the plastic. It was observed during the site visit that there is vertical rotation of the wall in some places, but it appears that there has been no additional movement following installation of the new timber wall behind. The predicted lifespan of the original uPVC wall is expected to be at least

another 15 years<sup>1</sup>. This is reliant on the ground level in front of the wall remaining at the current levels and not reducing.

Evidence of overtopping of the original uPVC wall were observed during the site visit with the presence of *Sarcocornia quinqueflora* (Glasswort) noted just behind the wall. Glasswort lives in contact with seawater and therefore provides a good natural indicator of where the extent of tidal inundation is. It is therefore likely that the uPVC wall is getting overtopped multiple times a month.

The new timber pole retaining wall extends the full length of the seaward margin of the main property parcel. It is positioned 0.5m inland of the original uPVC wall and extends to a higher level (750mm above). There is a concrete strip between the original sheet pile wall and the newer higher-level structure.

The Kirk Roberts report considers the condition of the newer timber wall to be good with the wall apparently experiencing no signs of movement or distress/overloading. As such the structural integrity of the wall is considered to be acceptable. Unlike the wall in front, the timber poles are not immersed in seawater continuously and therefore the durability of the timber wall itself is expected to exceed 20+ years.

Figure 3: Existing uPVC seawall and new timber pole retaining wall fronting the coastal fringe of 340E Pahoia Drive.

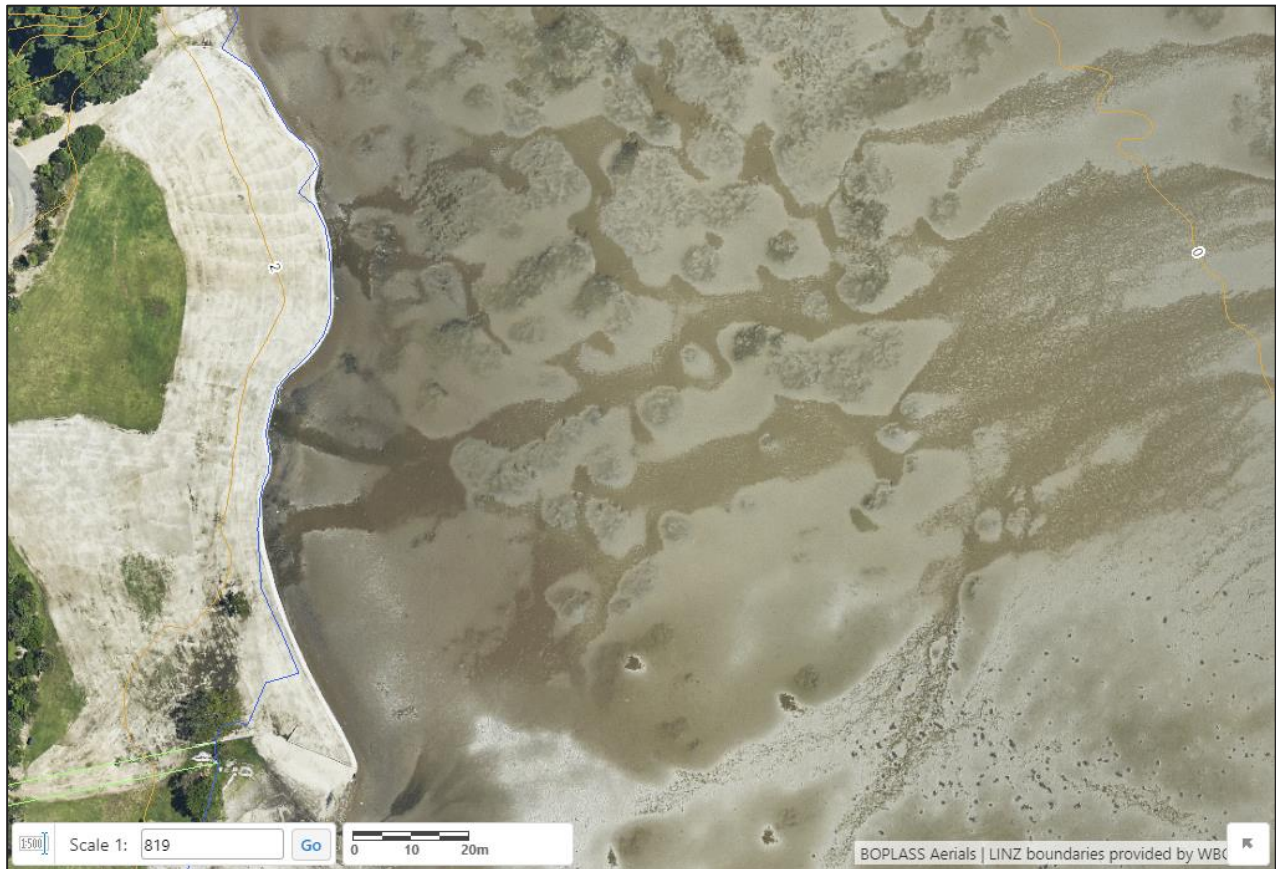
The exact level of the upper wall crest is not known so this assessment is reliant upon LiDAR data and observations from the site visit. It has also been assumed that the LiDAR data was obtained prior to the installation of the timber wall extension above the original uPVC structure. **Figure 6** below shows the location of the RL2m contour on average between 5-10m behind the original structure. The discolouration of the uPVC wall that can be seen in **Figure 3** above indicates that the majority of the structure is subject to tidal waters regularly and that the mean high tide mark is close to the crest of the wall. This is supported by the degree of wash out behind those parts of the wall where recent upgrade works have not yet been undertaken. Therefore, the crest of the recently installed timber retaining wall is assumed to be in the order of RL1.8-2m. Using this assumption and based upon the inundation levels provided in Table 2 above it is expected that the structure will be overtopped during extreme storm conditions.

Figure 6: Contour map of the site obtained from the Western Bay of Plenty Mapi site.

Moving beyond the 15-year lifespan for the structure, any future maintenance or upgrade works would need to take into account future sea level rise projections. This could be achieved through raising the crest height and/or planting of suitable salt-tolerant species.

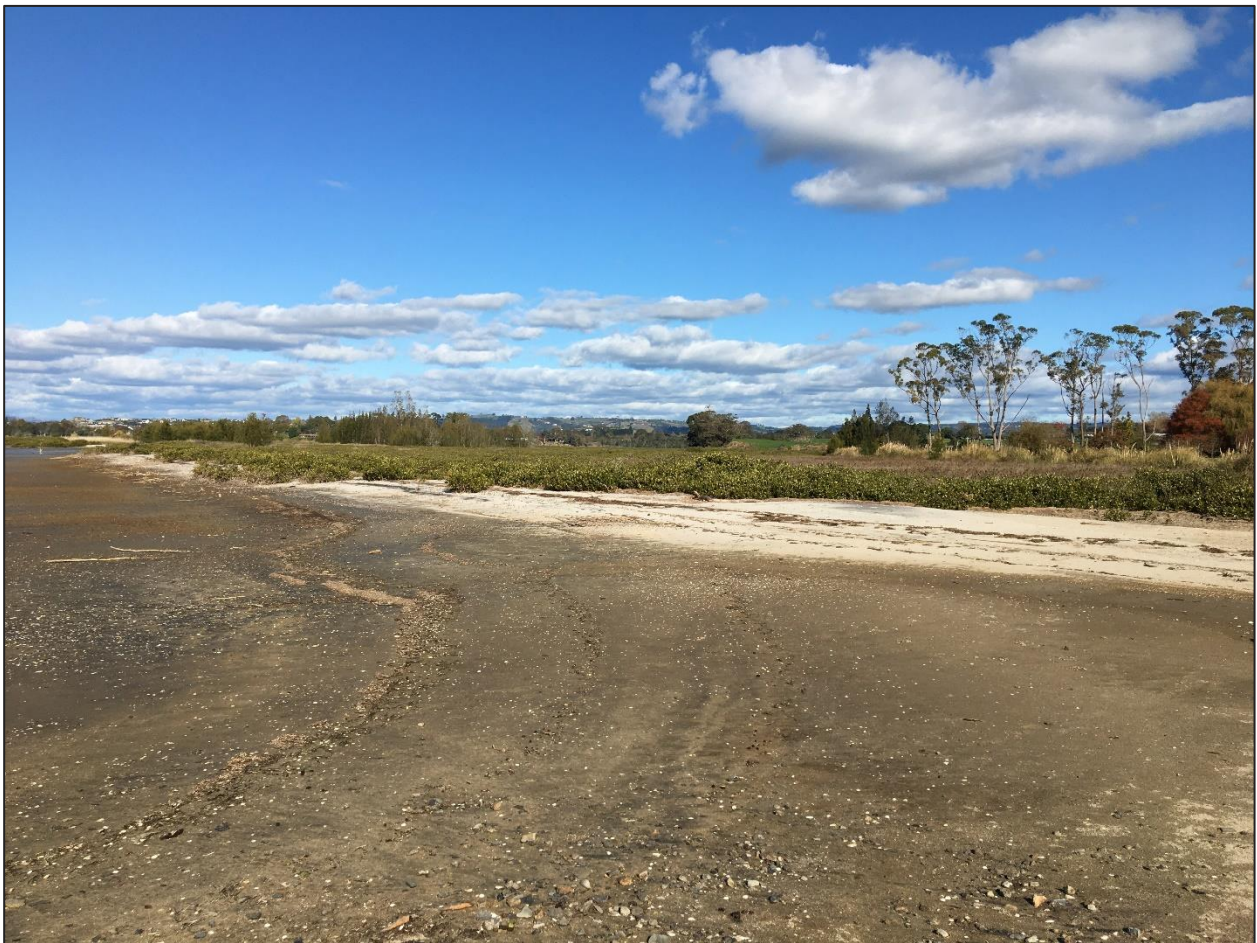
As noted above, there are no discernible effects on the Chenier Ridge or mangrove habitat observed during the site visit or within the air photo/satellite imagery analysis. These types of environments are thought to be relatively resilient; the Chenier Ridge is a transgressive feature, slowly rolling landward as it is overtopped by storm events and the mangrove habitats are able to absorb low wave energies and the root matting design to retain sediments.

Figure 7: Chenier Ridge and mangrove habitat immediately south of the subject site

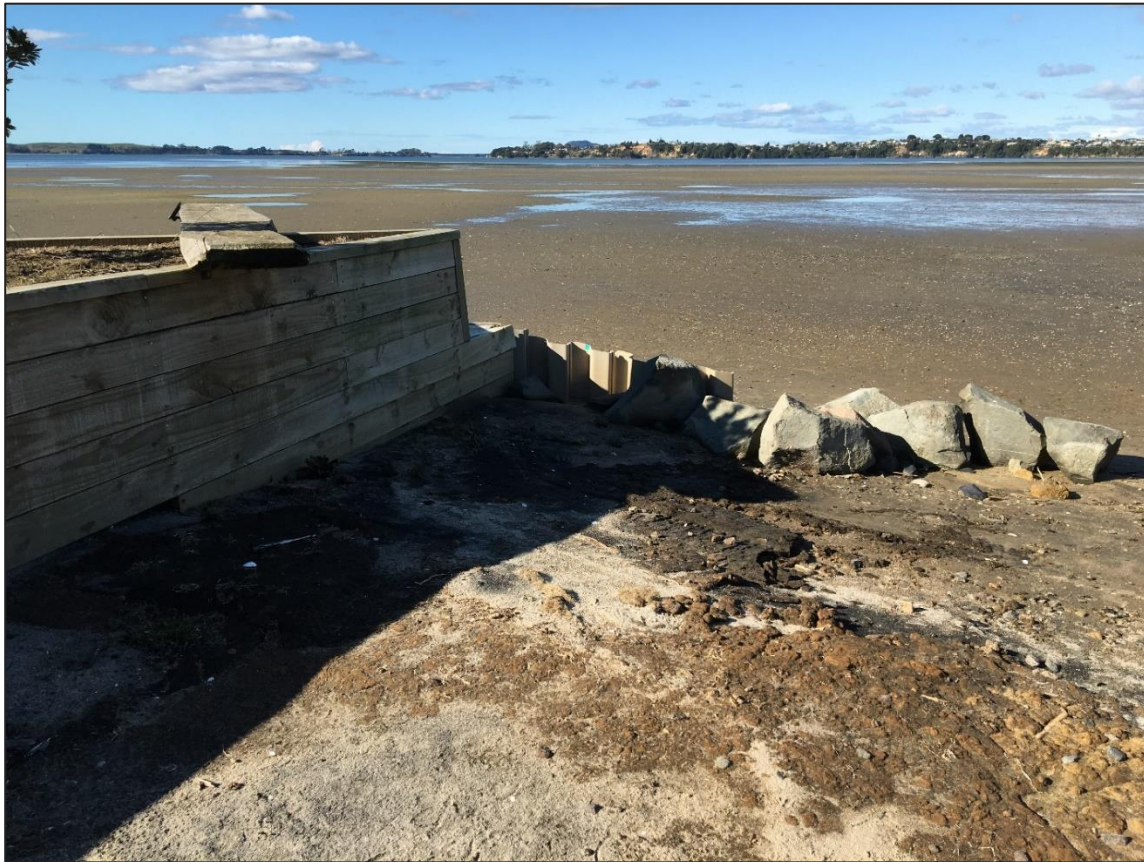
It is understood that recent works included an extension and small reclamation to the southern extent of the seawall. As with most coastal protection structures, this has the potential to cause some effects to the area immediately south. This potential has been mitigated to some degree by the return design and tethering the structure back into the ground. Further, the potential for end effects is reduced by the inclusion of a small deflection groyne at the end of the wall and small waterway area at which the structure terminates at. The small deflection groyne will act to push any

additional turbulence created by the vertical nature of the seawall toward more open waters instead of being focused around the end of the structure toward unarmed areas of shoreline.

Figure 8: Southern termination point of the seawall with small rock deflection groyne.

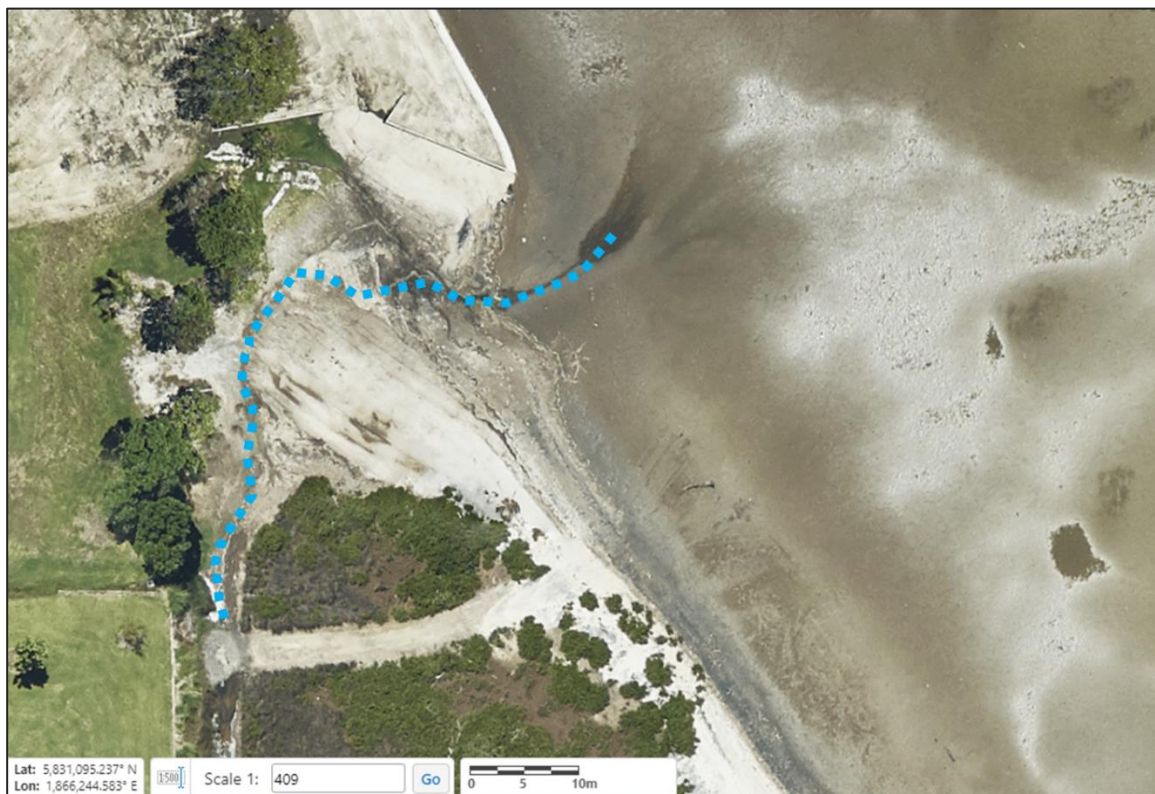
The small waterway appears to be draining the area behind the Chenier Ridge (**Figure 8**) and provides a degree of natural turbulence which the surrounding environment has adapted to. This will also serve to absorb any additional turbulence that is generated from the seawall.

Figure 9: Small waterway immediately south of the recent seawall extension.
