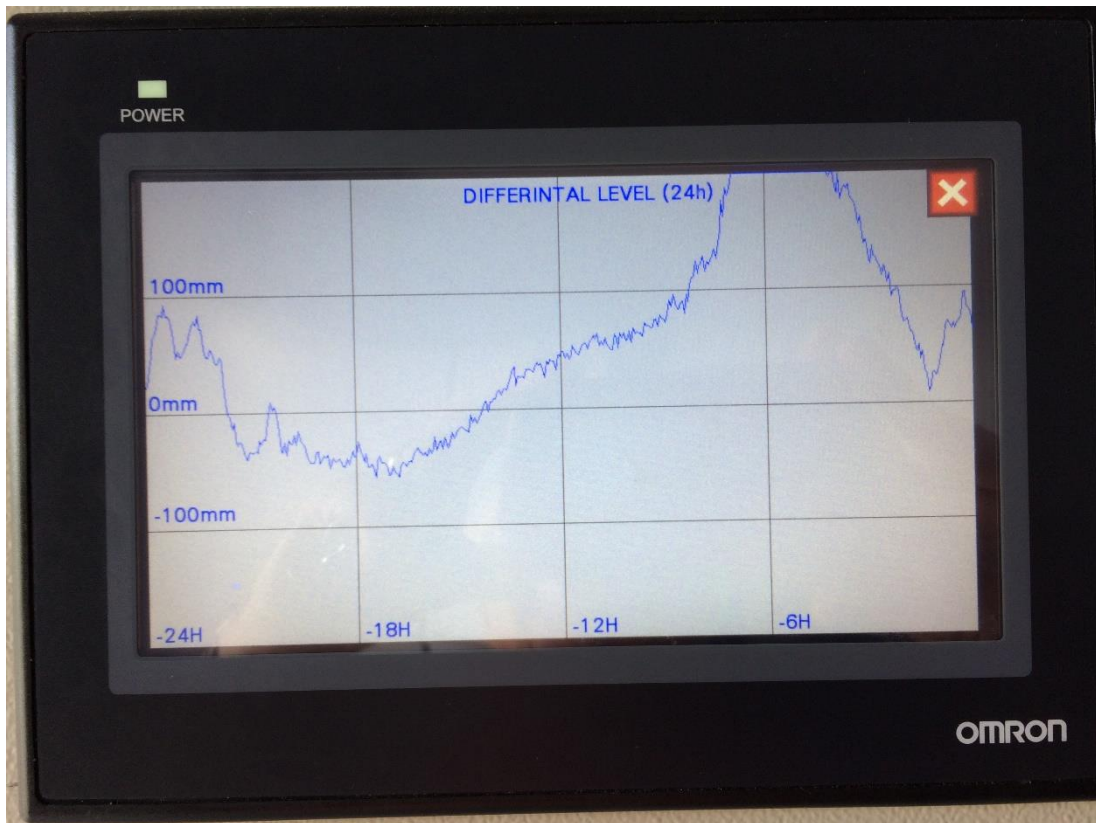
Photo 1: Differential water level across gates over the previous day (the gates may have been open for over 12 hours)

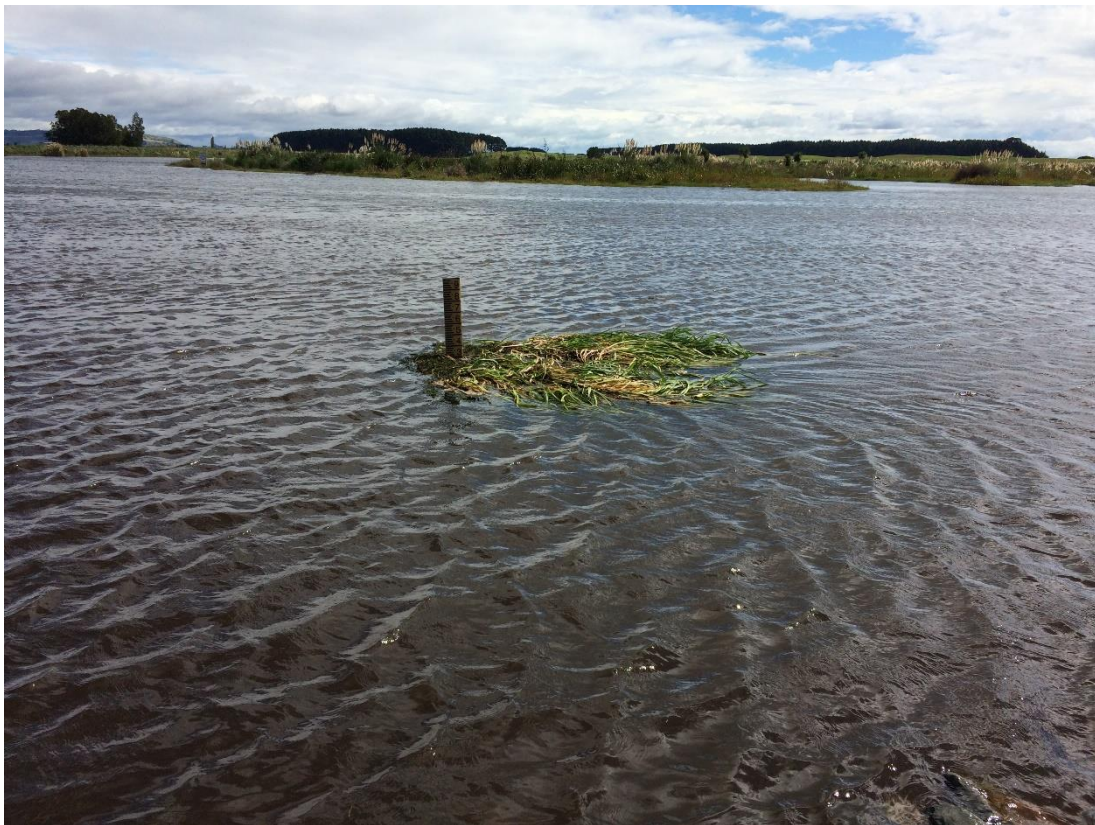
Photo 2: Upstream water level 1.3m

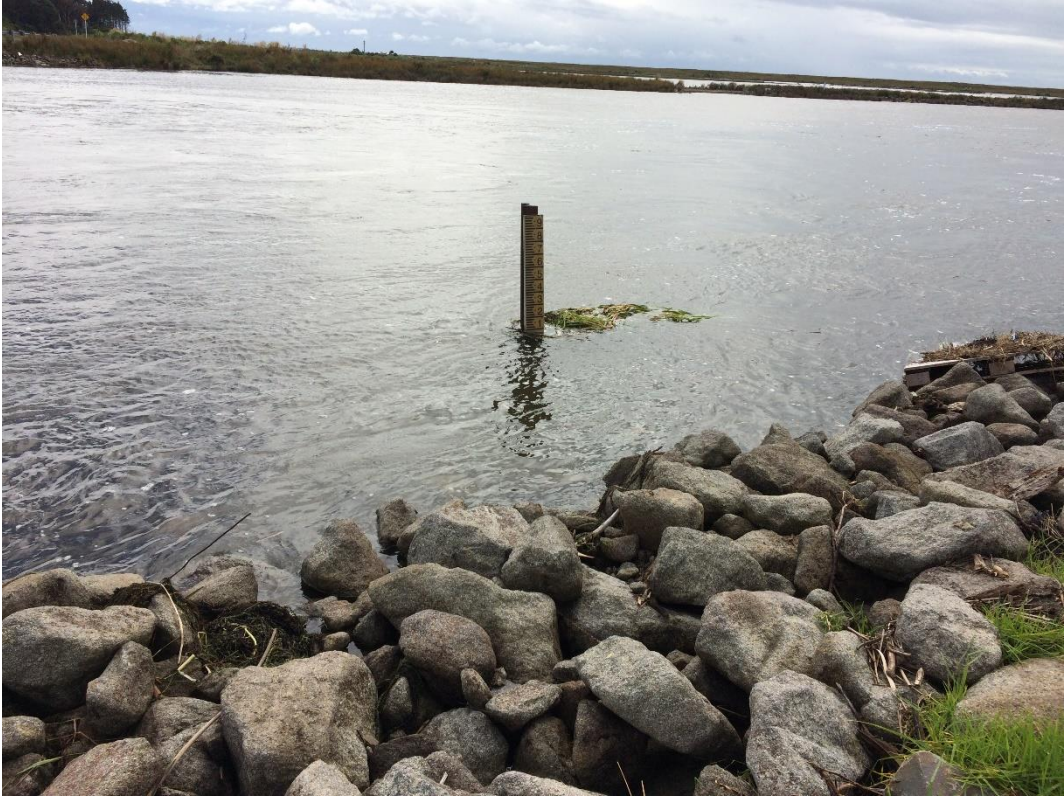
Photo 3: Downstream water level 1.2m

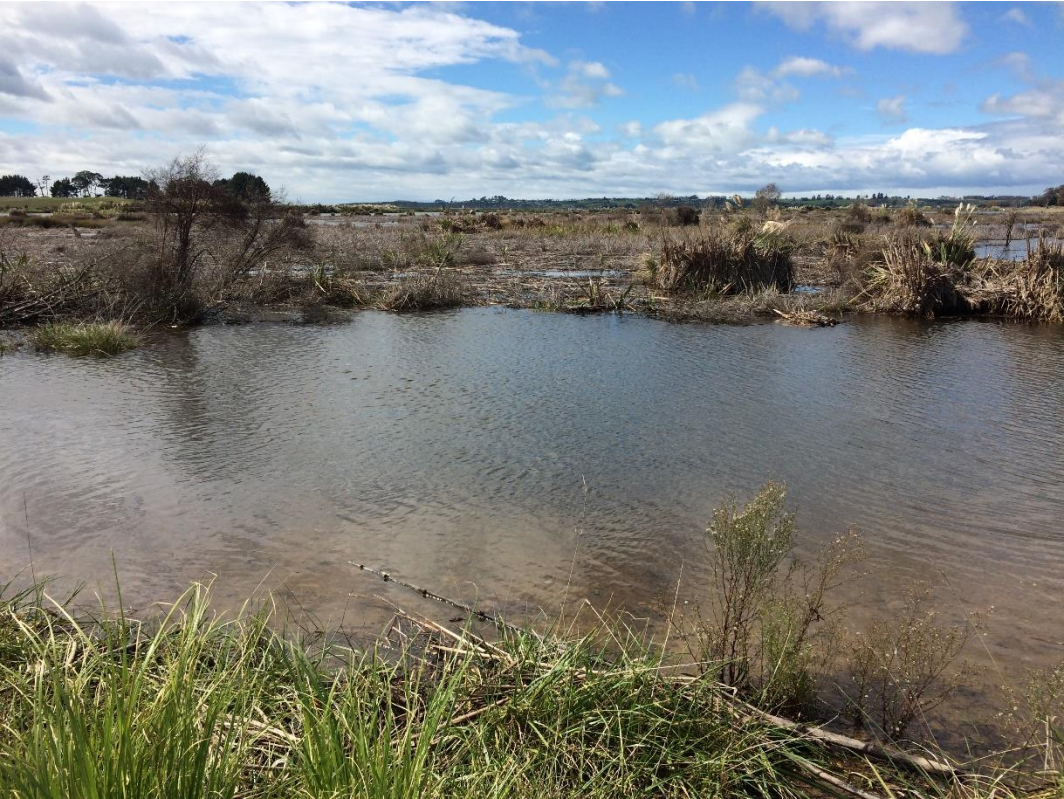
Photo 4: River bank wetland

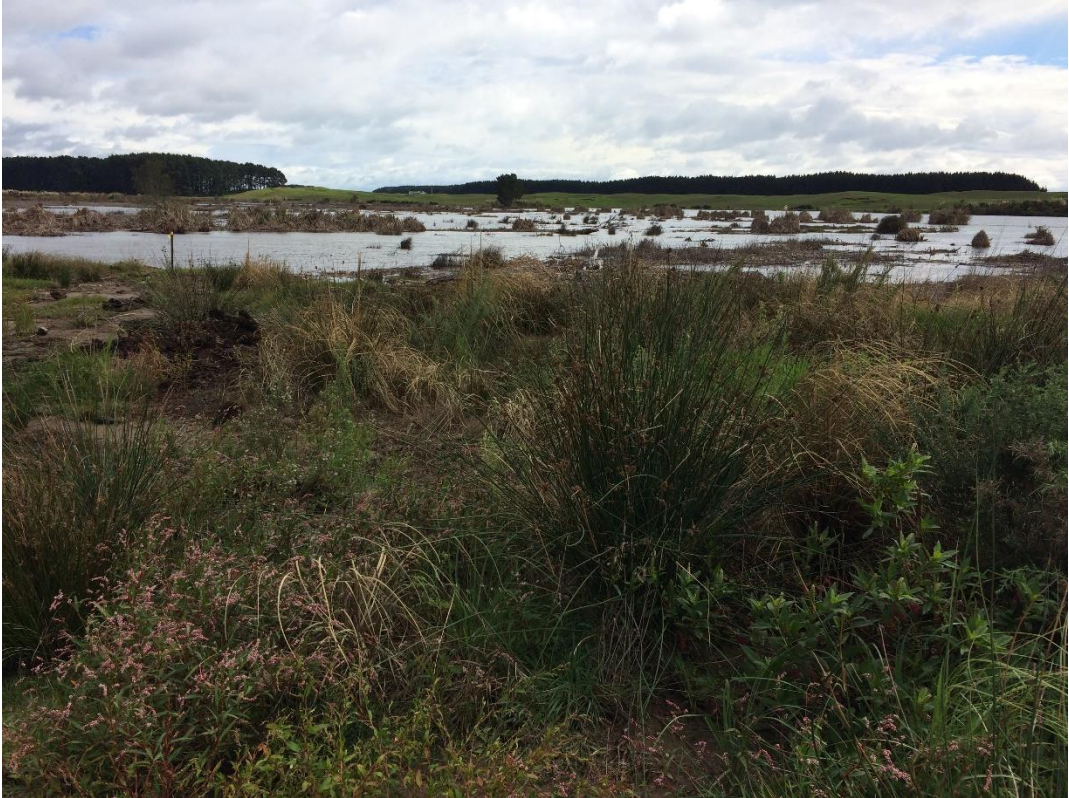
Photo 5: River bank wetland

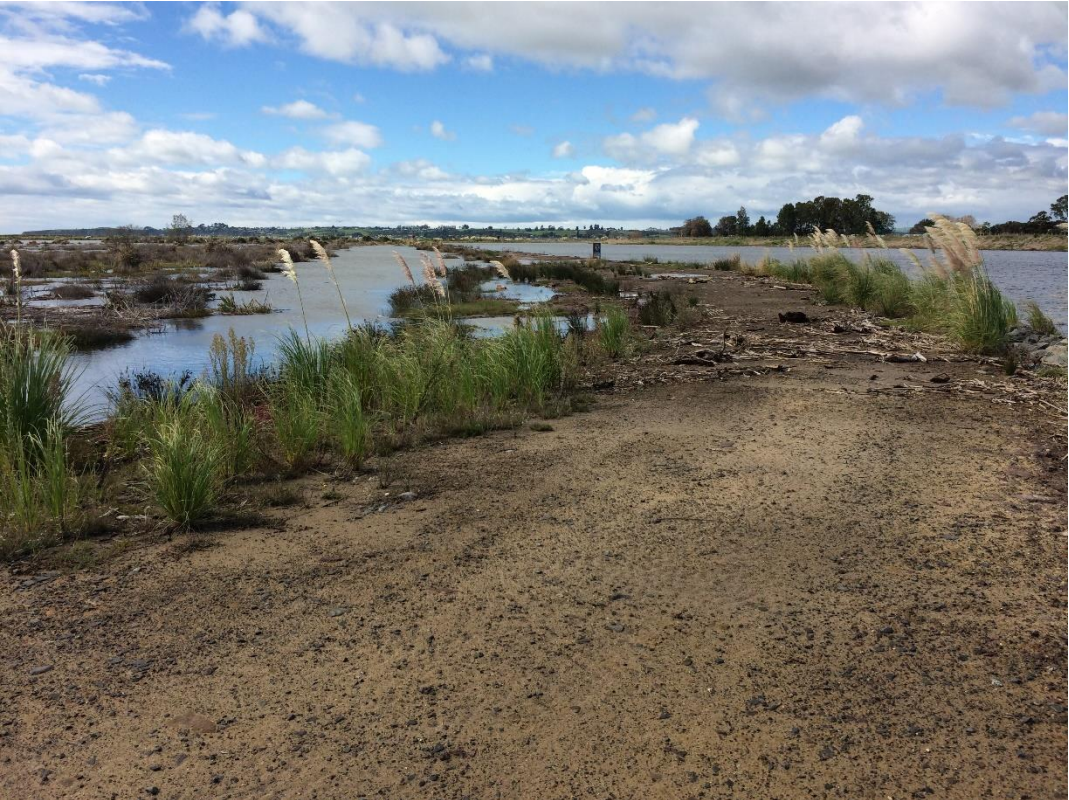
Photo 6: Left bank bund along new channel

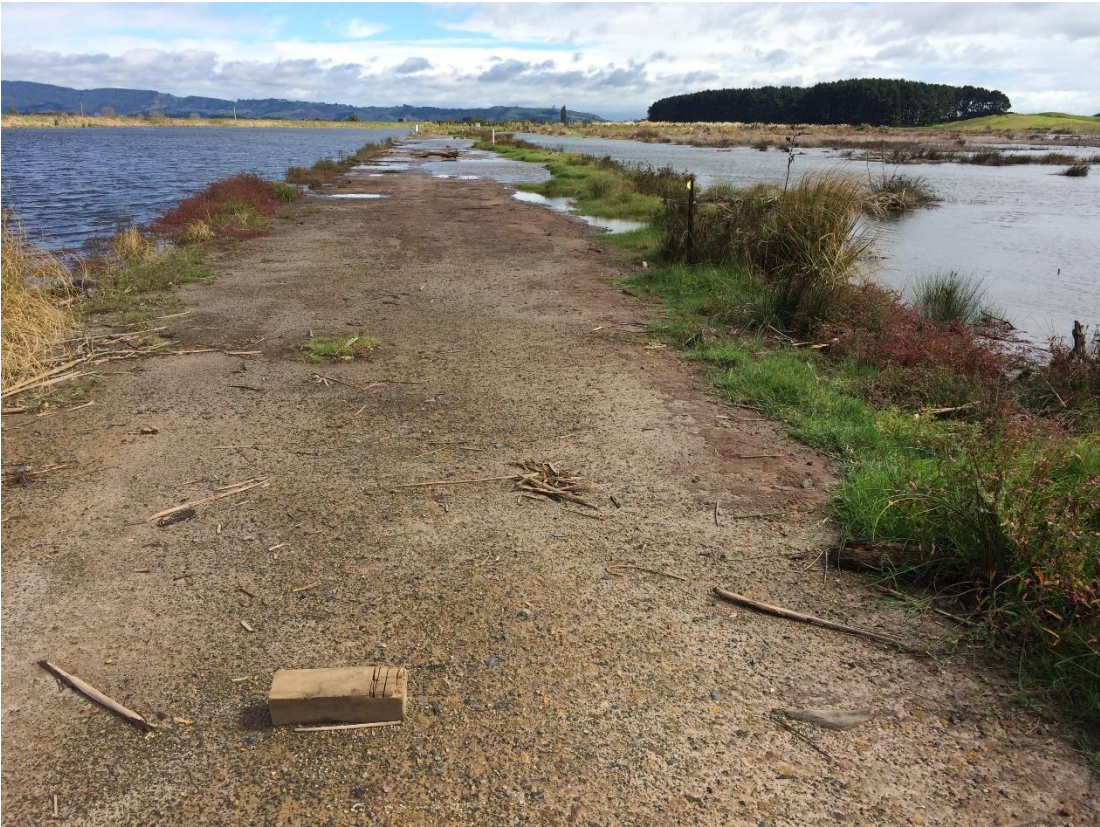
Photo 7: Left bank bund along new channel

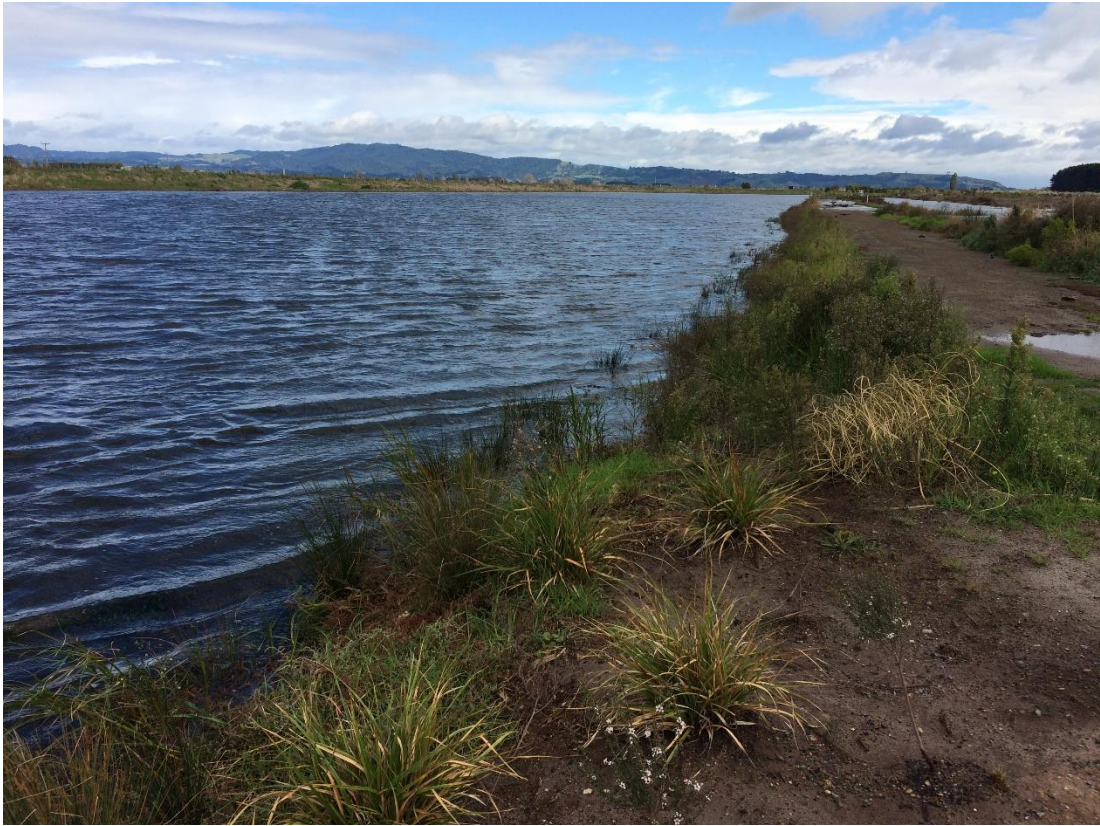
Photo 8: Left bank bund along new channel from outlet

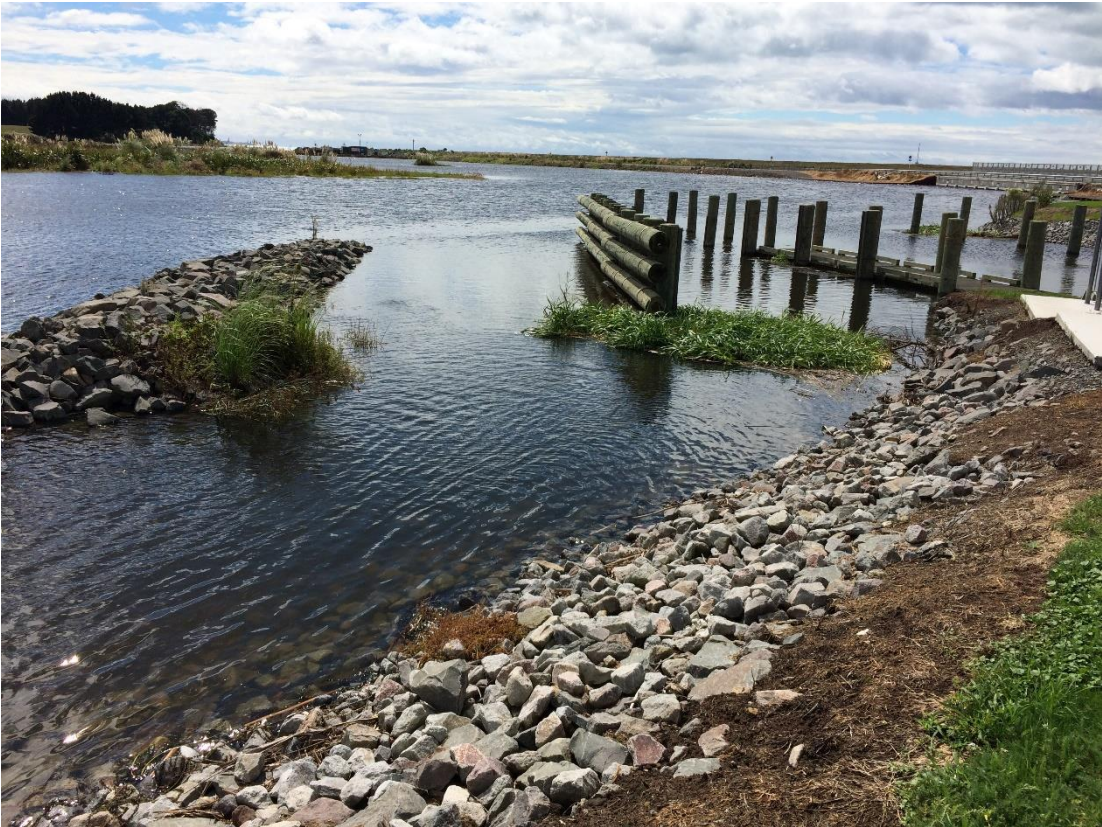
Photo 9: Rock bund and log deflector

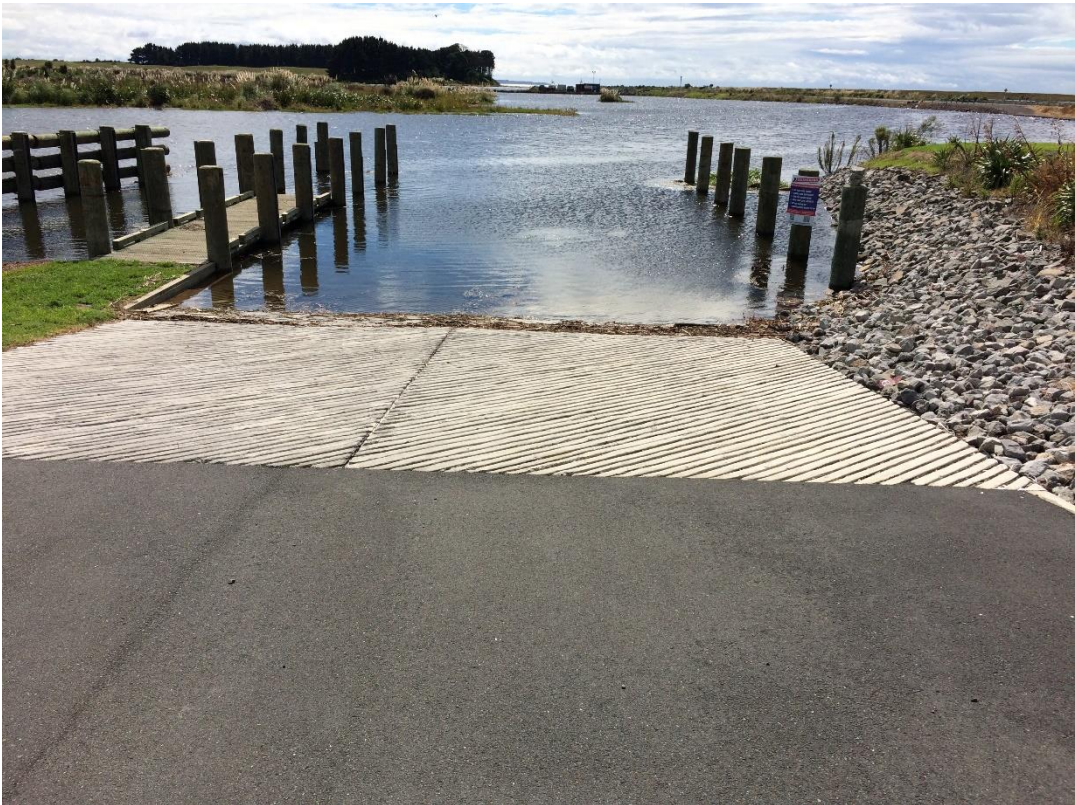
Photo 10: Boat ramp and public jetty

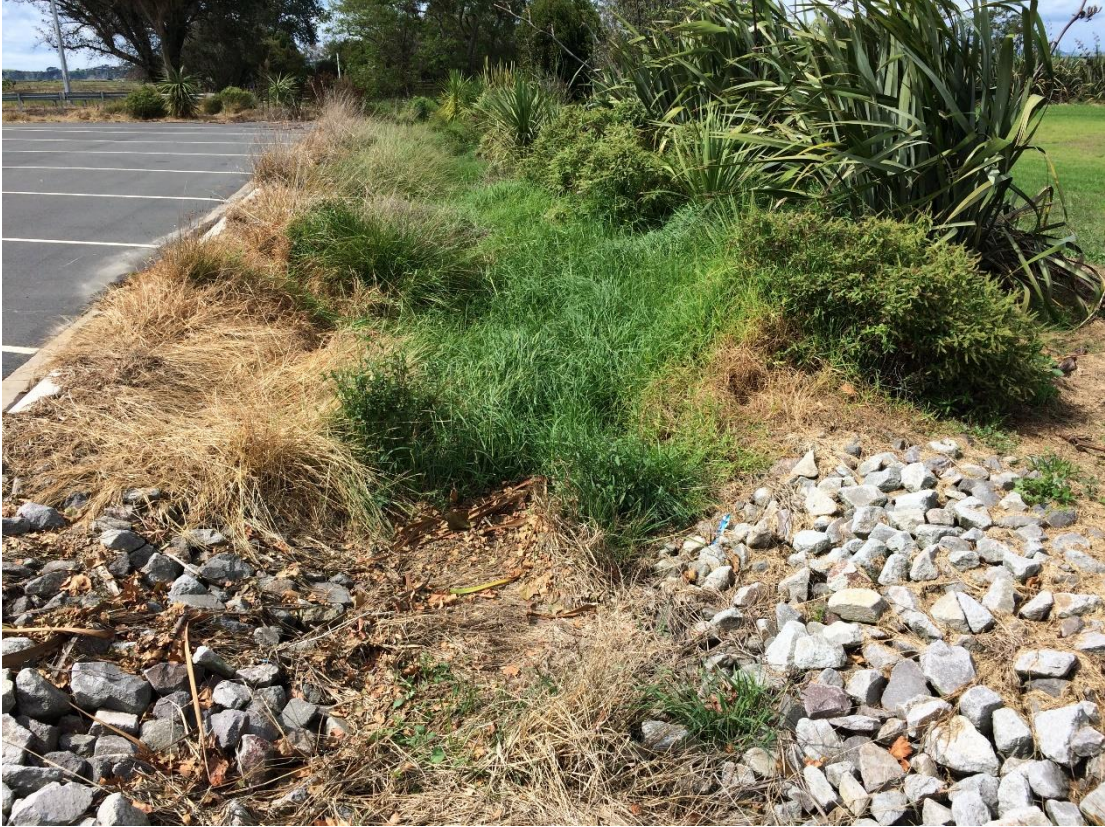
Photo 11: Car park swale drain

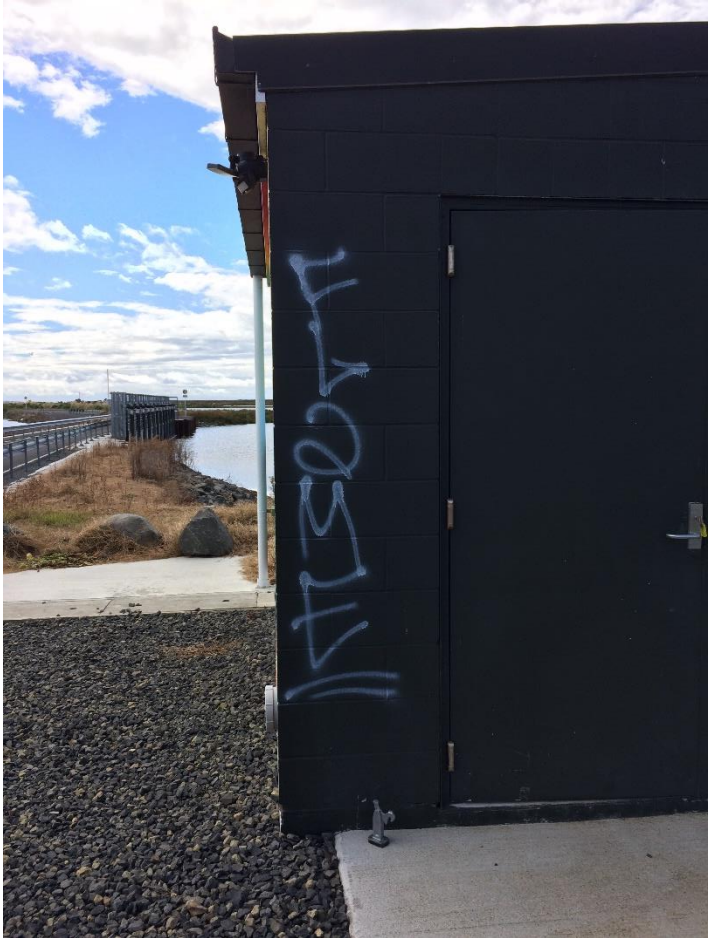
Photo 12: Control building graffiti

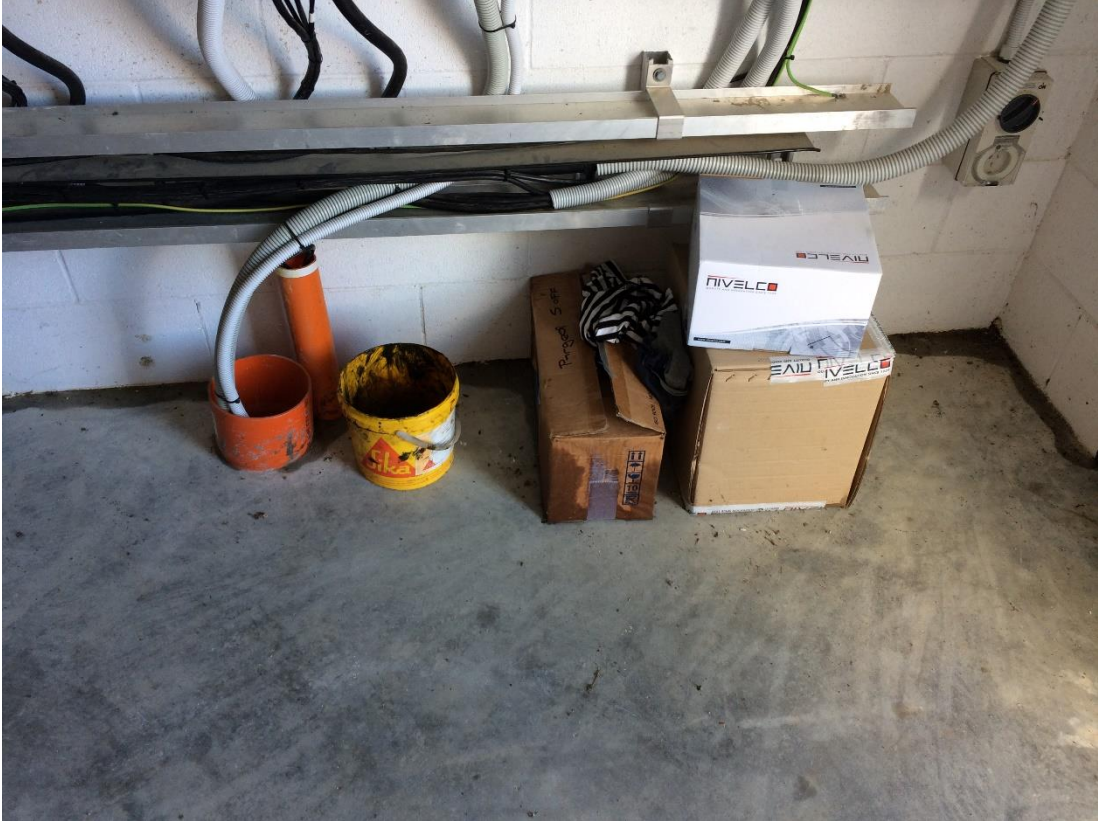
Photo 13: Control building moisture

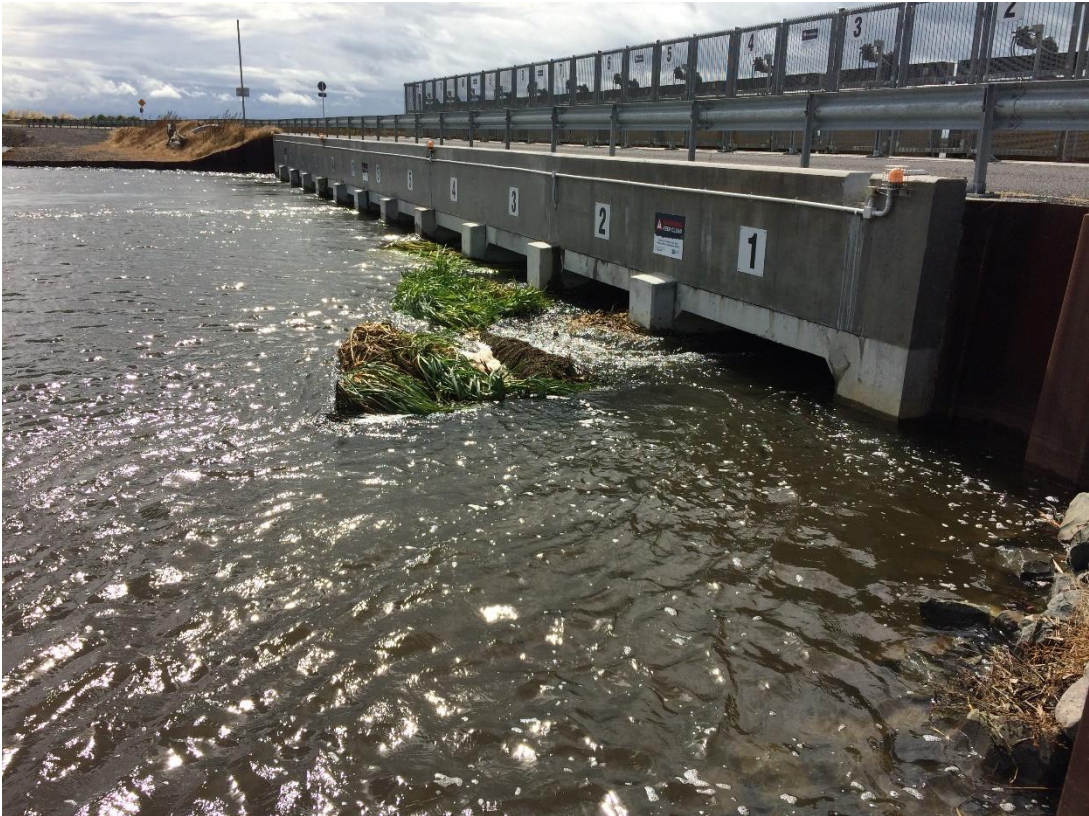
Photo 14: Weed raft across culverts

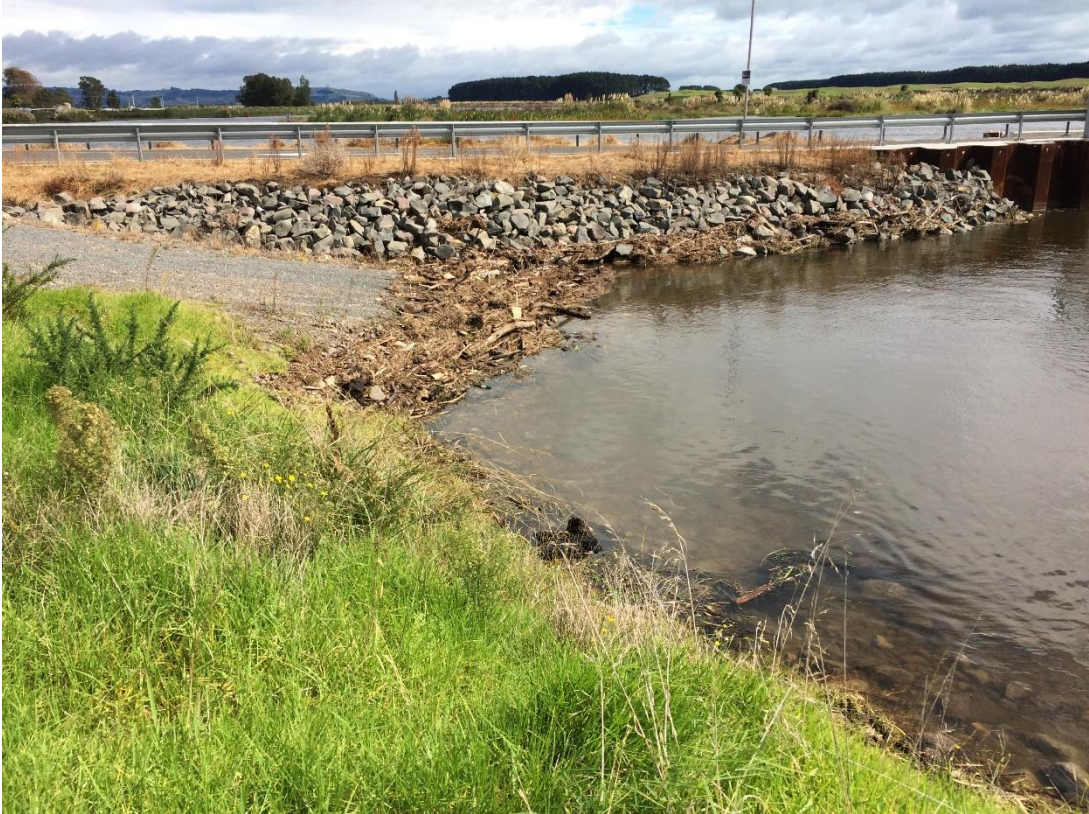
Photo 15: Debris downstream of culverts

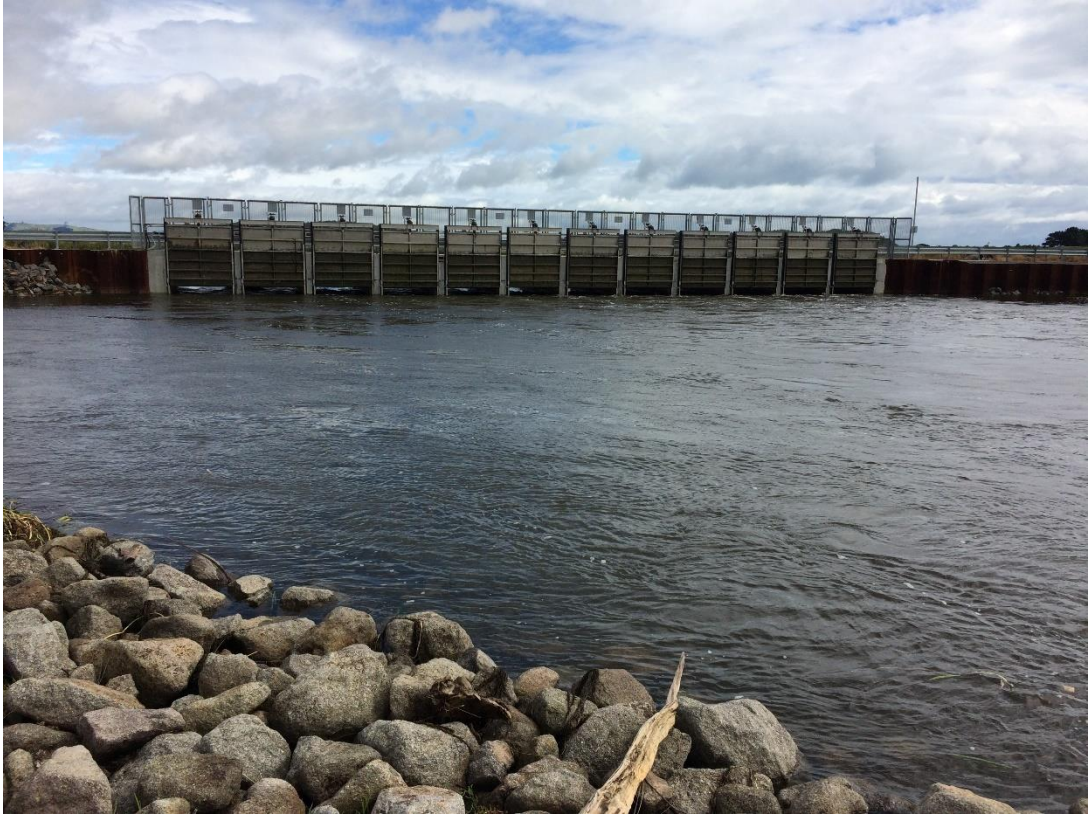
Photo 16: Debris impeding culvert flow

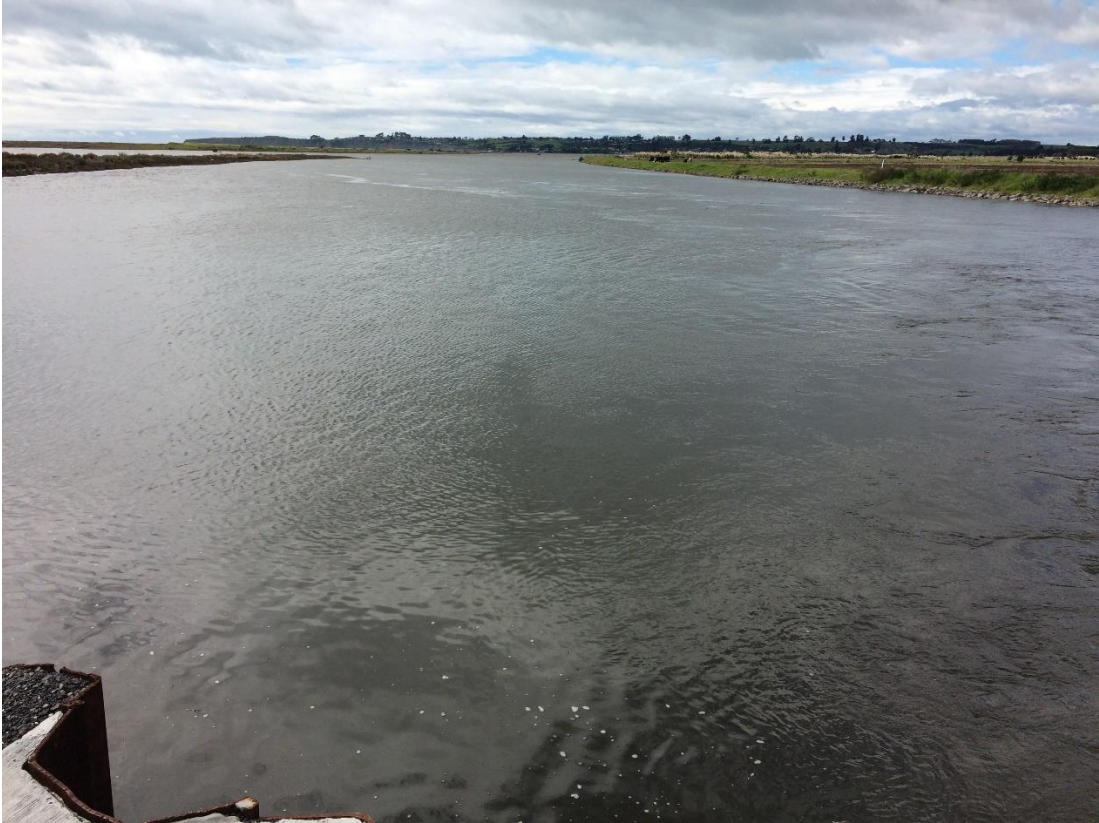
Photo 17: Fords Cut current reflecting towards Te Pa Ika

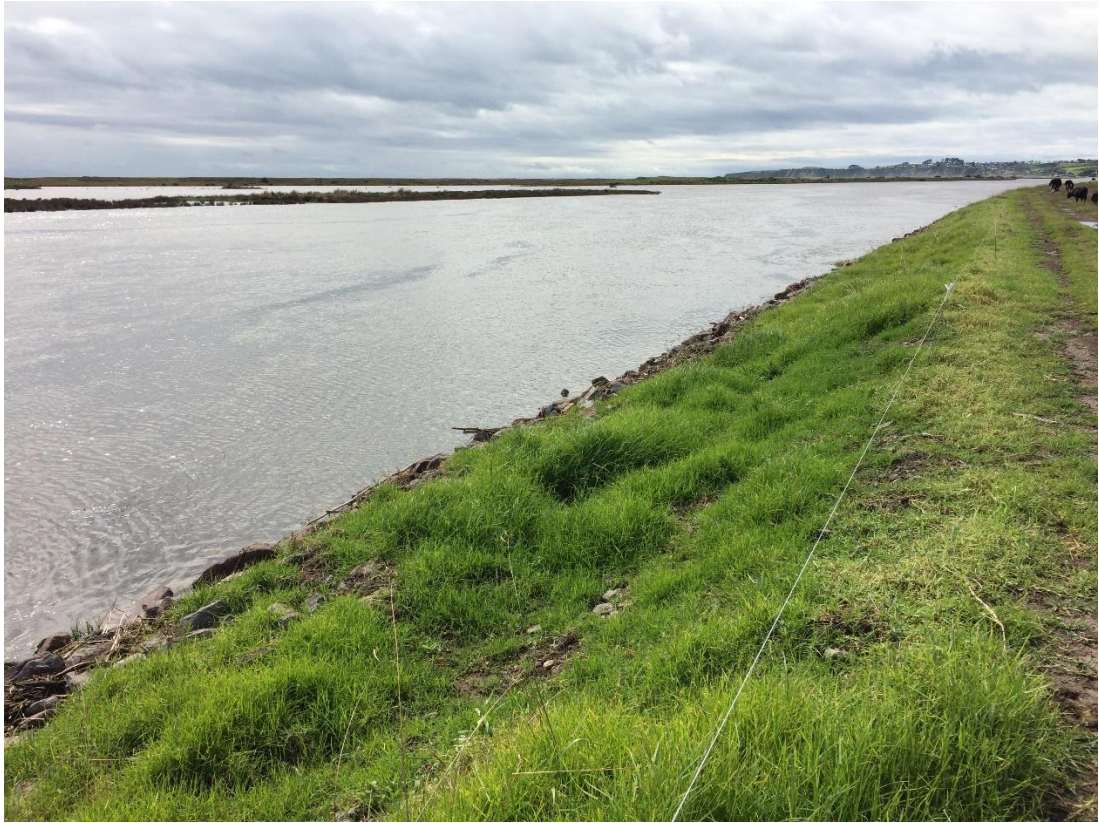
Photo 18: Current reflecting towards Te Pa Ika

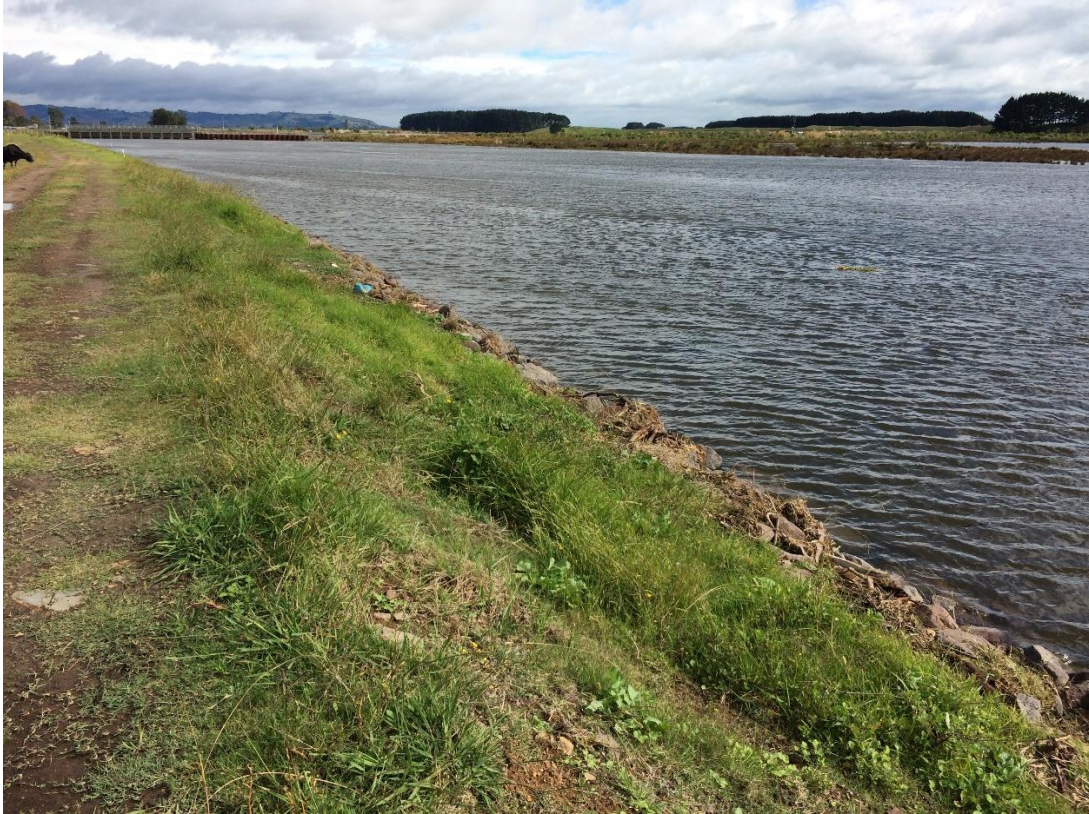
Photo 19: Fords Cut current patterns

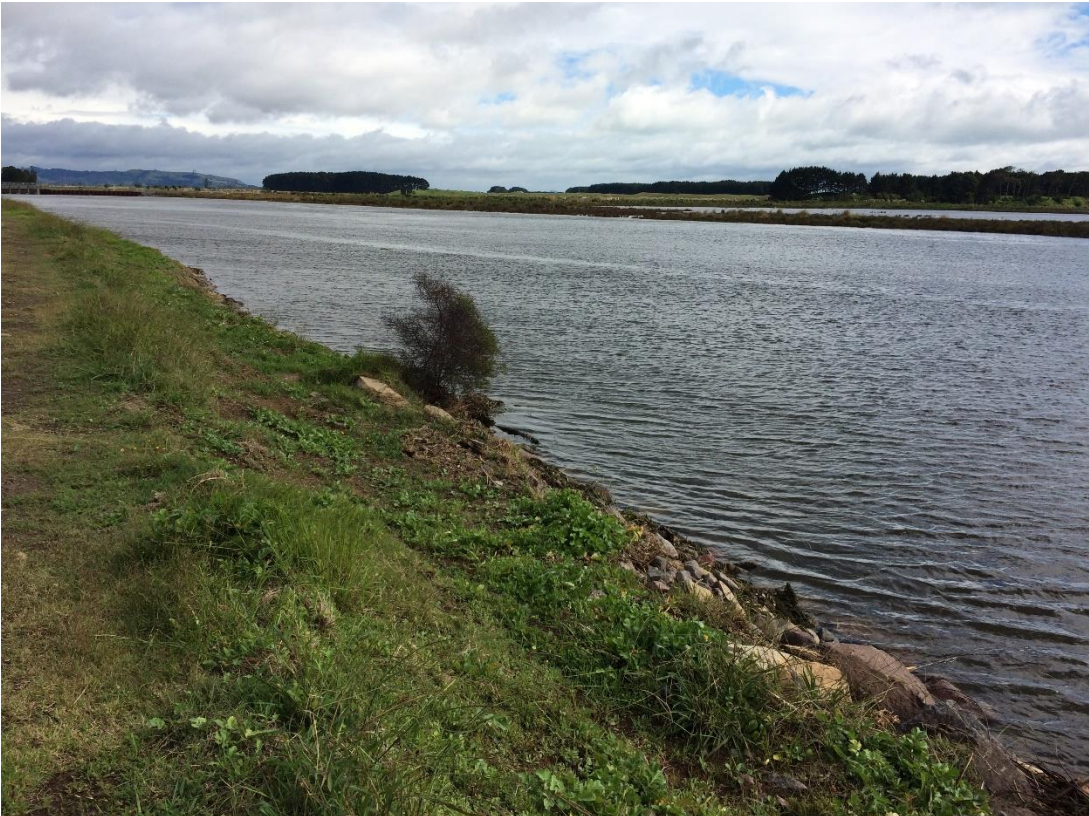
Photo 20: Fords Cut current patterns from end of Cut

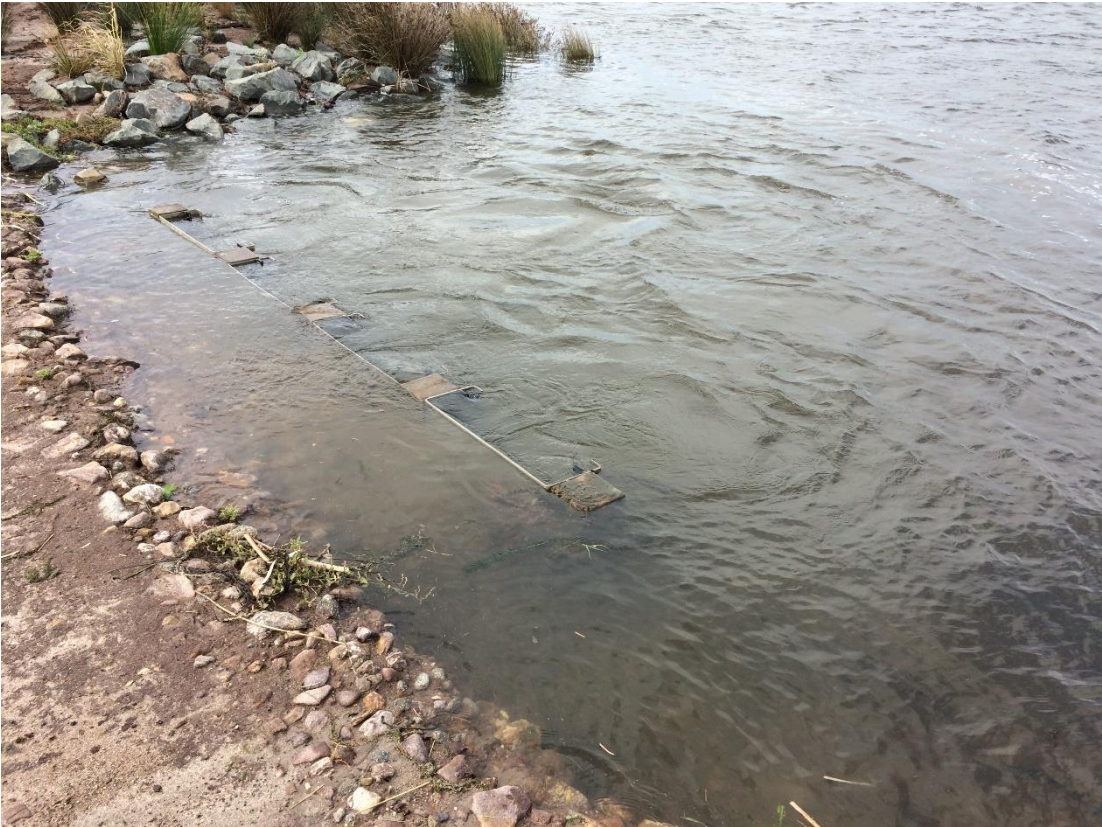
Photo 21: Te Pa Ika culverts outlet

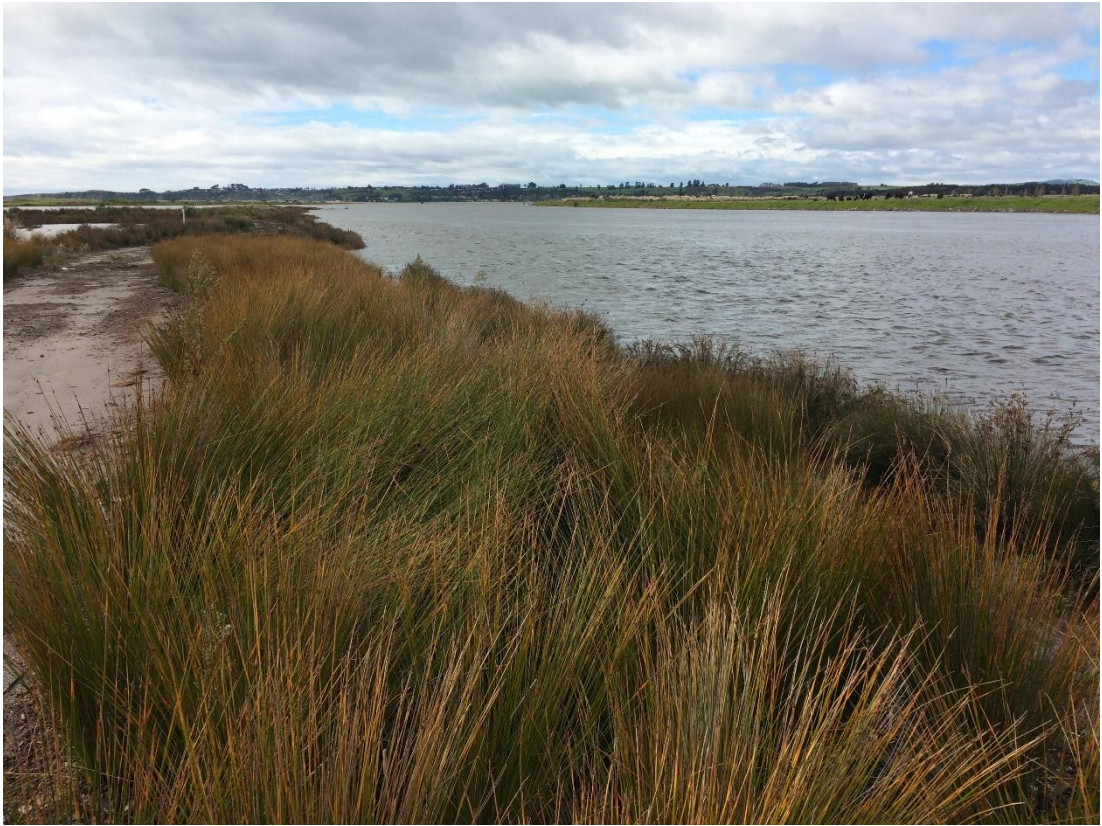
Photo 22: Current hitting left bank (approx. 40m downstream of BMKND2)

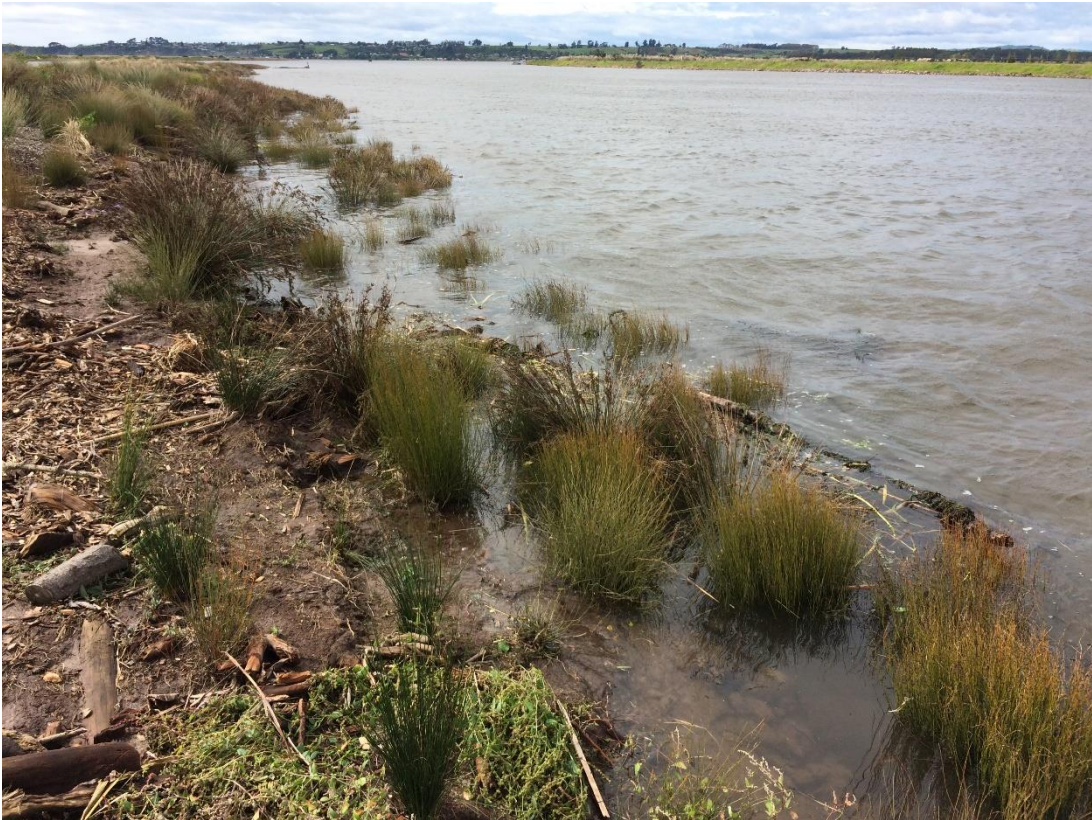
Photo 23: Bank where current hits

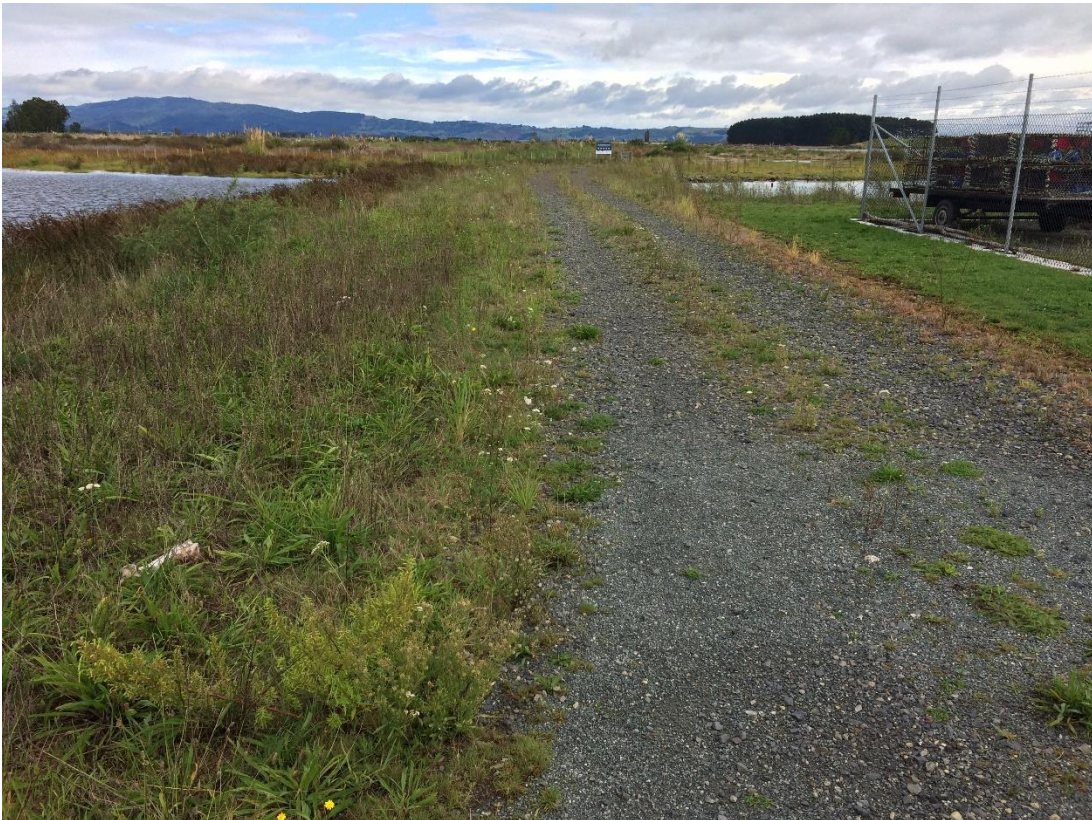
Photo 24: Salinity Block

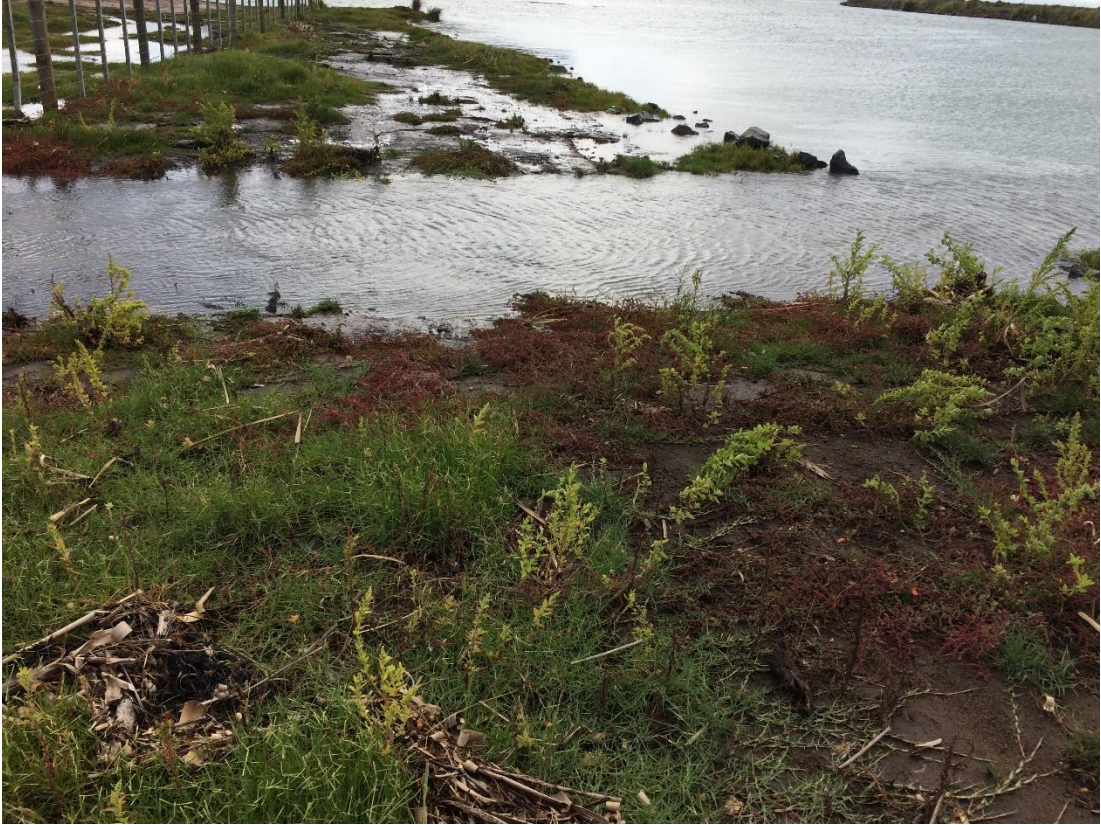
Photo 25: Water draining off Ford Island in swale

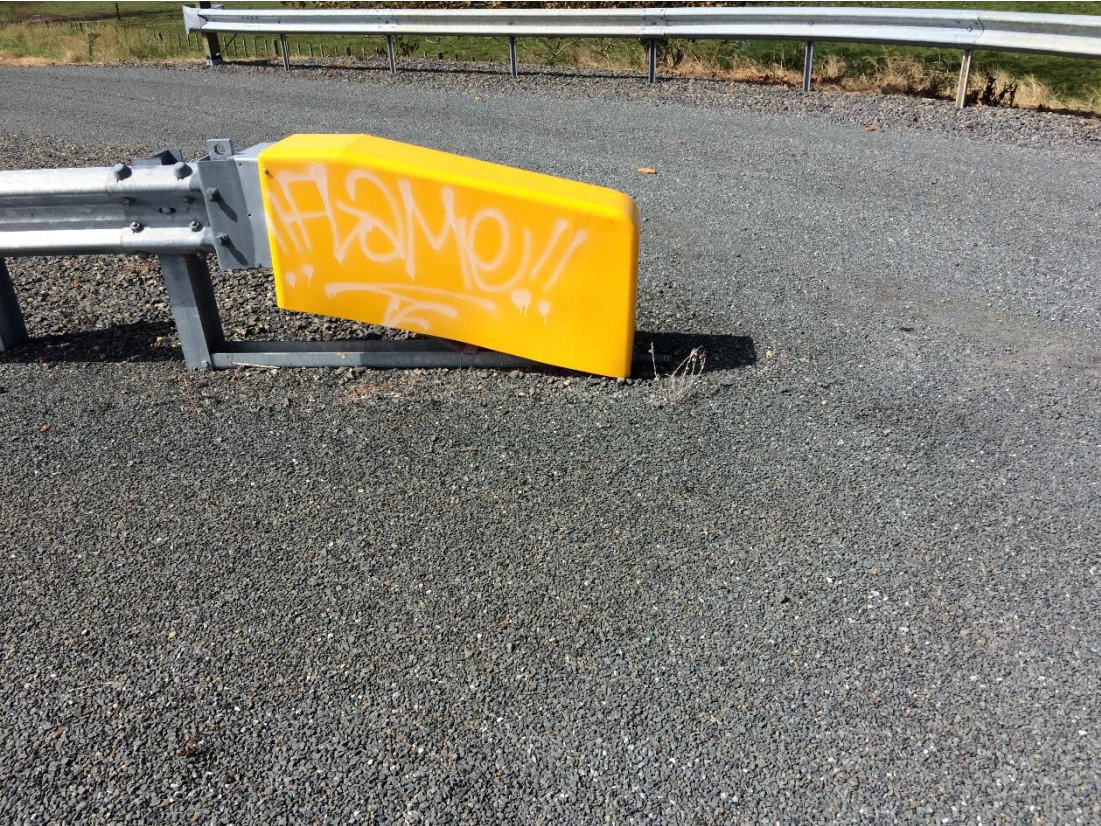
Photo 26: Guard rail graffiti
