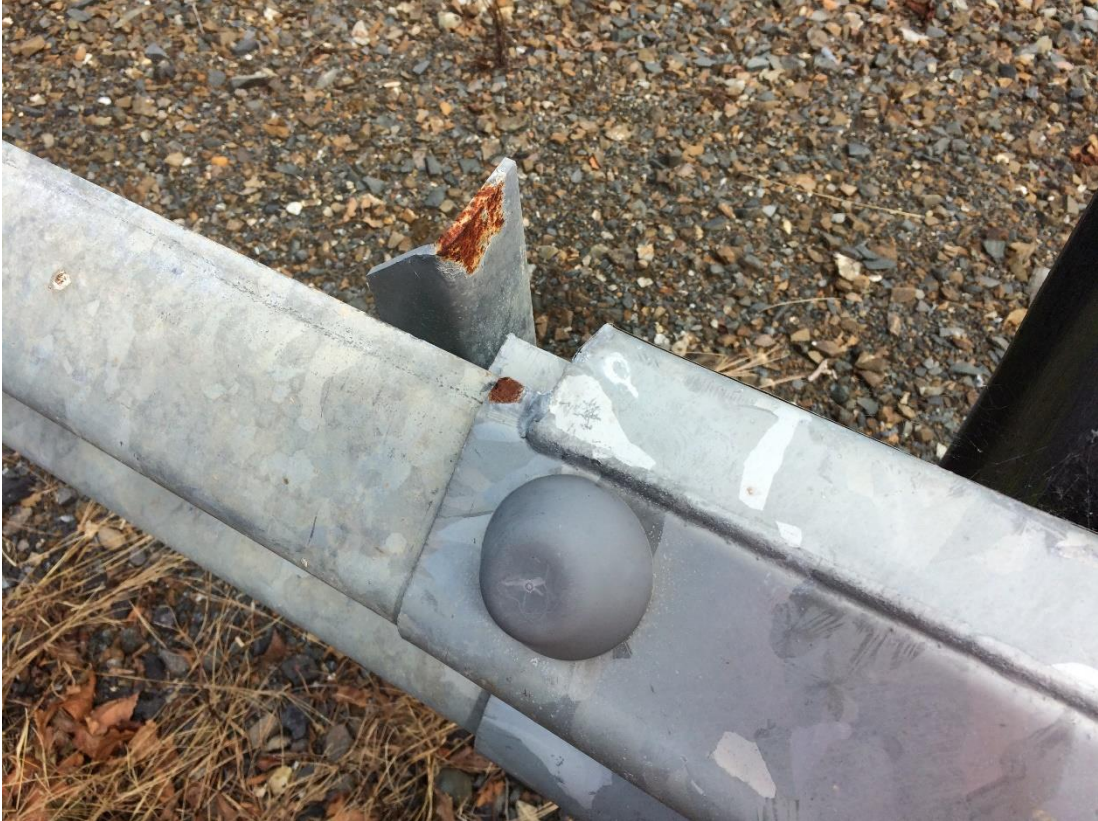
Photo 27: Guard rail post corrosion

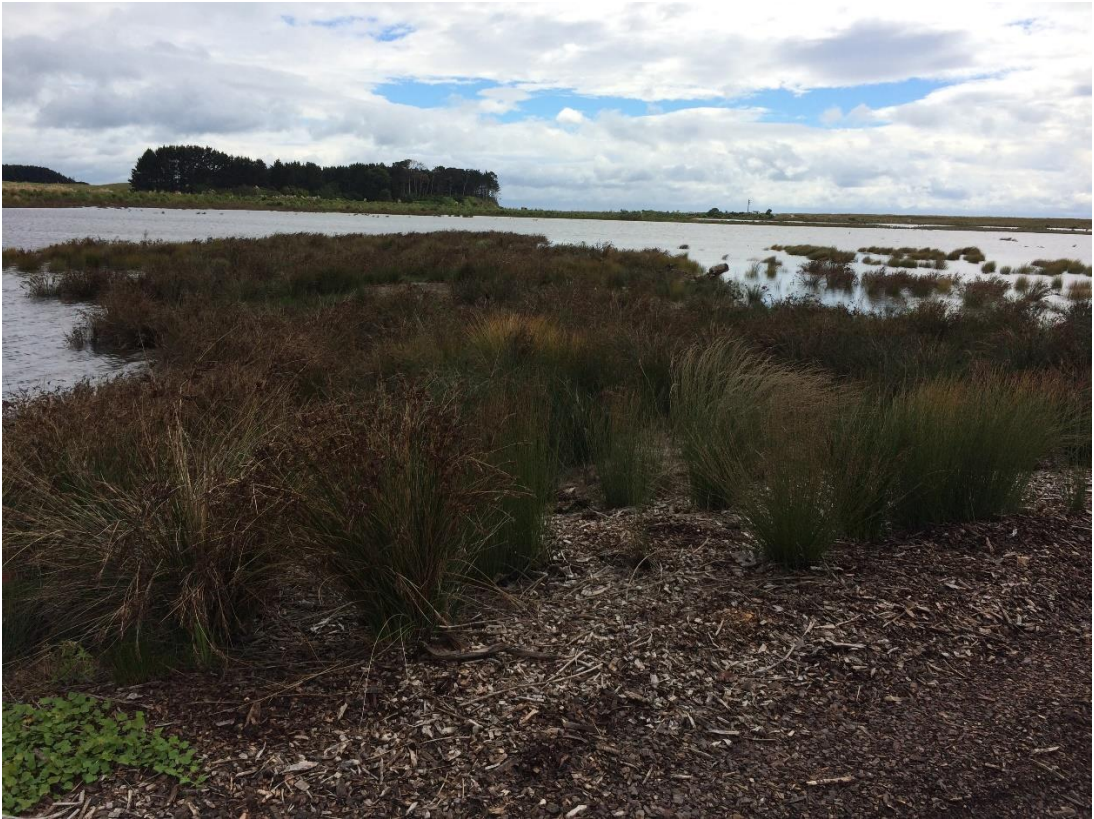
Photo 28: Te Pa Ika
