## **Bay of Plenty Regional Active Fault Mapping for Growth Areas**

**GNS Science Consultancy Report 2018/143  
March 2019**

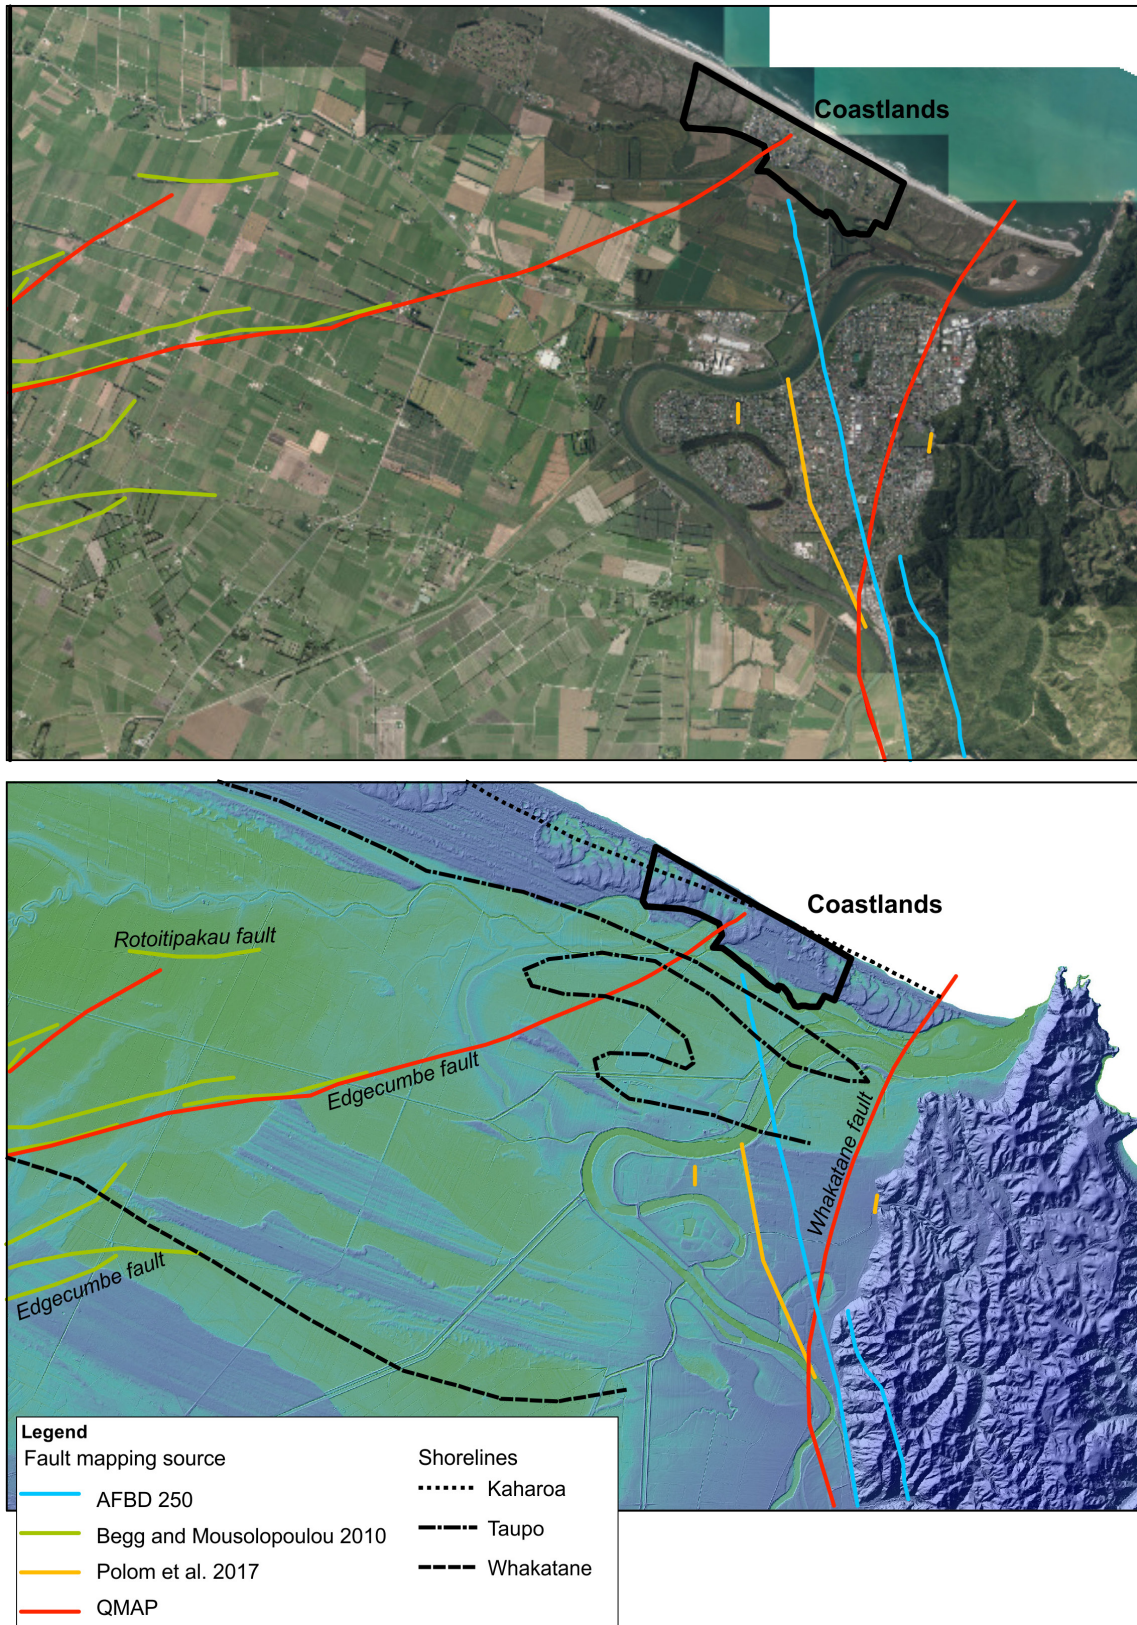
Figure 3.2 (A) Aerial image of the Coastlands site and surrounding areas showing the location of active fault traces mapped by various data sources (AFBD - Langridge et al. 2016; Begg and Mousolopoulou, 2010; Polom et al. 2017, and QMAP geology - Leonard et al. 2010). (B) LiDAR DEM with the same active fault traces as (A) and the position of past shorelines mapped by the extent of tephras (Kaharoa, AD 1314 ± 12 years; Taupo, AD 232 ± 10 and Whakatāne, 5526 ± 145 calibrated years BP, ages from Lowe et al. 2013).

In summary, none of the fault traces that are currently mapped across or very close to the Coastlands site are based on observed geomorphic features. We do not think the Edgecumbe fault projects throughs the Coastlands site. There are no geomorphic scarps of the Edgecumbe fault near the Coastlands site, and it is likely most slip on the Edgecumbe fault is transferred onto the White Island fault, which lies offshore to the west of the Coastlands site (Figure 3.3). As such, we consider the Whakatāne fault to be of greater significance to the Coastlands site. We consider the Polom et al. (2017) traces of the Whakatāne fault to be the best constrained fault traces. However, the northernmost locations where they were mapped are too far away from the Coastlands the site to be able to rely on simply projecting the fault line to the Coastlands site. Projecting the Whakatāne fault from its last well constrained location toward the Coastlands site will not be useful for the purpose of this study because the uncertainty in the location of the fault will be so large that the resulting fault avoidance zone may occupy most of the study site. We recommend a different approach as described below in Section 3.3.

Because the fault has not ruptured the land surface north of the Whakatāne urban area, near surface geophysical methods (methods that image the soil layers below the surface) will need to be used to assess where the fault is located. Within the resources available in New Zealand, we recommend that weight-drop seismic reflection (WDSR) methods are used to assess the location at Coastlands. Ideally two profiles are needed: one along the beach; and a parallel one along the “greenfield” area southwest of the Coastland site. Two profiles will be needed to be able to assess fault strike across the site and appropriately project the fault into the site. This is the ideal method but will also be costly. An alternative less expensive but also probably less effective approach will be to undertake Ground Penetrating Radar (GPR) in two or three profiles that cross the “projected fault” in the section between the Whakatāne River and the Coastlands areas. GPR is inexpensive but unfortunately does not work when strong electrical conductors are present in the ground, such as clay and water. Therefore, the technique will need to be trialled in the environment prior to the survey. A combination of both WDSR and GPR would be ideal.

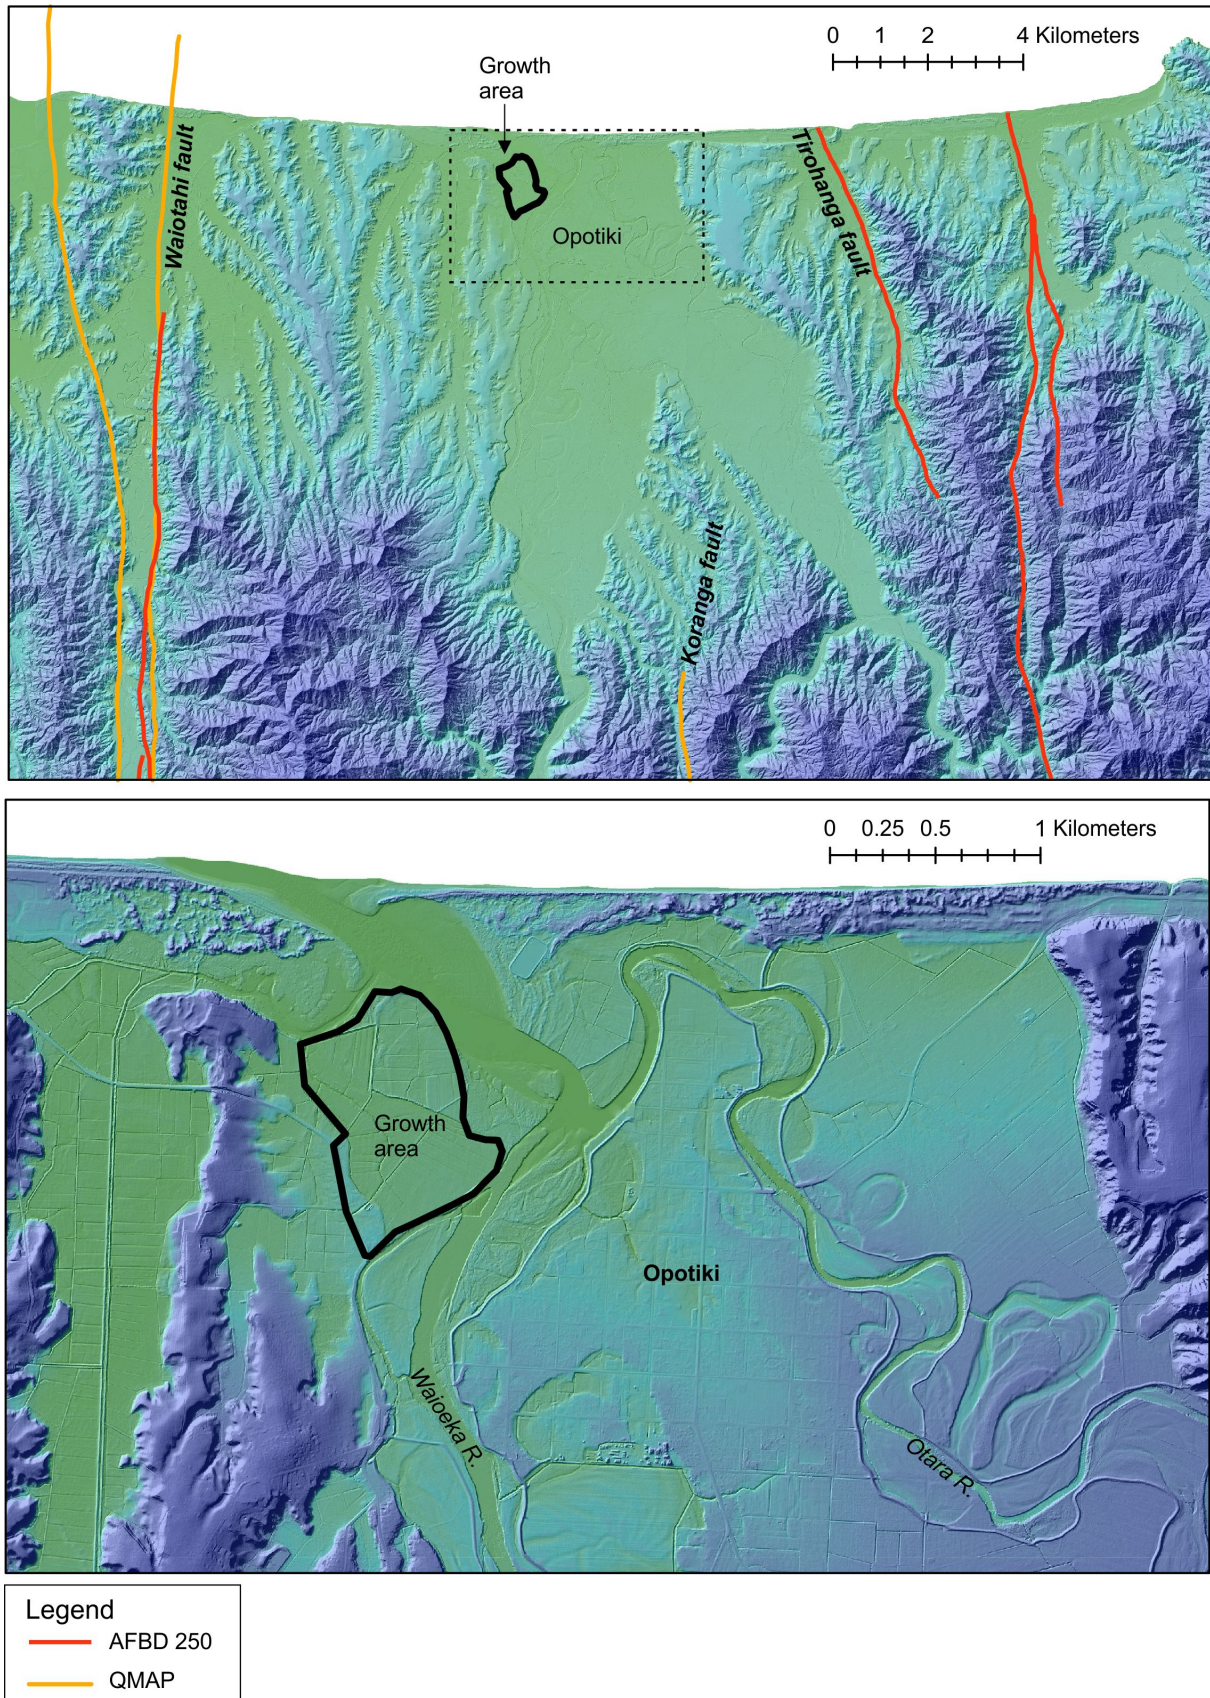
There is a small possibility that an active fault does cross the flood plain of the Waioeka and Otara rivers but that it has not ruptured in the time since deposition of the alluvial sediments. The precise age of the sediment infilling the floodplain is not known but we presume that sediments become younger in a seaward direction, like the Rangitaiki plains (Figure 3.2B). If the Koranga fault does extend northwards then it must underlie the Opotiki floodplain, although projecting the fault northwards on a strike similar to the surrounding faults would place the buried fault on the eastern side of Opotiki, rather than beneath the Opotiki development area polygon. There are two reasons to suggest a buried fault may underlie the Opotiki floodplain: (1) the floodplain is formed in a broad river valley and such valleys are frequently fault-controlled; (2) active faults have been identified offshore of Opotiki (see Opo-01, Opo-02 and Opo-03 in Figure 3.3, Lamarche and Barnes, 2005). The offshore fault traces, called the Opotiki faults, have a maximum slip rate of 0.5 mm/yr and estimated mean recurrence intervals of 4600–10875 years. We conclude that although there is potential for a buried fault beneath the Opotiki floodplain, it must have a low slip rate (<1 mm/yr) and long recurrence interval (probably >3500 years), and it is highly unlikely that the buried fault underlies the Opotiki development site because it is more likely to be located on the eastern side of the floodplain.

Figure 4.2 LiDAR DEM of the region around Opotiki, including the alluvial floodplain of the Waioeka and Otara rivers (upper image), and a more detailed DEM of the area proximal to the Opotiki development area. No active faults are seen on the alluvial floodplain.

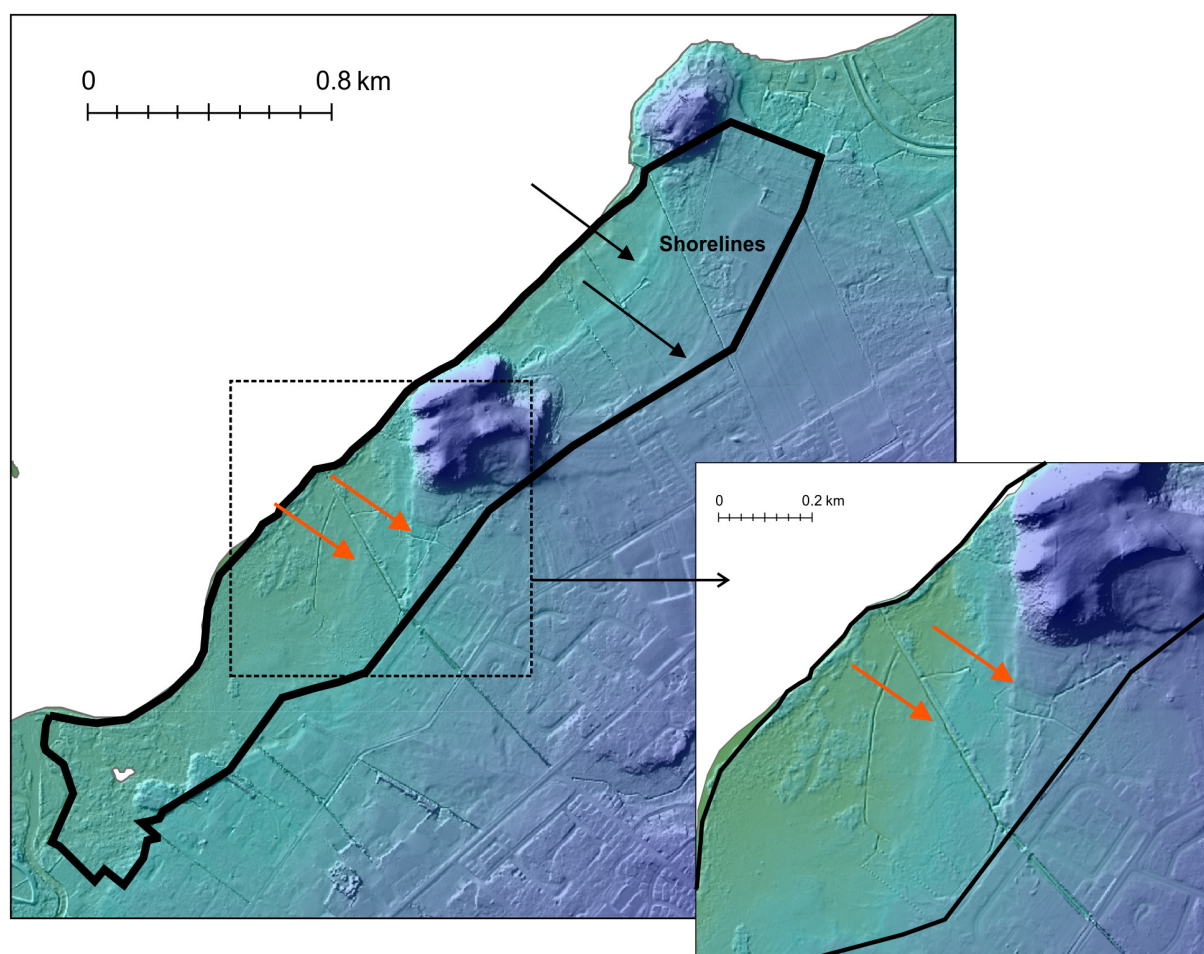
Figure 5.4 LiDAR DEM of the Eastside development area. The arrows show topographic lineations. The topmost arcuate lineations (black arrows) are most likely to represent lake shorelines. The lower, more northerly trending lineations (red arrows) may be either faults or shorelines; more detail on these lineations is shown in the inset map. For more details on shorelines see Appendix 3.

Two potential active fault traces have been identified at the Eastside development area, but they could also be old lake shorelines (Figure 5.4). The difficulty in assessing if the trace is a fault or a shoreline is that a fault line can uplift part of the shore during rupture and change the shoreline to follow the fault scarp. It is thus possible that a lineation could be an old lake shoreline that has formed along an existing fault scarp.

Based on the current data available, we cannot determine if the lineations in the Eastside area are active fault traces or not. Due to this uncertainty, we are treating the lineations as possible active faults and placing fault avoidance zones around the fault traces. We also provide recommendations for future work that may help to resolve if they are active faults or not.

Should the Council decide to investigate whether the lineaments are active faults or not, we recommend paleoseismic trenching and Ground Penetrating Radar (GPR) is used to assess the presence or absence of fault activity. Paleoseismic trenches could be excavated across the faults to assess the presence of a fault or other tectonic deformation features and the timing of the deformation. Because the ground water table will be close to the surface at the locations of the lineaments, an excavation may not be deep enough to discern the origin of the lineaments. In that case, we recommend that additional investigations using GPR to assess the possible northward extension of the fault located south of the site into the study site.

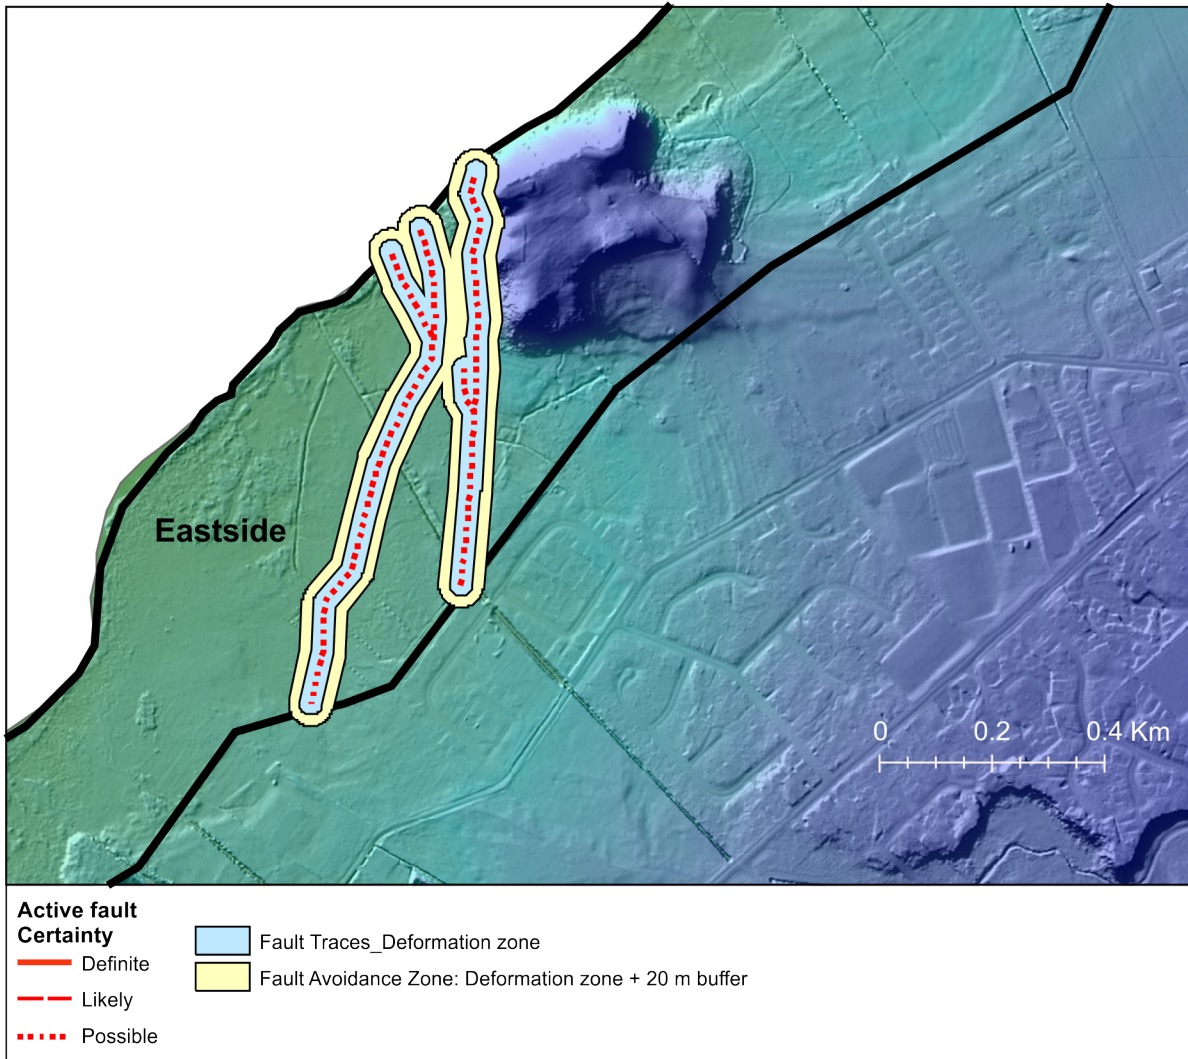
In accordance with the MfE Active Fault Guidelines, we place a fault rupture hazard zone around the possible fault traces identified at the Eastside site (Figure 5.5), and we place an additional setback buffer of 20 m width in order to construct what is defined in the MfE Active Fault Guidelines as a Fault Avoidance Zone (FAZ). The fault rupture hazard zone is defined by the deformation width of fault; that is, from the line of the fault trace we assess the distance over which fault rupture could reasonably be expected to occur. For the Eastside site the deformation width is 40 m and with the additional 20 m setback buffer the fault avoidance zones are 80 m wide (Figure 5.5). Where the fault traces merge, the fault avoidance zones become wider.

Figure 5.5 Fault avoidance zones at the Eastside site.

If the lineaments are treated as fault lines, we recommend that the MfE guidelines are implemented. In that case, the lineaments should be classed as active faults with a Recurrence Interval Class I, as the age of the landscape surfaces displaced by the fault is <2,000 years old (surfaces are below the 1.8 ka year old shoreline; see Figure A3.2 ).

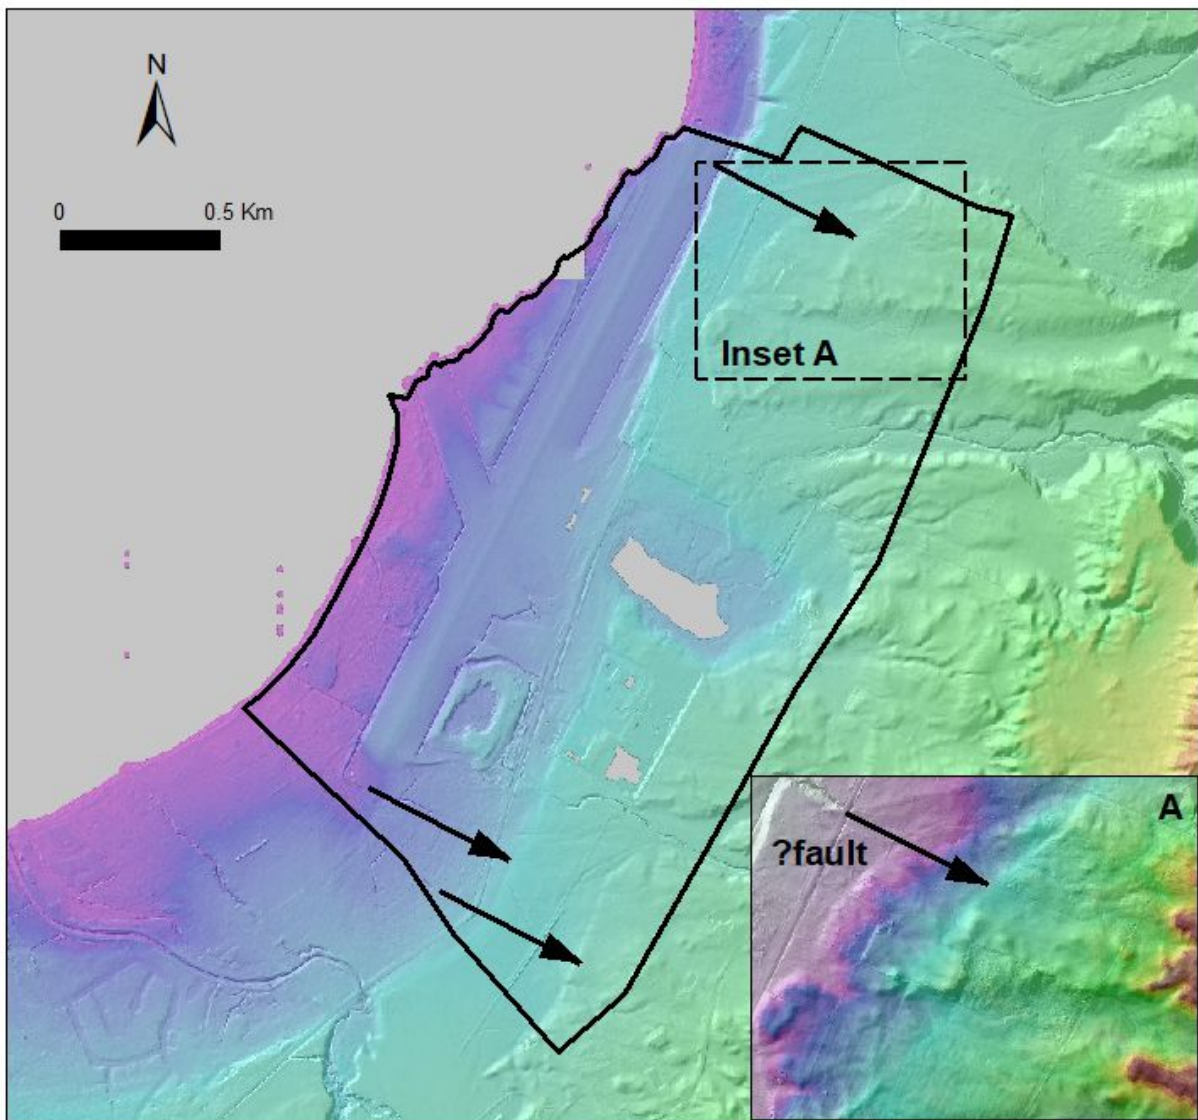
In the northern part of the Airport we did identify one topographic scarp as a possible active fault, but further investigation showed this was unlikely. The inset map of Figure 5.6 shows the scarp that we studied in more detail. We have concluded the scarp is most likely to be an old, poorly preserved and highly dissected lake shoreline (see Figure A3.1). We examined the height contours around the lake and it is possible that this feature correlates to other shoreline features at the same height around the north shore of the lake and that correspond with a shoreline form between 36,000 to 27,000 years ago (see Appendix 3; Figure A3.1). The shoreline at this elevation is not well preserved at any location, perhaps indicating the lake level was only at this elevation for a relatively short period of time, inhibiting the formation of a prominent shoreline scarp. This is likely the reason why this shoreline is not mentioned in the literature, as it would have been difficult to map without LiDAR derived high resolution maps.

Figure 5.6 Shorelines (unlabelled arrows) are clearly seen from LiDAR data. Inset A shows a sharp lineation that is likely to be an old dissected lake shoreline. For more details on shorelines see Appendix 3.

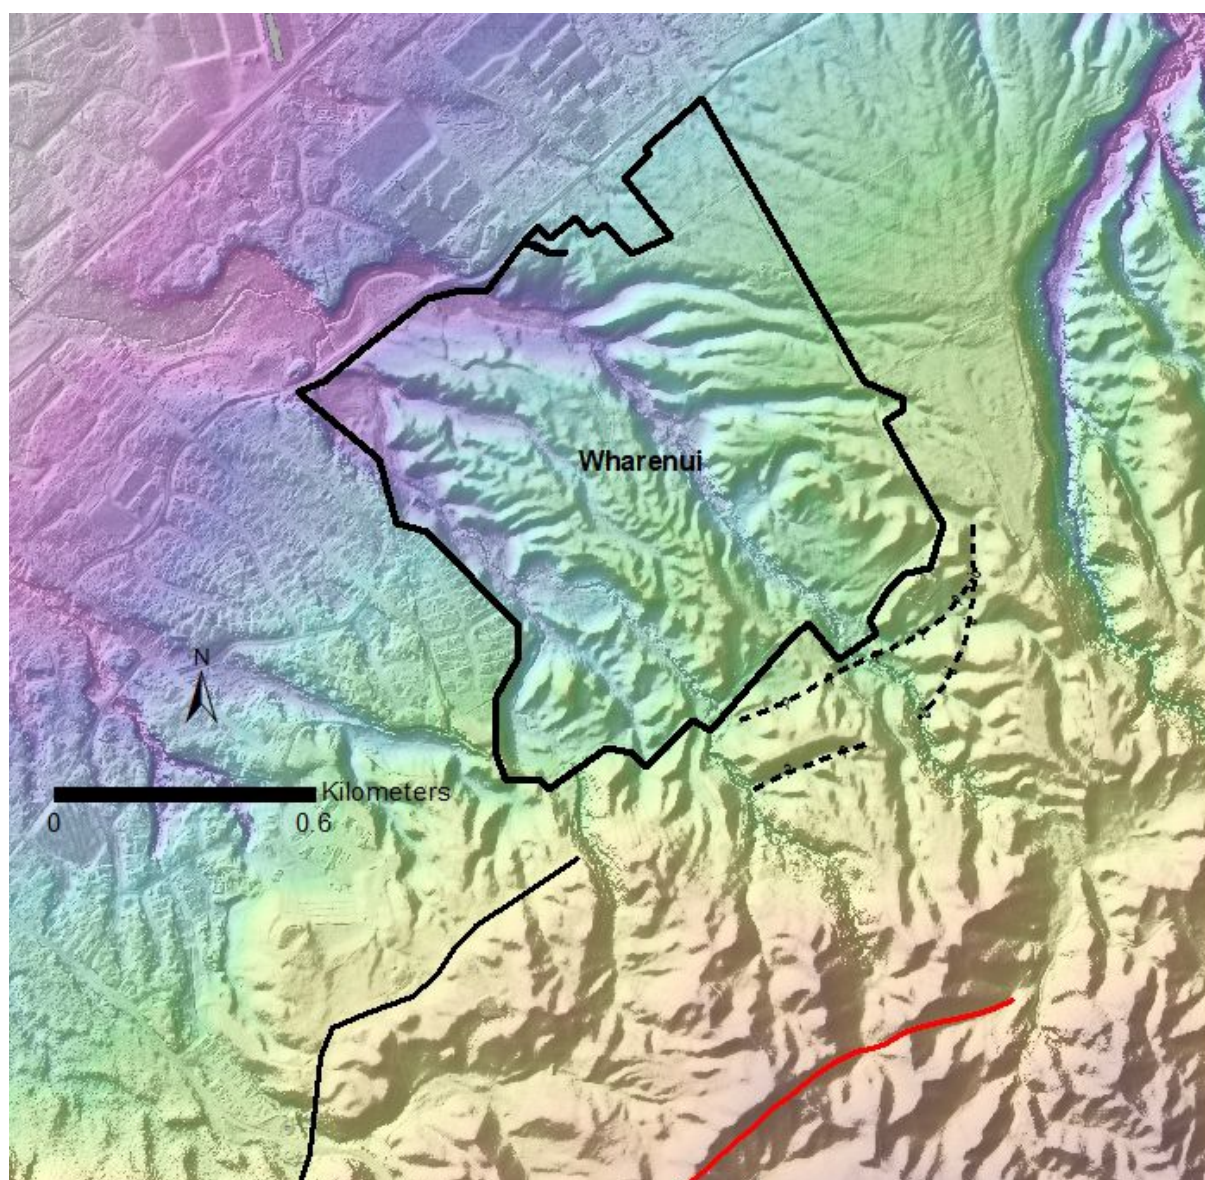
Within the Wharenui site, there is no evidence of any active faults (Figure 5.7). The landform surface in the Wharenui area is relatively old and is a highly dissected surface underlain by pumiceous fluvial and lake deposits aged ~12,000 to 186,000 years based on Leonard et al (2010), but could be more constrained 27,000 to 60,000 based on our compilation of shorelines (see Appendix 3; Figure A3.1). Approximately 1 km to the south of the Wharenui site, a possible east-northeast trending active fault has been identified (Figure 5.7). Subtle topographic lineations immediately southeast of the site boundary (dashed lines, Figure 5.7) may relate to the mapped active fault that lies southwest but these do not cross into the Wharenui site footprint.

Figure 5.7 LiDAR DEM of the Wharenui site shows an absence of active fault scarps. An active fault trace (red line) lies about 900 m southeast of the site but trends away from the area. An inactive fault (black solid line) trends to the northeast and may correlate to the lineations identified in the LiDAR (black dashed lines).

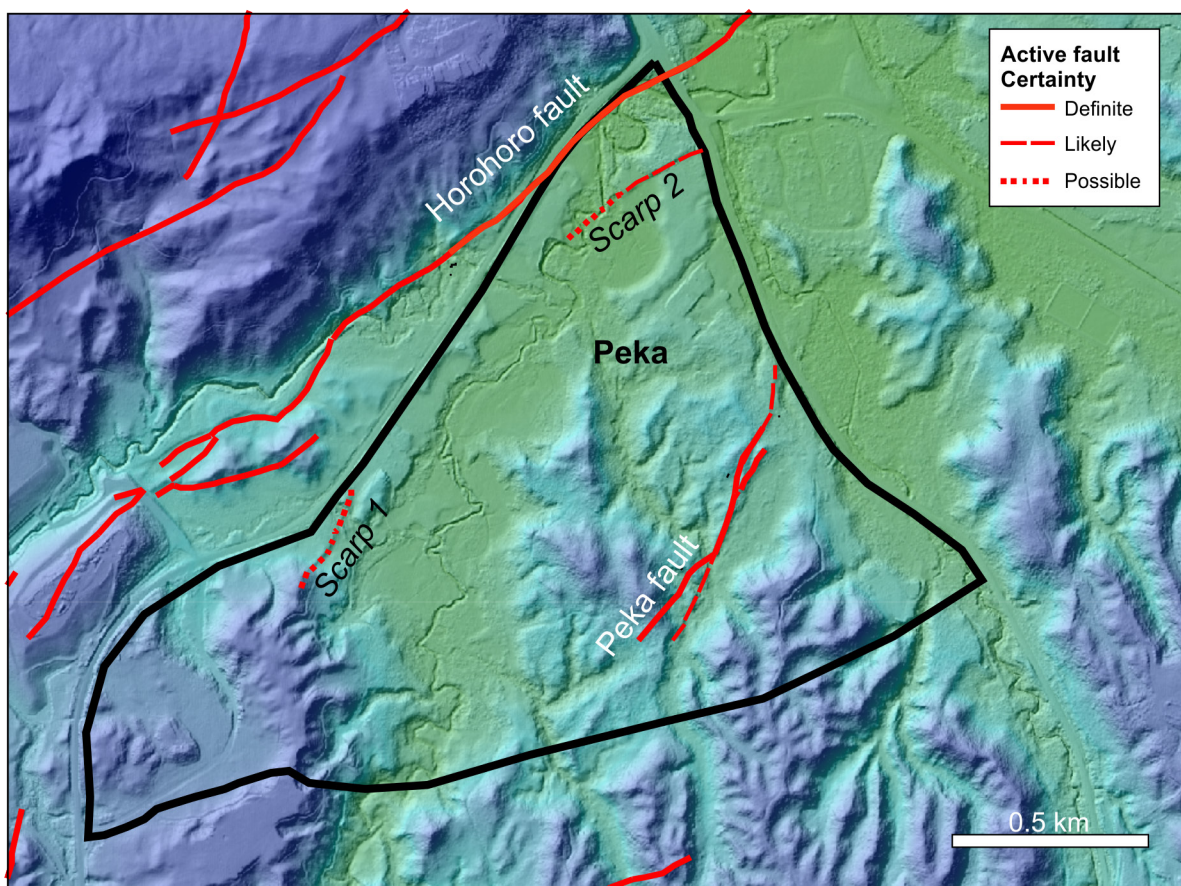
On the eastern side of the Peka site is an unnamed fault scarp, previously identified by Villamor et al. (2010). We informally name this the Peka fault and our fault mapping agrees with Villamor et al. but we extend the fault scarp about 100 m further to the northeast. We place a FAZ around the Peka fault, but no data is available to assess the slip rate and RI of the fault. We suggest the fault is likely to have a similarly low, or lower, slip rate as the Horohoro fault (<0.17 mm/yr) and a similarly long, or longer, RI (>7400 years), therefore it is an RI Class IV fault. Reasons to suggest the Peka fault has an equal or lower rate of fault activity to the Horohoro fault are based simply on the poor preservation and short surface traces of the Peka fault scarp. Two other short (<500 m) fault traces have been identified in the Peka site (Scarp 1 and Scarp 2, Figure 5.8). From such short traces it is difficult to assess the likelihood that these scarps are active faults, so we assign them “likely” and “possible” certainties. As with the Peka fault, we suggest these are treated as RI Class IV faults; these scarps may be part of the Horohoro fault zone.

Figure 5.8 Active faults (red lines) around and within the Peka development site. Each fault trace has an assigned certainty which reflects the confidence we have that the feature is an active fault scarp.

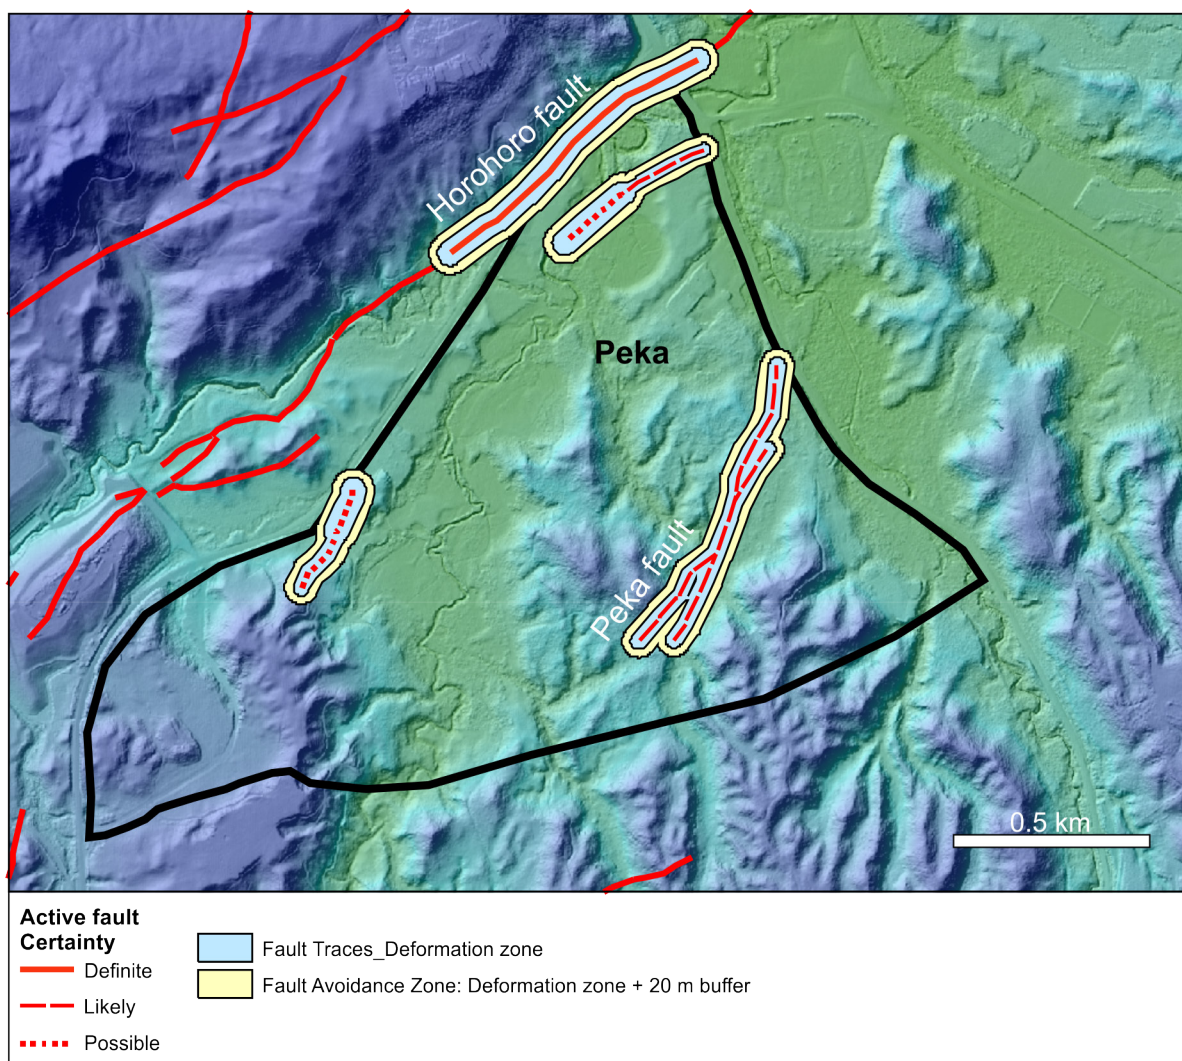
In accordance with the MfE Active Fault Guidelines, we place a fault rupture hazard zone around the definite, likely and possible fault traces identified at the Peka site (Figure 5.9), and we place an additional setback buffer of 20 m width in order to construct what is defined in the MfE Active Fault Guidelines as a Fault Avoidance Zone (FAZ). The fault rupture hazard zones (= deformation zones) for the Peka area fault traces are on the order of 40–60 m wide, and with the 20 m buffer the fault avoidance zones vary from 80 to 100 m wide (Figure 5.9). The faults of the Peka area should be treated as RI Class IV faults (RI >5000–<10,000 yr, Table A1.1). Should the Council decide to investigate whether the “likely” and “possible” fault scarps are indeed active faults, we recommend paleoseismic trenching and/or Ground Penetrating Radar (GPR) in order to assess the presence or absence of fault activity.

Figure 5.9 Fault avoidance zones for the Peka site active fault traces.

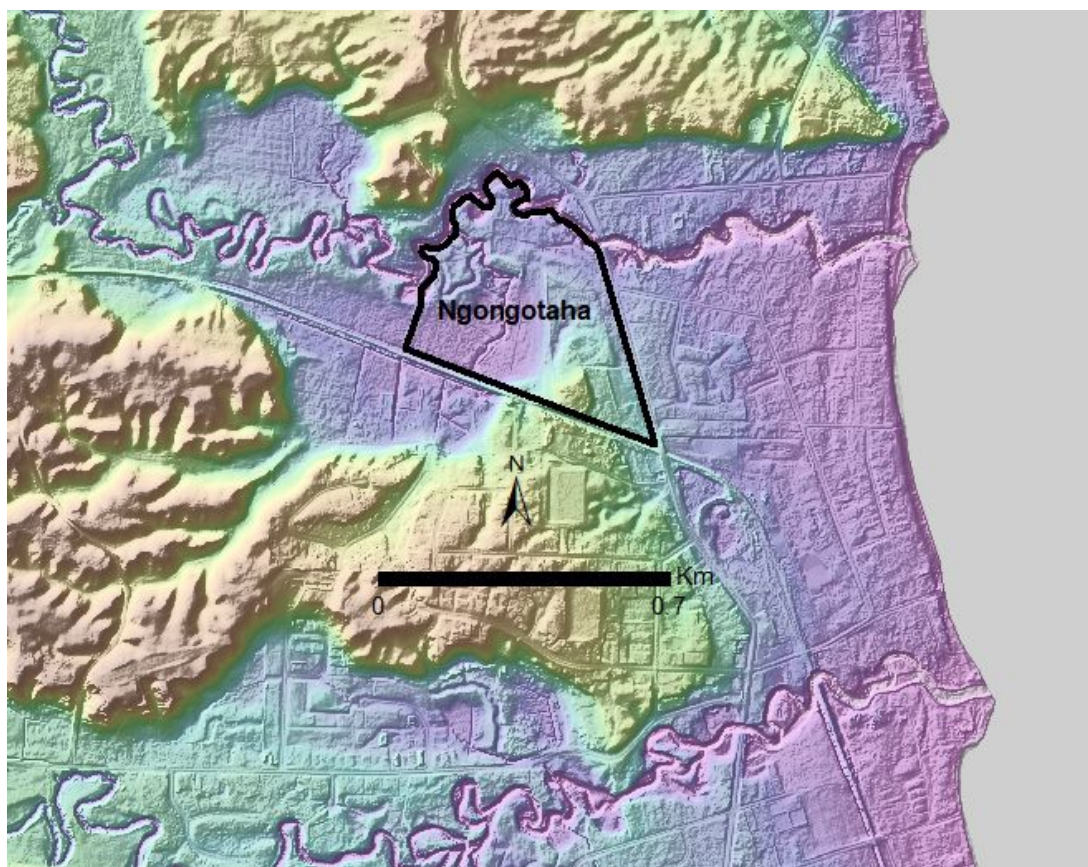
No active faults have been identified at the Ngongotaha site on the western side of Lake Rotorua. The Ngongotaha site is relatively distal from the zone of active faulting of the Taupo Rift (Figure 5.1) and the nearest active faults are located about 4 km north of the site. Recent fluvial and lake sediments underlie the Ngongotaha site, and although it is a quite youthful landscape, no active fault traces can be seen on the older, higher landforms immediately north and south of the Ngongotaha site (Figure 5.10). The absence of faults on the older surfaces shows there is an extremely low likelihood of any active faults concealed under the Ngongotaha site.

Figure 5.10 LiDAR DEM of the Ngongotaha site, where no active fault scarps have been identified.

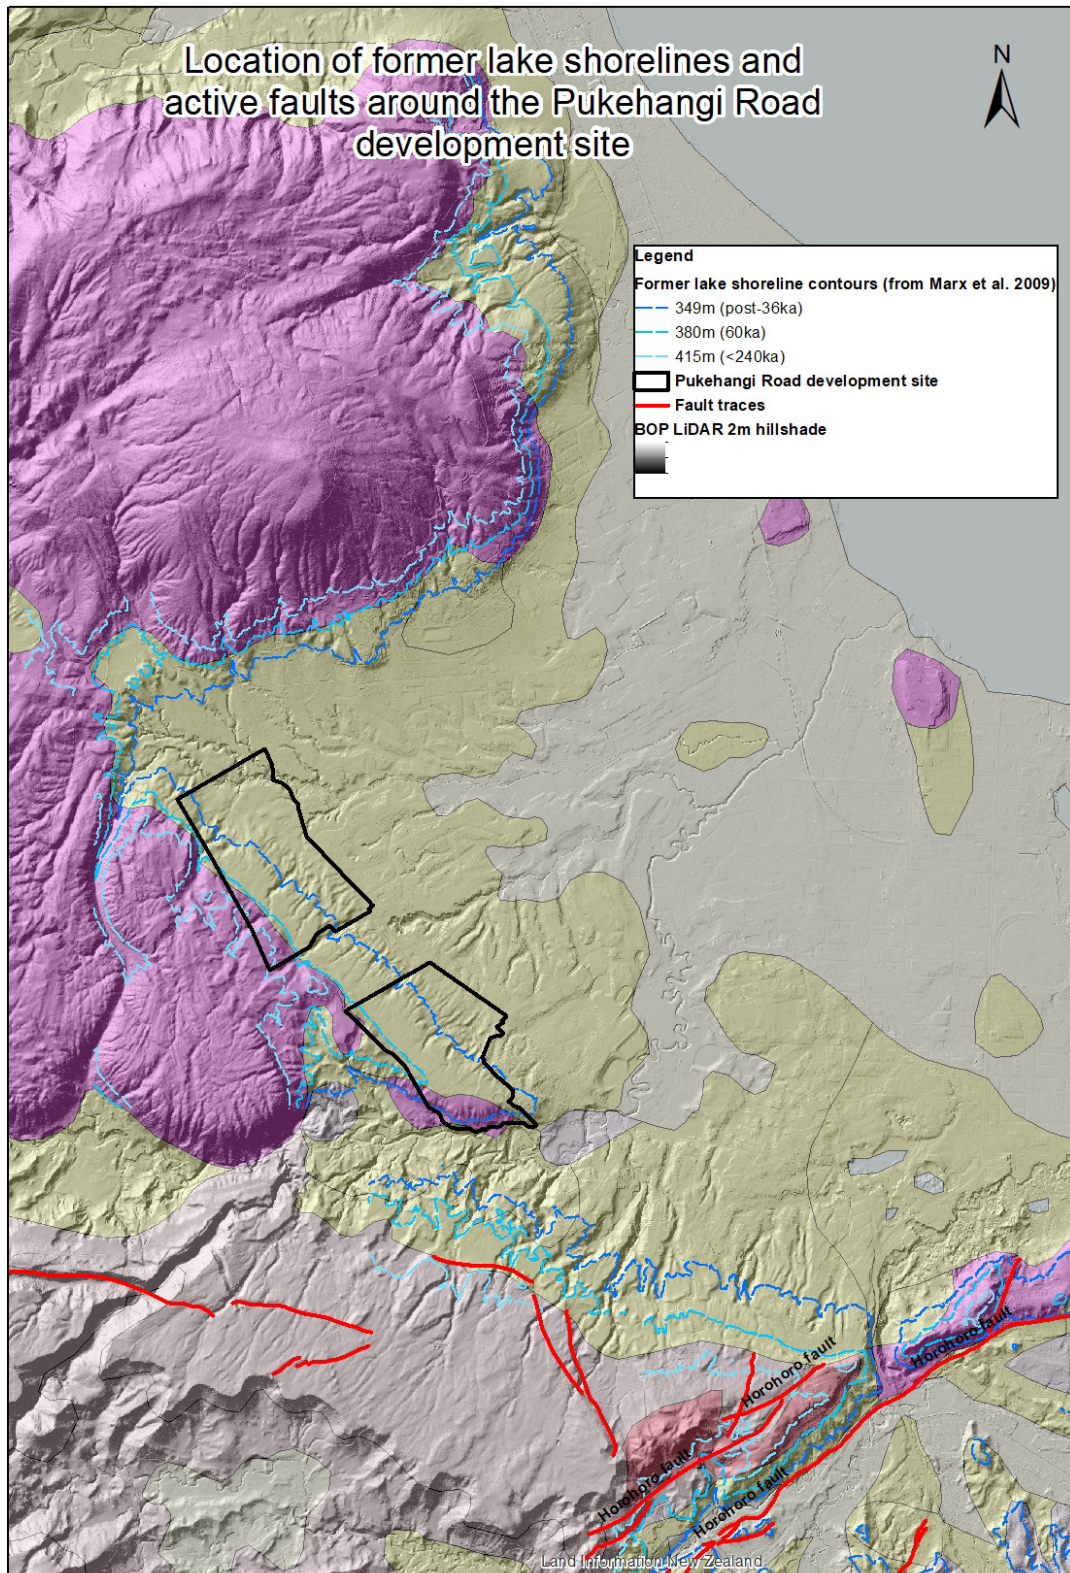
reactivate, the age of the unfaulted lake terrace surfaces overlying the basement faults shows us the recurrence intervals must be very long (>12,000 years). The position of the lake shorelines (in blue, Figure 5.11) is similar to the alignment of the inferred basement faults at depth, but this simply reflects deeper structural controls on the lake boundaries and does not necessarily indicate the faults reach the surface.

Figure 5.11 Location of the Pukehangi Rd development site (black solid lines) with respect to active faults (red solid lines: Leonard et al. 2010; Villamor et al. 2010; Langridge et al 2016; this study). Main coloured polygons are: purple= post -Mamaku eruption domes including Ngongotaha lavas (<240,000 years old); dark yellow= Late Pleistocene lake deposits (190,000–125,000 years old); and light yellow= Holocene river deposits (<12,000 years old).

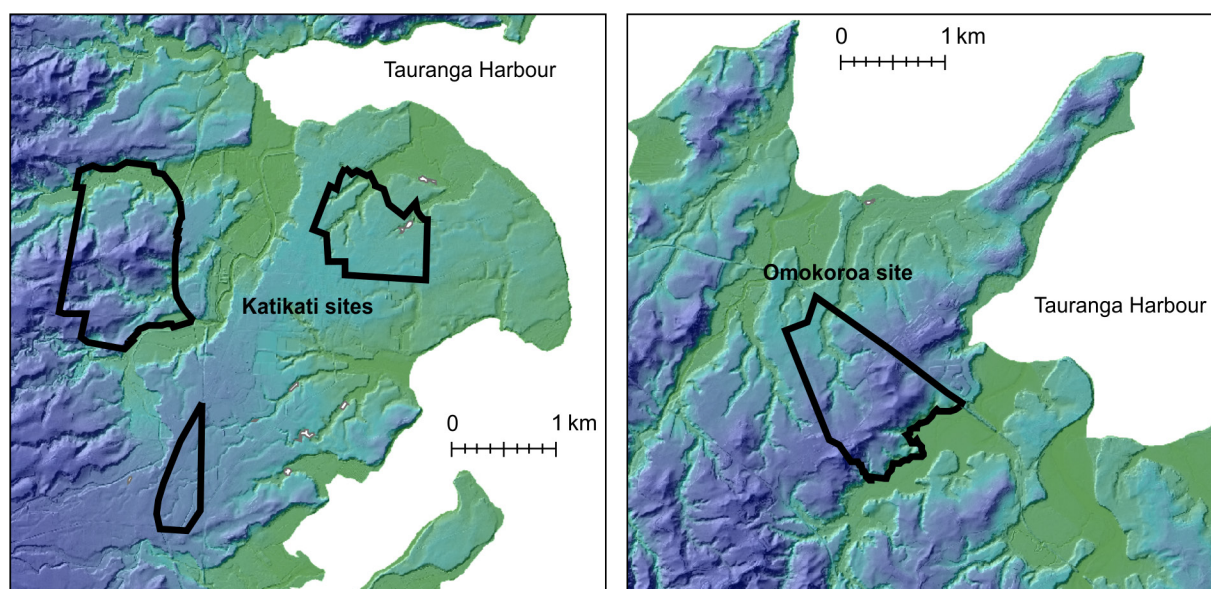
No active faults were identified at either the Katikati or Omokoroa sites (Figure 6.1). To assess the potential presence or absence of active faults at the Katikati and Omokoroa development sites, we: reviewed the existing published and unpublished literature and maps of the area; reviewed 1940s and 1960s aerial photographs (NZ Aerial Mapping, see references for list); and analysed the landforms from a digital elevation model derived from Light Detecting and Ranging (LiDAR) data (provided by Bay of Plenty Regional Council). We did not identify any geomorphic features in the landforms at either the Katikati or Omokoroa sites that could be classified as active faults. There may be old faults that are buried beneath the sediments and volcanic rock at these sites, but these would not likely have ruptured in at least the last 128,000 years, as the surfaces of that age do not seem to be displaced by any faults. Prior to this study, no active faults at those sites had been identified through geological mapping (Edbrooke 2001; Heron 2014) and active fault mapping (New Zealand Active Fault Database, Langridge et al., 2016). There are also no known offshore faults near the development sites (Lamarche & Barnes 2005).

Figure 6.1 LiDAR DEM of the Katikati (left) and Omokoroa (right) sites. No active faults were identified at either site.

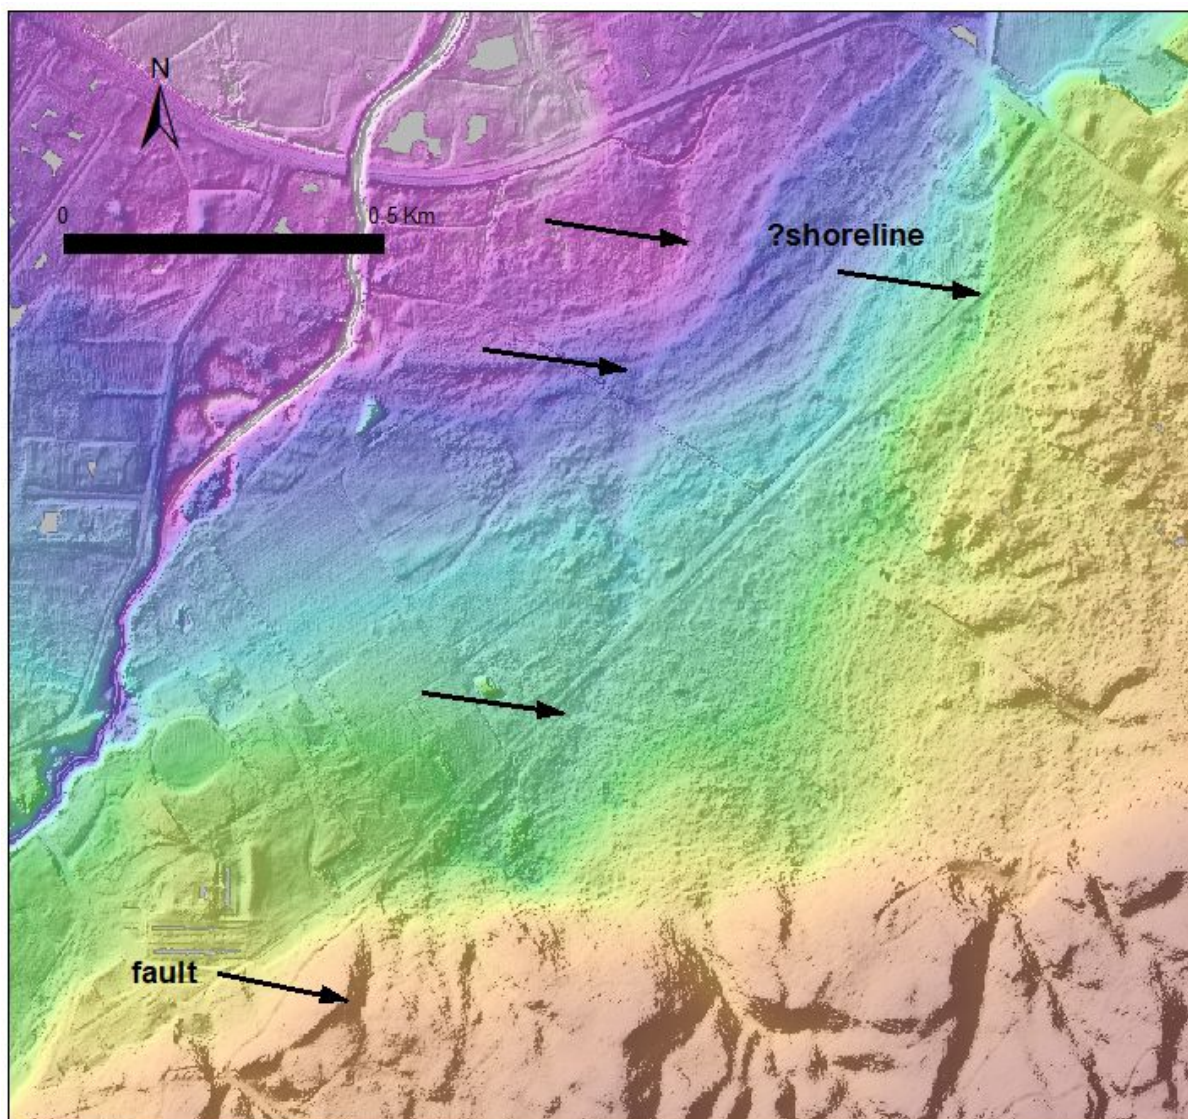
Figure A2.1      Lineations identified from LiDAR data (see Inset B in Figure 5.3) that trend northwards in the direction of the Eastside development site. The feature labelled "fault" is identified as a fault trace. The unlabelled arrows highlight a lineation that may possibly be a fault. The sharp lineation on the right may be a shoreline.
