## **Denitrification in a Rotoehu Stream, 2nd installation**

Landcare Research Contract Report: LC0708/143

DATE: May 2008

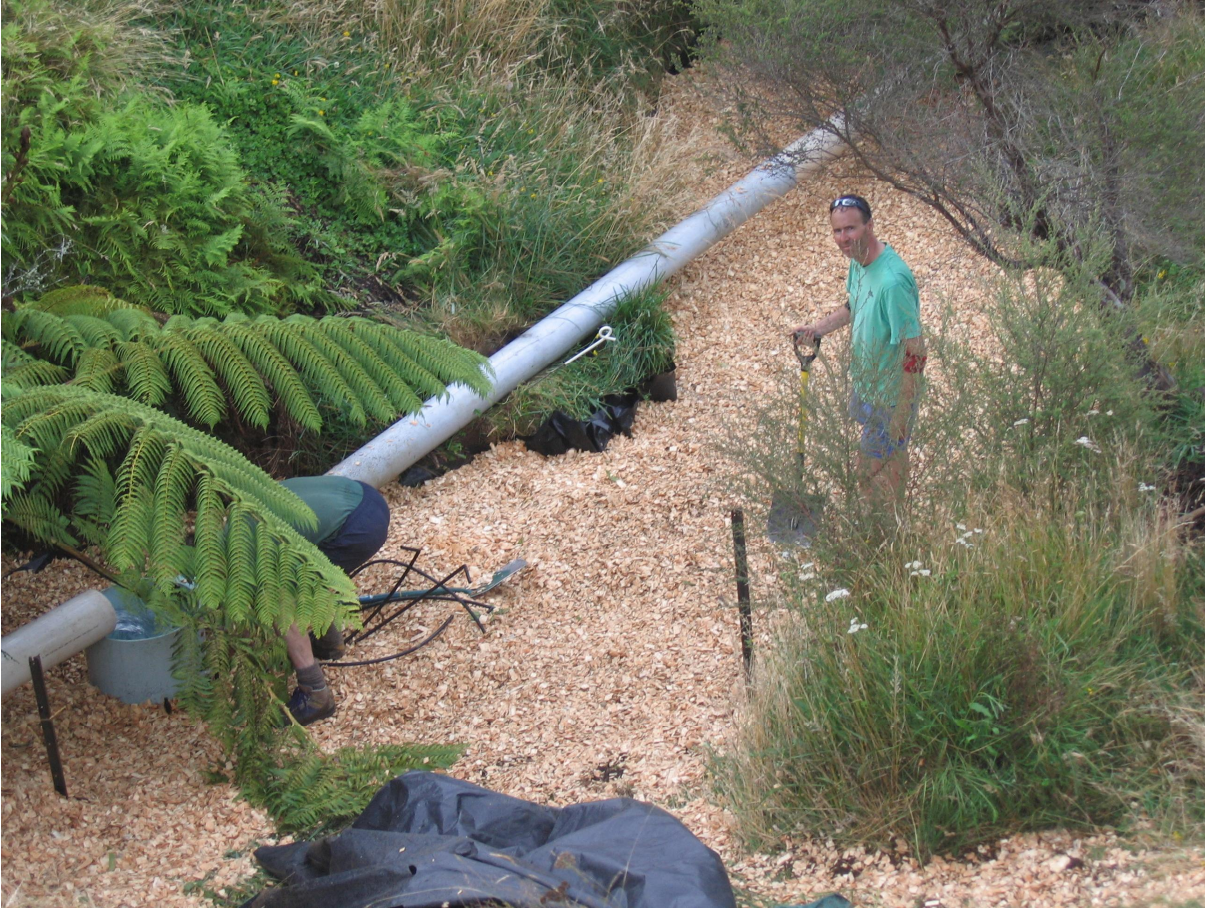
**Fig. 1** Bed overview on construction

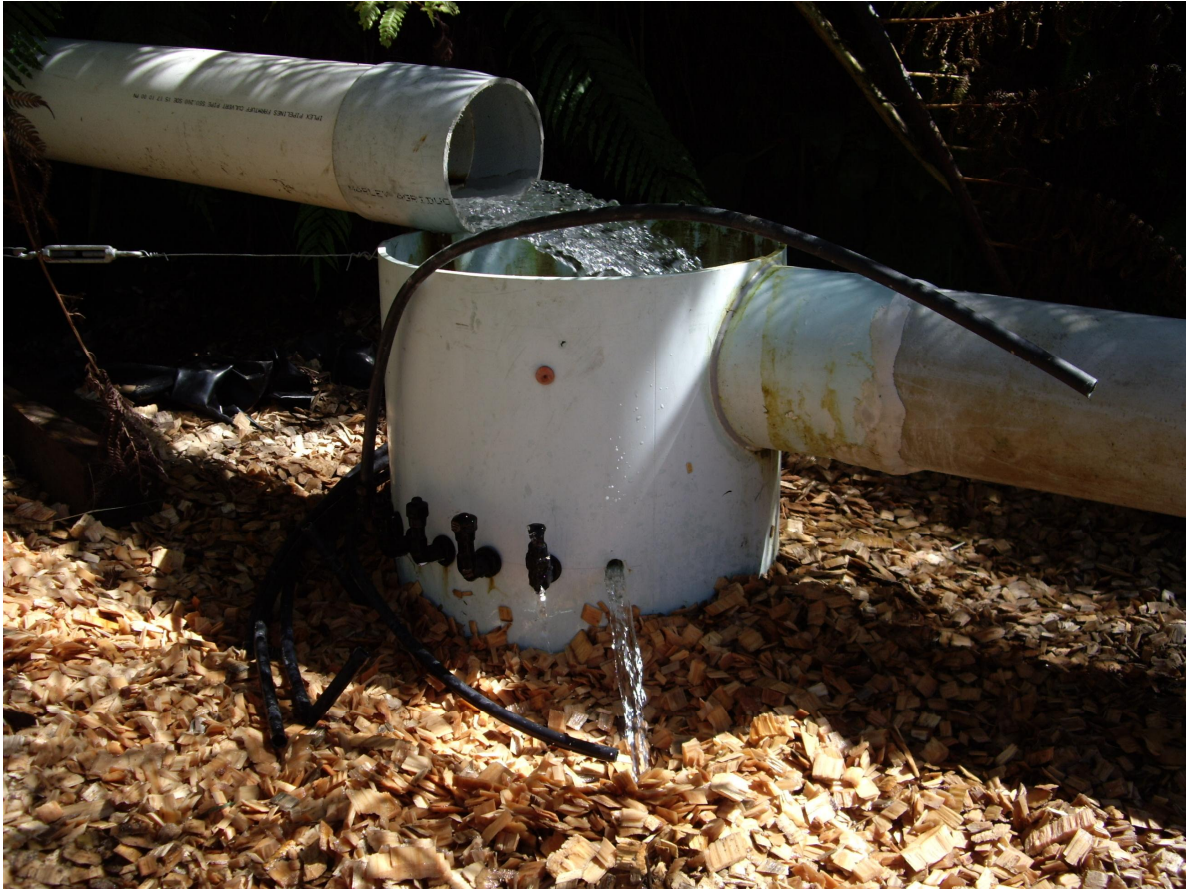
An upright riser, made from farmtuff piping, was placed at the head of the installation to intercept the stream piped from a culvert (Fig. 2). Flow into the denitrification bed was controlled by orifices drilled into the riser, while overflow was bypassed back to the stream bed (Fig. 3). Installation work was completed on 7 February 2007.

**Fig. 2** Headworks March 2007

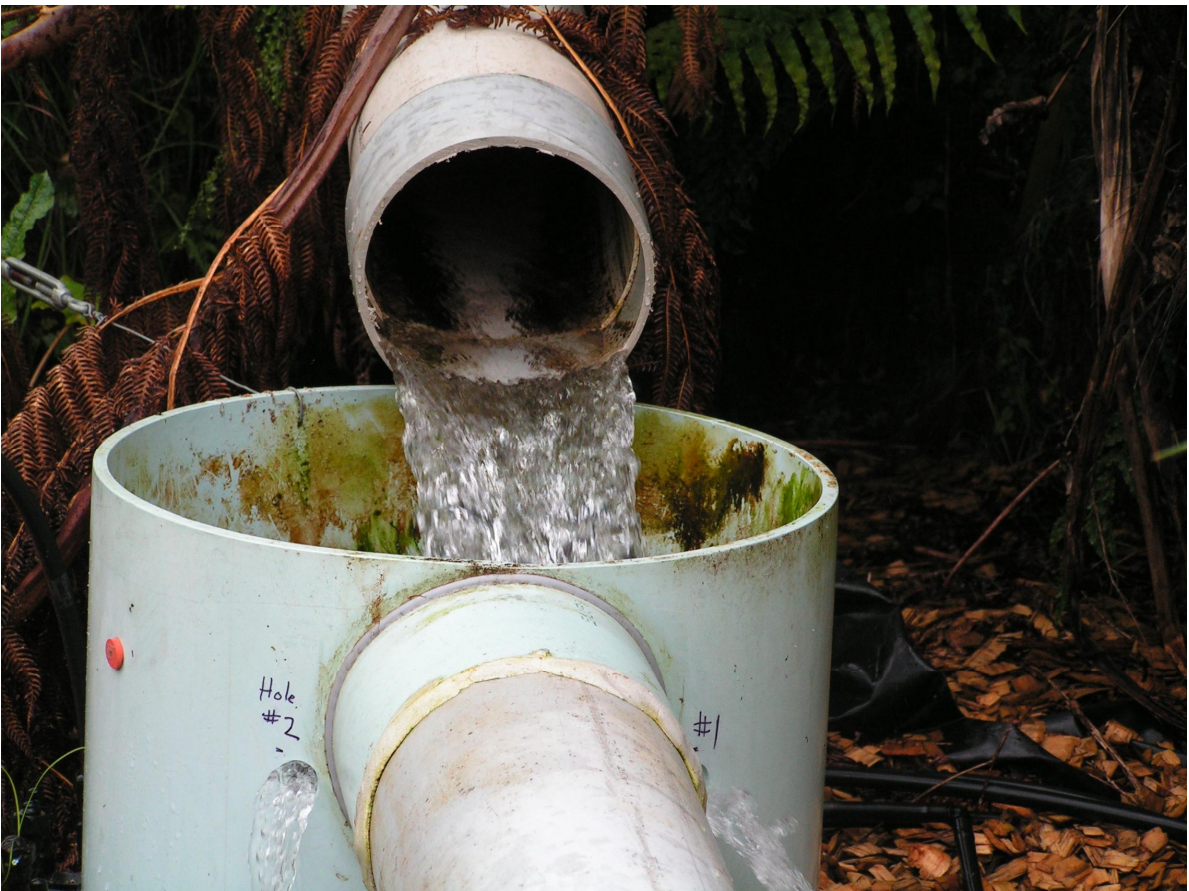
In the first month of operation the overflow pipe-work separated from the riser and water washed into the bed, flushing significant volumes of chips over the barrier. These chips were recovered and the pipe-work resecured. As algal growth was found to have blocked the feeder tubes to the point where the bed was drying out, it was decided to leave all but one of the feeders blocked and the remainder was simplified to a finger-size bore hole in the riser wall. A later problem with sediment build-up in the riser required that this hole be bunged and new holes drilled (diameter approx 25 mm) higher up on the lysimeter walls near the point of bypass flow. At this height, water turbulence was expected to alleviate sediment blockage and inhibit algal growth.

**Fig. 3** Headworks October 2007

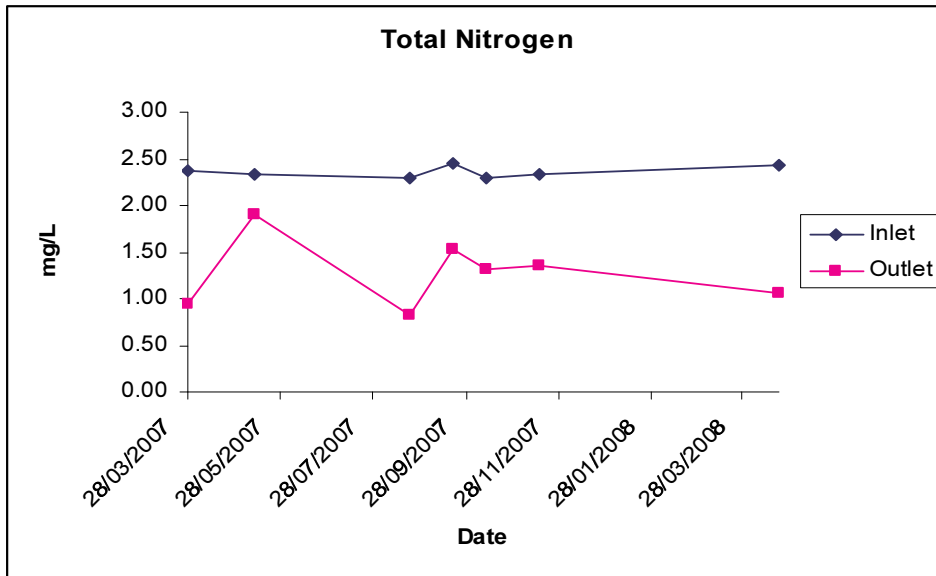
Fig. 4 Total Nitrogen levels entering and leaving the denitrification bed

Overall, the denitrification bed removed about 50% of total N (Fig. 4) but, the beds nitrate removal efficiency deteriorated over time (Fig. 5). Total nitrogen levels in the stream varied little in level over time and nitrogen is almost wholly in nitrate (or partly nitrite) form. The nitrate removal per day is in the order of 5 to 6 times that observed by Taylor and Thornburrow (2006) at the site, which is in line with the increased size of the bed. The denitrification rate per cubic metre therefore appears to be similar for bark and woodchip. Nitrogen reduction of  $1 \text{ mg L}^{-1}$  from a flow of  $25 \text{ L min}^{-1}$  represents a removal rate of  $36 \text{ g N d}^{-1}$ , from an  $18\text{-m}^3$  denitrification bed. This yields a removal rate of  $2 \text{ g NO}_x \text{ m}^{-3} \text{ d}^{-1}$ . Higher removal rates have been observed at Taupo municipal wastewater tertiary treatment beds where nitrate inputs have been higher, personal communication Nicola Church, Taupo District Council.

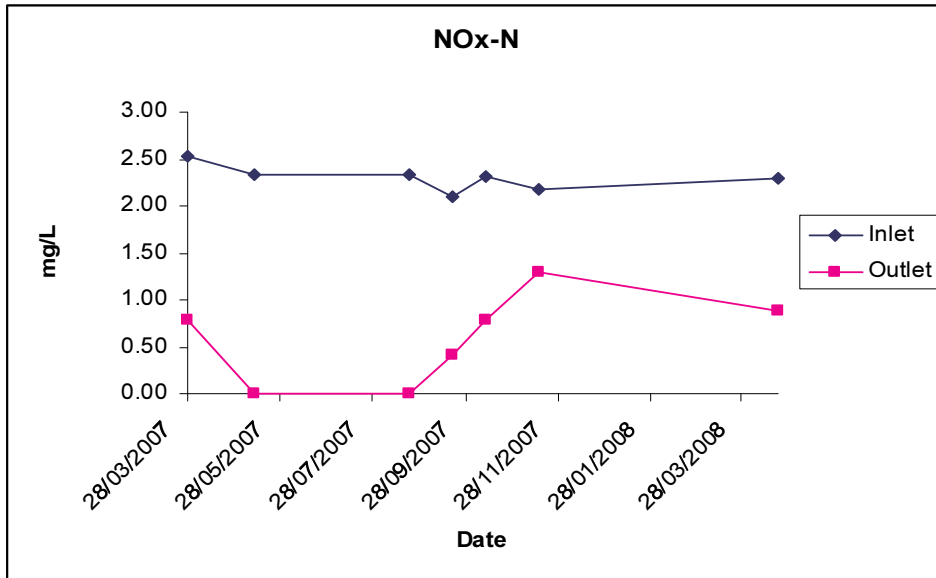
Fig. 5 Nitrate levels entering and leaving the denitrification bed

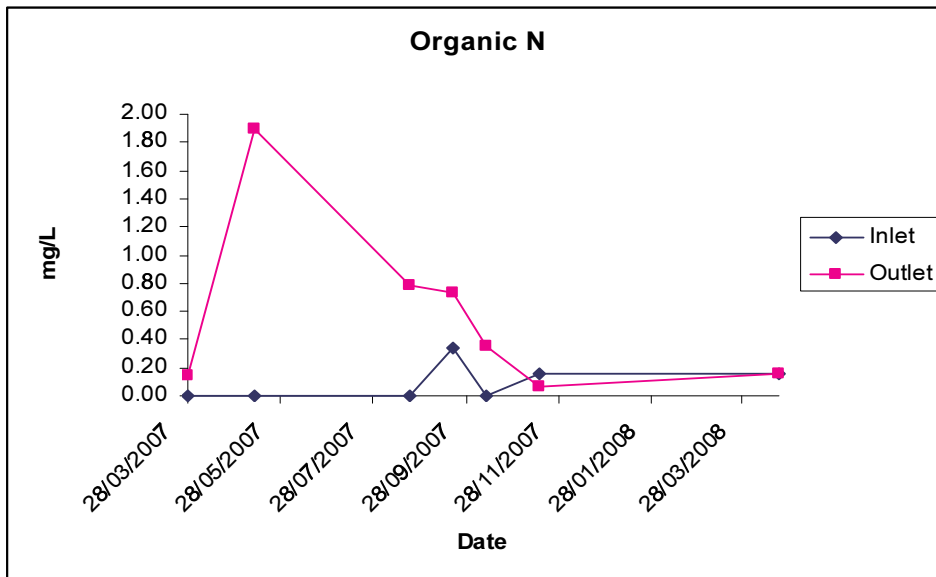
Fig. 6 Organic Nitrogen levels entering and leaving the denitrification bed  
Landcare Research New Zealand

Similar to the results of Taylor and Thornburrow (2006), a flush of organic N (Fig. 6) was seen at the outlet in the early months of the experiment. This did correspond with the period of greatest reduction in nitrate. As nitrate levels at the outlet increased, organic N decreased and current levels of organic N at the outlet are now similar to inlet values.
