# Onsite Effluent Disposal in the Bay of Plenty 2006

Prepared by Paul Scholes, Environmental Scientist

Environment Bay of Plenty  
Environmental Publication 2007/01  
January 2007

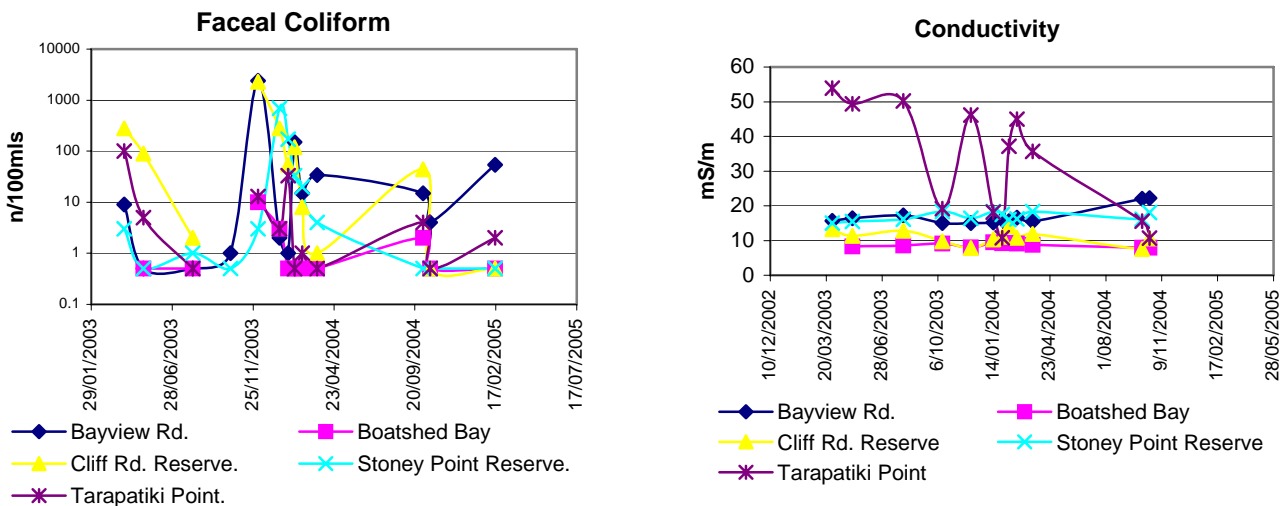
Figure 2.2 Faecal coliform and conductivity results from five groundwater sampling sites, Lake Tarawera.

Median indicator bacterial levels measured in ground water samples are generally low (Table 2.1, Figure 2.2). Elevated results were observed in three locations over the 2003/2004 summer. This may be a result of higher occupancy rates in residences over the summer period creating higher effluent flows to groundwater.

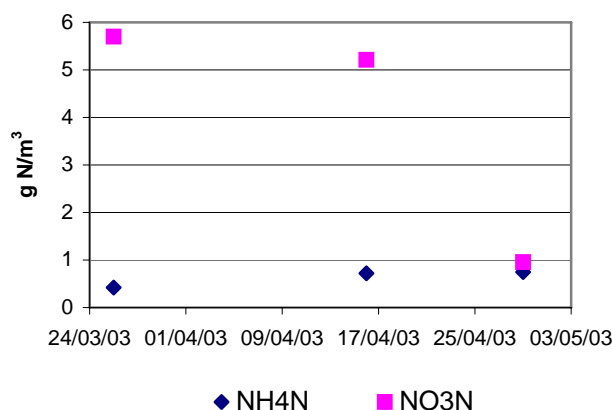
Figure 3.2 NH<sub>4</sub>-N & NO<sub>3</sub>-N concentrations in groundwater bore, 6 Steep Street, Lake Okareka.

Little groundwater monitoring has been undertaken since the NIWA survey of 1999/2000. A shallow groundwater bore located at 6 Steep Street has been monitored in March and April of 2003. Elevated nitrate-nitrogen and ammonium-nitrogen results (Figure 3.2) indicate septic tank effluent contamination is highly probable. Indicator bacterial monitored for faecal contamination were also detected at levels unsafe for drinking water.

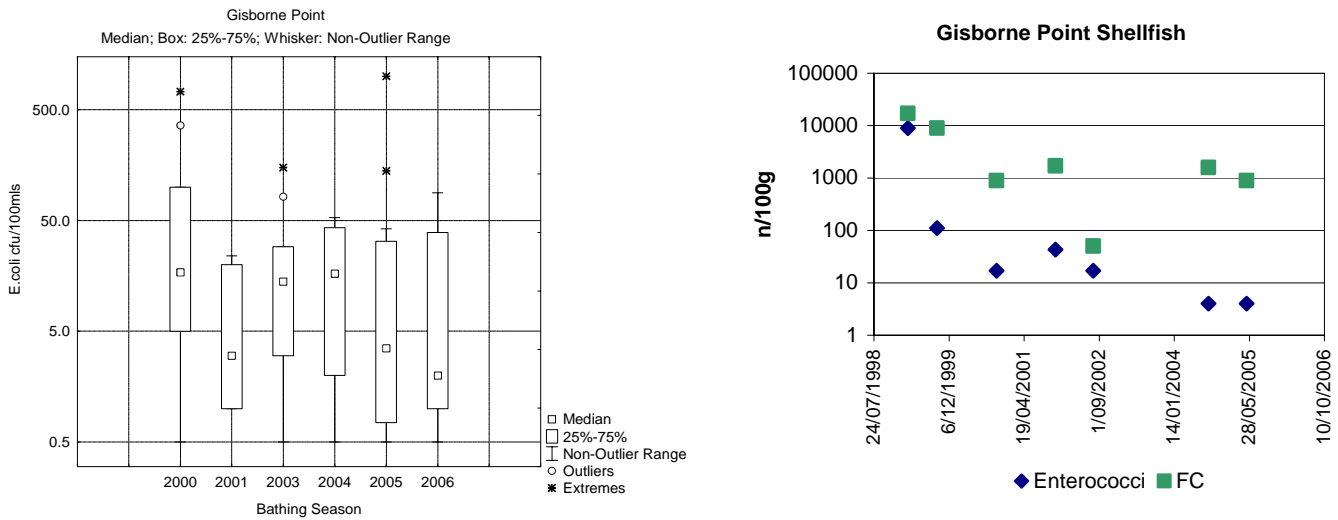
Figure 4.8 Gisborne Point bathing and shellfish monitoring, 1999 to 2006.

Figure 4.8 displays the bathing beach *E.coli* results since the 1999/2000 bathing season. Generally results have been acceptable for swimming, with only two exceedences in the past seven years (*E.coli* > 550 cfu/100mls). The median values indicate a slight improvement over the past few years and this is also apparent in the shellfish monitoring at Gisborne Point. However, faecal content in the shellfish is often at a level regarded as unsuitable for human consumption. *Clostridium perfringens* was also tested for in a recent shellfish sample, with the enteric bacterium only just being detected.

While bathing water quality is generally good at Gisborne Point, shellfish sampling does indicate some contamination of the lake exists. Shallow groundwater monitoring indicates that only low level bacterial contamination is occurring and is unlikely to be sufficient to represent levels found in shellfish.

At peak occupancy times, effluent concentrations may be elevated and more concentrated sampling may be required at these times to determine the impact of high usage periods. It is recommended that current bores be abandoned and a more intensive shallow groundwater survey be undertaken.

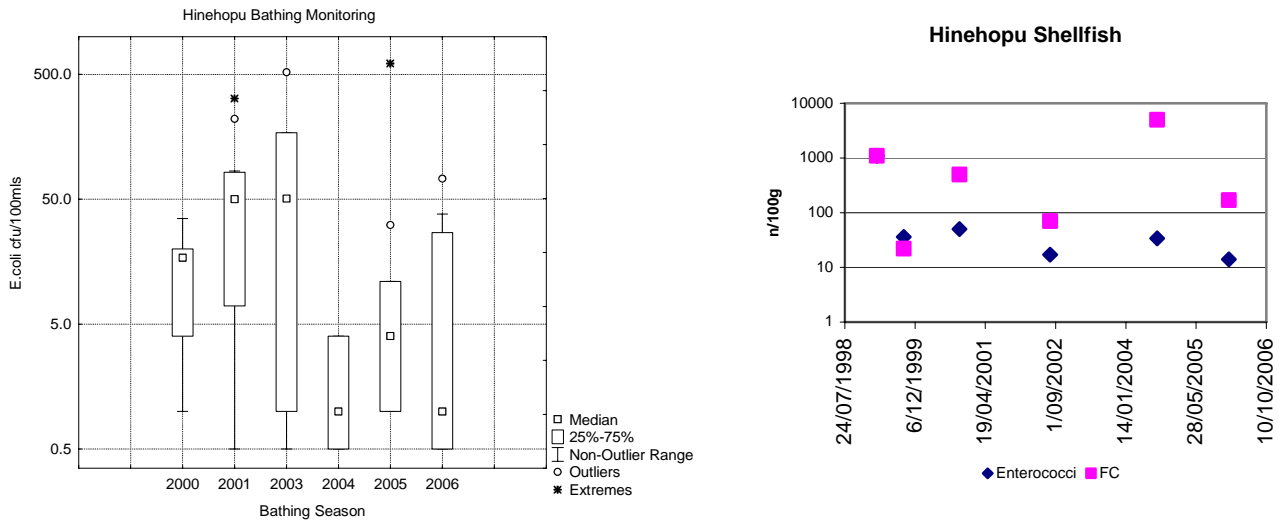
Figure 4.10 Hinehopu bathing and shellfish monitoring, Lake Rotoiti.

Even though contamination of the drain would appear to be occurring, the drain and the bathing area of the lake adjacent to the drain rarely experience faecal contamination levels that exceed recommended guidelines for microbiological recreational water quality (Figure 4.10). However, analyses of freshwater muscles at Hinehopu show fluctuating bacterial contamination levels, with faecal coliform levels at times above those considered safe for human consumption. Enterococci concentrations found in shellfish are relatively steady (with one exception) compared to the fluctuating faecal coliform concentrations. As the enterococci to faecal coliform ratio is highly variable, this may indicate a variable faecal source such as septic tanks or seasonal water fowl arrivals. No seasonal pattern is apparent in the data.

Recent monitoring shows that any contamination at the Tamatea drain outlet to Lake Rotoiti is of a low level. While occasional shellfish monitoring has found moderate levels of contamination in the lake, microbiological bathing surveys are on the whole at an acceptable level for recreational use.

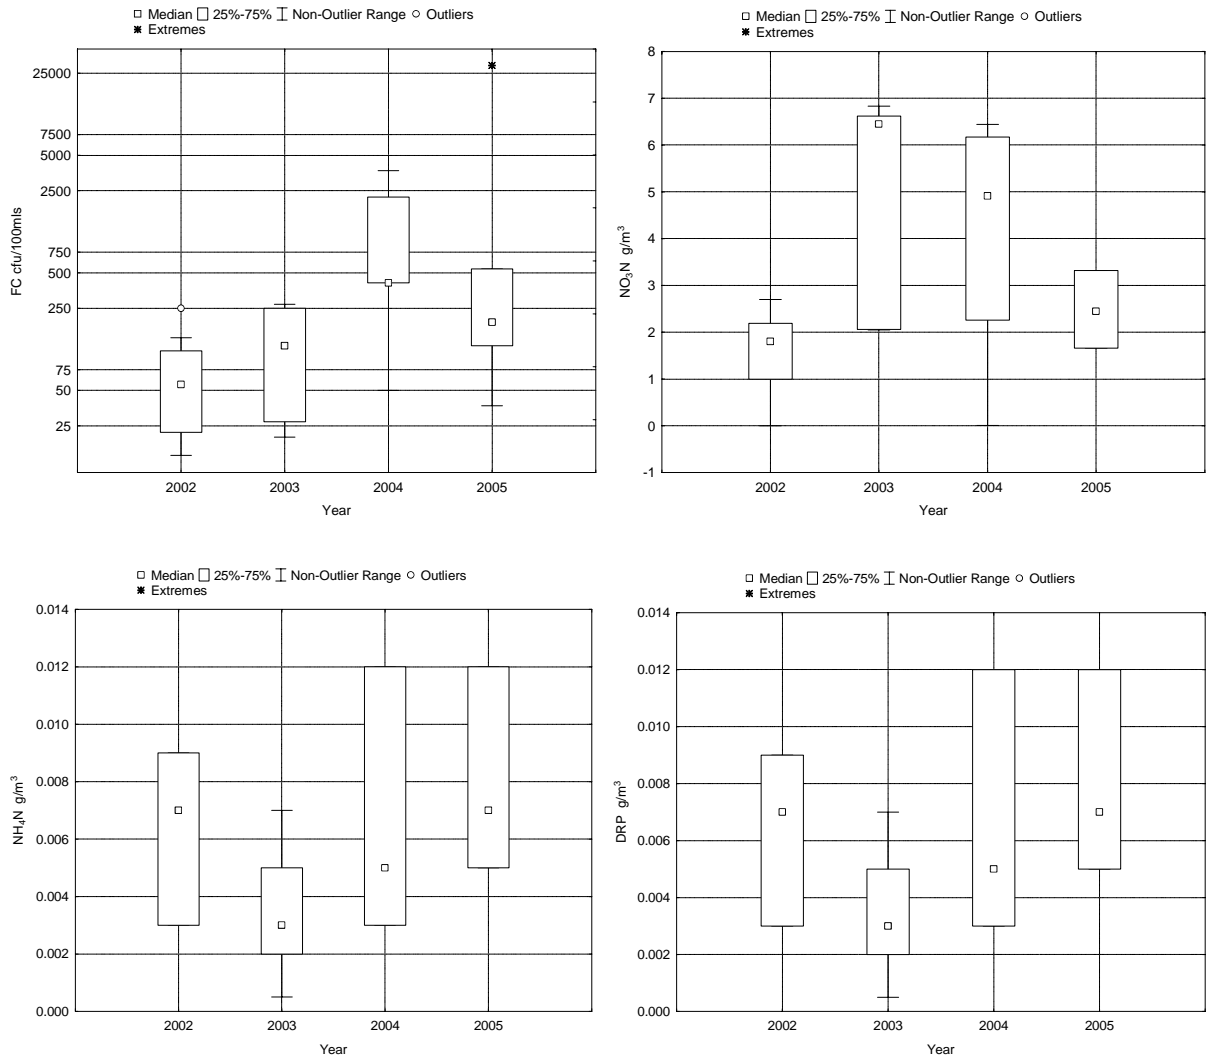
Figure 6.2 Box-whisker plots for four water quality parameters of data monitored in boat ramp drain, Tanners Point.

It is possible that contamination stems from the public toilet block located a couple of hundred metres away from the boat ramp drain outlet. However, faecal coliform results and nitrate levels from a drain behind the toilet block are higher than found in the boat ramp drain, showing contamination comes from sources other than the toilet block. This is also shown by sampling of some of the sub-surface drains flowing into this water table drain behind the toilet block. These sub-surface drains all had elevated bacterial contamination above recommended contact recreation guidelines.

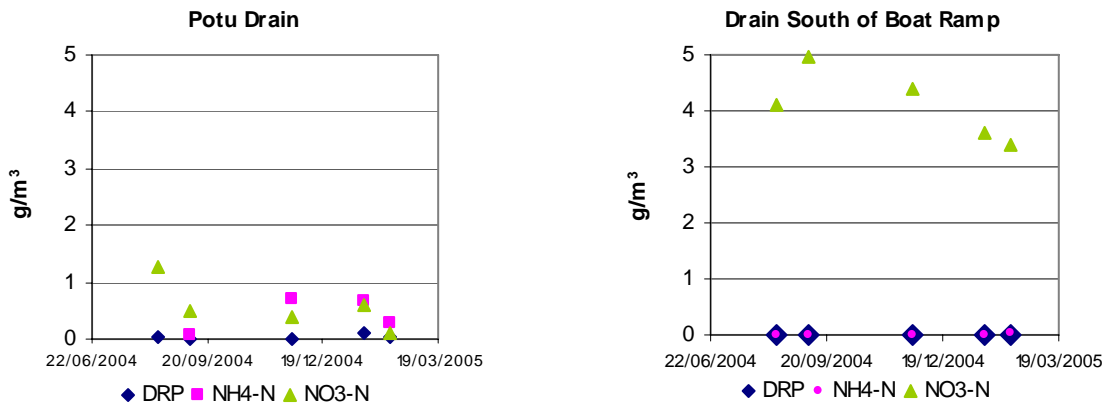
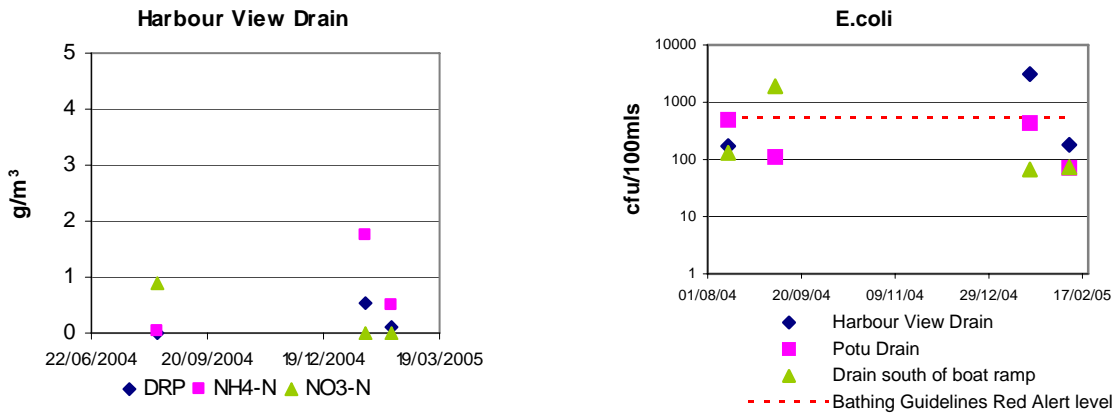
Figure 7.3 Monitoring results, Ongare Point drains.

The drain south of the boat ramp displays similar bacterial and nitrate-nitrogen levels as the drain near the toilet block (Figure 3). This suggests that contamination is also occurring in this location with the most likely cause being a slow creep of septage through soils. Comparison of nitrate-nitrogen level with the other two drains in Figure 3 shows how markedly elevated nitrate-nitrogen levels are in the drain south of the boat ramp.

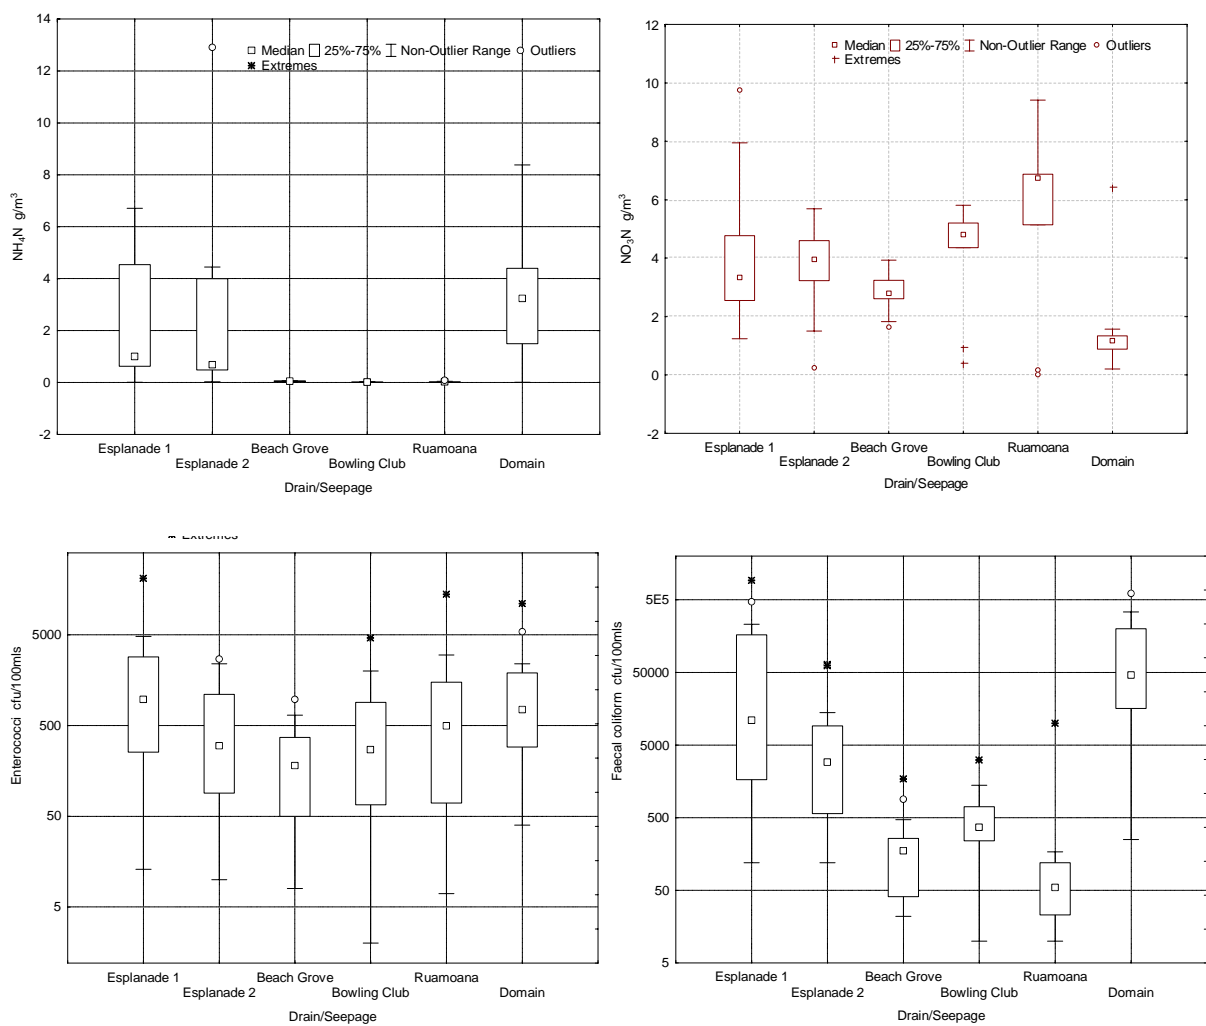
Figure 8.2 Box-whisker plots for four water quality parameters of data monitored from Omokoroa drains and seepages, 1997 to 2003.

Almost all drains surveyed had elevated levels of nitrate-nitrogen indicating the presence of septage. The one exception was the Domain stormwater outlet, and this is likely to be because most inorganic nitrogen is present as ammonium-nitrogen. This outlet also has on average a conductivity five times greater than the other drains (mean = 709.9 mS/m), although salinity is slightly elevated as well. Dissolved reactive phosphorus concentrations are also elevated in the Domain drain (mean = 0.198 g/m<sup>3</sup>) which helps explain a high fluorescence whitening agent test result from this drain (4.8mg/m<sup>3</sup>). Both are likely to be a result of detergents entering the stormwater system.

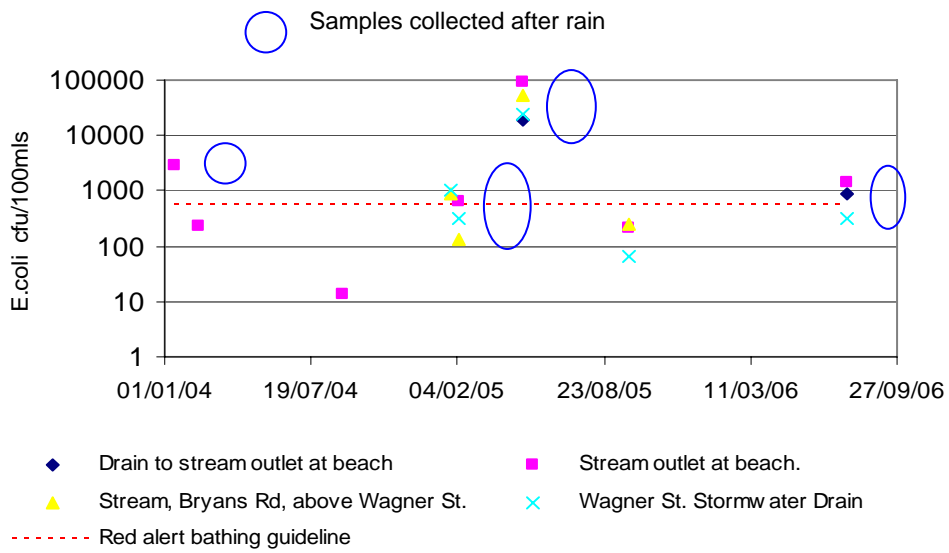
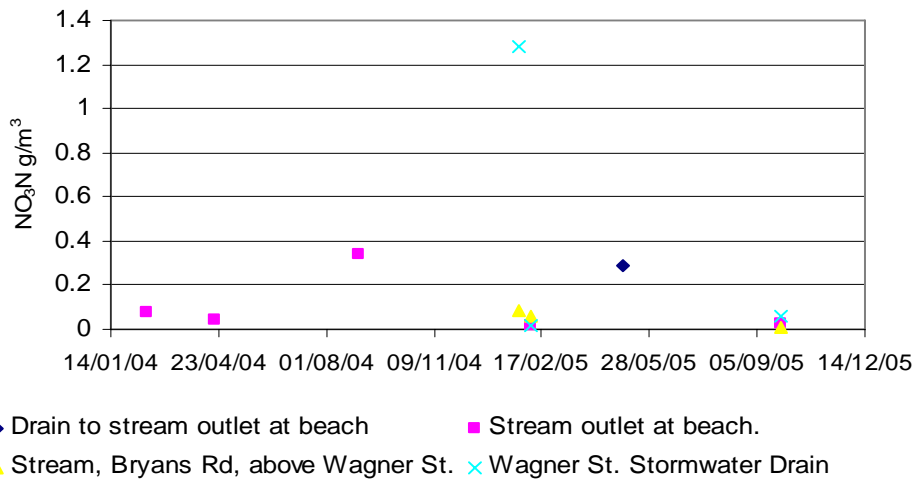
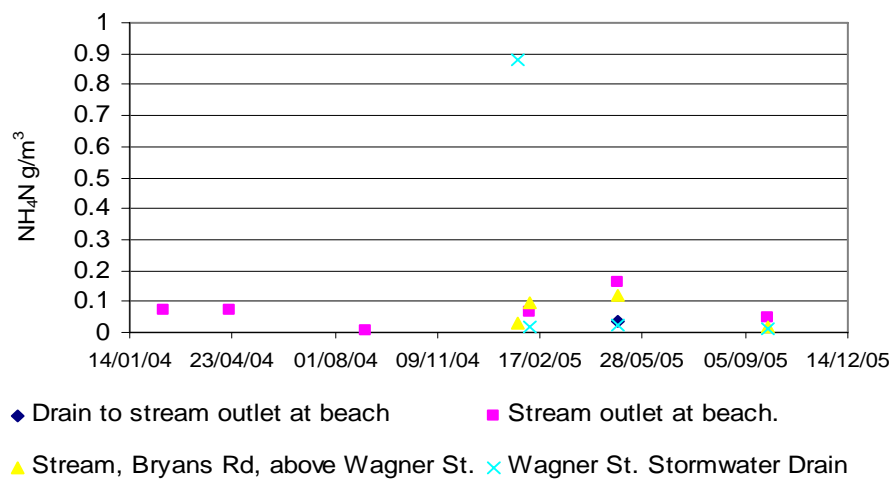
Figure 10.2 E.coli, NO<sub>3</sub>-N and NH<sub>4</sub>-N results for monitoring at Bryans Beach.

Nutrient indicators in the stream and drains alike are generally low (Figure 10.2). Only the Wagner Street stormwater drain displayed elevated nitrate-nitrogen and ammonium-nitrogen concentrations after one rainfall event. Ammonium-nitrogen and faecal coliform results at the stream outlet to beach do show a good relationship (Figure 10.3). Such a relationship may indicate that a poorly treated effluent and/or other raw faecal source(s) are contributing the faecal loading in the stream. However, neither site upstream of the outlet has such a strong relationship between these two parameters, although data is limited.
