Memorandum

То:	Peter and Pat King
From:	Alison Clarke – 4Sight Consulting Ltd
Date:	09/02/2022
Subject:	340E Pahoia Road Seawall Options Assessment

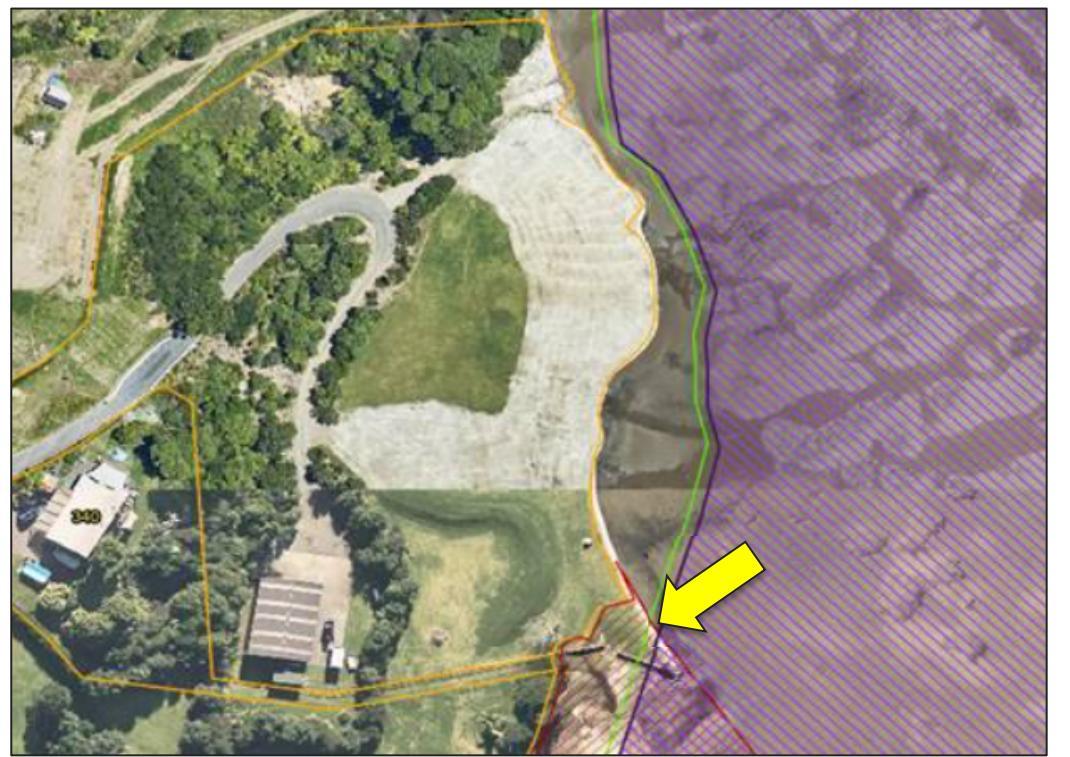
Figure 1: The subject site at 340E Pahoia Road. The area in red is the IDBA. The orange polygon indicates the property boundary. The yellow arrow indicates the area of reclamation and area of non-complying activity. Source: BOPRC.

This is the option suggested by the BOPRC and entails removing the section of the wall and reclamation at the southern end where the wall extends into the IBDA A area. To achieve this it has been proposed to pull the fill landward during dry weather conditions back to the natural surface. The area to be pulled back is approximately 150m². Intensive planting of native species would then take place along what would be the new southern boundary (orange line in **Figure 1**) to help mitigate the potential for accelerated erosion due to end effects.

This option is to rebuild the end of the retaining wall along the property's southern boundary (orange line in **Figure 1**) to avoid the IDBA ecological area. Pulling the structure landward means that it will be subject to less regular interactions with coastal processes as the structure will sit higher within the tidal cycle. Given that the relocated wall will be of a similar form (i.e. vertical face), footprint and orientation to the existing, it is likely that it will act in a similar manner to the existing structure and therefore the potential impacts on the coastal environment will likely be less than the existing situation due to its higher position within the tidal cycle. It is noted that this option may require liaison and input from an engineer to refine the design.

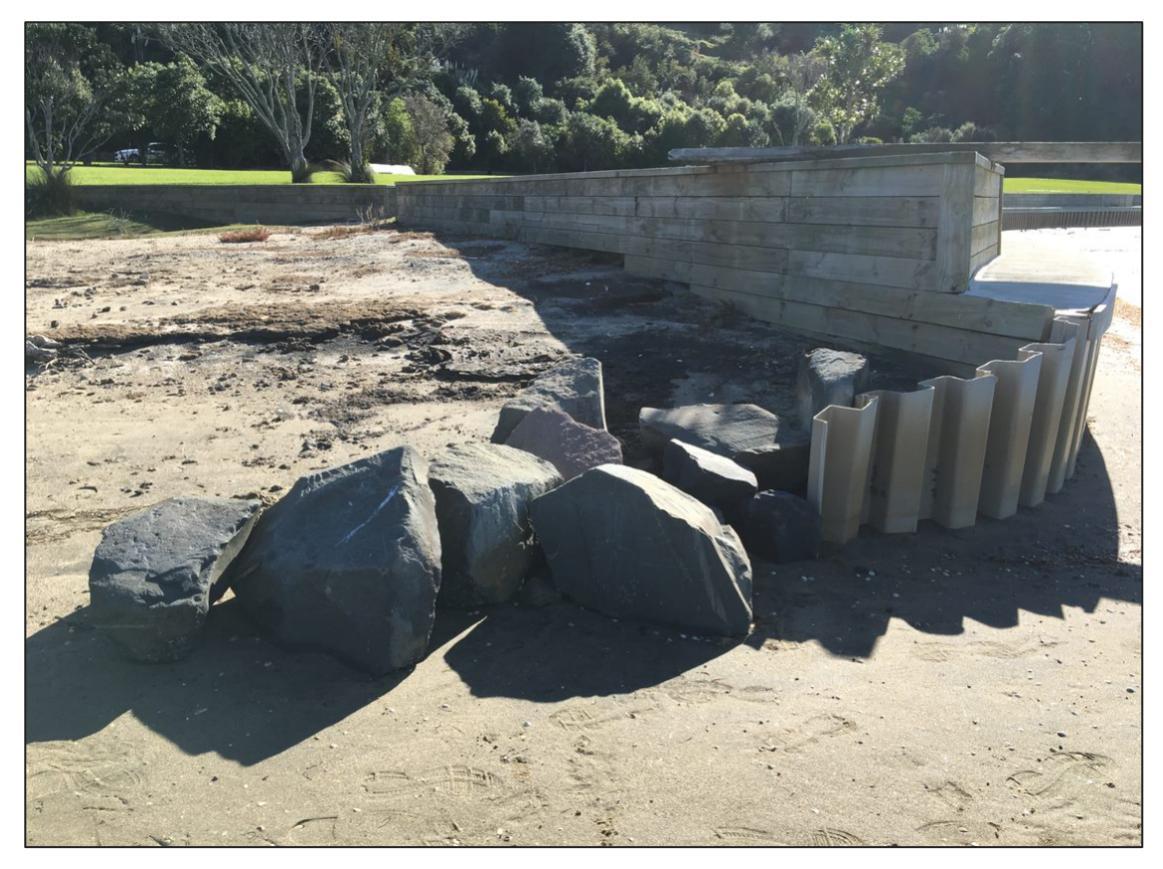
Figure 2: The southern-most portion of the seawall which extends into the IDBA ecological area.

At around this same time a new section of retaining wall was constructed at the southern end of the existing structure. The seawall extension is approximately 27m long and sweeps westwards at the southern end of the property (see **Figure 2**). As outlined in our prior coastal processes impact assessment¹, the return design of the southern portion of the seawall helps to mitigate the potential for end effects to develop which could otherwise impact the area immediately south. The assessment concludes that overall the potential for any adverse effects from the seawall are considered to be low over the short to medium term (assuming the structure remains in a similar condition as it is currently), and this is partly due to the return design of the southern point of the structure. Therefore, from a practical and functional point of view we consider the return portion of the timber seawall extension has been in place approximately 5 years it is anticipated that the geomorphology and sediments within the vicinity have largely adjusted to its presence.

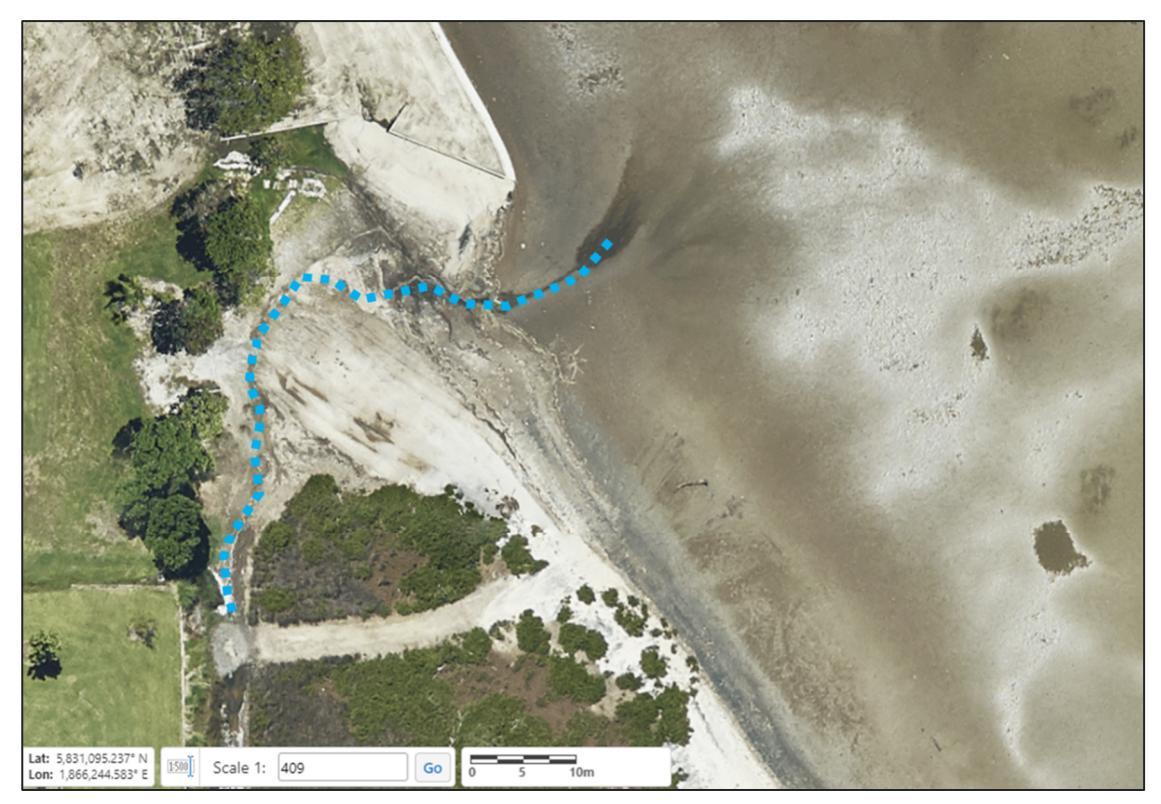
Figure 3: Small waterway immediately south of the seawall extension.
