Groundwater Recharge at the Kaharoa Rainfall Recharge Site - Rotorua

Prepared by Jonathan Freeman, Environmental Scientist

Groundwater Recharge at the Kaharoa rainfall recorder and lysimeter site, Rotorua

Environmental Publication 2010/21 ISSN: 1175 – 9372 (Print) ISSN: 1179 – 9471 (Online)

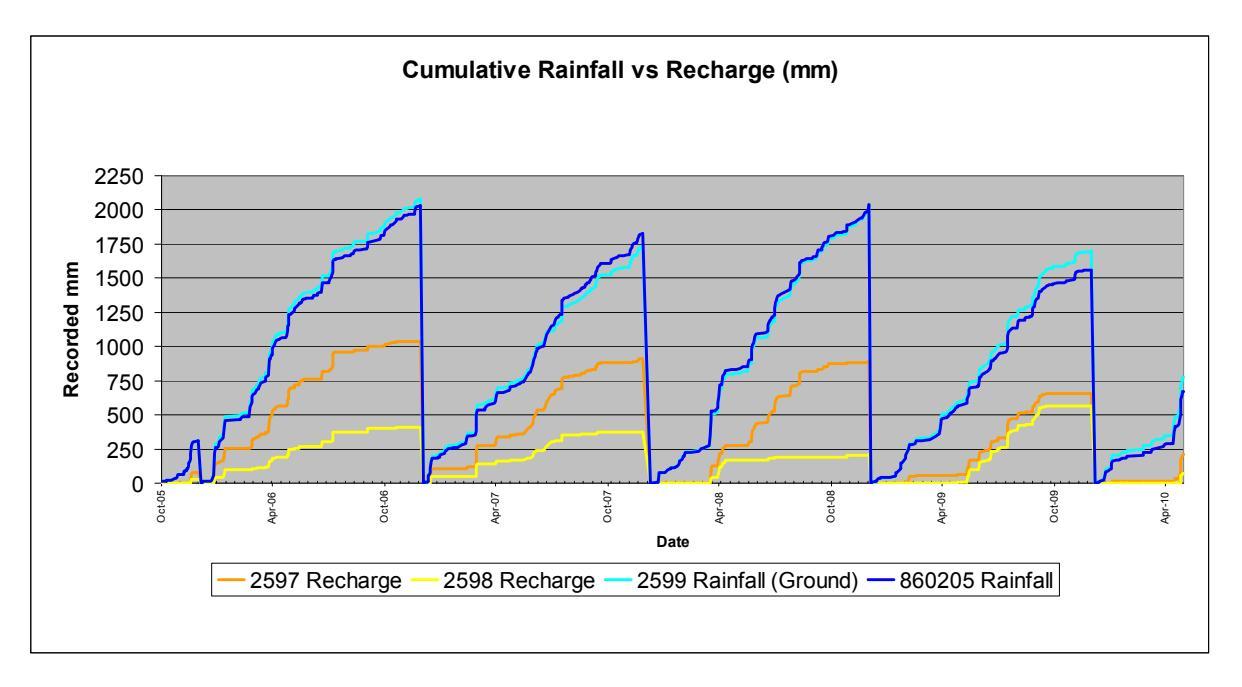
A review of annual accumulated and monthly rainfall and recharge was undertaken in order to assess repairs to lysimeter 2598. Figure 3 below of annual accumulated recharge and rainfall provides an illustration of the under recording trend exhibited in lysimeter 2598. It is apparent from the 2009 data series that lysimeter 2598 has been repaired as at August 2008. While 2598 still records less than 2597, the difference between the two lysimeters is comparable to the difference between the two rain gauges. White et al. (2007) identified the difference between a ground level rain gauge and a standard above ground rain gauge, as is the case at Kaharoa, is in the vicinity of 3%. Due to the large discrepancies identified in early 2010, it appears as if the drift between the two lysimeters has resurfaced and it is recommended that lysimeter 2598 is monitored and its results used with caution (Craig Putt, pers. comm.). For a full description of repairs and maintenance undertaken by GNS Science to lysimeter 2598 see appendix 4.

Figure 4 Annual accumulated rainfalls for the two lysimeter sites and rainfall recorders.

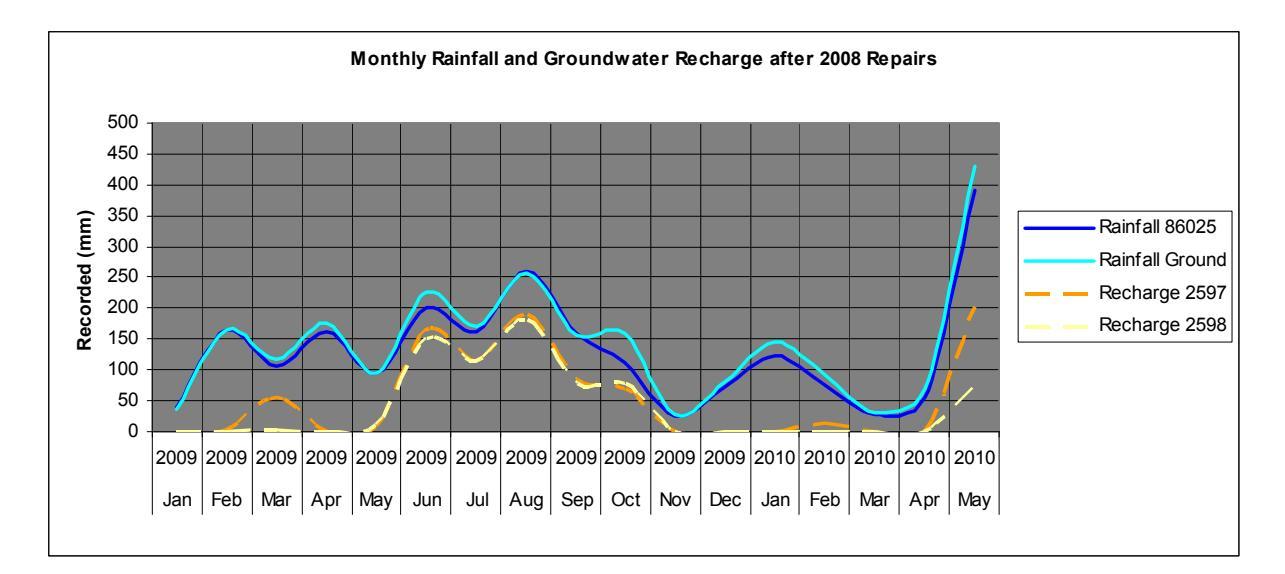
Figure 5 2009 – 2010 monthly rainfall and recharge after repairs to lysimeter 2598.

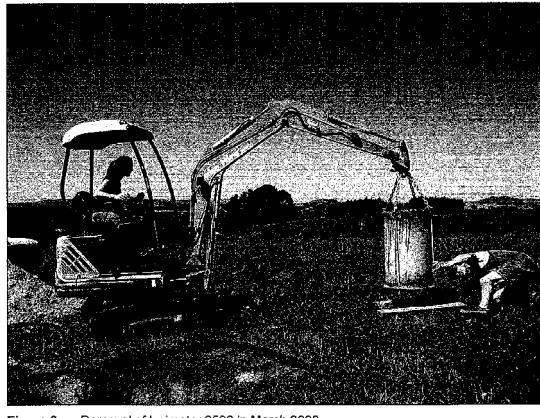
Two lysimeters were installed in June 2005 to measure groundwater recharge at the Environment Bay of Plenty Kaharoa rainfall site as part of the Lake Rotorua groundwater study. Field studies showed that one of these lysimeters (number 2598) was leaking.

Removal of lysimeter 2598 in March 2008 re 3

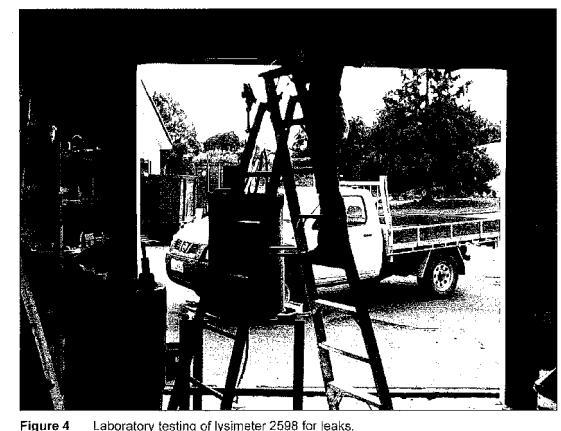
A laboratory test of lysimeter 2598 confirmed that it was leaking around the join between the base plate and the lysimeter wall. The join was probably not properly sealed since installation of lysimeter 2598. This join was replaced and a test showed no leaks were occurring. Lysimeter 2598 was then reinstalled at Kaharoa.

Water began to flow from the lysimeter drain line after 80 minutes. For approximately 30 minutes after the water started flowing only very small seepage leaks were observed around the join between the base plate and the lysimeter wall (Figure 5). The rate of seepage through leaks between the base plate and lysimeter wall was insufficient to account for the assumed leakage measured during the field infiltration test in August 2007. After 111 minutes from the start of the test the drainage line from the lysimeter was closed to raise the water level in the lysimeter. This caused significant increase in leakage from the join between the base plate and the lysimeter wall. The rate of leakage was easily enough to account for the discrepancy measured in the field infiltration test. An attempt was made to stop the leakage by tightening the four vertical rods that hold the base plate in place (Figure 5). This was ineffective. At this time the testing was abandoned and the lysimeter was allowed to drain overnight.

Laboratory testing of lysimeter 2598 for leaks ure 4

The next day all of the silicone sealant was removed from the join by cutting knife, wire brush, and a wire brush mounted on an angle grinder. The steel around the join was regalvanised after the leakage had completely ceased and water evaporated. Galvanised paint was allowed 24 hours to dry as specified in the manufacturer's instruction. On 15 March 2008 the joint was sealed with marine grade silicone sealant. The silicone sealant was given 48 hrs to cure as specified in the manufacturer's instructions.

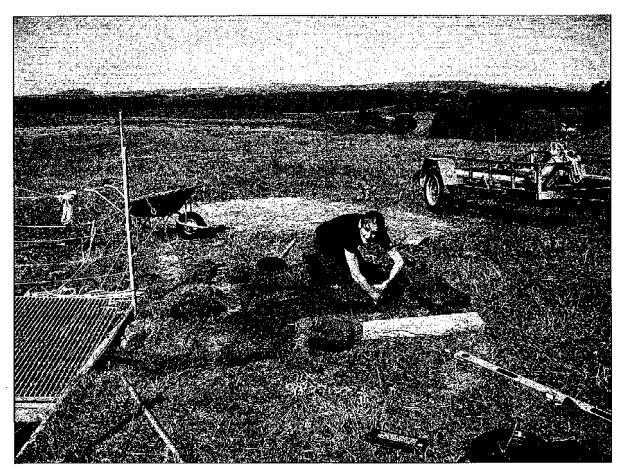
Laying grass sod after reinstallation of lysimeter 2598. Figure 7

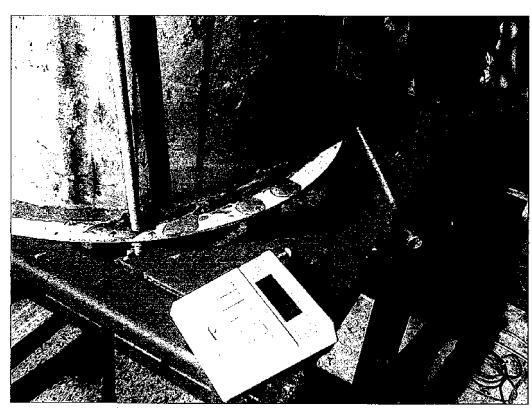
Water leakage around the join of base plate and lysimeter wall. Note vertical rod holding base plate in place. Figure 5

The join between the base plate and the lysimeter wall should be tested prior to lysimeter installation and a test like that outlined in Section 5 is recommended. This test will add approximately 48 hours to lysimeter installation time. Equipment to test the join will be required for field operations.

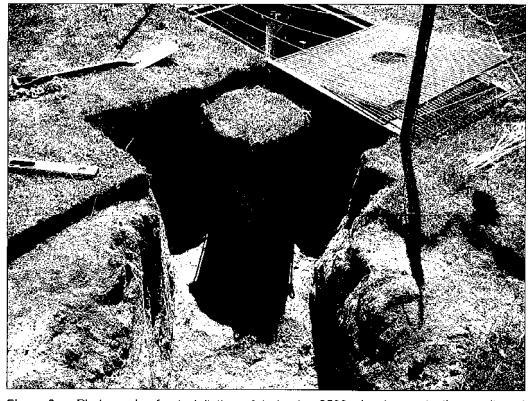
Figure 6 Photograph of reinstallation of lysimeter 2598 showing protective cardboard 'skirt' around the base plate-wall join.
