Bathing and Shellfish Surveillance Report 2011/2012

Bay of Plenty Regional Council
Environmental Publication 2012/09
September 2012

Bathing and shellfish surveillance report 2011/2012

Environmental Publication 2012/09

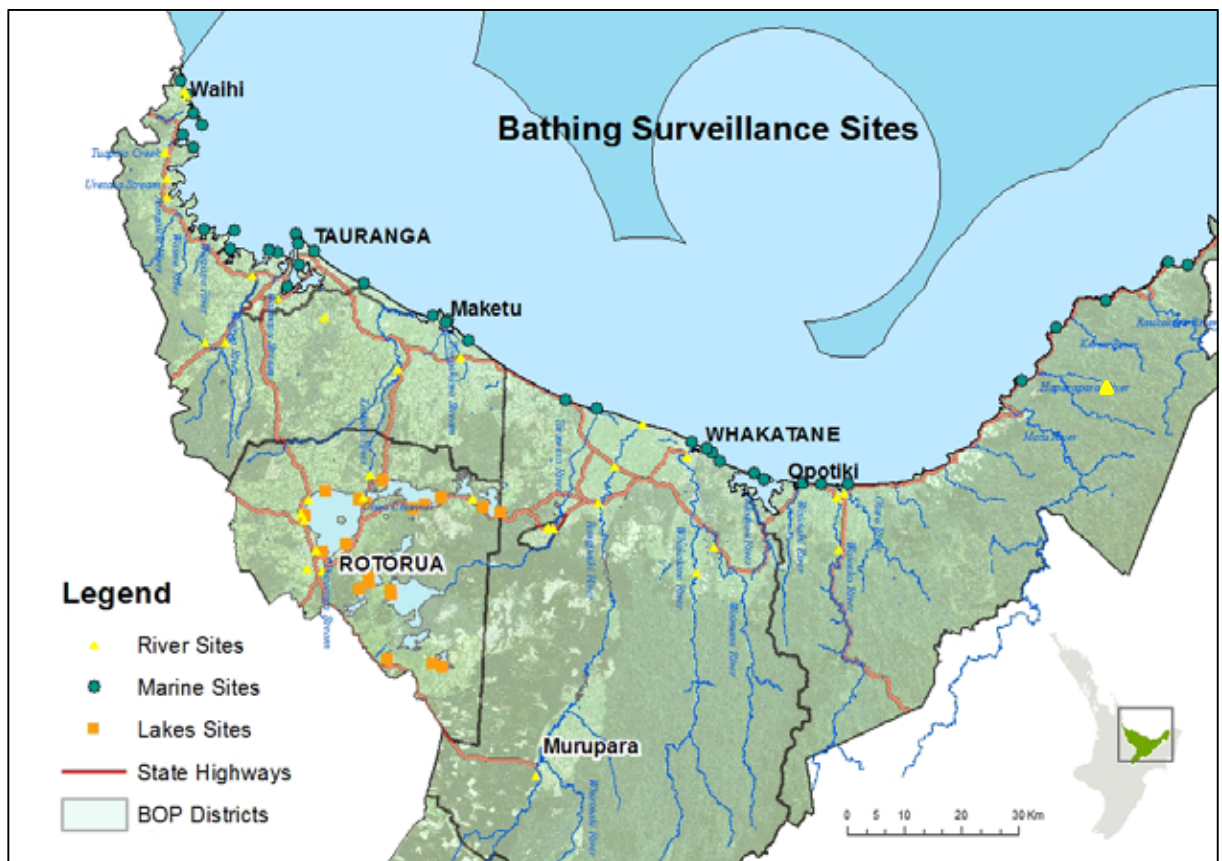
Figure 1.1 Bathing surveillance sites, Bay of Plenty

The bathing surveillance monitoring sites are shown in the maps that follow (Figure 1.1).

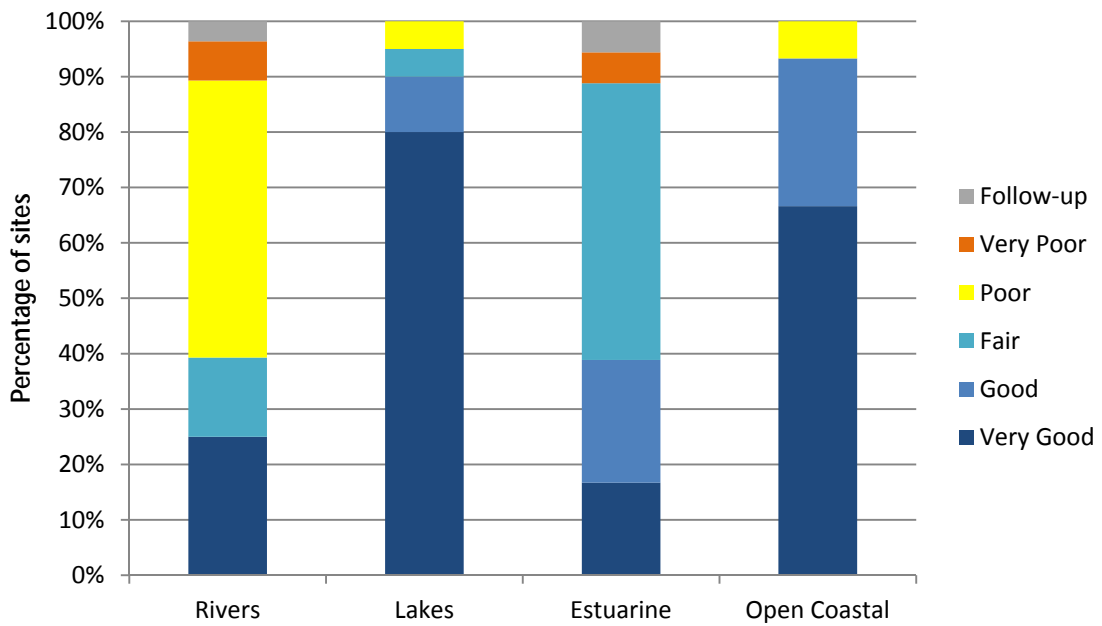
Figure 4.2 Comparison of the results for the Suitability for Recreation Grade (SFRG).

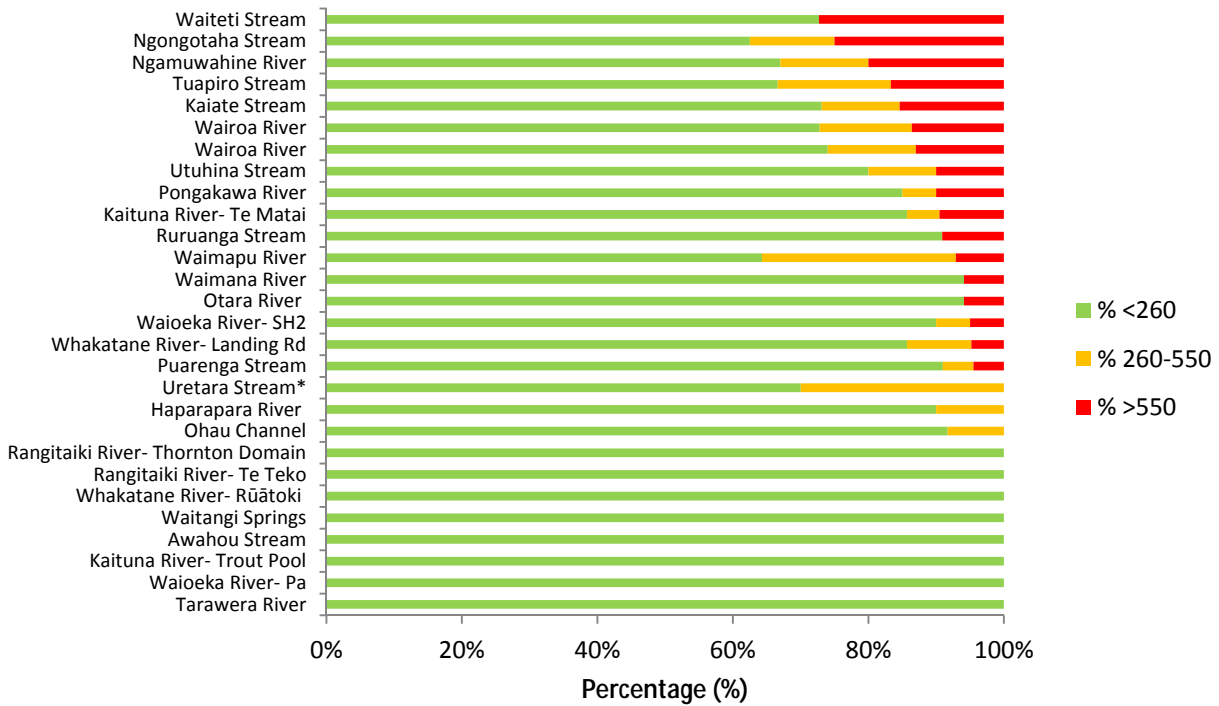
Over the 2011/12 season seven sites exceeded the Orange/Alert mode 25% of the time. The Ngongotahā and Waimapu Streams were over this level on 35% of monitoring days. The Ngamuwahine Stream was the third most contaminated of the river sites. The cause of this should be investigated further as a large proportion of the Ngamuwahine catchment is in native bush and therefore the stream would normally be expected to have elevated levels of faecal contamination.

Both the Ngongotahā Stream and the Waitetī Stream exceeded the Red/Action mode more than 20% of the time during the season, although both have lower median E.coli levels than a number of other streams (Figure 4.3). This would seem to indicate that the results from these spring-fed streams have been affected by seasonal storm events. Likewise, multiple storm events that occurred over the summer have driven many of the results at other sites above the Red/Action mode.

Figure 4.2 River and stream *E.coli* levels compared against each of the modes in the NZ Microbiological Water Quality Guidelines (MfE/MoH 2003), 2011/2012 bathing season.

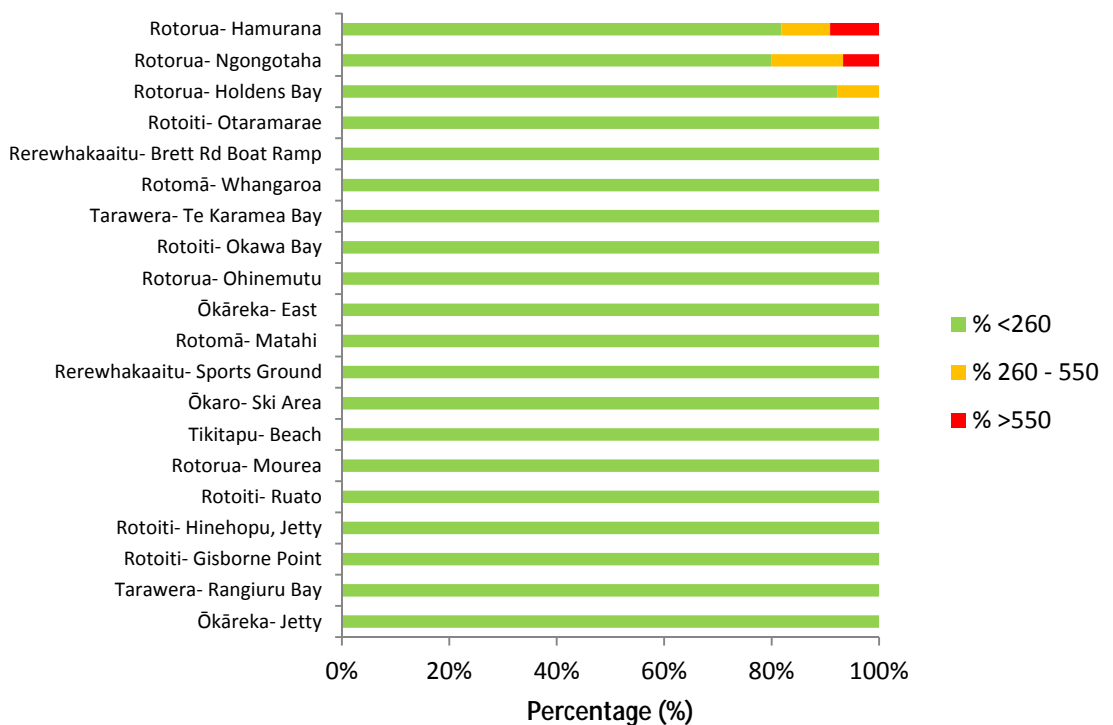
Two Lake Rotorua sites (Hamurana and Ngongotahā) reached the Red/Action mode during the 2011/2012 season (Figure 4.4). The Orange/Alert mode was also reached at Holden’s Bay. These results are thought to be due to strong prevailing winds disturbing the sediments in the shallow littoral zone.

Figure 4.4 Lake E.coli levels compared against each of the modes in the NZ Microbiological Water Quality Guidelines (MfE/MoH 2003), 2011/2012 bathing season.

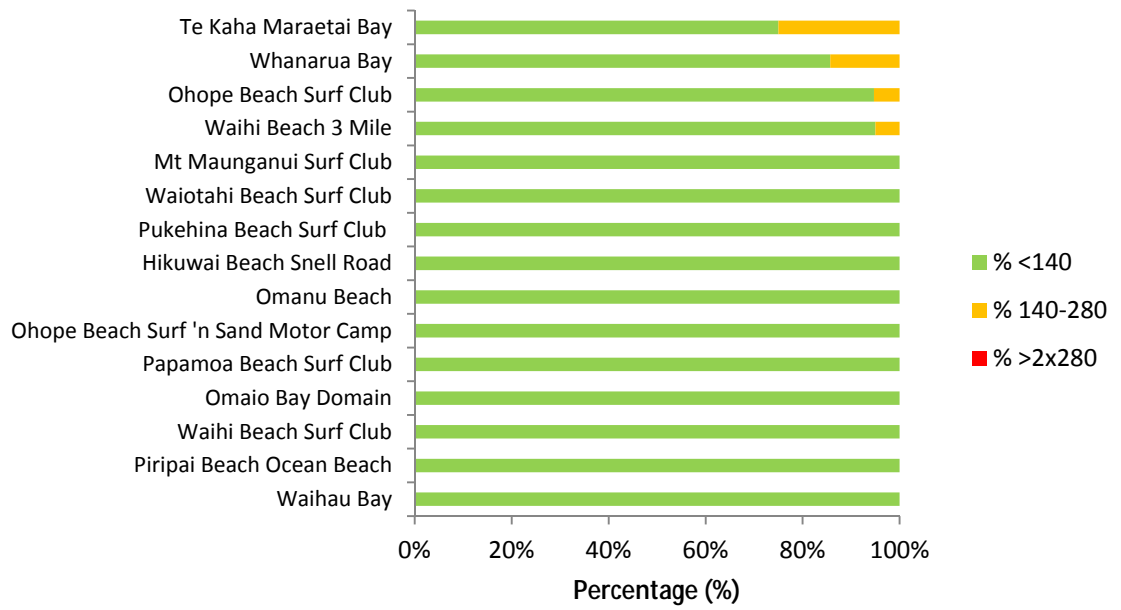
Figure 4.6 Coastal marine enterococci levels compared against each of the modes in the NZ Microbiological Water Quality Guidelines (MfE/MoH 2003), 2011/2012 bathing season.

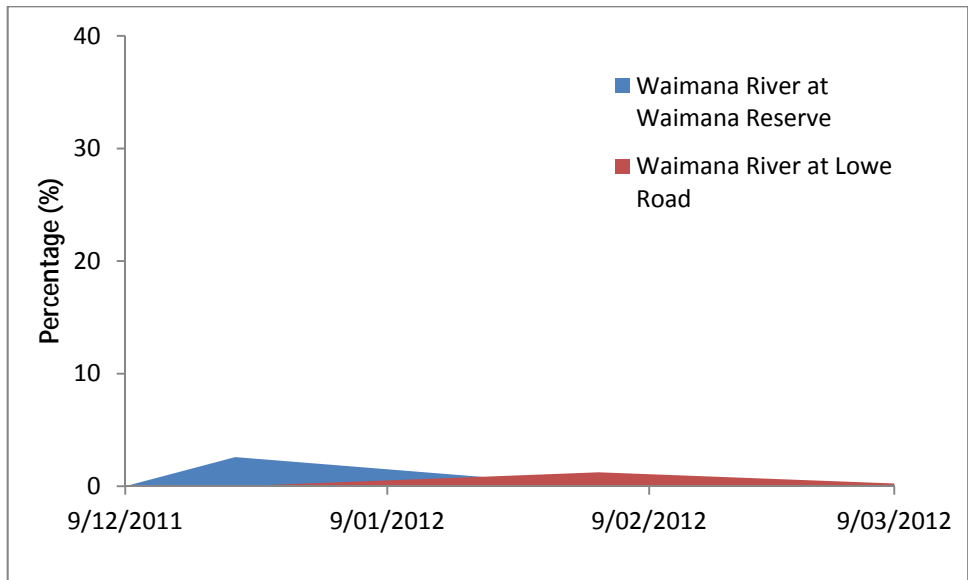
As with the 2009/2010 and 2010/2011 summer season *Phormidium* coverage was low in the 2011/2012 summer season (1-2%) and no health warnings were issued. After very low cover in spring *Phormidium* was effectively absent at both sites over summer and autumn (Figure 6.1). The last health advisory for this river was in February 2009.

Figure 6.1 Percentage Phormidium cover, Waimana River

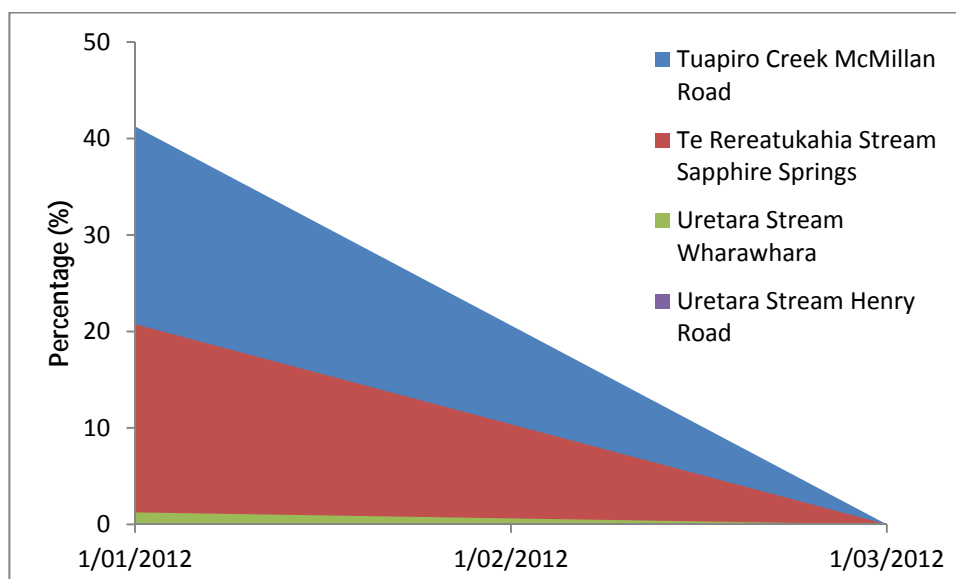
A gradual build-up of mats occurred in Te Rereatukahia Stream (Sapphire Springs) reaching its highest level (20.75 %) in the weeks prior to floods in January (Figure 6.3). The *Phormidium* was very concentrated above and below the bridge. The high flows that resulted from the early January floods removed almost all of the mats.

Tuapiro Stream was very near the threshold at 41% cover, the *Phormidium* was very concentrated just above the ford. Mats did not re-establish after the January floods. No other Western Bay of Plenty sites recorded extensive *Phormidium* development.

Figure 6.3 Percentage *Phormidium* cover, Western Bay of Plenty
