Draft Onekawa Te Mawhai Regional Park Operational Management Plan

September 2014

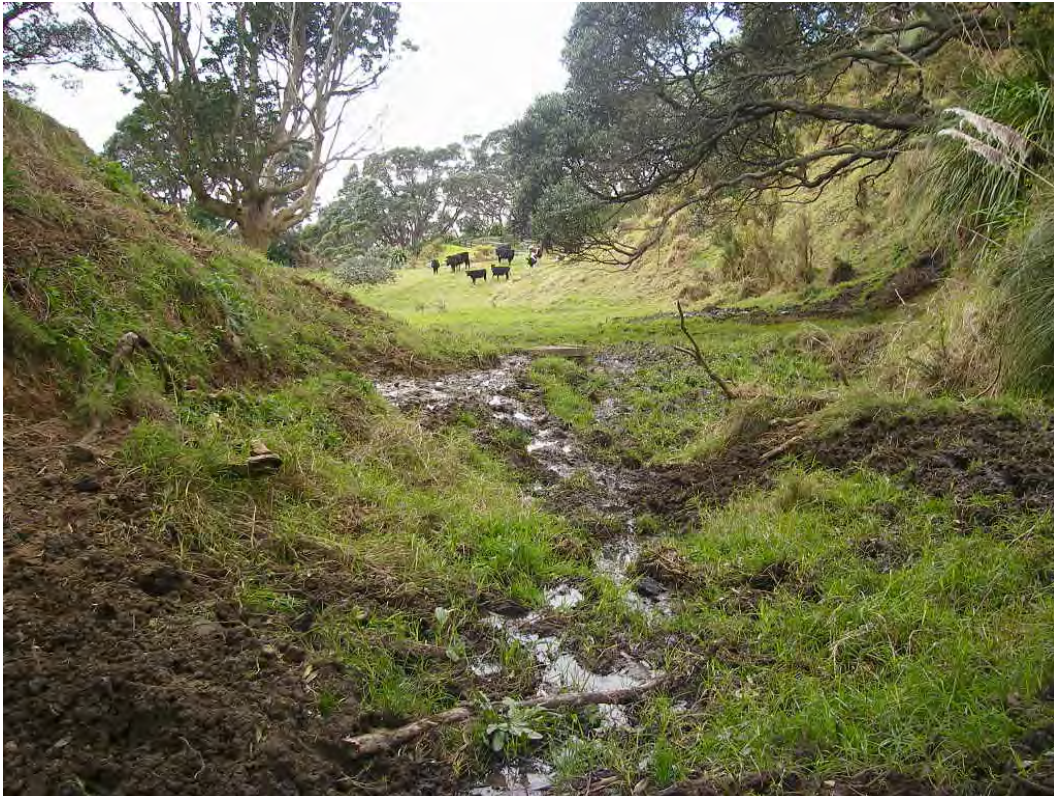
Natural threats present include pest plants, pest animals and erosion during extreme rainfall events. The grazing which assists the control of pasture also restricts visitor movement around the property as existing walkways can become muddy over winter (Figure 1).

Figure 1 Opportunities and threats – Pohutukawa loop track winter condition.

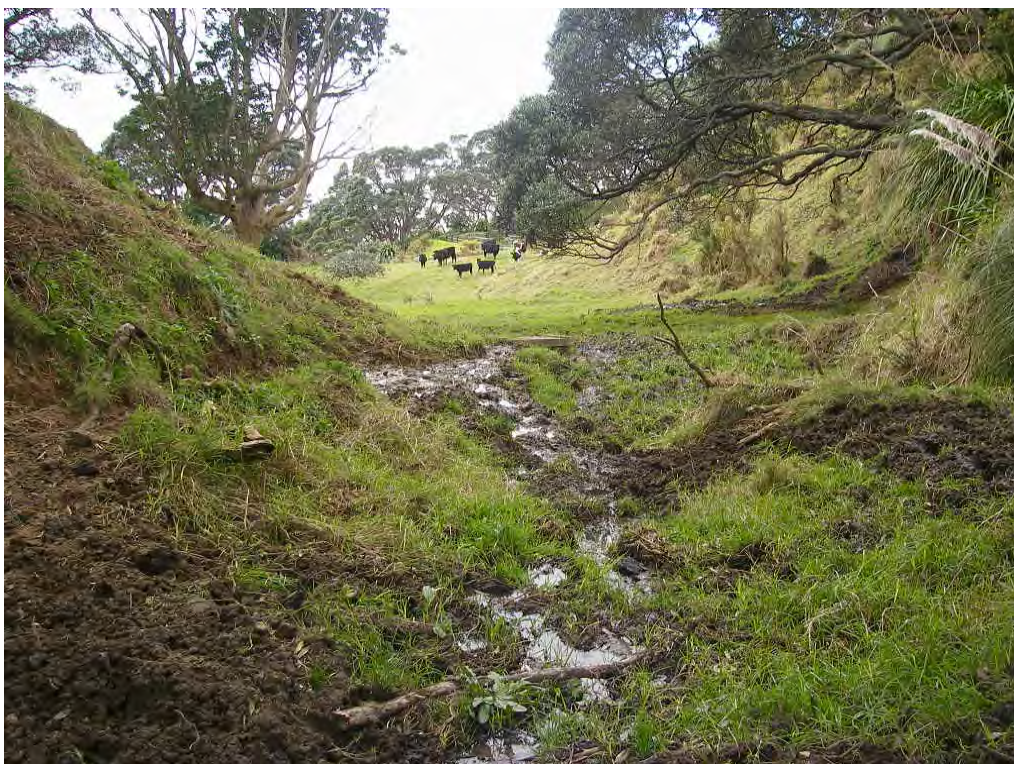
There are no formal water dams on the land but several naturally wet areas exist. Figure 6 shows an ephemeral waterway in the Pohutukawa paddock.

Figure 6 Natural wet area, winter 2010.

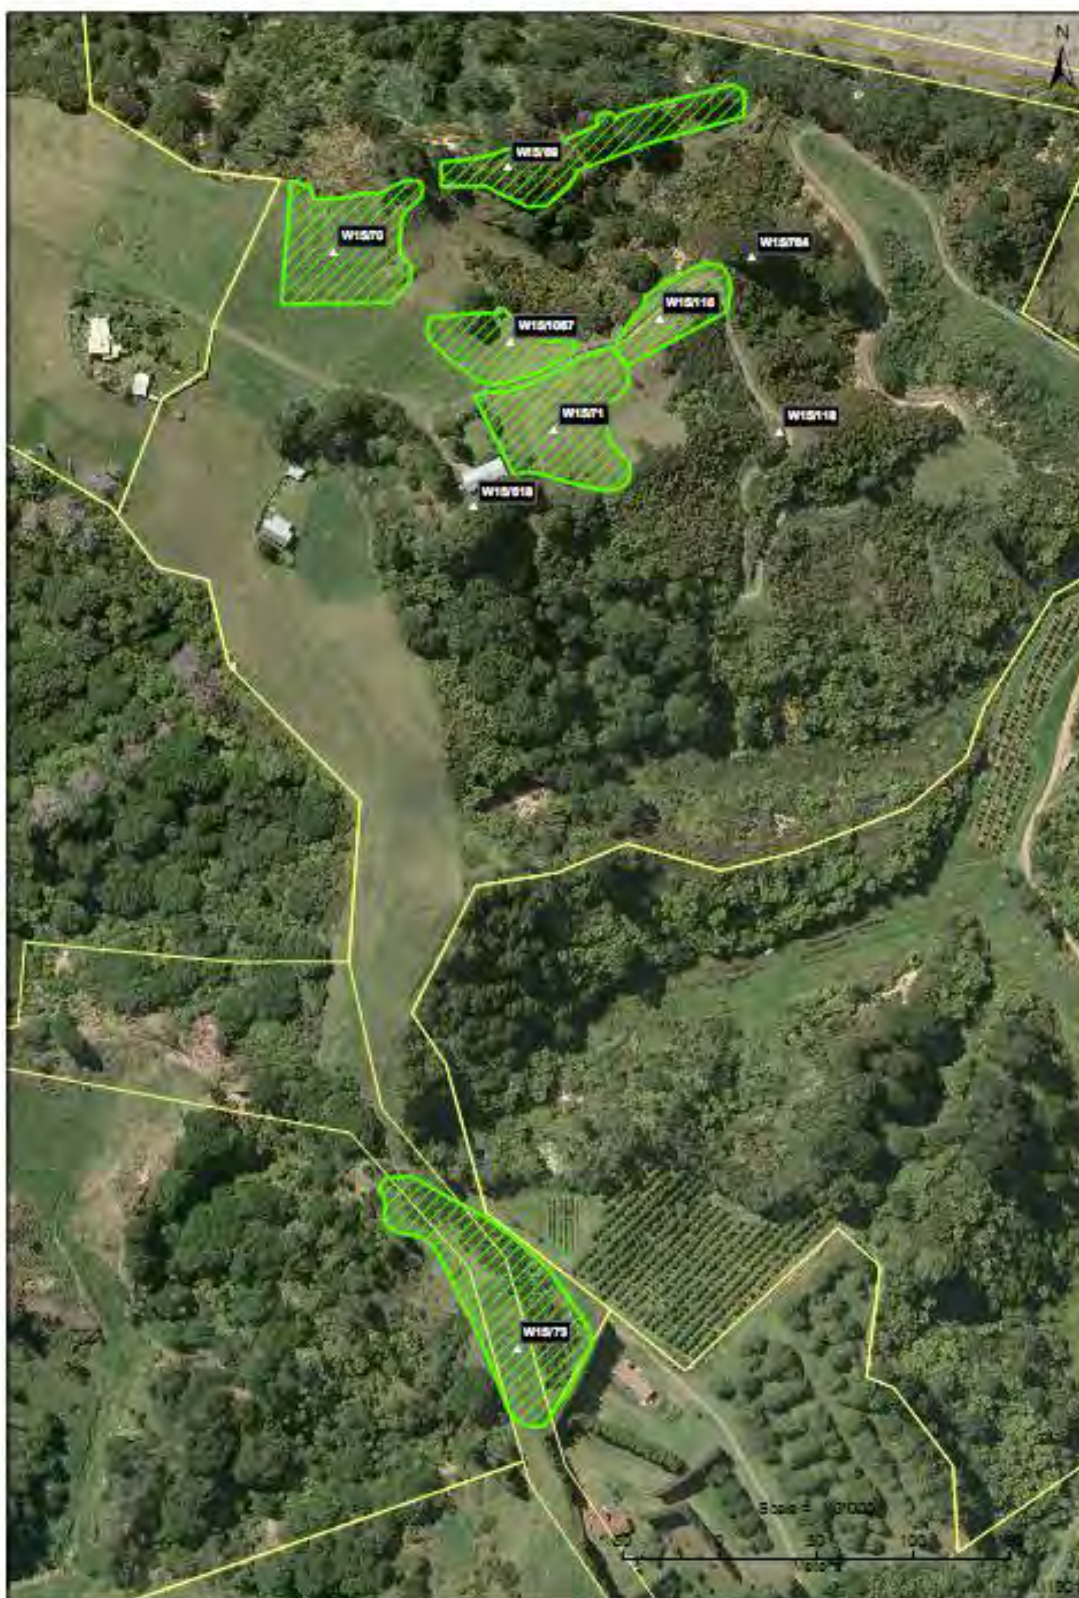
Figure 8 Bay of Plenty Regional Council aerial photograph of the eastern portion of the Onekawa Te Mawhai Regional Park showing archaeological site locations and extents (numbers refer to NZAA metric site record numbers).

Sites recorded by Ken Moore in 1969 were assigned imperial reference numbers, which appear on the early NZAA records. Imperial numbering was still in use when an archaeological inspection was undertaken by the Heritage New Zealand staff in 1980. The marked aerial photograph that recorded archaeological site locations at the time of the 1980 visit, used imperial reference numbers has been included within this report to illustrate the location of sites in relation to the original formation of the farm access track (Figure 10). The sites recorded in 1969 and 1980 have since been assigned metric numbers and are referred to by those numbers within this report.

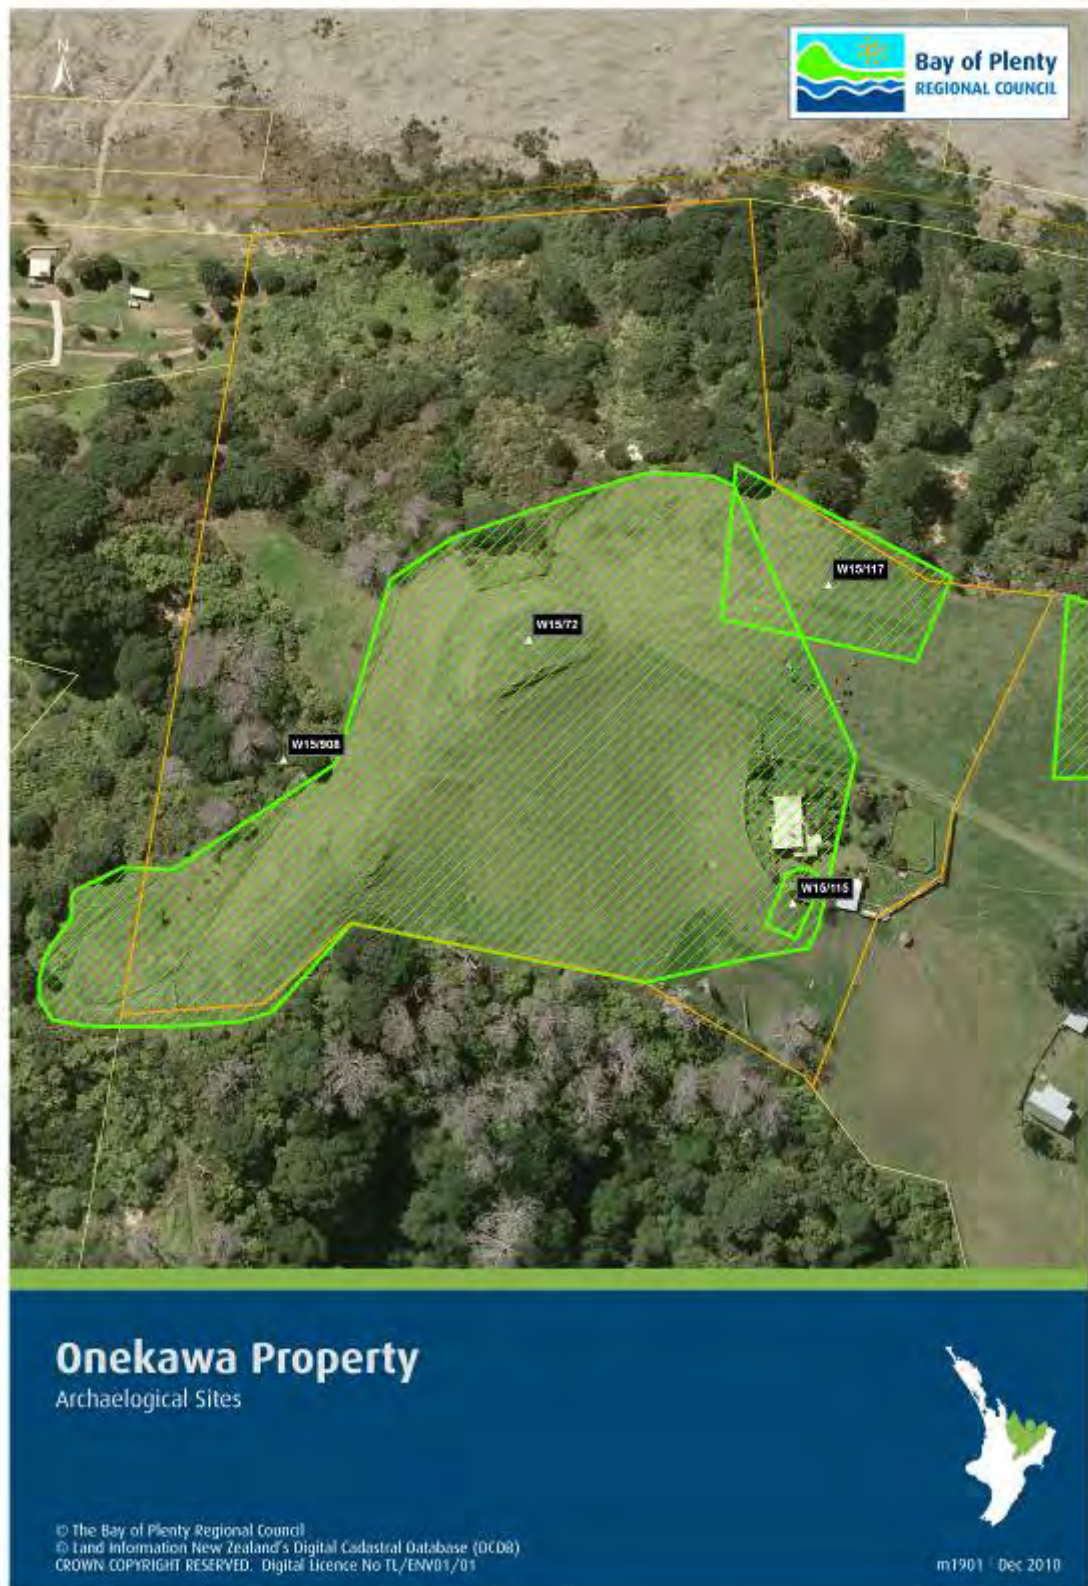
Figure 9 Bay of Plenty Regional Council aerial photography of the western portion of the Onekawa Te Mawhai Regional Park showing archaeological site locations and extents (numbers refer to NZAA metric site record numbers).

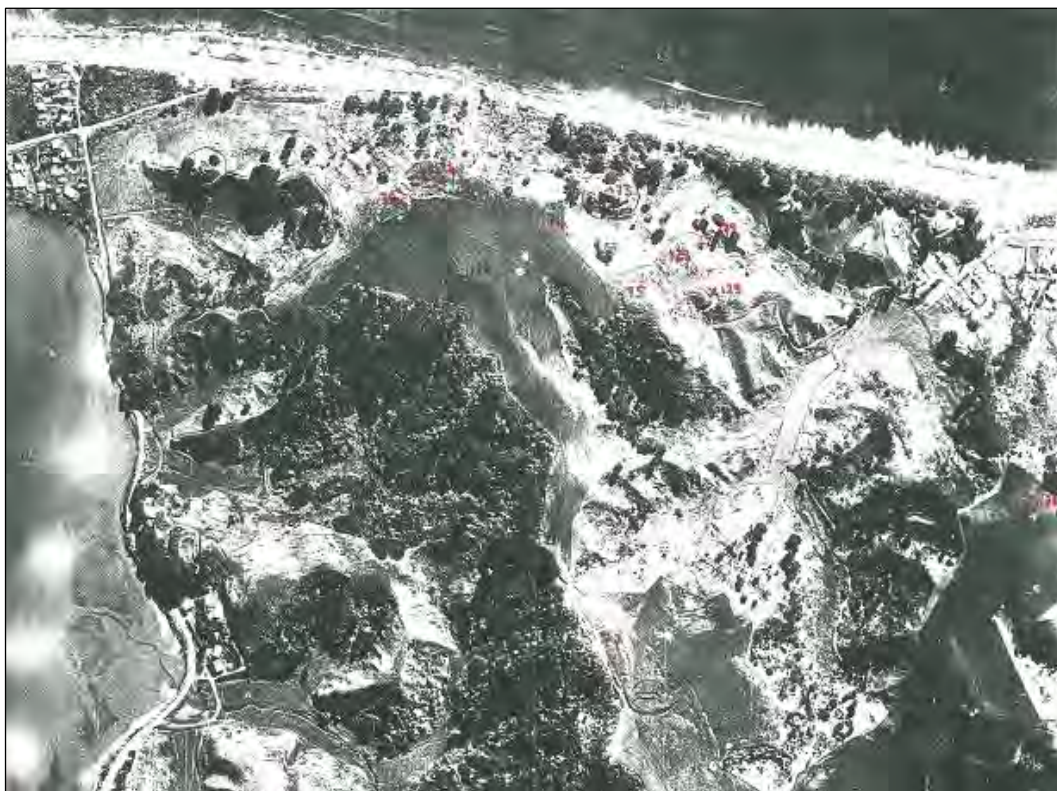
Figure 10 1962 aerial photograph of Onekawa showing archaeological site locations (hand written numbers (in red) refer to NZAA imperial site record numbers).

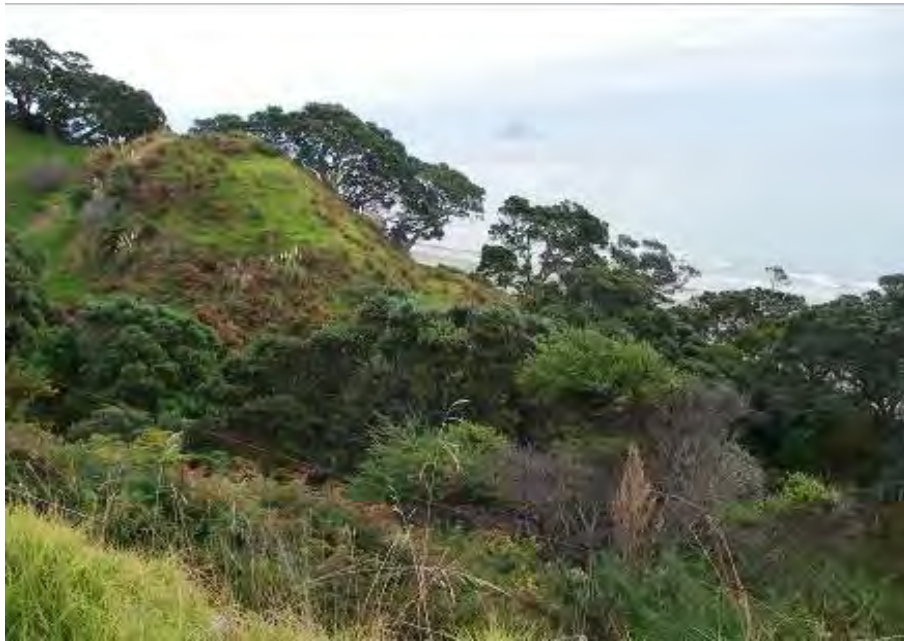
The pa was visited during the May 2010 survey and is in very similar condition to that noted in 2001 (Figure 11). There has been some further loss of terraces on the northern side as a result of land slippage in 2004. A QEII covenant fence runs through the ditch and bank and then along the northern side of most of the terraces and is now very close to the cliff in some places (Figure 12). This fence has resulted in substantial damage to the archaeological site.

Figure 11 W15/69 Pa, May 2010.

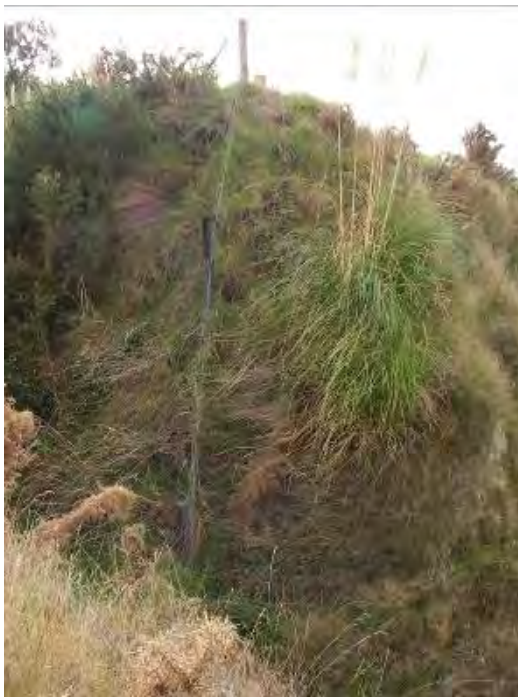
Figure 12 W15/69 QEII covenant fence through main ditch and bank. Weed issues also illustrated.

Consideration should be given to moving the QEII covenant fence so that it no longer cuts through archaeological features. This may involve adjusting the boundaries of the covenant and possibly incorporating the pa into the covenant area. This would have the benefit of preventing livestock from accessing the pa but may require intensive management of weed issues on the pa. An archaeological authority must be obtained from the Heritage New Zealand prior to any new fencing work in this area.

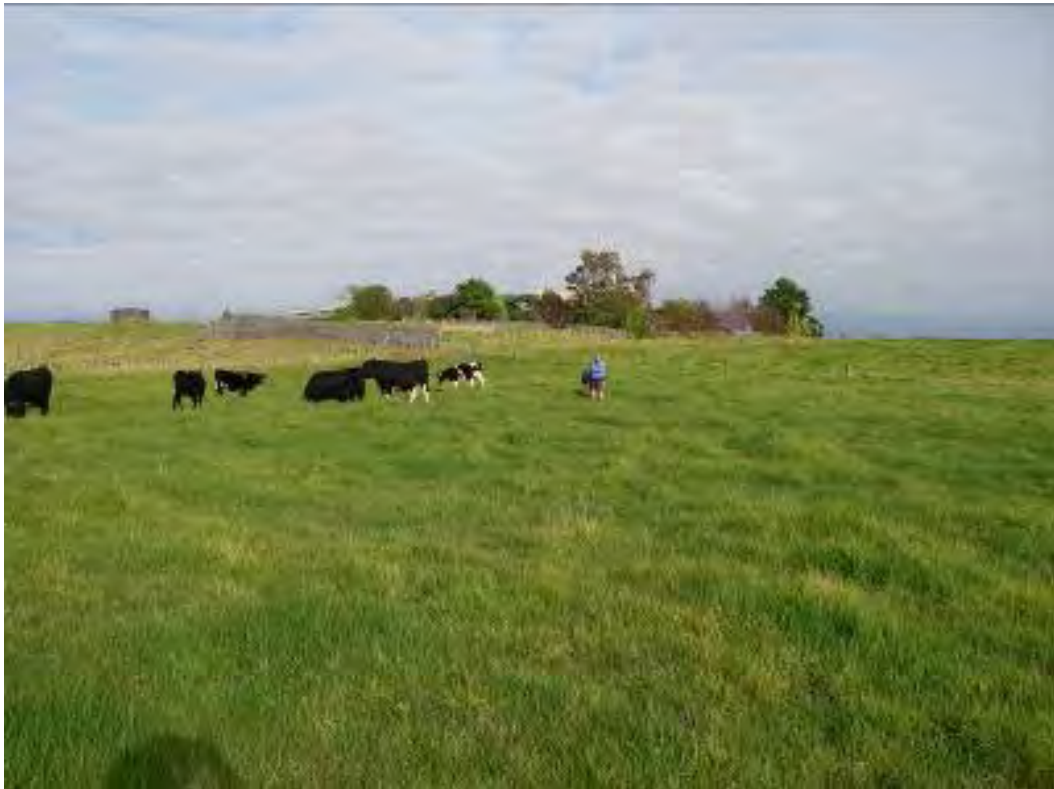
Figure 13 Cattle grazing on infill portion of Te Mawhai Pa W15/70.

The pa was visited during the May 2010 survey and is in very similar condition to that noted in 2001. At the time of the visit the site was being grazed by cattle and was covered by rank pasture dominated by kikuyu. The remnant portions of the site that were not affected by the infilling of the ditches in the early 1960s, are distinct and in reasonable condition (Figure 14). It is likely that the earthworks carried out in the 1960s primarily resulted in much of the site being buried. Although there would have been some significant loss to the banks and elevated portions of the site, it is highly likely that a substantial part of the site survives as buried archaeological deposits. This site is likely to contain human remains on the basis of the exposure of such remains in the 1960s.

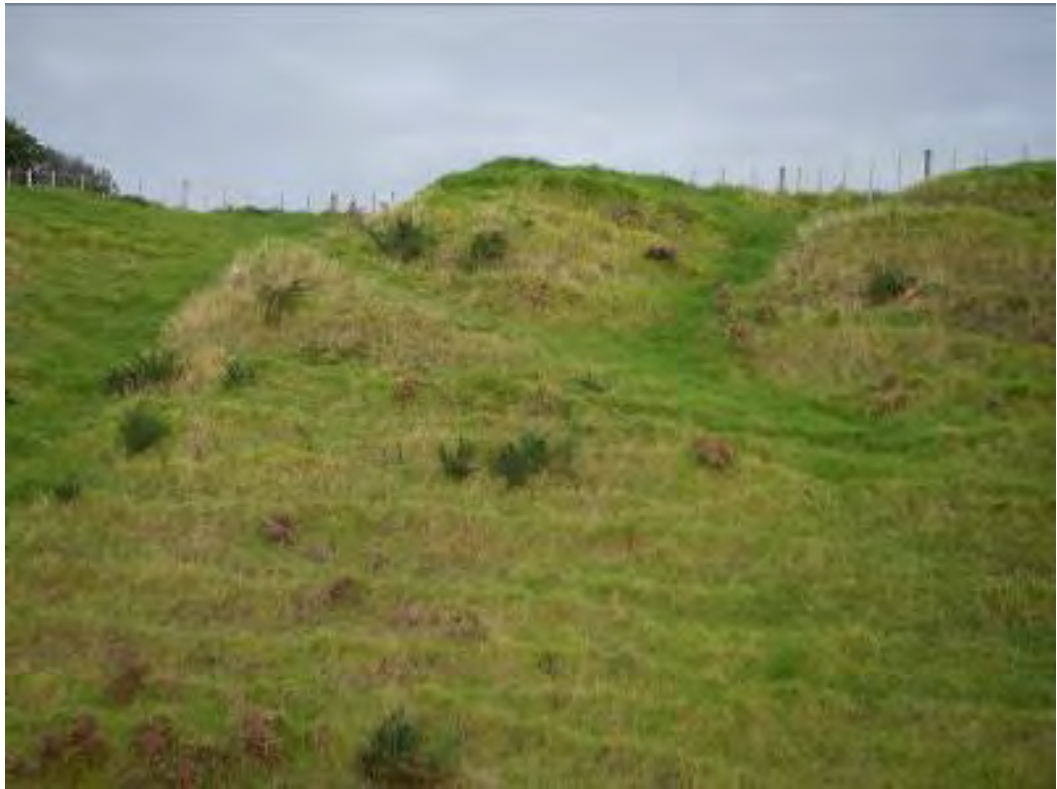
Figure 14 Intact ditch remnants Te Mawhai Pa W15/70, May 2010.

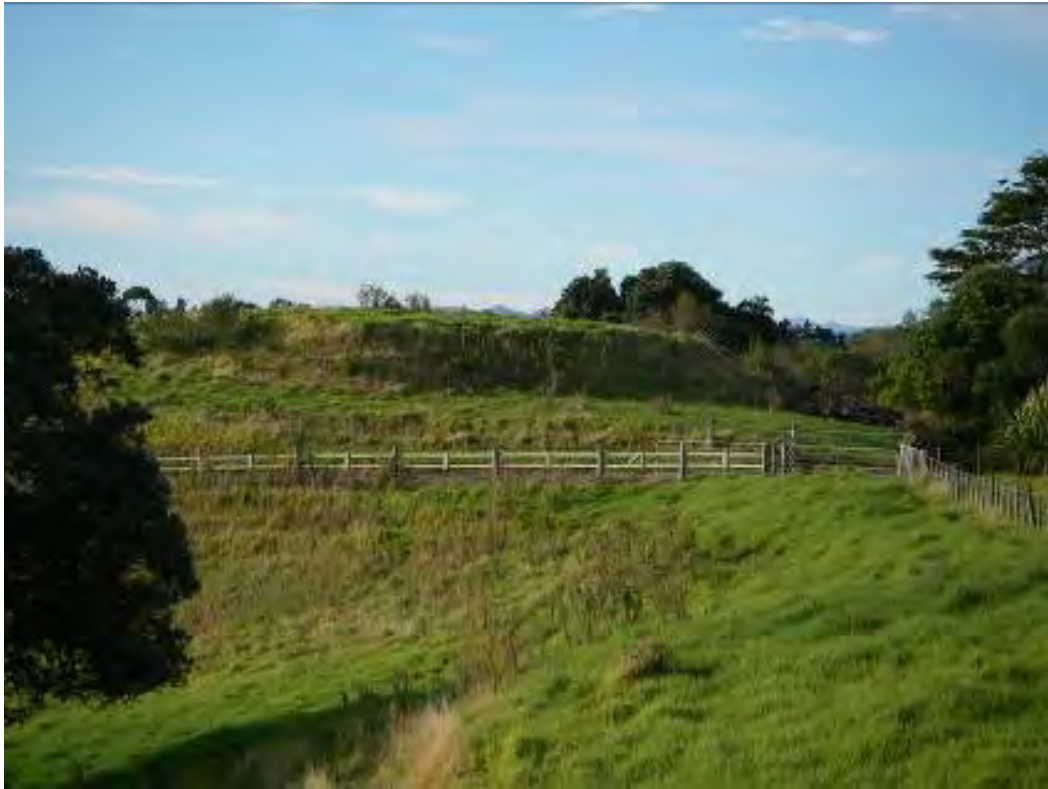
The pa was visited during the May 2010 survey and is in very similar condition to that noted in 2001 (Figure 15). The majority of the site is covered by rank kikuyu grass and appears to be in reasonably stable condition.

Figure 15 Pa W15/71 viewed from W15/70, May 2010.

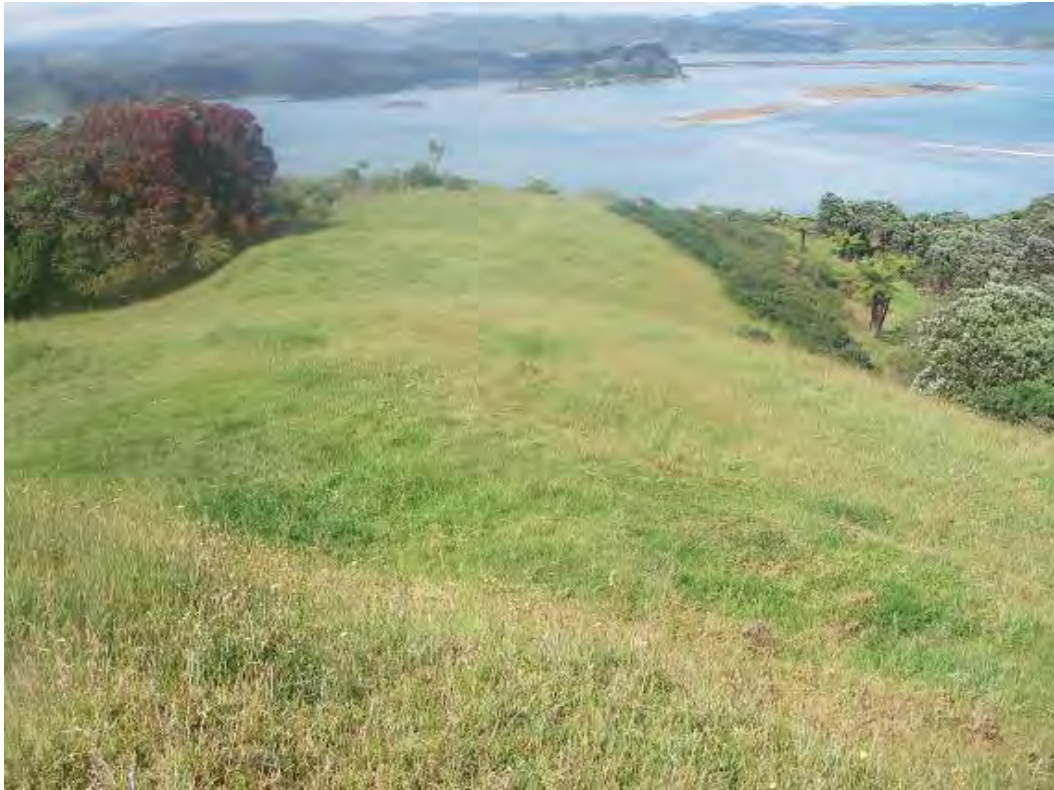
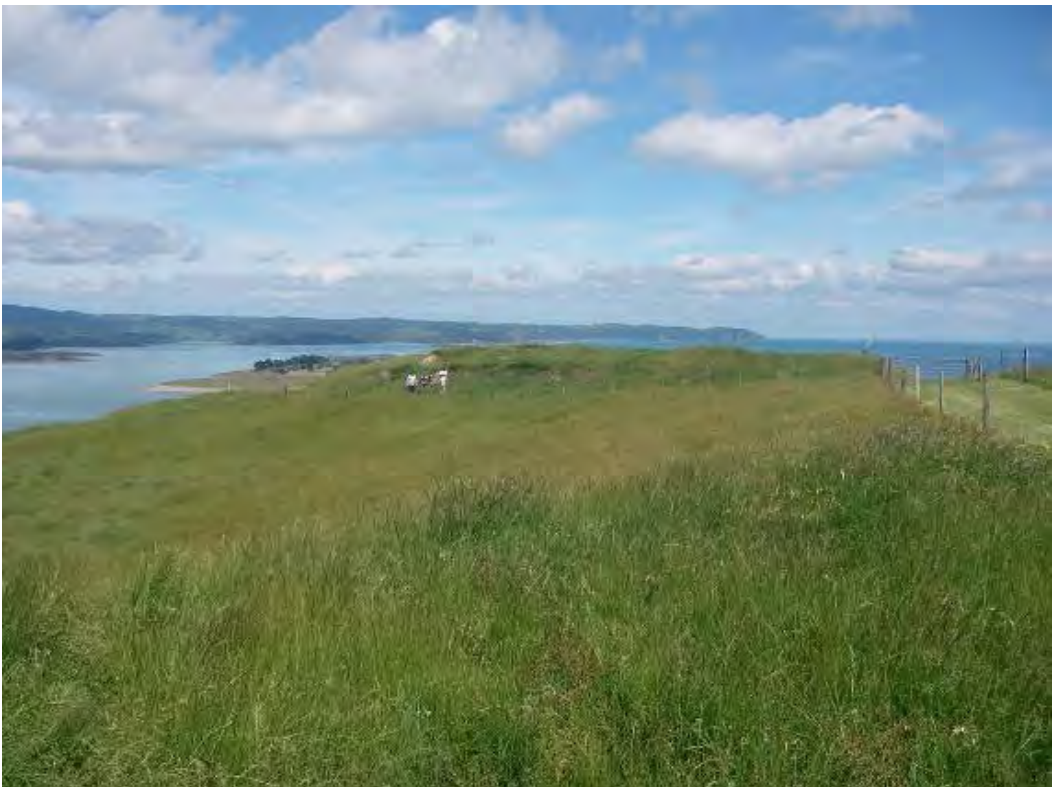
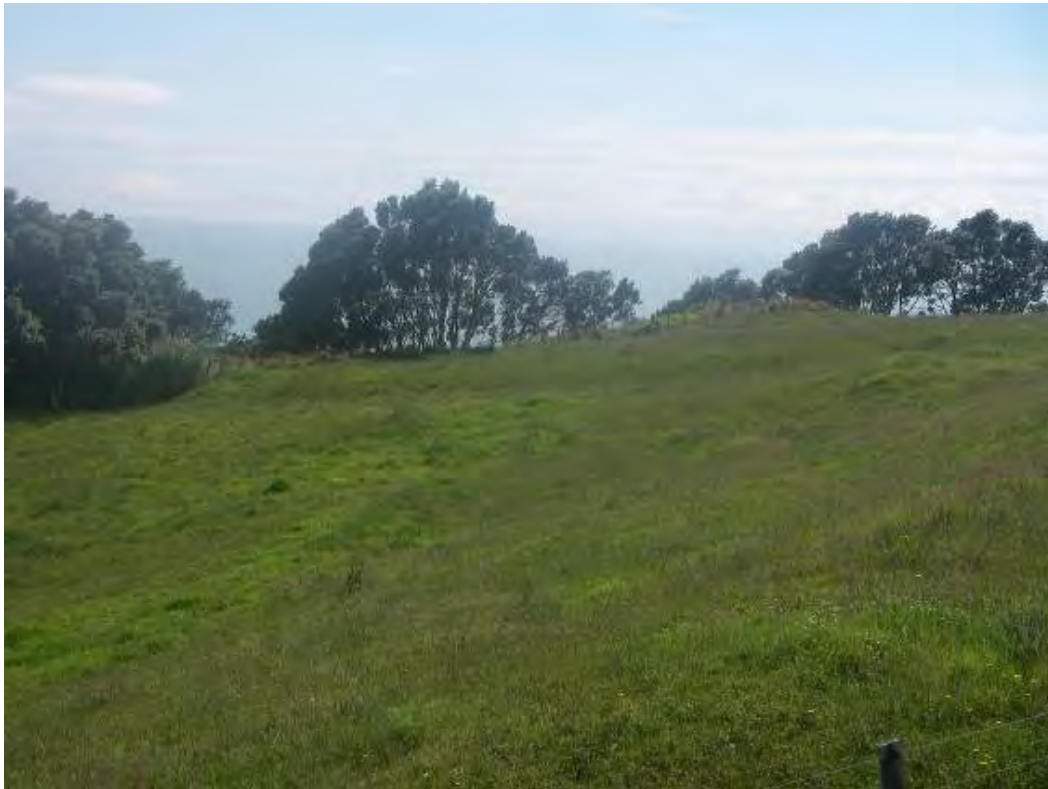
Figure 16 W15/72 Onekawa Pa, southern unit, December 2010.

Figure 17 W15/72 Onekawa Pa, central platform, December 2010.

Figure 18 W15/72 Onekawa Pa, northern unit, December 2010.

Onekawa Pa consists of two distinct ‘units’ and a central platform, and extends over the majority of the western portion of the park (Figures 16, 17 and 18). The subsurface extent of the site is likely to encompass adjoining visible features recorded as separate sites – such as W15/115, W15/117 and W15/908.

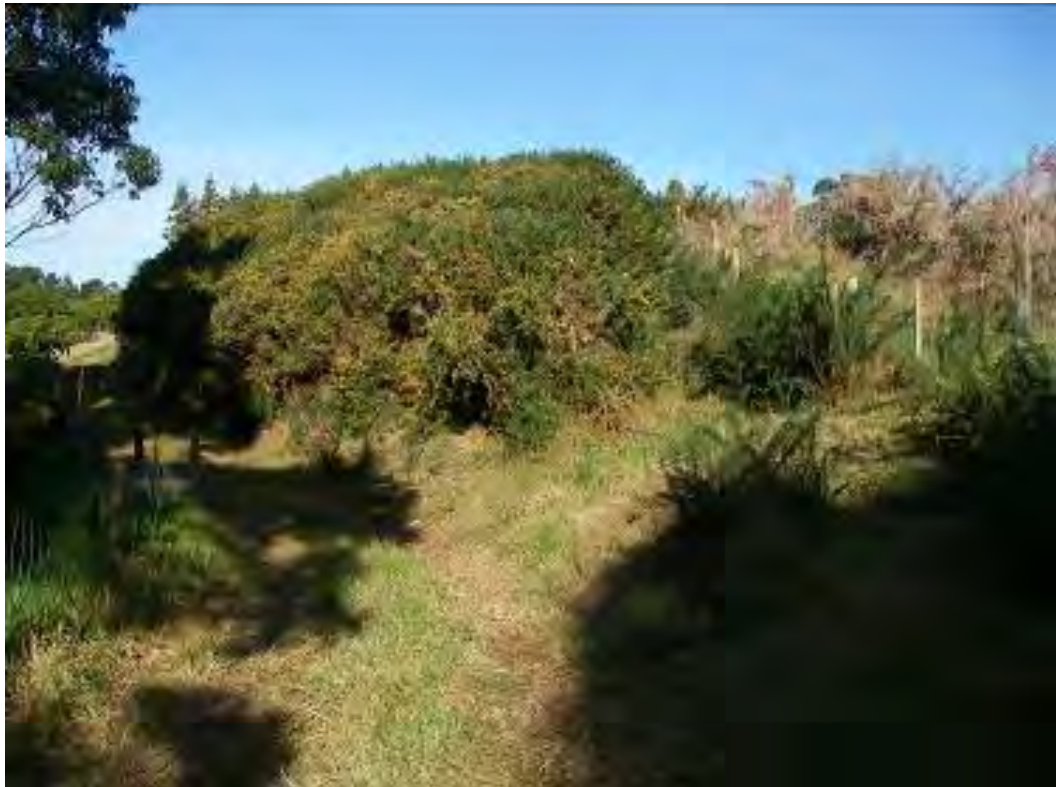
Figure 19 Pa W15/73 viewed from northern end, May 2010.

Recorded by Moore in 1969, updated records provided by Jones (1986), Tatton (1994 and 2001). The site is a ridge top pa consisting of three terraces with a transverse ditch at the southern and northern ends. A subsidiary terrace at the northern end contains surface evidence of rectangular pits. There is extensive evidence of eroding midden along the north-eastern scarp of the pa where a farm track has been formed immediately adjacent to the scarp.

The pa was visited during the May 2010 survey (Figures 19, 20). The site is located on a small triangular shaped portion of the park adjacent to the southern boundary. The pa extends beyond the park boundary onto the road reserve administered by Ōpōtiki District Council to the west.

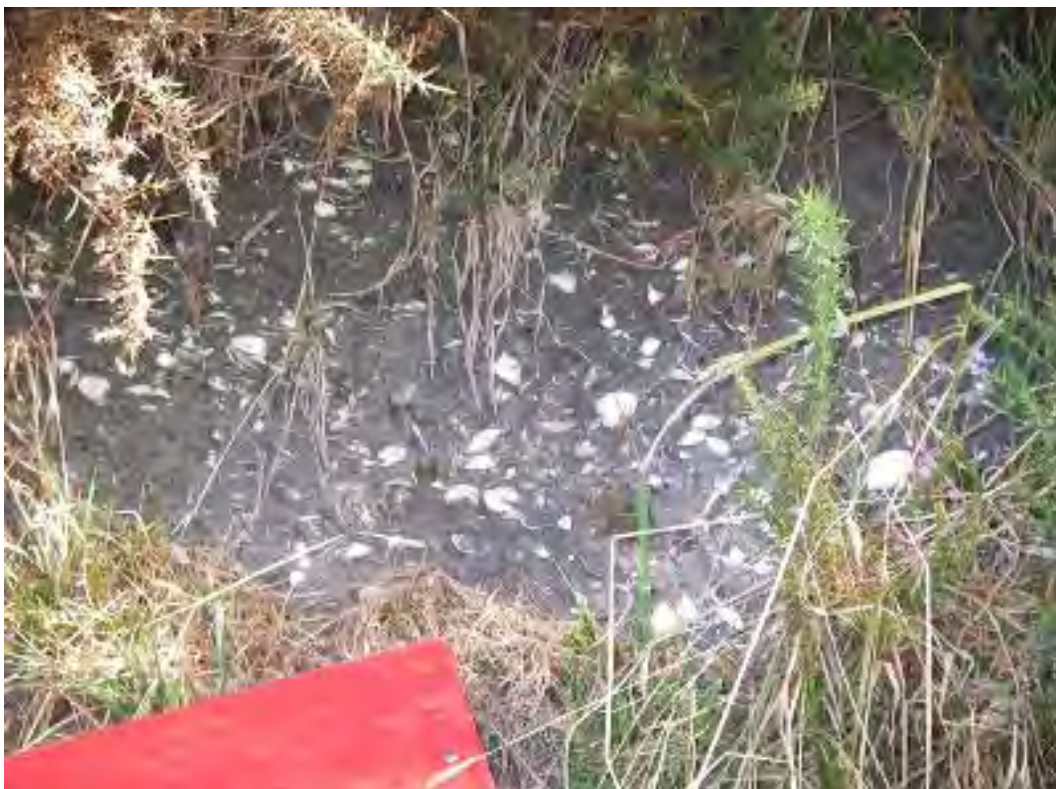
Figure 20 Pa W15/73 midden eroding from north-eastern scarp, May 2010.

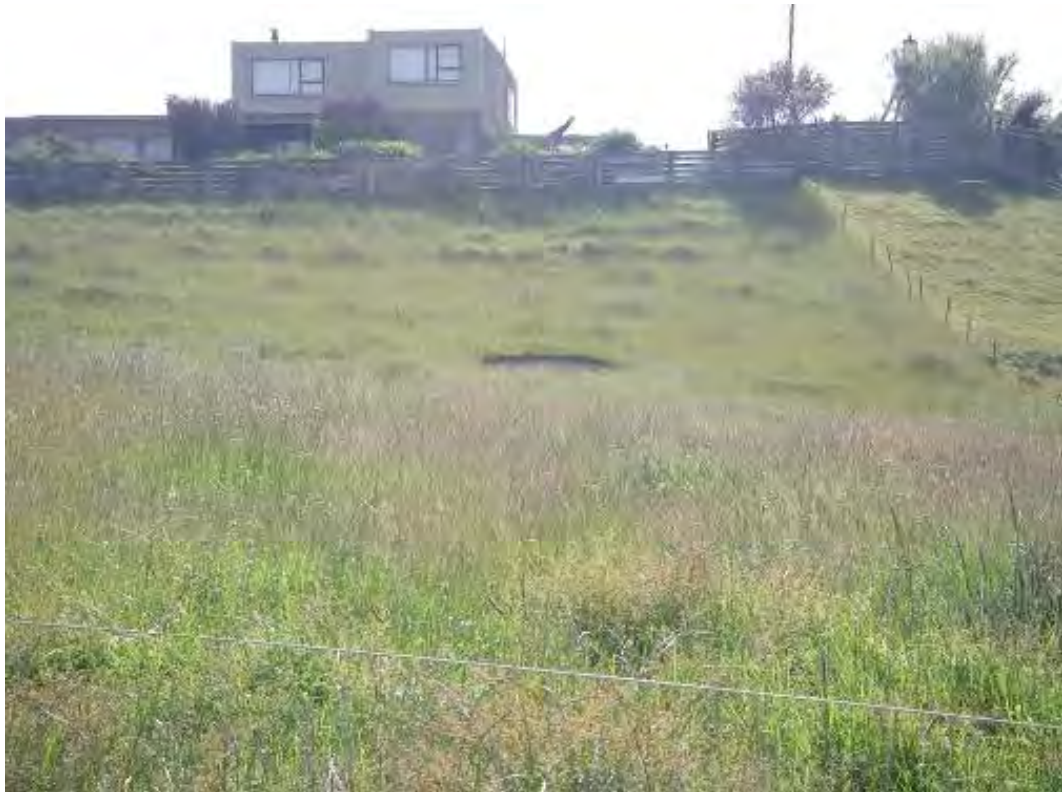
This midden is subject to on-going cattle trampling and the pasture sward is broken and discontinuous in this area. The visible midden consists of primarily of cockle and pipi. Fire-cracked rocks are prevalent, but no other artefact material was visible during the December 2010 visit.

Figure 21 W15/115 located at trig beacon visible to right of house and eroding down slope at right of photograph.

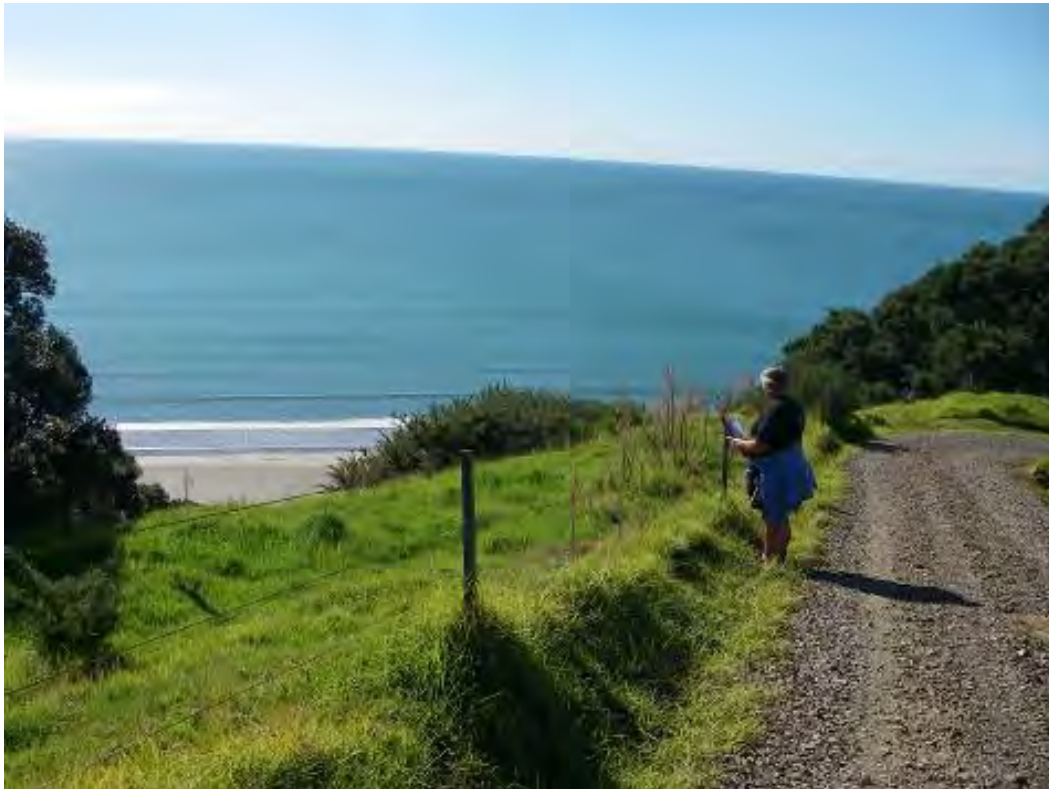
This site was visited during the May 2010 survey. It consists of remnants of the previously recorded features distributed on either side of the main vehicle access track. There is a single intact terrace on the north-western side of the track, and midden is visible in the track cutting. A portion of the terraces are still intact on the eastern side of the track adjacent to W15/71 (Figure 22). The site extends across the vehicle access track to the north and includes a small flat area where a picnic table is located. The site is also visible as a cultural soil and midden layer on the western side of the access track just before the bend where the picnic table is located. Most of the remaining portions of the site are covered by gorse.

Figure 22 W15/116, an intact terrace on the north-western side of main access track.

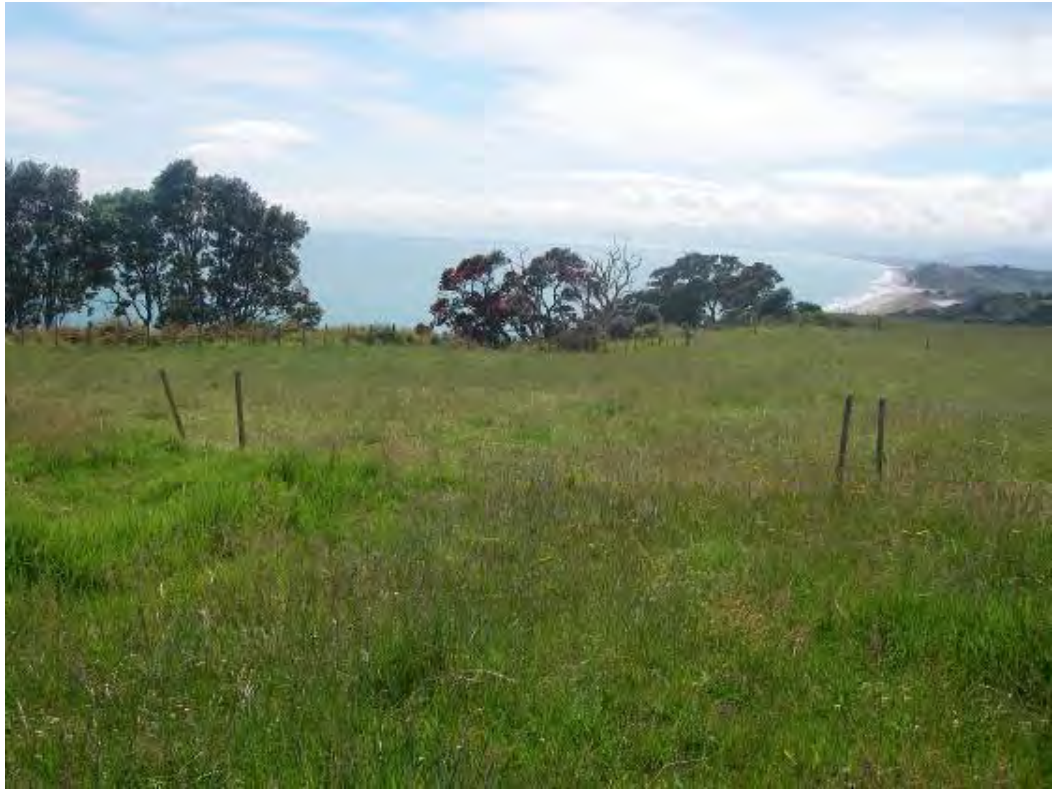
The site was visited during the December 2010 survey. At the time of the visit the area was covered by long pasture, however, the ditches and banks are discernible due to slight undulations in the ground surface and differential grass growth. The features appear to be as described when they were last visited in 1994, although a rubbish pit that had been dug in the centre of the pa is no longer visible. The site has a good robust grass sward cover. There is a fence-line running through the western side of the site (Figure 23).

Figure 23 Pa W15/117.

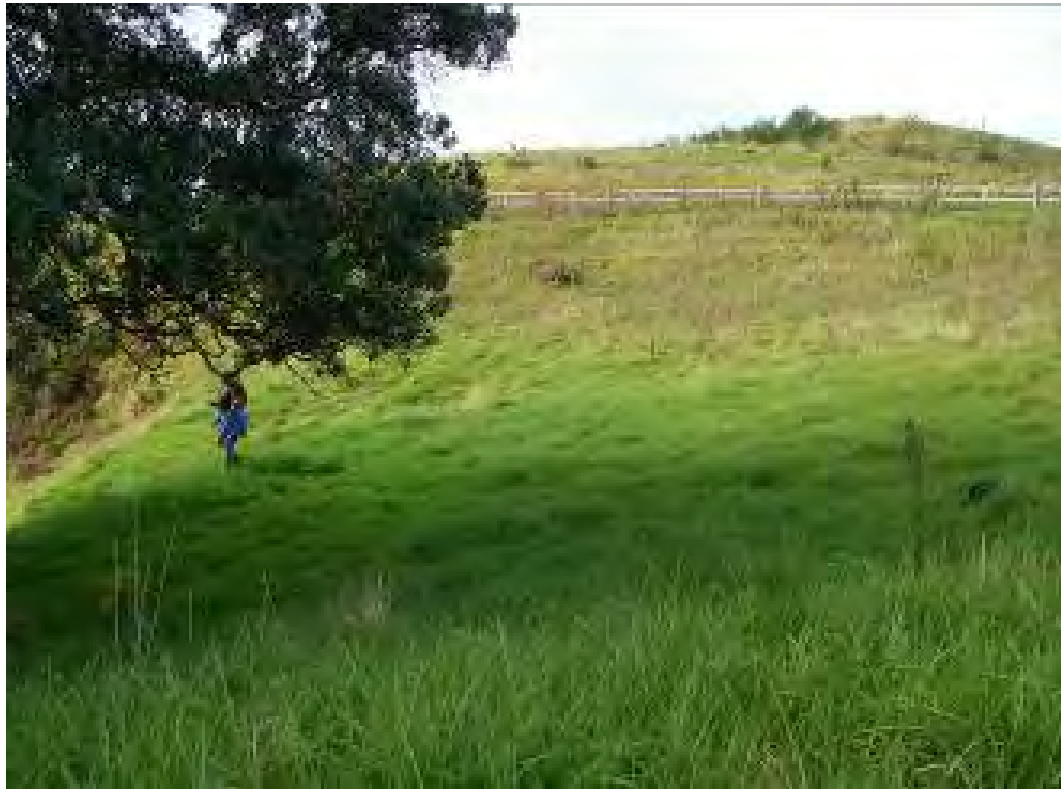
The terraces are covered by a robust kikuyu grass sward and are in good condition (Figure 24). The midden is subject to on-going erosion and loss due to stock trampling and soil creep.

Figure 24 W15/1067, terraces and midden in north facing 'basin' between W15/70 and W15/71, May 2010.

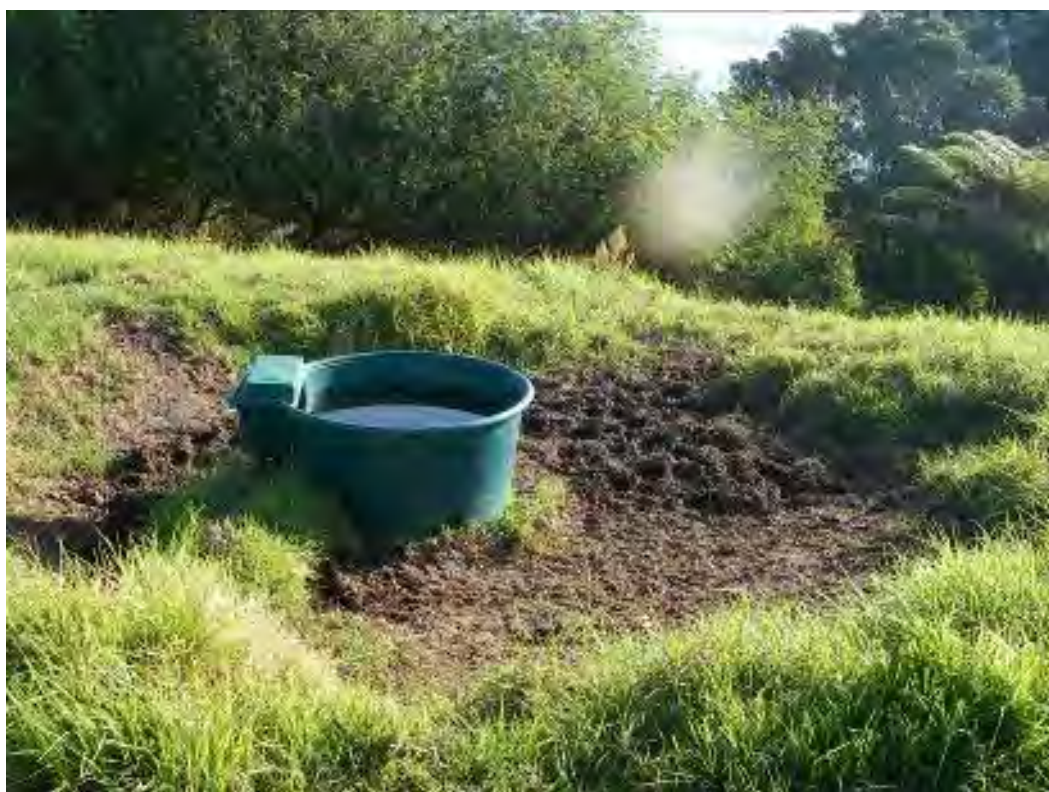
Grazing, and trampling on the hill sidings and around gateways and water troughs (Figure 25), can cause significant damage to the archaeological sites. The loss of vegetation cover, trampling and compaction of the fragile ground surfaces on the steep hill sides in the park will accelerate the rate of natural erosion caused by geological processes and water run-off.

Figure 25 Example of stock trampling around a water trough near W15/73.

Management of the grazing and associated fencing is a key requirement to stabilise archaeological sites and reduce the rate of deterioration of archaeological features. A degree of ground damage due to stock trampling and tracking is always going to occur as a consequence of using grazing animals to maintain a pasture sward. This risk should be managed to restrict damage to areas where archaeological sites are not affected.

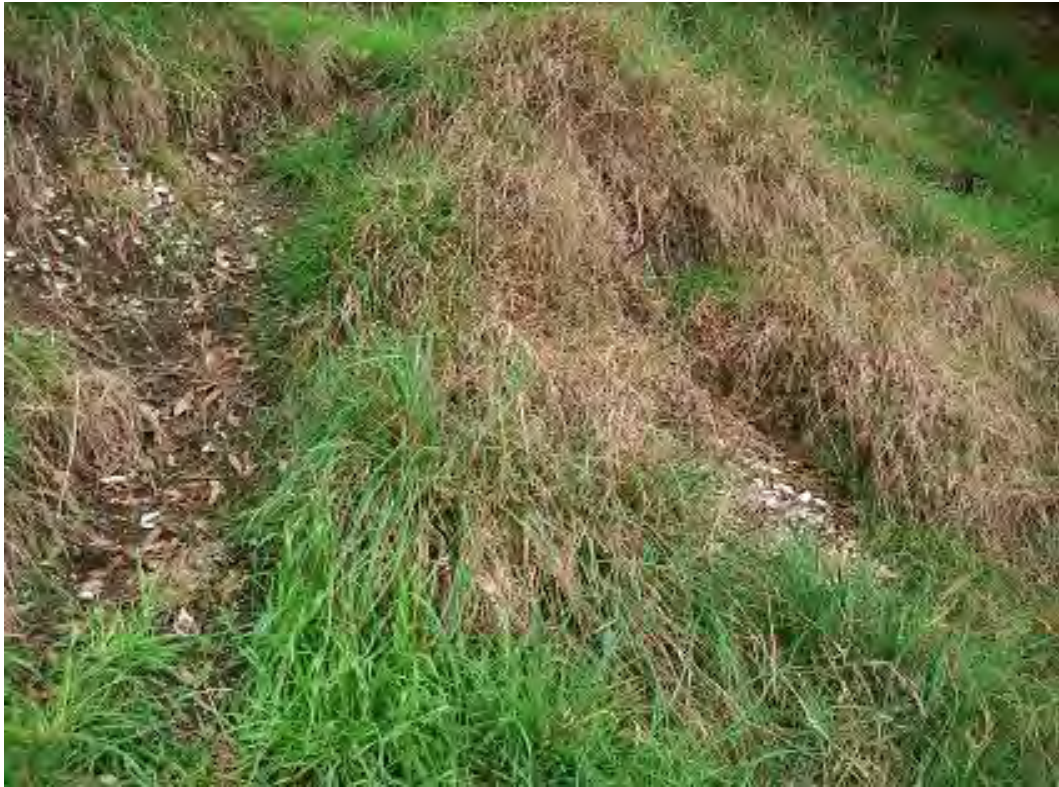
The southern side of the pa was damaged by the construction of a farm track in the 1960s and this has created an erosion face from which substantial quantities of shell midden continue to spill out into the north-easterly facing gully below. This erosion has been accelerated by cattle tracking and trampling over the years. Most of the site is covered by gorse, kikuyu grass and there are a few large pohutukawa growing on the terrace scarps.

Figure 26 Midden eroding on the southern side of W15/69.

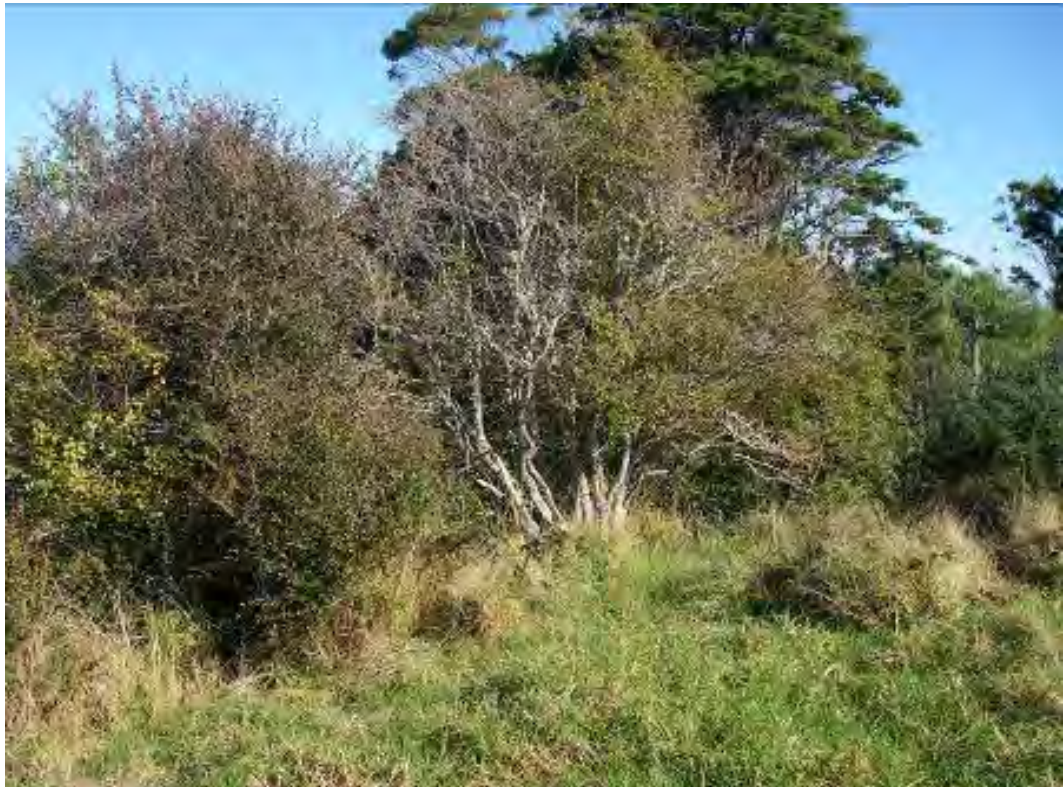
Figure 27 Trees on the southern scarp of W15/71 that should be removed.

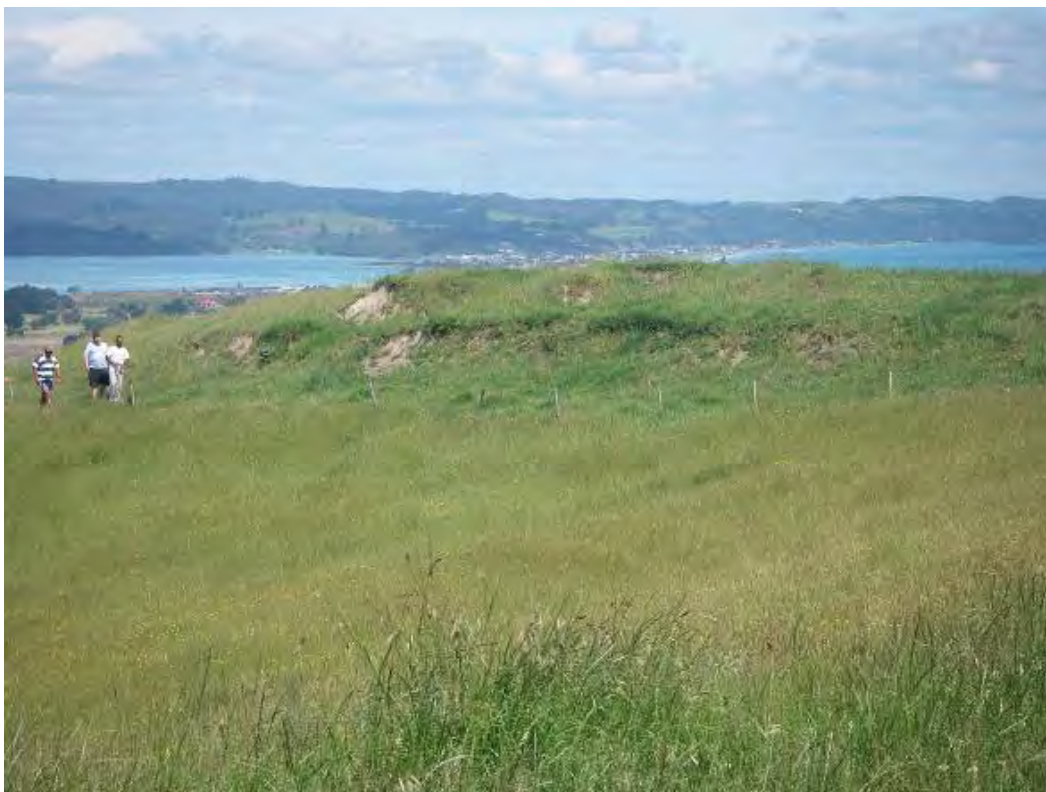
The pa was visited in December 2010. It is generally in reasonable condition with a well-developed pasture sward over most of the site. Erosion damage is continuing on the south eastern scarps, where a farm track was formed in the past on a south-eastern terrace. The erosion is being exacerbated by cattle trampling. The archaeological material noted during the 2001 visit was not visible in 2010. Midden is however eroding from the western side of the site wherever the grass sward has been broken by cattle tracking.

Figure 28 Erosion on south-eastern scarps of Onekawa Pa W15/72.
