Draft Onekawa Te Mawhai Regional Park Operational Management Plan

September 2014

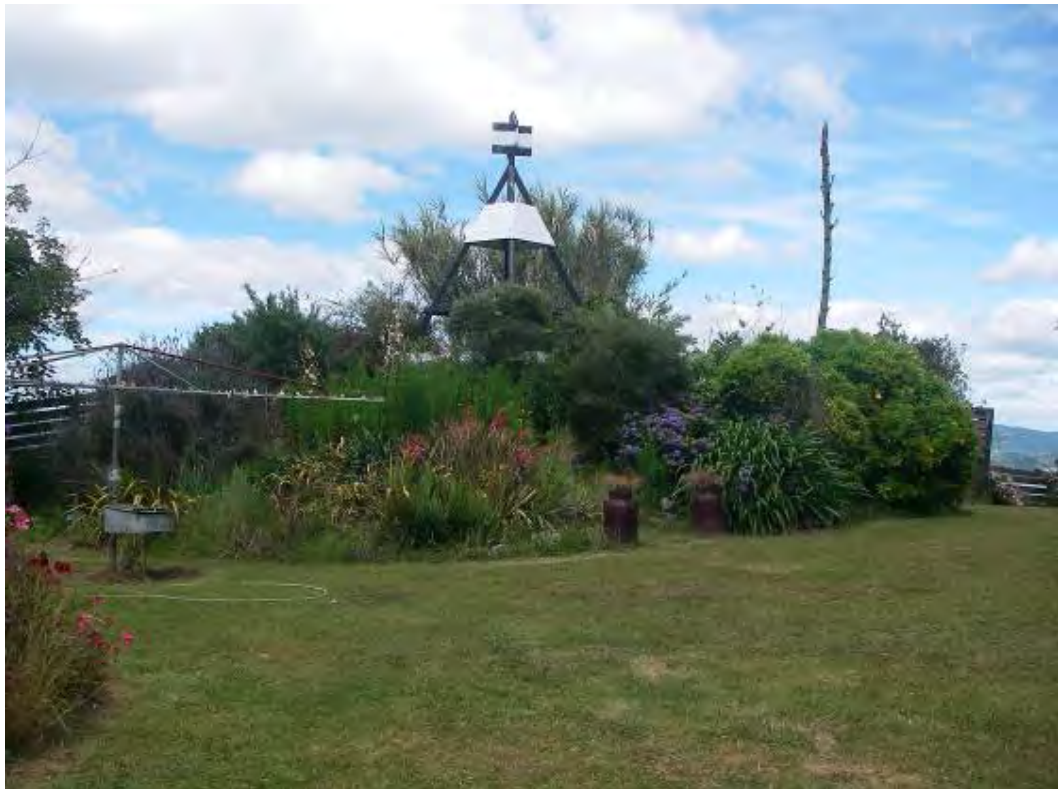
Figure 29 Onekawa trig beacon and location of W15/115 within curtilage of Tuck house.

In approximately 1980 the Tuck house was constructed on a large flat area that had previously been recorded as part of Onekawa Pa (Figure 29). At the time of construction of the house, a midden was noted as being disturbed by earthmoving carried out to form the house platform. This midden is continuing to erode down the slope to the south of the Tuck house and is also visible in gardens on the southern side of the house (Figure 30).

The erosion of the midden is being exacerbated by cattle trampling in areas of poor grass sward development on the south facing slope. Careful management of the grazing in this area is required in order to encourage thickening of the sward and a reduction in the erosion damage. The area should also be monitored as it is highly likely that archaeological material is being periodically exposed and is probably eroding down the slope.

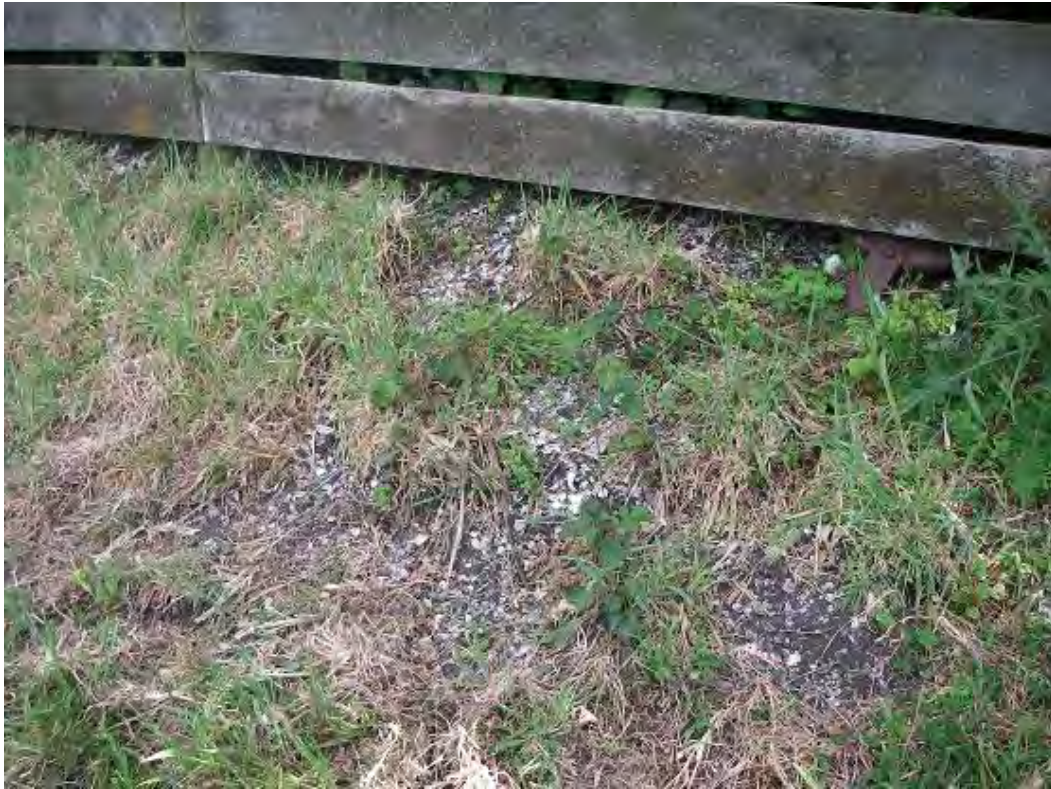
Figure 30 Midden from W15/115 eroding below garden fence at south side of Tuck house.

If the Tuck house were to be removed at some point in the future, or there is any significant alteration to the curtilage and garden area, it is likely that intact archaeological deposits will be exposed. An archaeological authority from Heritage New Zealand will be required prior to any such work.
