Consent Holder Annual Report

Okere Gates and Ohau Weir - 1 June 2015

Consent Holder Annual Report on Okere Gates (Consent 65979) and Ohau Weir (Consent 65980) – 1 June 2015

Operations Publication 2015/04
ISSN: 1176-5550 (Print)
ISSN: 1179-9587 (Online)

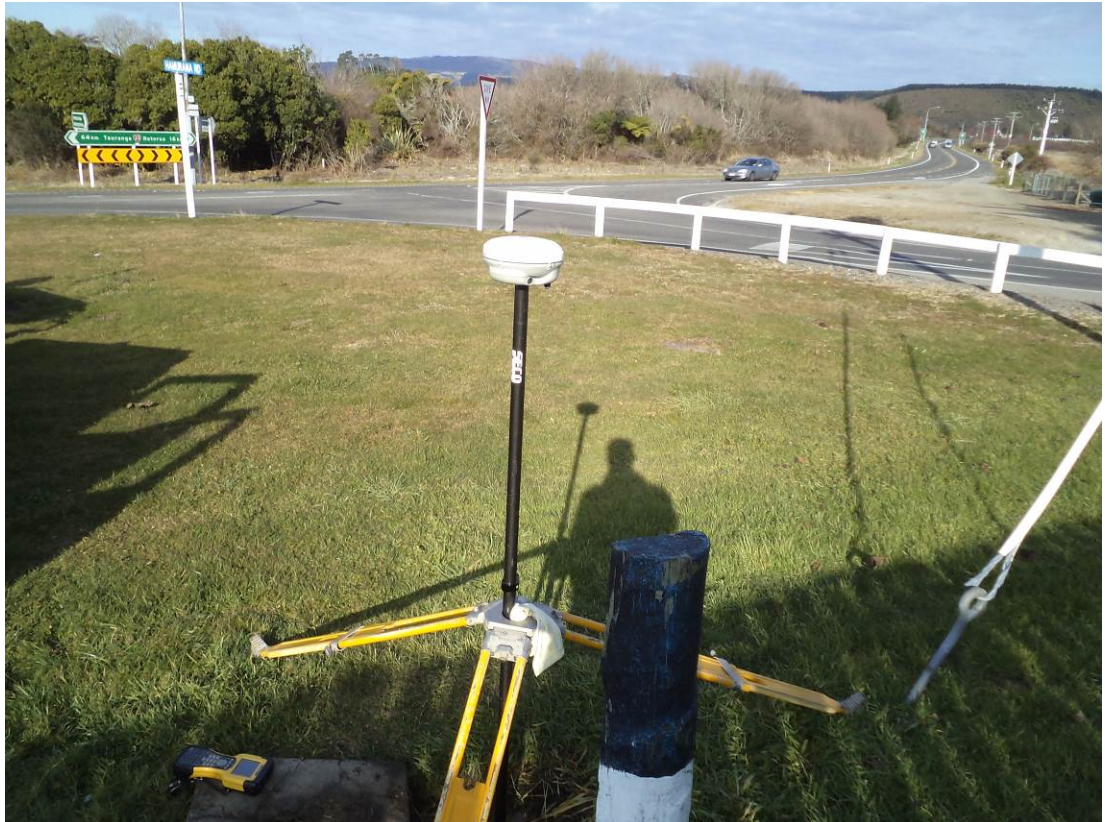
Figure 1 GPS equipment used to establish a Survey Control Network around Rotorua lakes - BM AQ69 at State Highway 33/Hamurana Road turnoff.

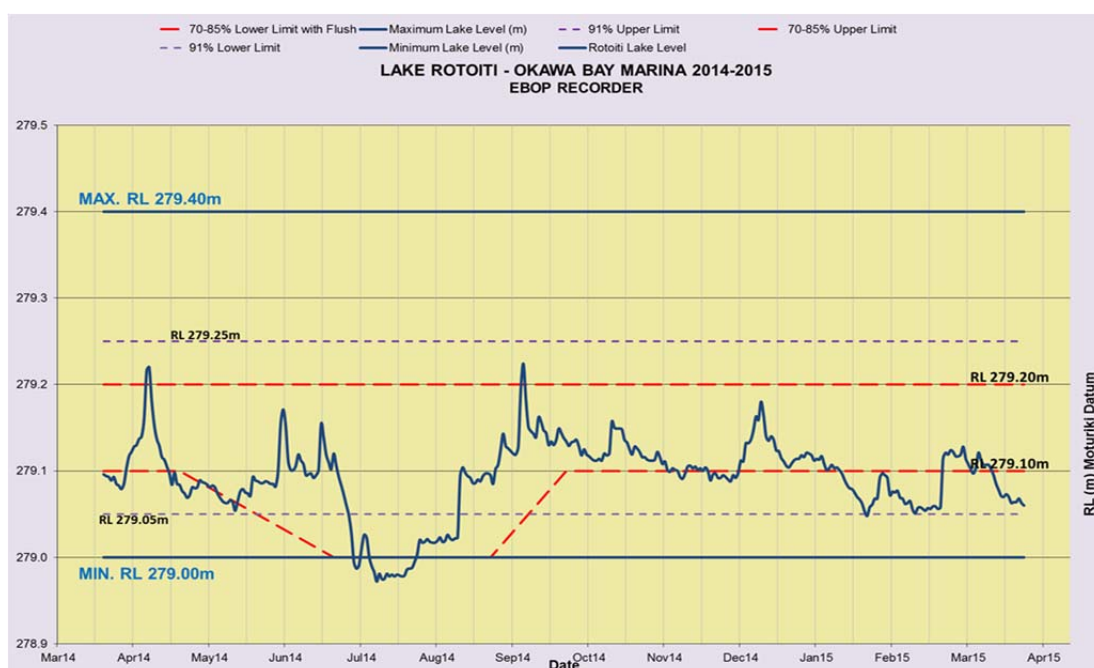
Figure 5 Lake Rotoiti levels measured at Okawa Bay Marina from 1 April 2014 to 31 March 2015.

Figure 5 below shows the 12 month trace of levels for Lake Rotoiti from 1 April 2014 to 31 March 2015.

- Significant rain (70 mm) on 19 August 2014 resulted in a rapid recovery of lake levels to back inside the main operating range of RL 279.10 m to 279.20 m.
- Lake levels fell below the 'main operating range' of RL 279.10 m for 55 days from January 2014 to March 2015 as dry conditions persisted across the North Island.

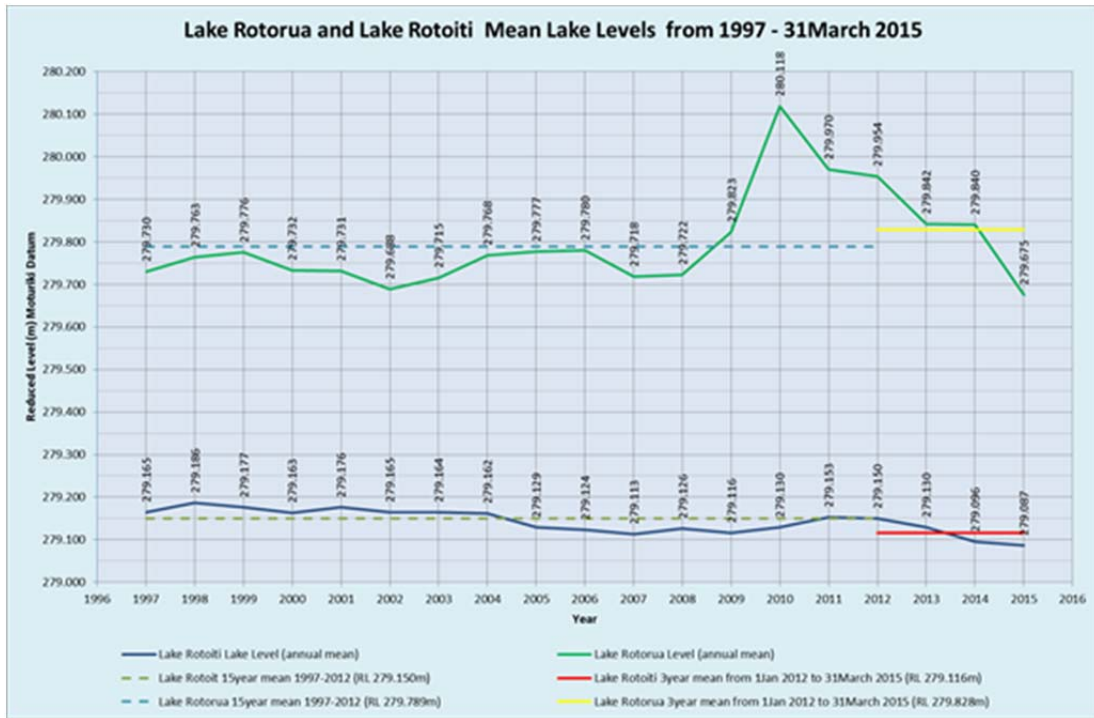
Figure 6 Graphical summary of Lake Rotorua and Lake Rotoiti mean lake levels from 1997 to 31 March 2015.

Figure 6 below summarizes mean lake levels on Lake Rotorua and Lake Rotoiti from 1 January 1997 to 31 March 2015. It can be shown that Lake Rotoiti levels are on average lower under the new consent (red Line) than under the old consent (green dash line) while Lake Rotorua levels are marginally higher (yellow line).

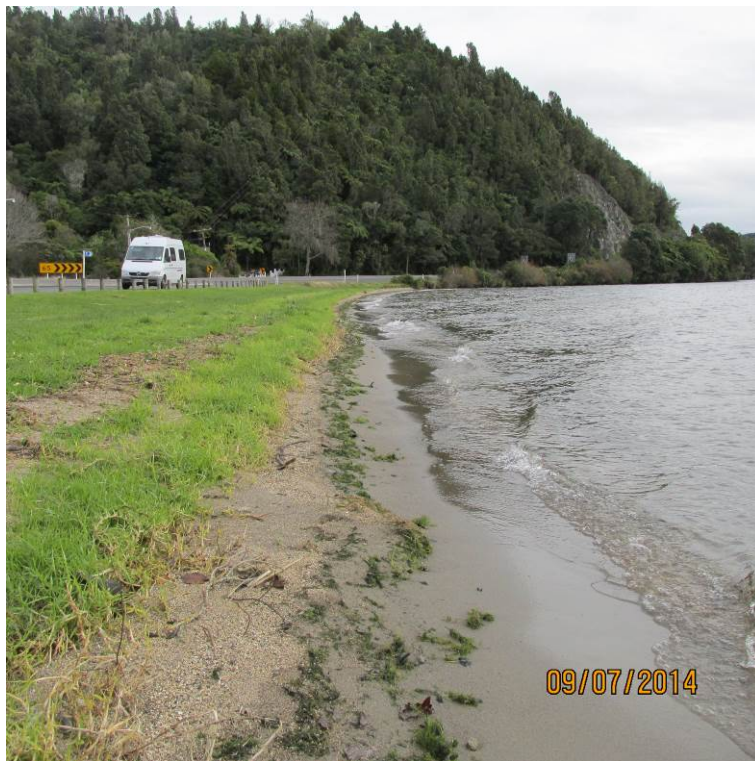
Figures 7 and 8 below show beach profiles at Te Rauto Bay and Hinehopu during the bottom of the drawdown phase in July 2014.

Figure 7 Te Rauto Bay during annual drawdown – Lake level RL 278.994 m on 9 July 2014.

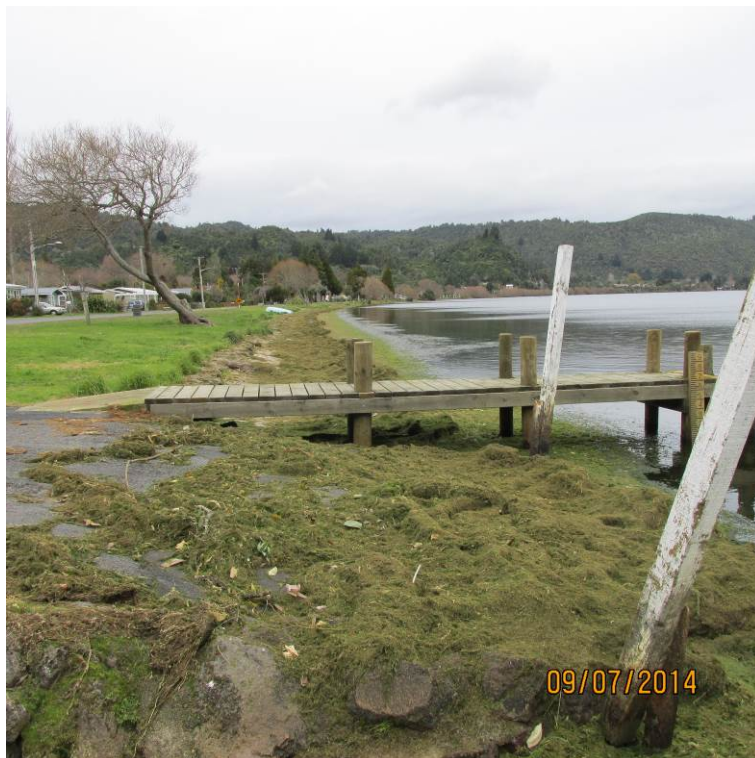
Figure 8 Hinehopu during annual drawdown – Lake level RL 278.994 m on 9 July 2014.

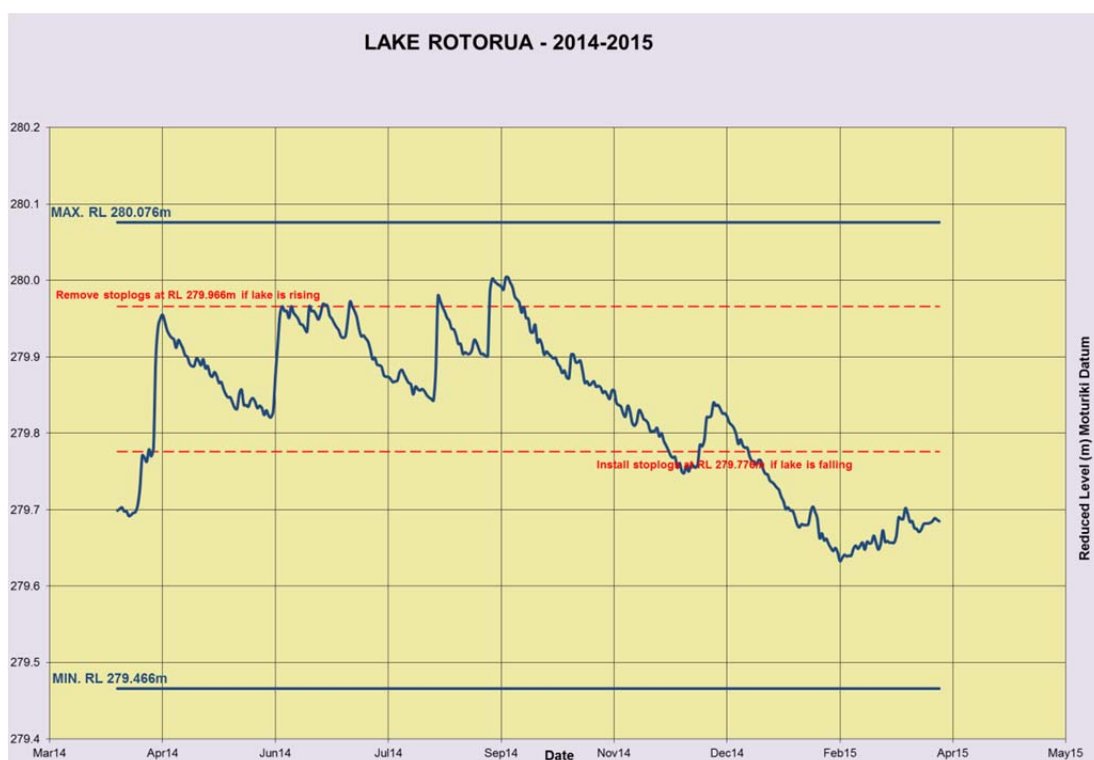
Figure 9 Lake Rotorua levels measured at Town Wharf from 1 April 2014 to 31 March 2015.

- The Ohau Weir stoplogs remained in place for the entire 12 month period indicating again that Lake Rotorua levels were below average compared to four installations/removals in 2013, two in 2012, six in 2011 and two in 2010.
- The highest level recorded this term was RL 280.004 m on the 20 September 2014 or 0.072 m below the consented maximum of RL 280.076 m.
- The lowest level recorded this term was RL 279.633 m on the 15 January 2015 or 0.167 m above the consented minimum of RL 279.466 m.

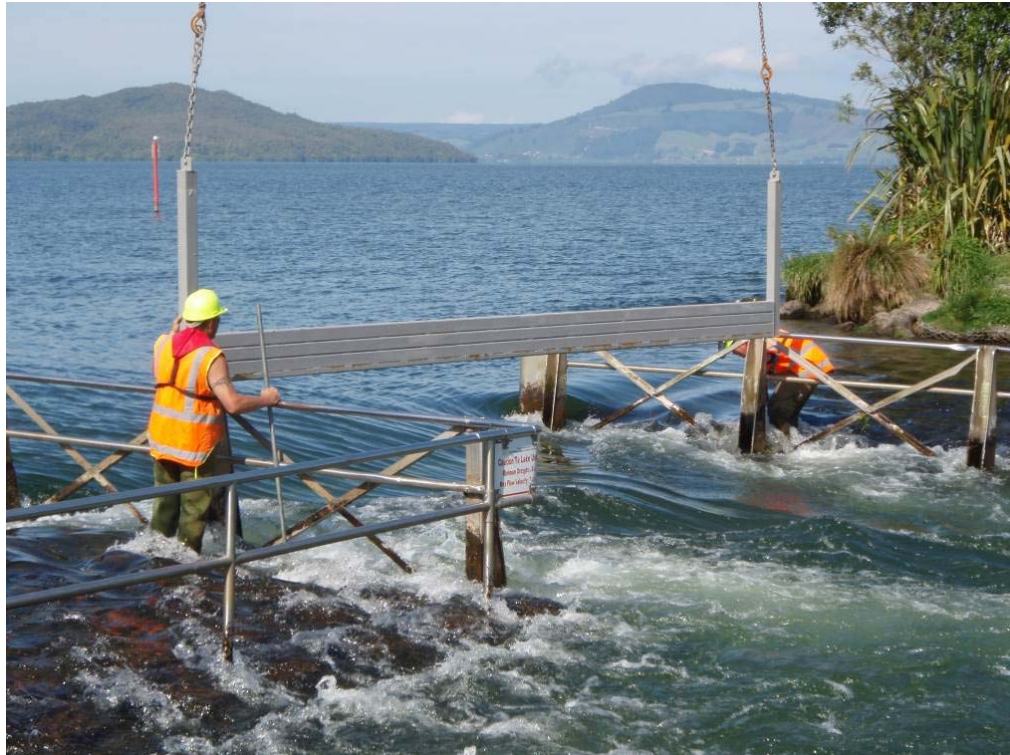
It is noted that the Ōhau Channel Weir provides minimal flood relief once maximum lake levels occur as the weir becomes drowned. The stoplogs perform best during low lake levels to decrease outflows and maintain lake levels. Ōhau Channel Weir at Lake Rotorua Outlet.

Figure 10 Removing Ōhau Weir stoplogs - 29 October 2010.

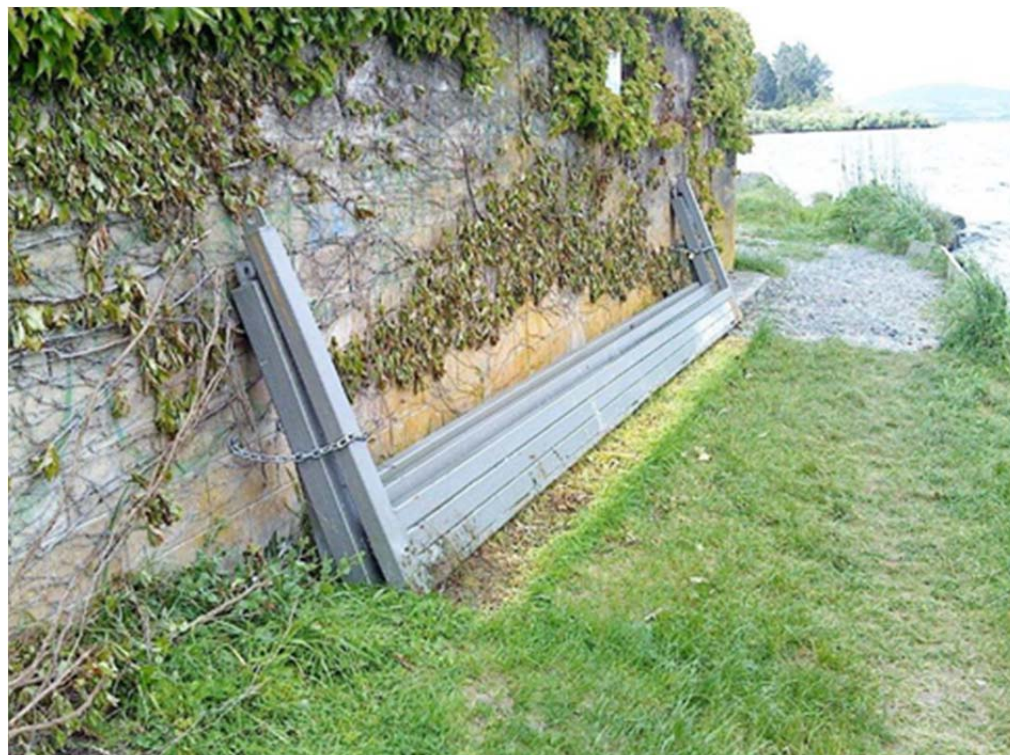
Figure 11 Ohau Channel stoplogs stored on site following refurbishment.

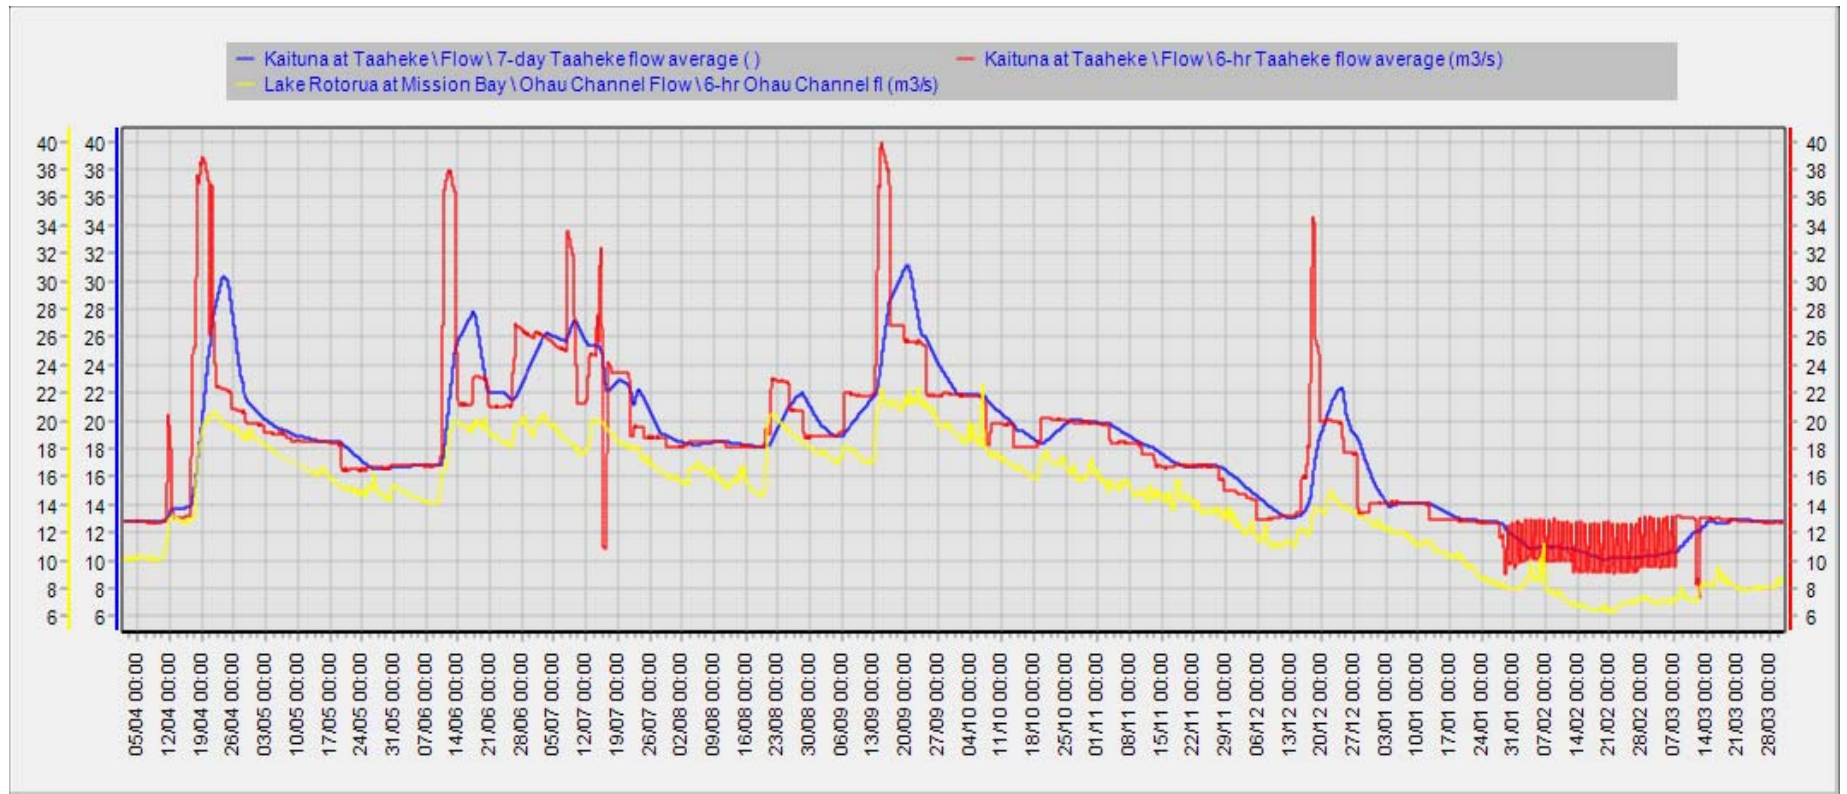
Figure 13 HydroTel summary of Ōhau Channel and Kaituna River flow rates – six-hourly and seven-day averages.

For a more comprehensive analysis to assess the six-hourly and seven-day flow averages, refer to Figure 13 below. These results have been summarized in Table 2.

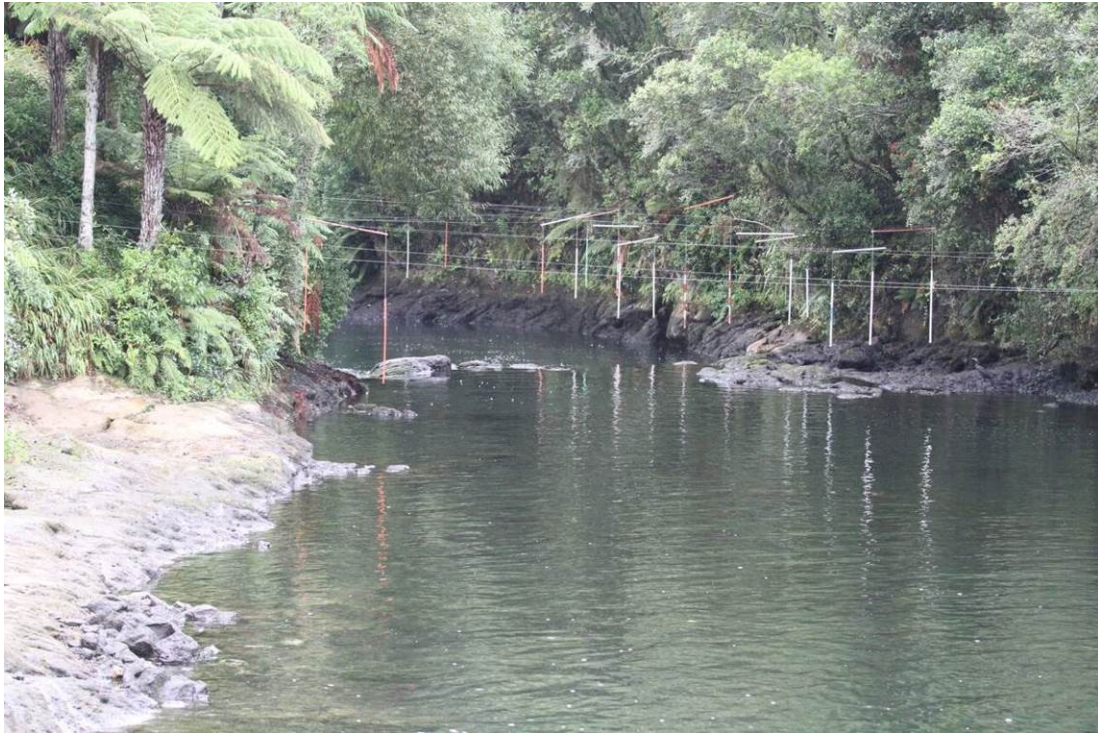
Okere Gates outflows were greater than Ōhau Channel inflows for 100% of the time except for a few hours each day (11-12 March 2015) while the Kaituna River was lowered during the police search and rescue operation. This allowance is covered in Condition 7.4.(g) stating:

Figure 14 Kaituna River 'low flows' below the Okere Gates – 12 March 2015.

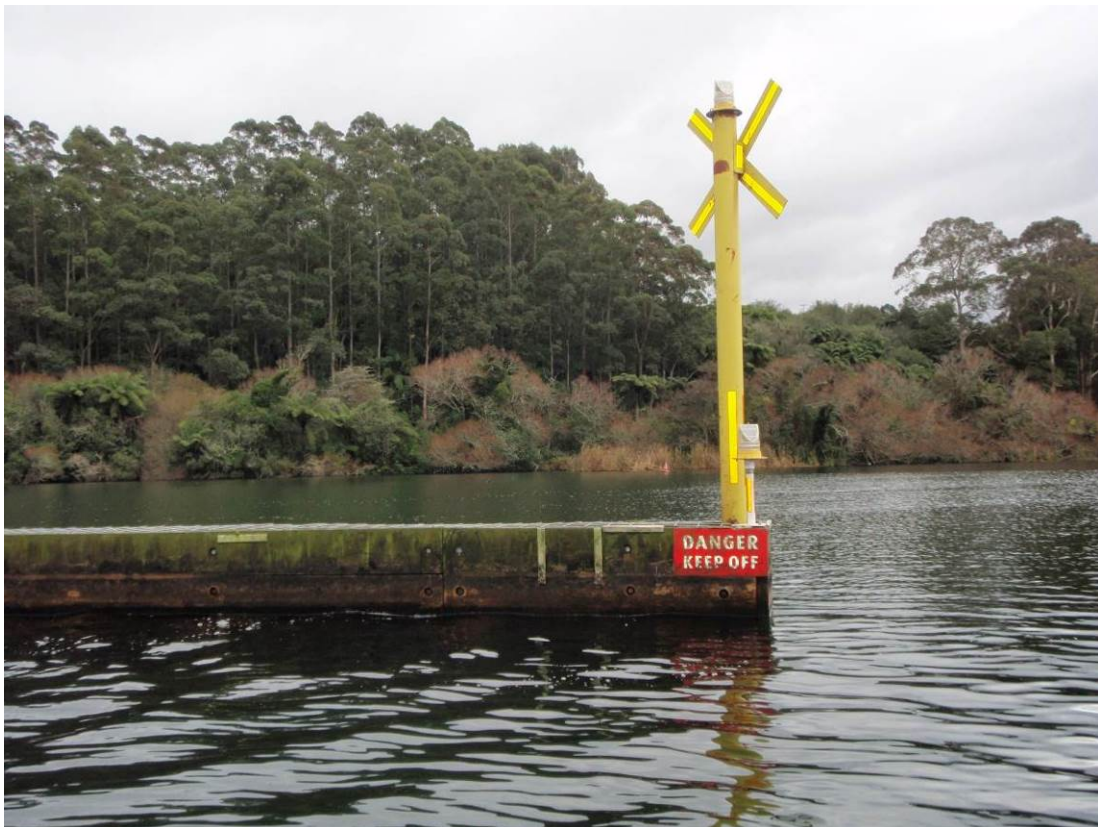
Figure 15 Ohau Diversion Wall directing Ōhau Channel flows to Okere Gates – 21 May 2014.

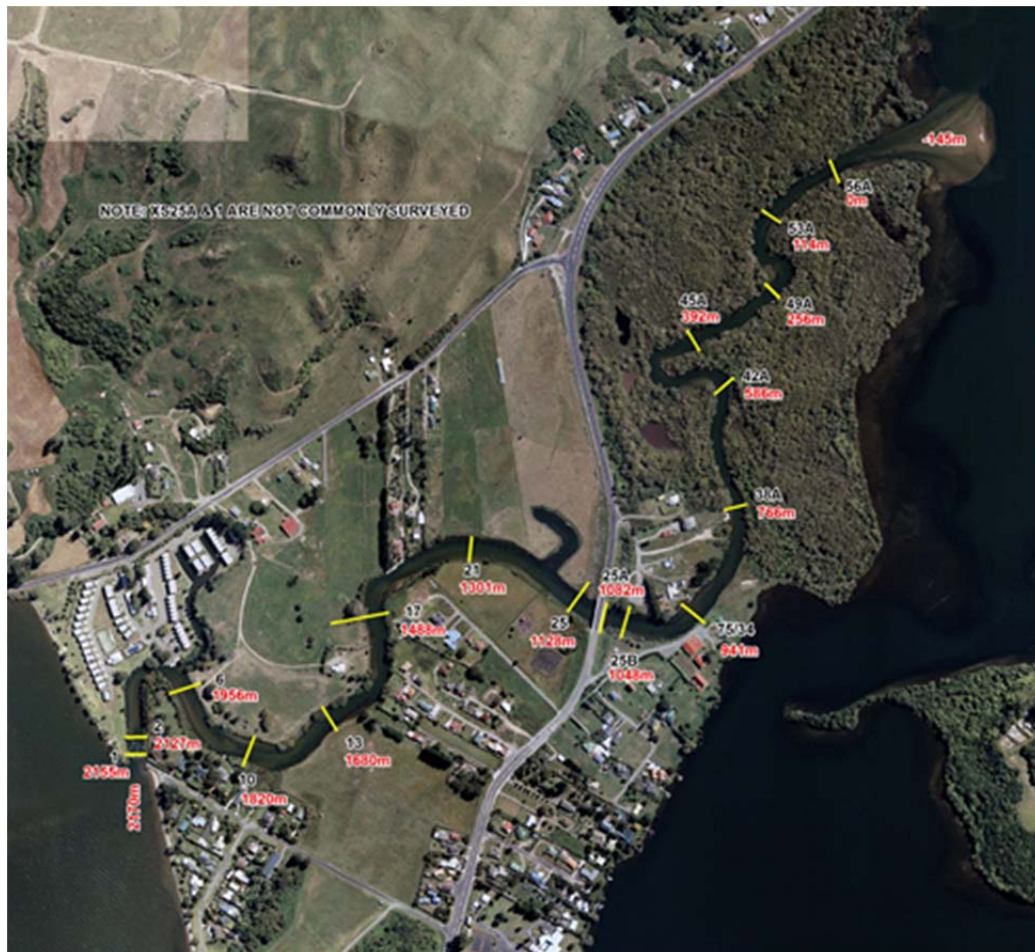
Figure 16 Ohau Channel cross section locations.

Ohau Channel cross sections are undertaken annually at locations shown in Figure 16 to monitor bed levels prior to and after channel flush each year.

Several years of survey monitoring indicate that the Ōhau Channel is reasonably stable with no significant changes occurring since introducing the annual Flush Programme in 2012.

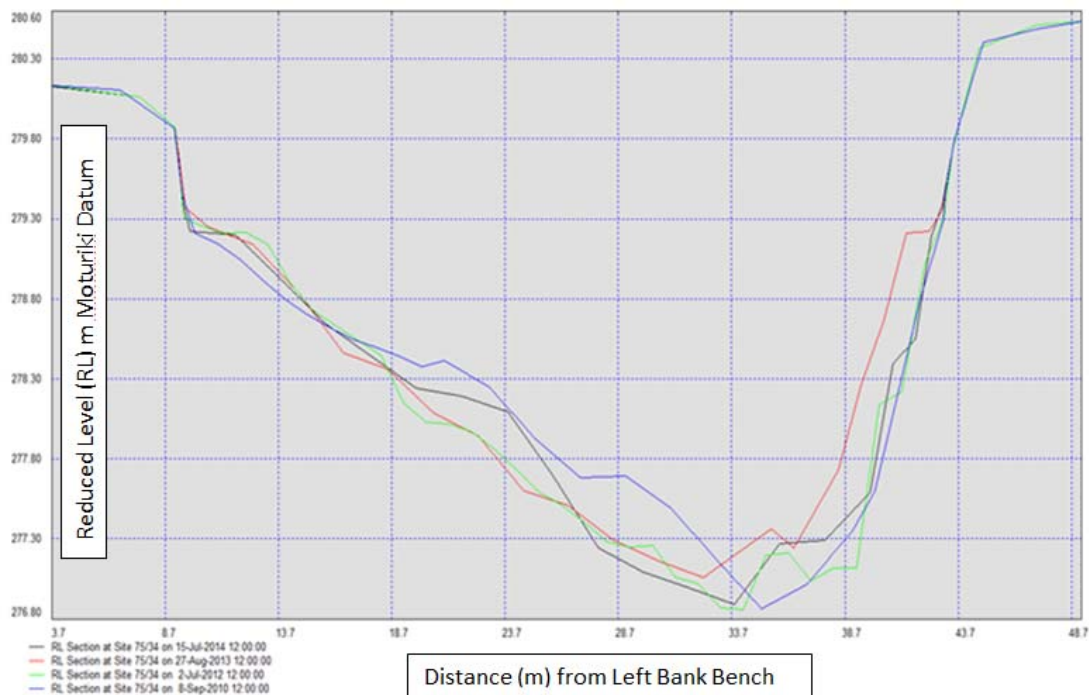
Figure 17 Cross section number 75/34 at Marae – 2010–2014.

Figure 17 below shows an example of cross section 75/34 located downstream of State Highway 33 at Te Takinga Marae.

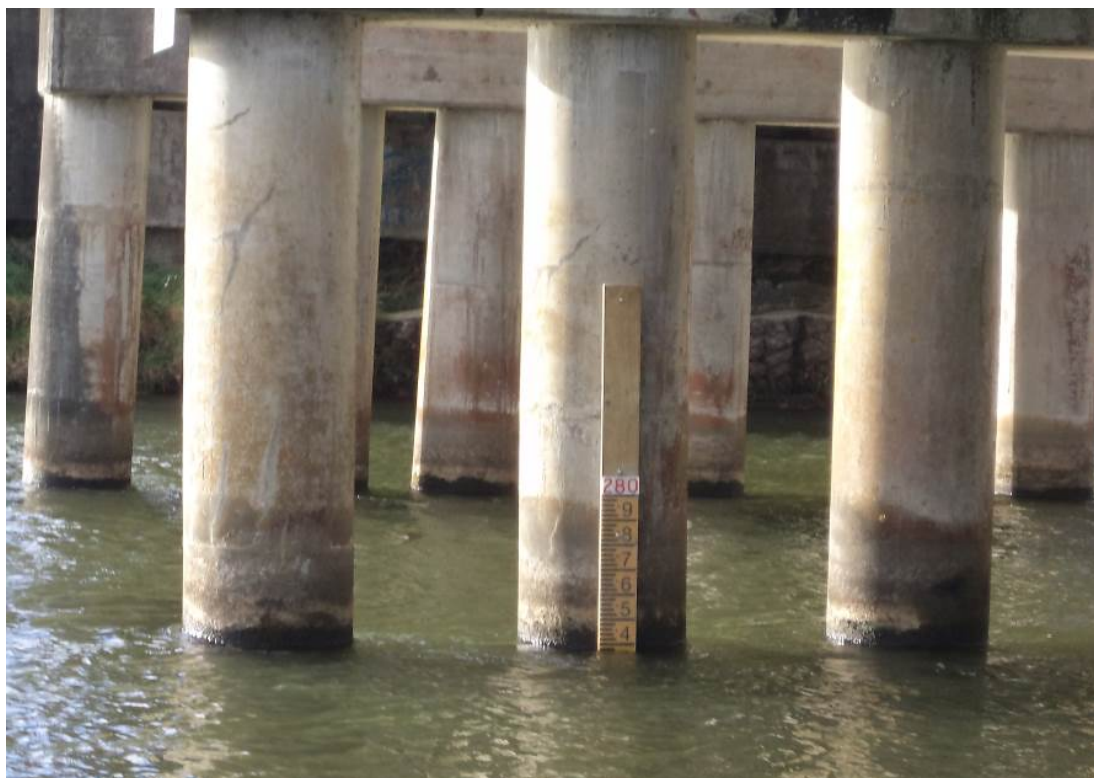
Figure 18 Ohau Channel Staff Gauge on State Highway 33 Bridge – Mourea.

In July 2012, a new staff gauge was fitted to the Ōhau Channel/ State Highway 33 Bridge (Figure 18) to monitor the relationship between Lake Rotorua, Ōhau Channel and Lake Rotoiti water levels.

Following three years of monitoring, it appears that the dominant influences on Ōhau Channel water levels are Lake Rotorua levels. This trend was particularly evident during the 2014 drawdown phase when Lake Rotorua and Ōhau Channel levels remained high while Lake Rotoiti was drawn down to its consented minimum of RL 278.994 m on 9 July 2014.

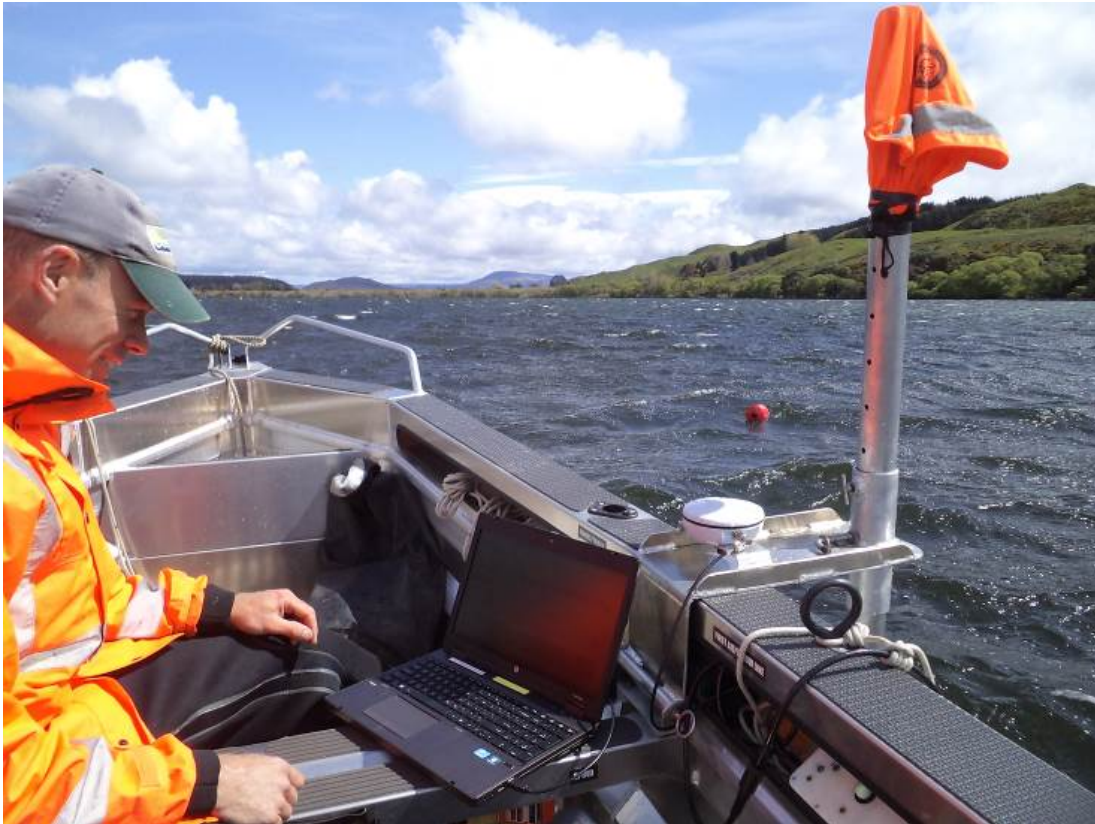
The results of this monitoring were inconclusive due to wind and wave action on the day, but initial indications suggested a negligible effect for these test conditions.

Figure 19 BOPRC EDS staff measuring lake currents near the Ohau Channel Diversion Wall at Te Akau Bay – Lake Rotoiti (October 2012).
