Te Awanui Harbour

Literature review of scientific reports

Bay of Plenty Regional Council
Environmental Publication 2014/13

July 2015

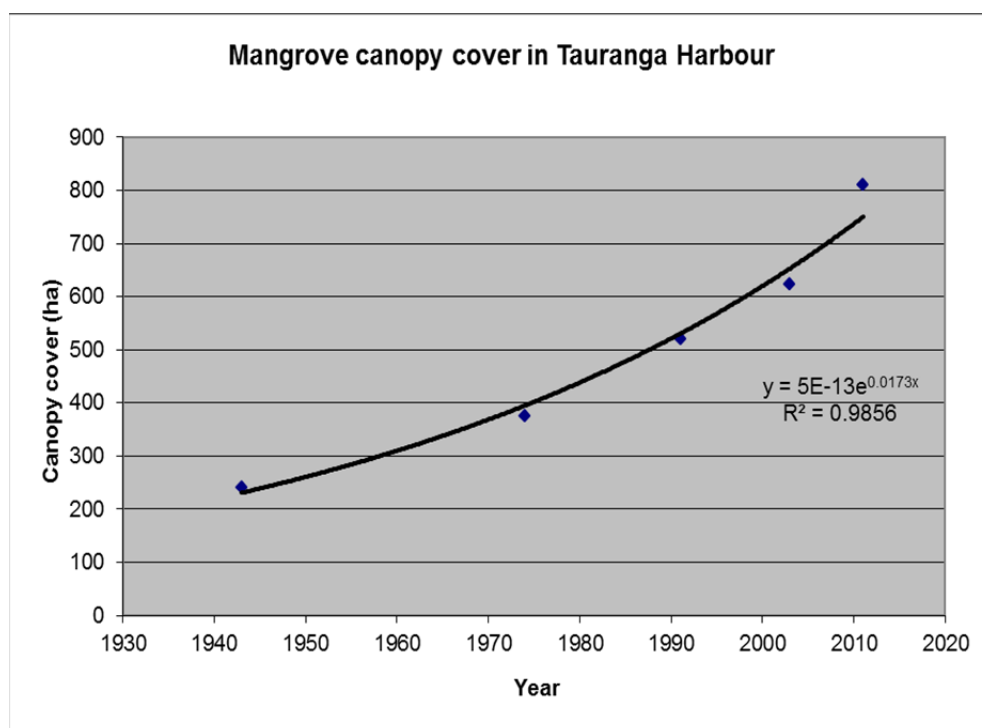
Figure 4 Mangrove canopy cover hectares (ha) in Tauranga Harbour from 1943 to 2011.

Mapping of the extent of mangroves in the harbour indicates that canopy cover of mangroves has increased significantly from just over 200 ha in the 1940's to 811 ha in 2011 (see Figure 4). Mangrove expansion in the harbour is a natural response to increased sedimentation, nutrients and less frequent frosts.

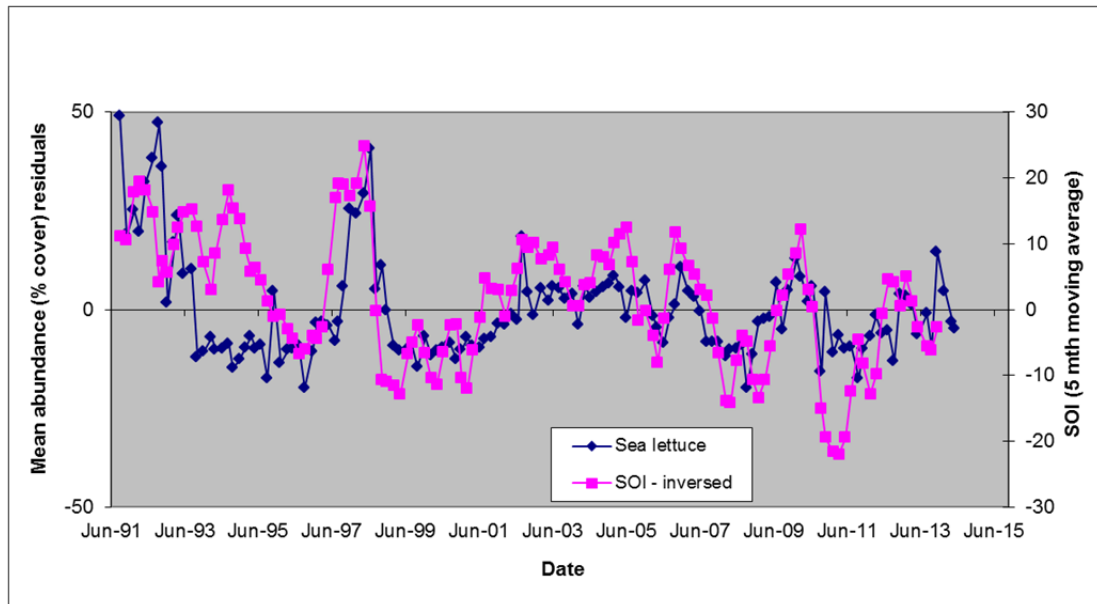
Figure 5 Mean sea lettuce abundance as percent cover averaged across seasons and sites from Tauranga Harbour versus Southern Oscillation Index (SOI) for El Nino and La Nina conditions.

Monitoring of sea lettuce abundance occurs at a number of sites across the harbour. Monitoring since 1993 shows the abundance of sea lettuce is highly variable with a strong correlation between blooms of sea lettuce and El Nino and La Nina events (see Figure 5). Large blooms of sea lettuce have been recorded during El Nino years compared to smaller blooms during neutral years. Research is currently being conducted to better understand the drivers of sea lettuce growth in the harbour through PhD research conducted with the University of Waikato.

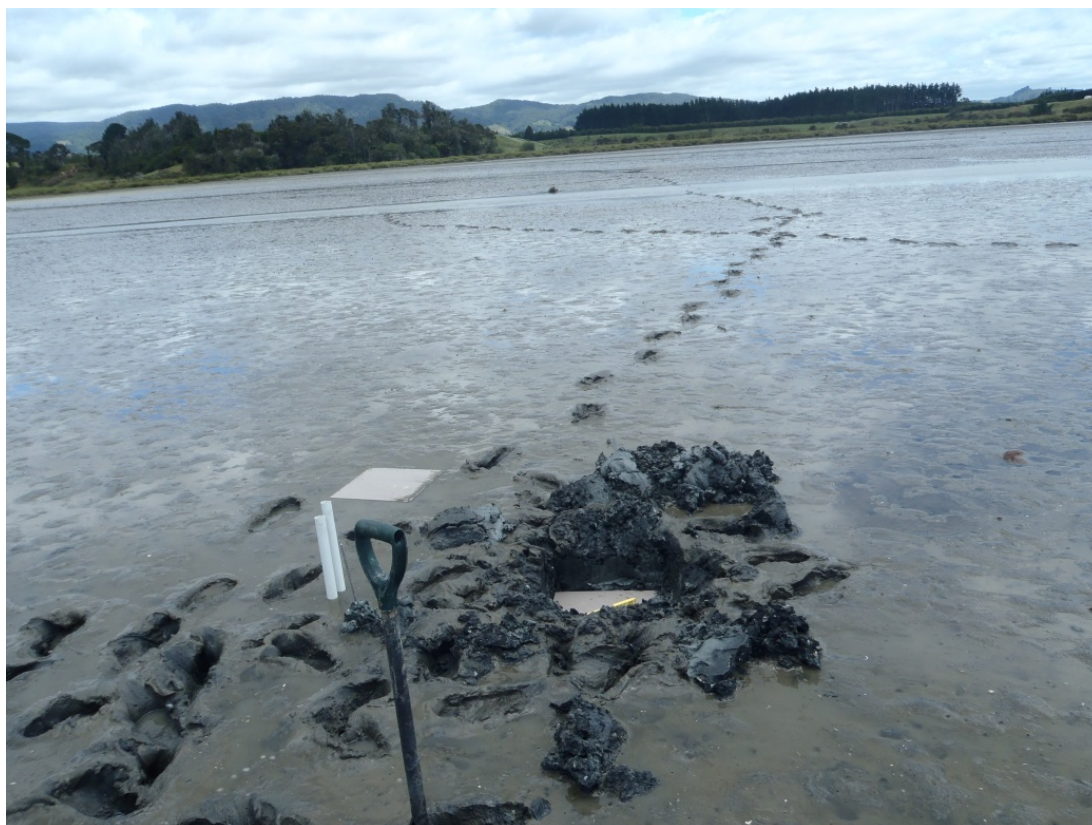
Figure 6 Sediment Accumulation Rate (SAR) monitoring plate installation in Wainui Estuary. Note the thick soft mud anoxic muds a clear sign of high erosion rates from the surrounding catchment.

Impacts from high sedimentation rates in the harbour are caused mainly by high loads of fine clay and silt fractions which settle in more sheltered sub-estuaries. Since the times of first land clearance, sediments in sheltered areas have become muddier causing a decline in health of harbour ecology. In the open areas of Tauranga Harbour, high wave and current energy keeps the sediments in a healthy sandy state, and no significant change has occurred at monitored sites since the 1990's. Additional monitoring of both the sediment mud content and the Sediment Accumulation Rates (SAR) has been setup at 60 sites across the harbour to provide more accurate trend analysis (see Figure 6).
