Mount Maunganui Reef – Assessment of Management Options

Prepared for the Bay of Plenty Regional Council

December 2013

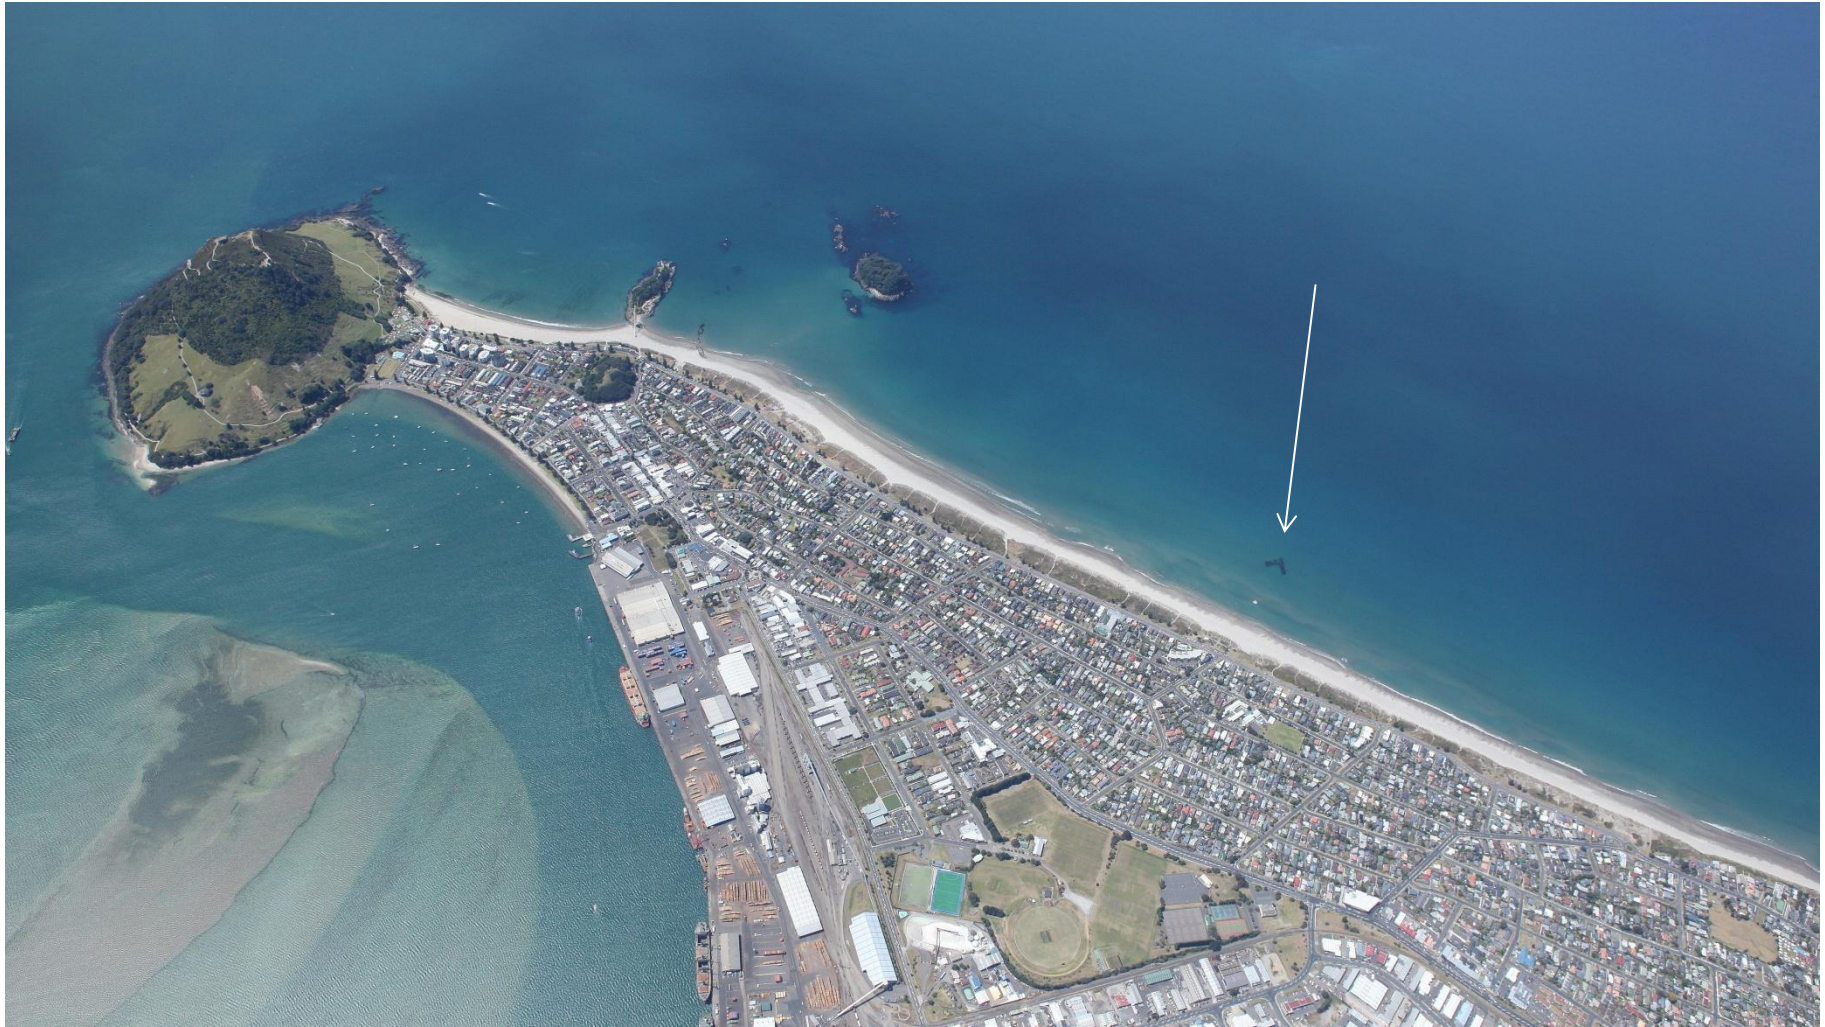
Figure 1: Aerial view of Mount Reef (arrowed). Photo supplied by BoPRC.

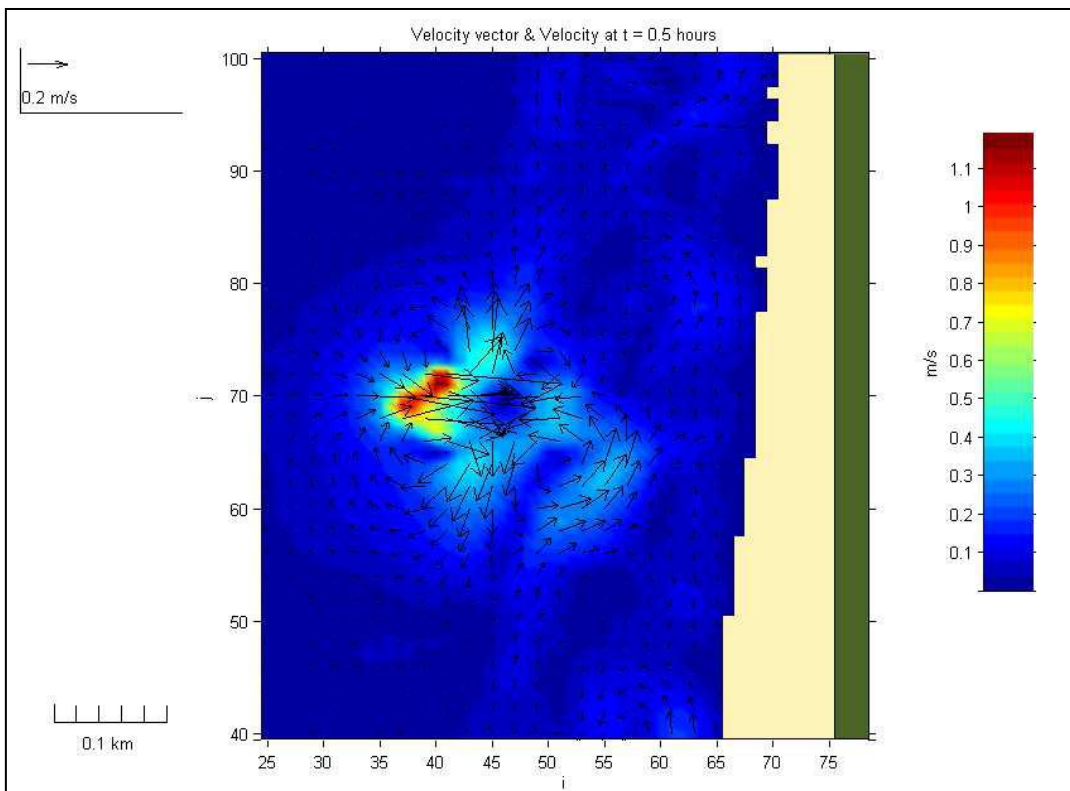
Figure 2: Predicted hydrodynamic circulations in the vicinity of the reef for wave height of 1.0 m (top) and 2.0 m (bottom), at shore-normal incidence. Note the complex current patterns in the lee of the reef. (from Weppe, 2010).

Weppe (2010) modelled waves and currents in the vicinity of the reef and observed that the hydrodynamic circulation can be significantly disturbed when wave heights are sufficient to break on the reef. In these conditions, a strong onshore flow is generated over the reef, and an associated set-up of the water level in its lee. This generates a circulation pattern in the lee of the reef that includes return currents on the reef sides. The increase in current velocities and complex changes in current direction can be seen in Figure 2. While these wave and current patterns change significantly under different offshore wave conditions, strong onshore water fluxes over the reef, and associated high velocity return currents are common in the modelling results.
