Waiotahi Catchment Management Plan

Bay of Plenty Regional Council
Operations Publication 2011/02

The Waiotahi Catchment Management Plan

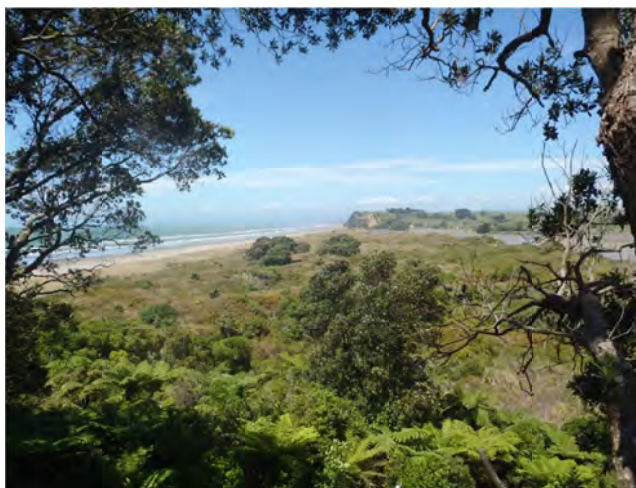
Figure 2 Dunes on the Waiotahi Spit.

The windblown dune system makes up less than 0.1 % of the catchment. This area is characterised by the pingao and spinifix in the foredunes and scattered pohutukawa found throughout the dunes.

The 22 hectare dune system also makes up part of the Waiotahi River mouth and the Waiotahi Spit

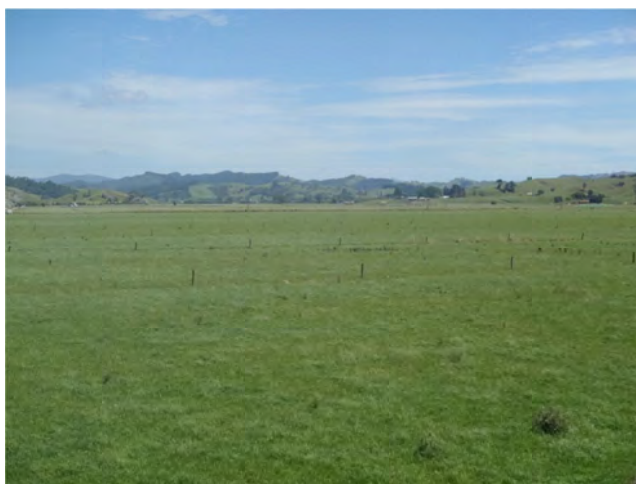
Figure 3 Alluvial plains in the Waiotahi Catchment.

The low lying alluvial plains make up 14% of this catchment and are located on the river terraces on the flood plains in the lower catchment. These areas are the dairy farms in the catchment. Due to the low lying nature of these areas they are subject to flooding and most of this unit is part of the Waiotahi Drainage Scheme.

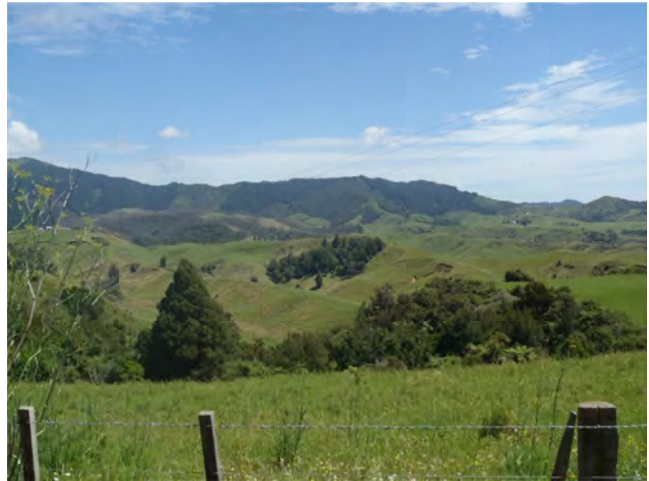
Figure 4 Rolling to moderately steep hill country.

The rolling to moderately steep hill country occupies 29% of the catchment. The land cover for these areas are is pastoral with some of the moderately steep areas being used for forestry. There is evidence of soil slips across this land form, which is partially due to the high intensity of the rain fall events in this area.

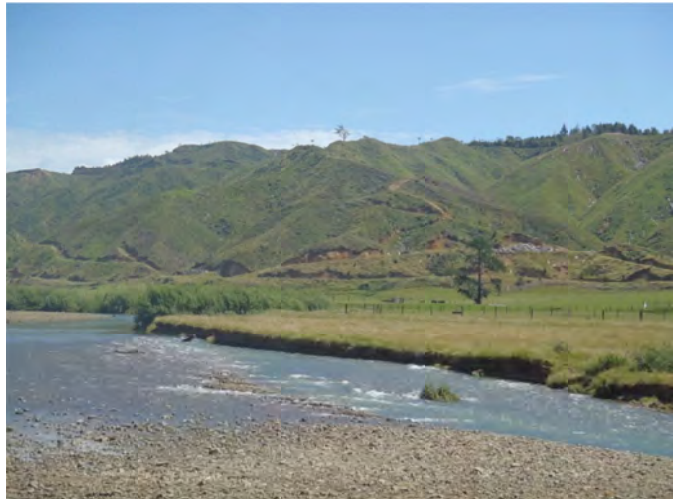
Figure 5 Steep hill country.

The steep hill country accounts for 44 % of the catchment. The largest proportion of this is in forestry, with some indigenous forest. While this is the most appropriate land use, the intensity of the rain fall events is of concern especially when there is little canopy cover and tracking has occurred cross slope.

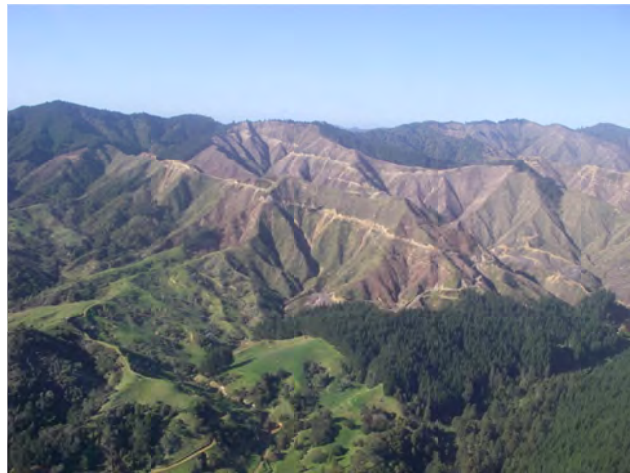
Figure 9 Exotic forest.

There is 15% or 2523 ha of forestry in the catchment. Much of the forestry takes place on the class VII areas, draining into the Waiotahi River. Exotic forestry in the catchment is able to provide beneficial soil and water benefits over a long time period.

However harvesting and re-establishment operations are capable of causing downstream sedimentation. There will need to be careful controls on roading and tracking, with earthmoving areas kept to a minimum. There are areas that will need to be harvested using aerial hauler systems, rather than ground based harvesting systems.

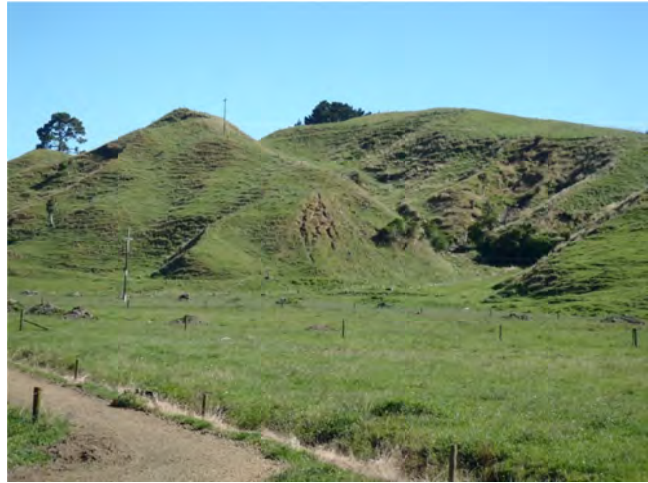
Figure 12 Localised rill erosion.

Sheet erosion occurs when thin layers of soil are washed down a slope, in a dispersed pattern, generally over a widespread area of a hill slope. Bare ground or intensively grazed pasture on steep slopes is susceptible to sheet erosion.

Sheet erosion becomes more pronounced when rainfall intensity increases or where filtration is reduced (through soil compaction). Rill and sheet erosion often occur together, with sheet erosion advancing to rill erosion once it has cut a channel into the open soil. Rill erosion often damages cultivated paddocks with exposed soils, earthwork sites and farm tracks. Repeated erosion of the same rill can eventuate into gully erosion. On pastoral areas it is usually associated with over grazing, stock tracking, cultivated slopes and bare ground.

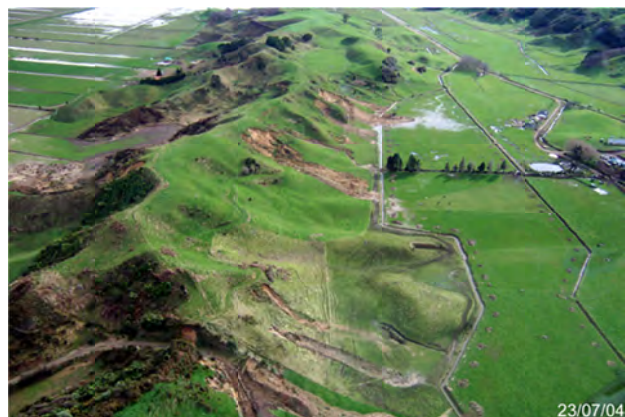
Figure 13 Soil slips on pasture, 2004.

Soil slips are the mass movement of soil generally occurring in heavy rain events. When the soil becomes saturated and there is an impermeable material below the surface, the soil slips. When mixed with water this can become a chaotic mix of debris, and often fans out forming a debris tail.

Soil slips are often induced by human activities especially slope modifications for roads and tracks, and compaction from heavy stock.

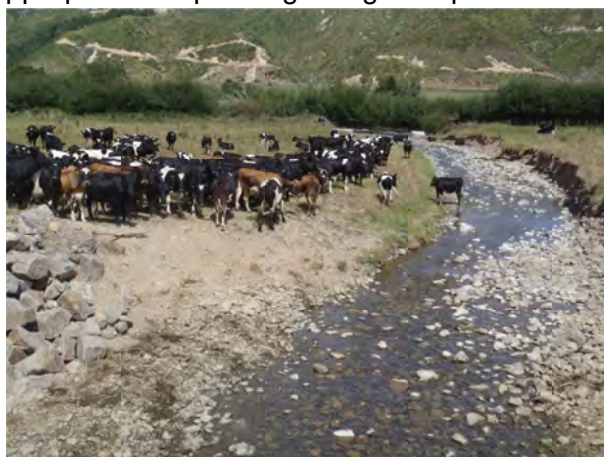
Figure 16 Slight stream bank erosion.

The stream bank erosion shown in this photo has stabilised in places. There are still areas actively eroding where the water is eroding the toe of the bank, this often occurs on the outside of corners. The placement of suitable shrub willows or native trees with good root structure should be used to increase the stability.

When the height of the bank increases beyond the rooting depth of your selected species, alternative methods will need to be used.

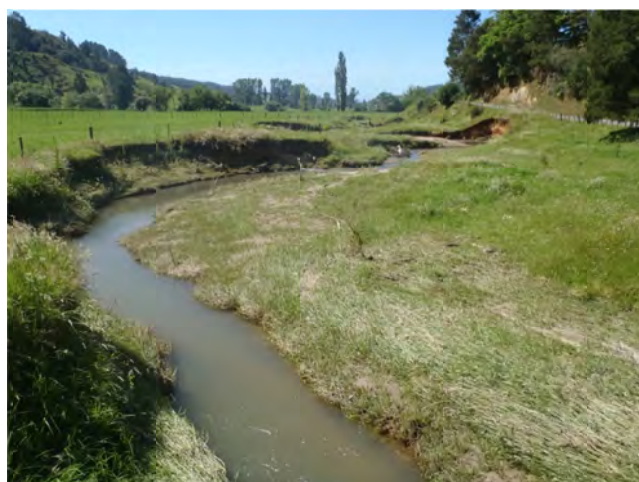
Figure 17 Stream bank with grass sward.

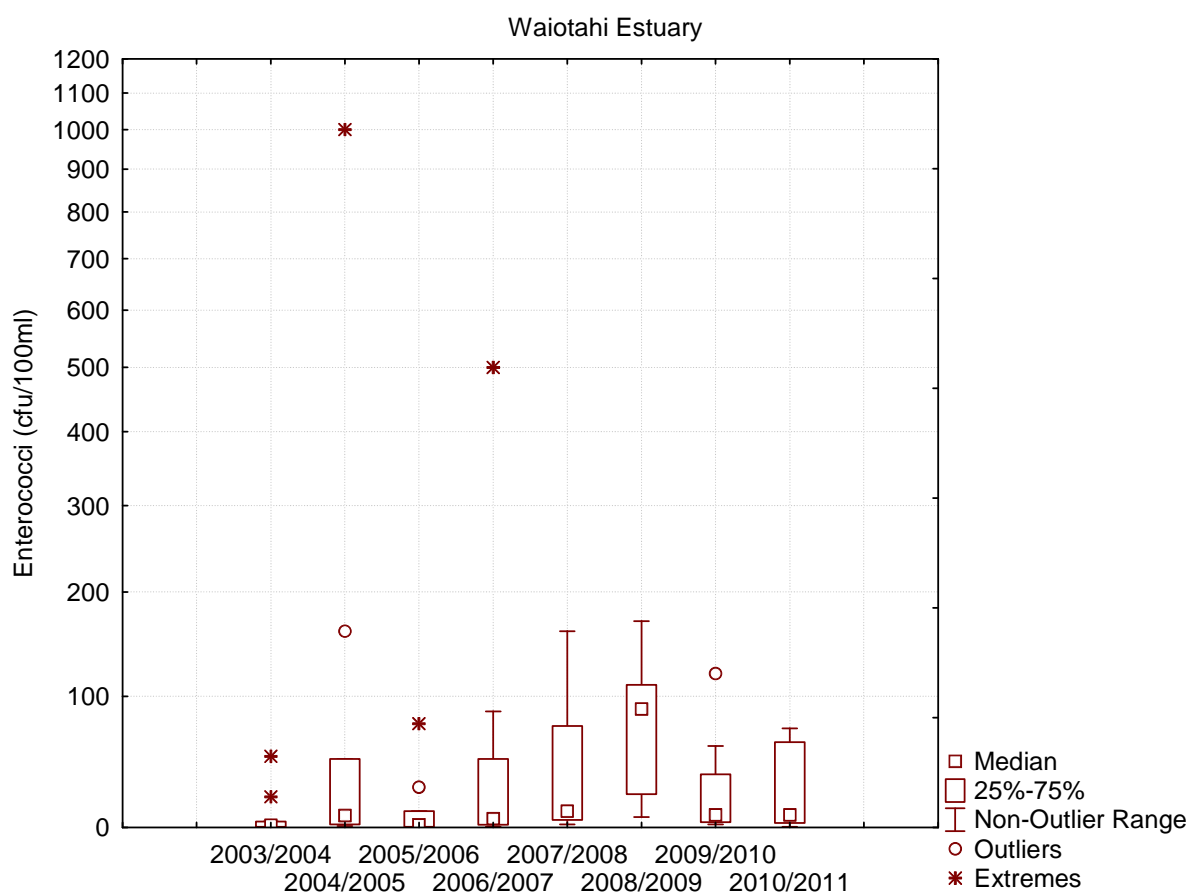
Table 5 Levels of Enterococci in the Waiootahi Estuary since 2003.

The graph above show the Mann-Kendall test for Enterococci (cfu/100mL). Monitoring is undertaken over the summer months, Enterococci (faecal matter) is used as the indicator. The period analysed is for the calendar years 2003 and 2010. Results indicate an increasing trend of increasing faecal contamination but has been a bit lower on average over the last couple of seasons. The recommended response is

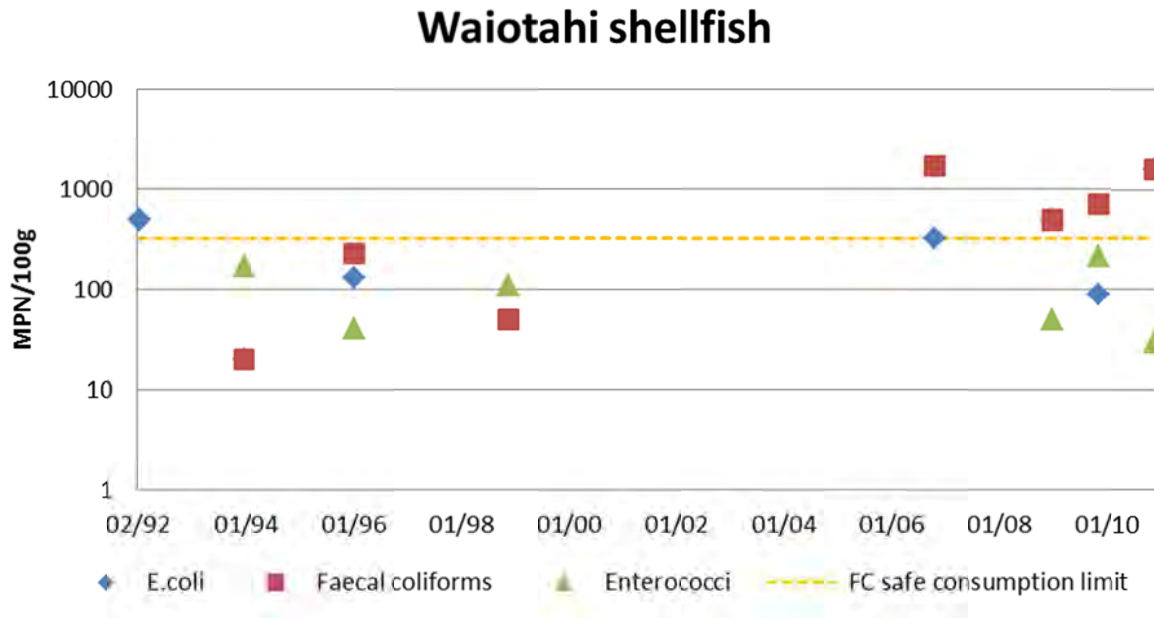
Table 6 Levels of contaminants found in the shell fish flesh.

To comply with the standard faecal coliform levels in shell fish flesh should be less than 330 MPN/100g, and levels from 230 to 330 MPN/100g are marginally acceptable. Faecal coliform limits have been used historically for shellfish quality assessment but these have been abandoned in recent years in favour of *E.coli*. The *E.coli* median MPN of the shellfish samples must not exceed 230 *E.coli* per 100g and not more than 10% of the samples must exceed an MPN of 700 per 100g.

The above graph indicates which years shell fish have been above the FC safe consumption date. It must be noted that for the results for the 2010 year the Waiotahi Estuary pipi had elevated faecal coliform levels although *E.coli* levels were well under the NZFSA guideline. Levels were likely to be increased due to rainfall around the time of sampling.

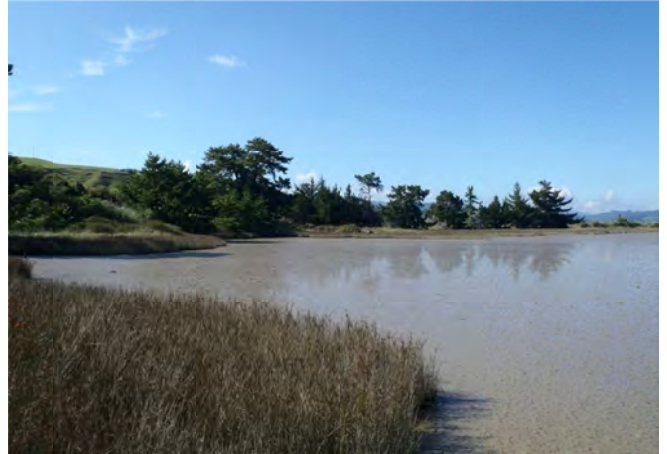
Figure 22 Waiotahi estuary.

There are distinct zones within the estuary, the sandfields, reedlands and the mudflats. Within the mudflats there is also a small mangrove population (along with the Waiaua Estuary) which is at the south eastern range of mangroves in New Zealand.

The threats for this area are the siltation, eutrophication as well as adventive weed species.
