Uretara Stream Capacity Review

Environment Bay of Plenty Operations Publication 2006/07 August 2006

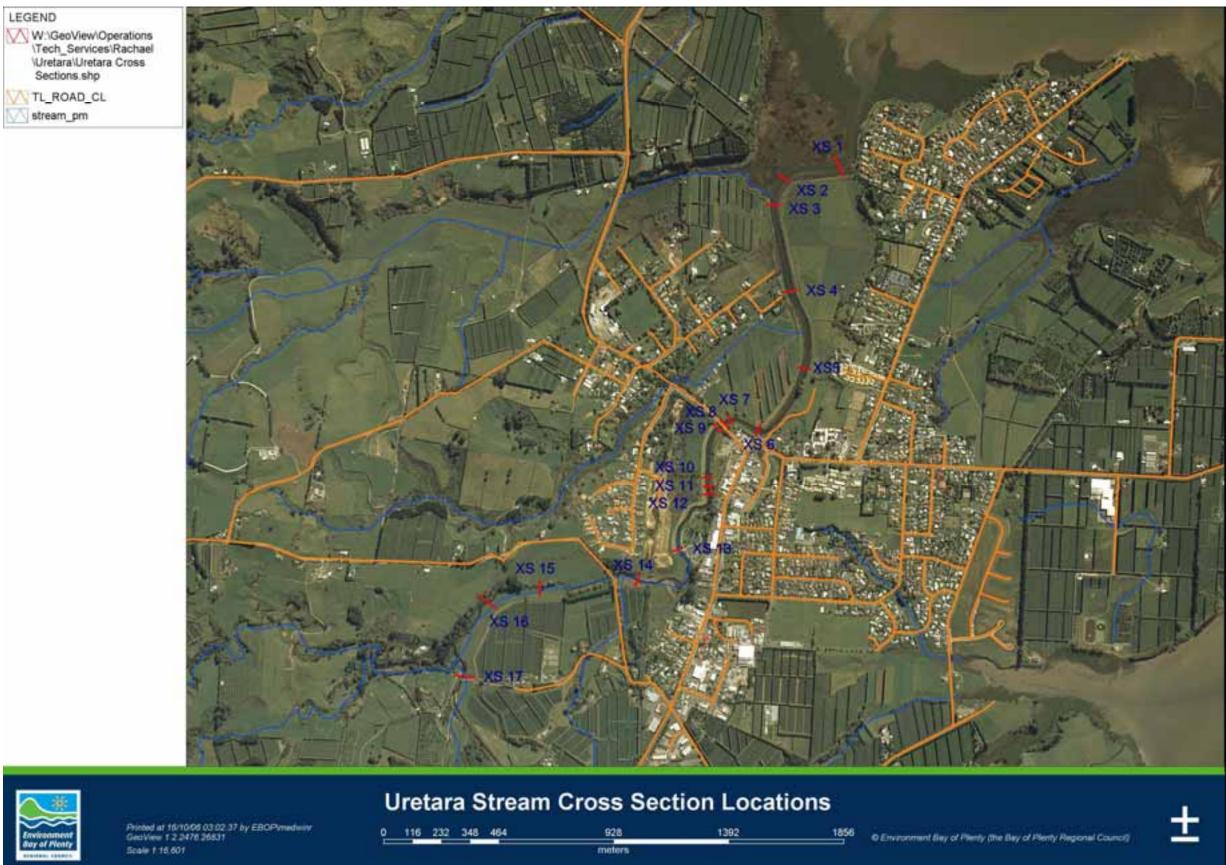
Appendix 2 – Cross Section Locations

Cross Sections were completed along the stretch of the stream bed protected by stopbanking; this involves the section from the stream mouth up to Rawaka Drive, a distance of approximately 3800 m. This was covered by a total of 17 cross sections and long sections taken of both the left and right side stream stopbanks. Debris marks were collected a month post the 24 January flood event and surveying was done a month later. Surveying was undertaken by Peter Vercoe, Carl Iverson, David Marven, Krystle Doney and Rachael Medwin. Locations of surveyed cross sections are shown in Appendix 2.
