Recreational Waters Surveillance Report

Prepared by Paul Scholes, Science Team Leader - Water Quality
Environmental Publication 2018/03
April 2018

Bay of Plenty Regional Council
5 Quay Street
P O Box 364
Whakatāne
NEW ZEALAND

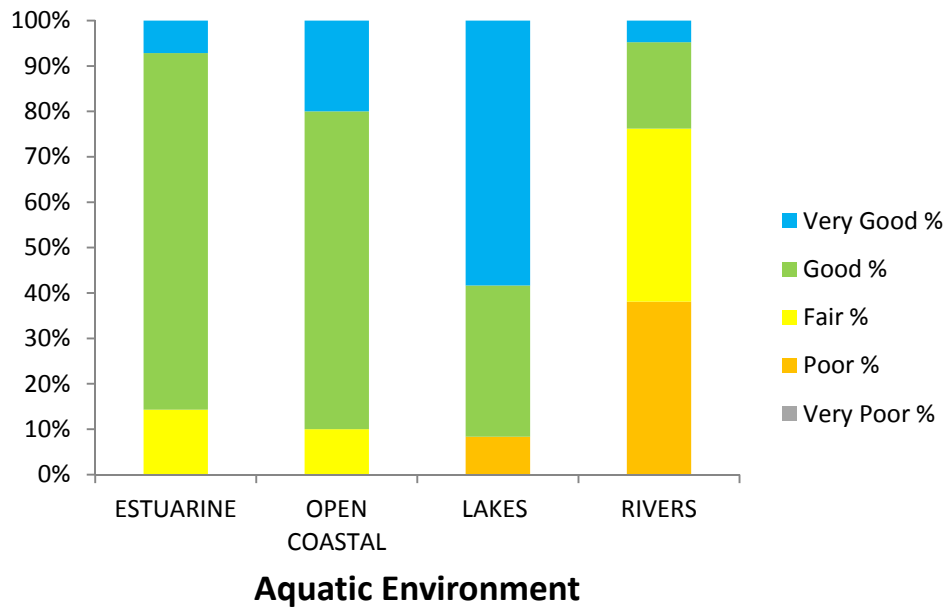
Figure 3.2 Comparison of the 2016/2017 results for the SFRG across aquatic environments.

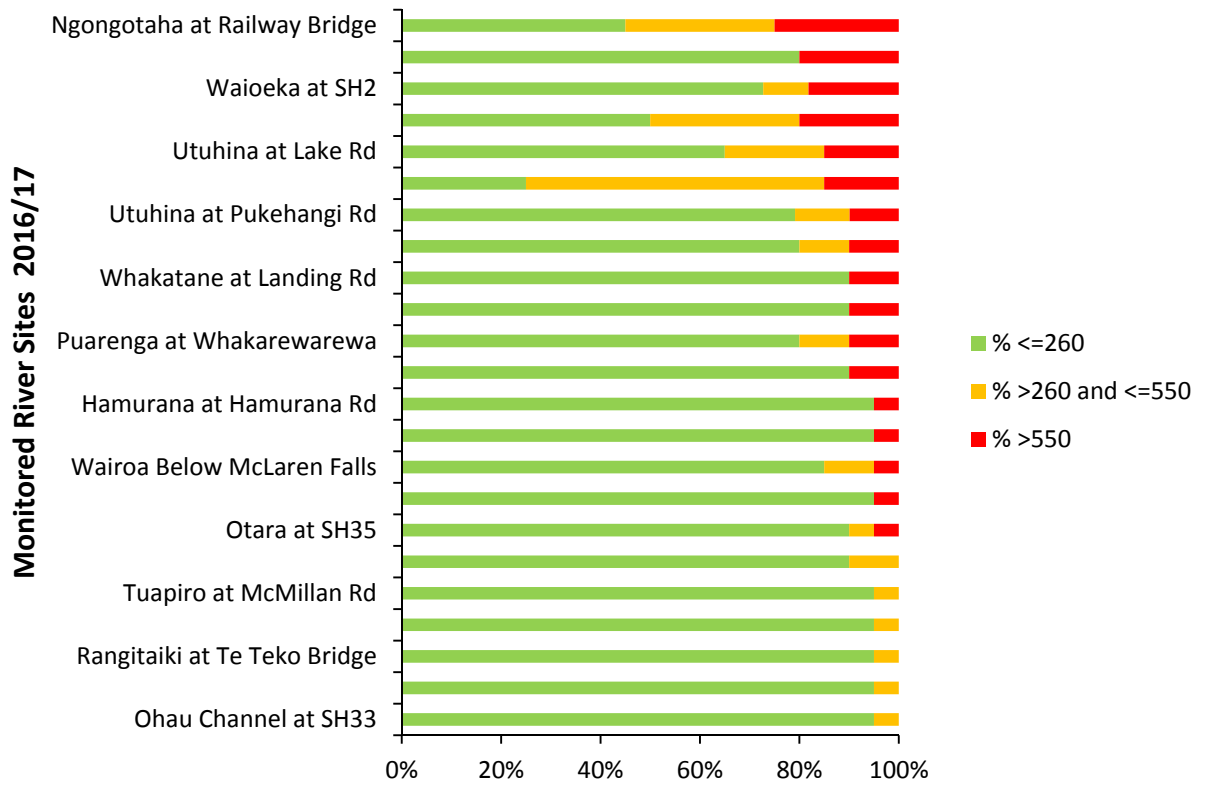
Figure 3.3 Percentage of samples from river and stream sites with *E. coli* concentrations (cfu/100 ml) in each of the modes in the Microbiological Water Quality Guidelines (MfE/MoH 2003), 2016/2017 bathing season.

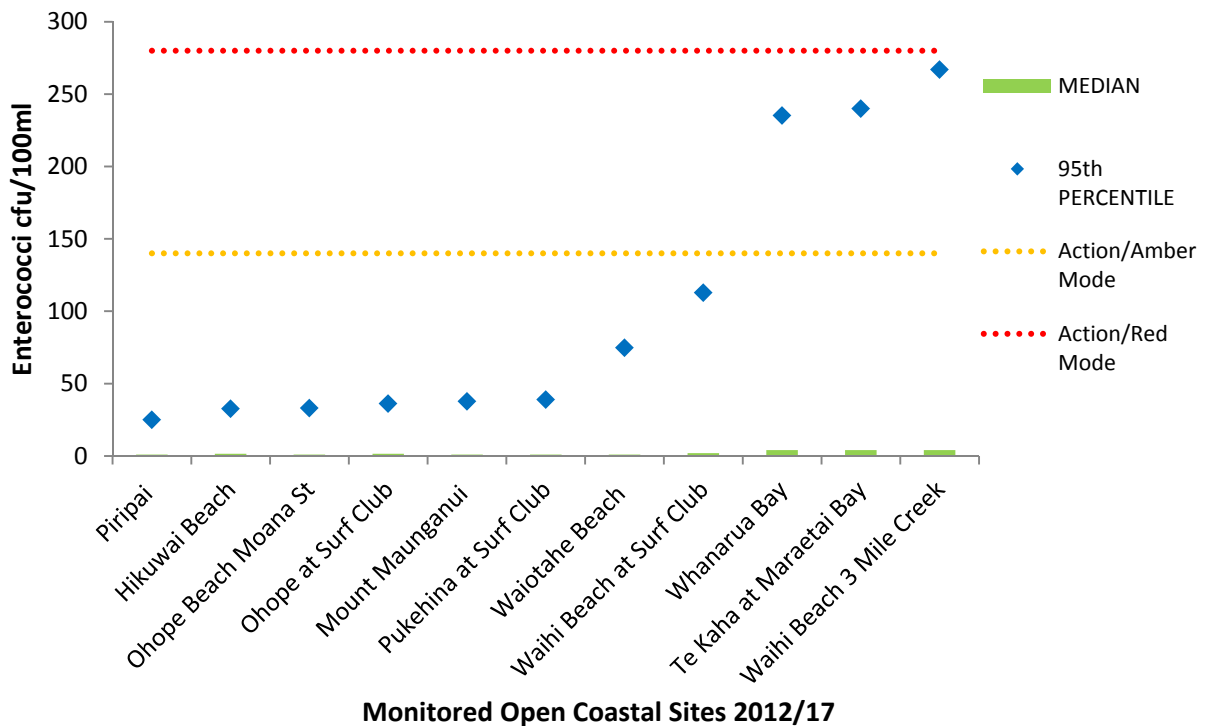
Figure 3.8 95th percentile and median results of enterococci concentrations, coastal marine sites over the past five years.

Wharanua Bay and Waihi Beach at 3 Mile Creek are the only two sites that have a 95th percentile to exceed the Orange/Alert Mode over the past 5 years (Figure 3.8).

All 12 open coastal sites had median enterococci concentrations below 5 cfu/100 ml in both 2016/2017, and the last five years (Figure 3.8). This indicates a low level of enterococci indicator bacteria contamination overall for marine coastal waters in the Bay of Plenty.

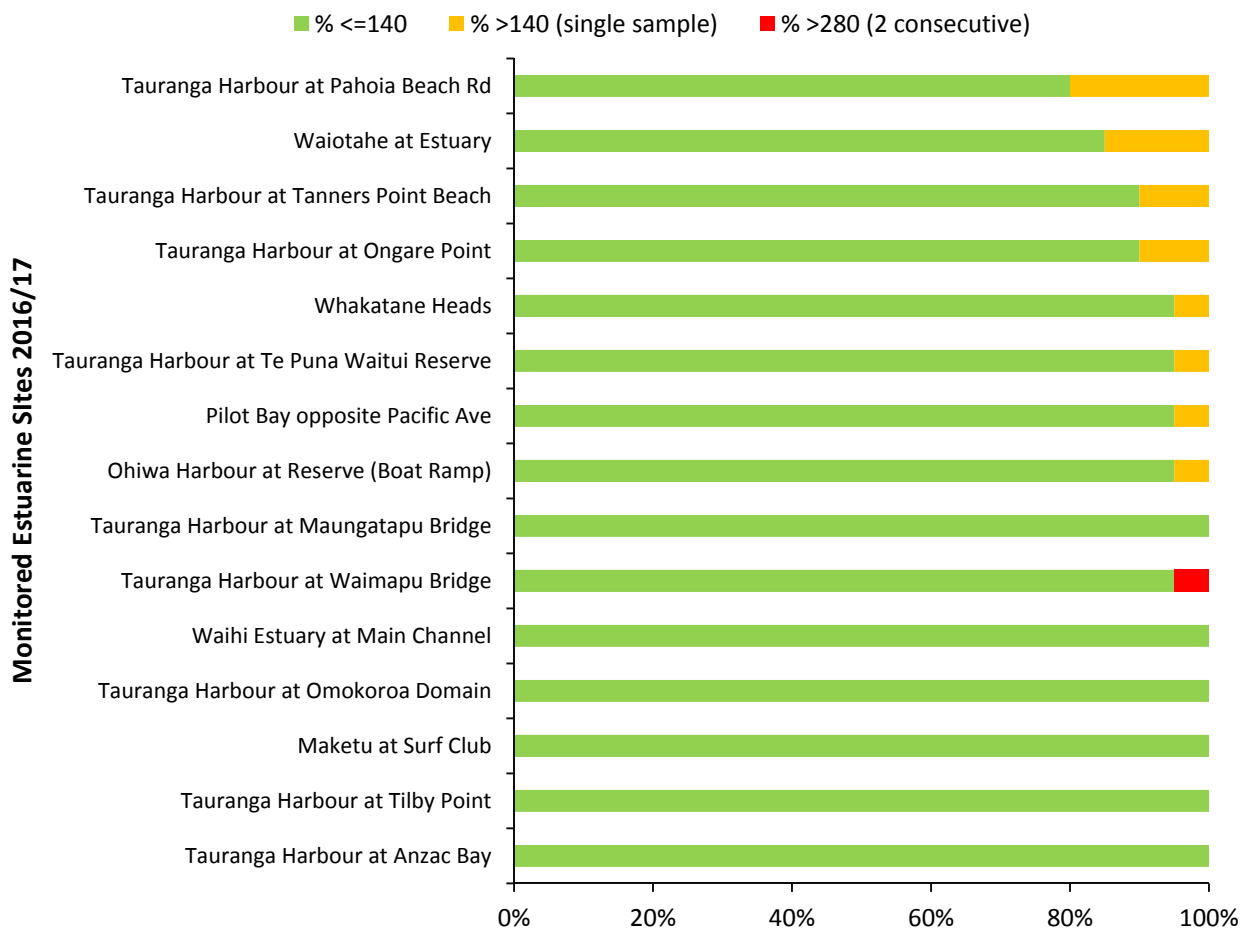
Figure 3.9 Percentage of samples from estuarine sites with enterococci concentrations in each of the modes in the New Zealand Microbiological Water Quality Guidelines (MfE/MoH 2003), 2016/2017 bathing season.

Eight of the 15 estuarine sites reached Orange/Alert Mode during the 2016/2017 season (Figure 3.9). Tauranga Harbour at Waimapu Bridge was the only site to reach Red/Action Mode – this only occurred on one occasion throughout the 2016/2017 season. Whakatane at the Heads had the highest median enterococci concentration of all estuarine sites over the last five years, at 13 cfu/100 ml (Figure 3.19).

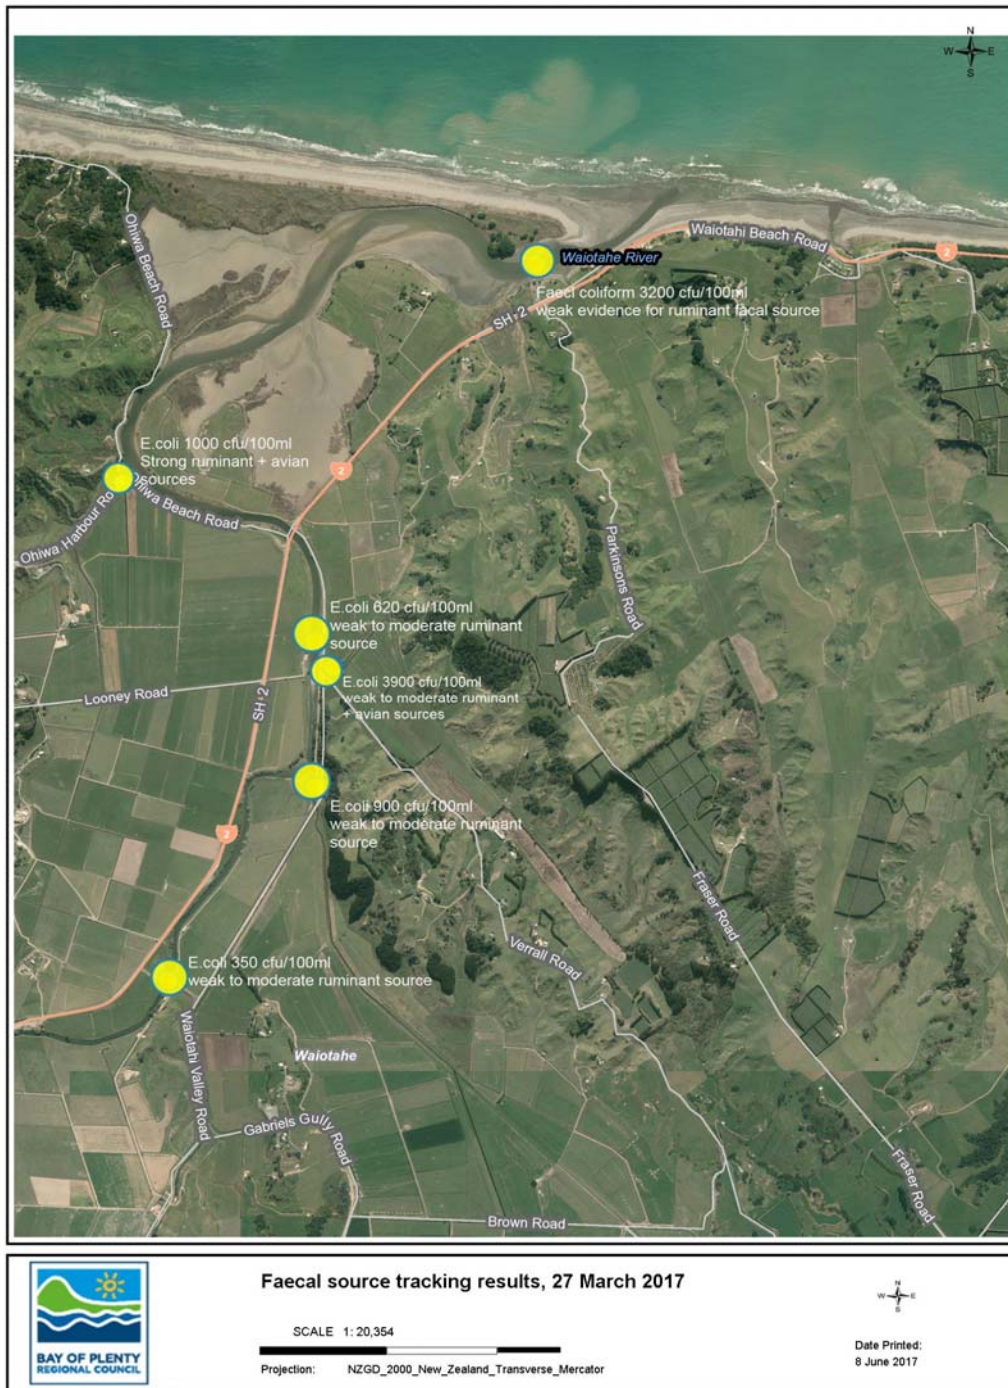
Figure 4.5 Maximum *E. coli* concentrations and faecal source tracking results for river and drain sites in the lower Waiōtahe Catchment, January to May 2017.

Six sites distributed across the lower catchment were analysed for the DNA markers that separate human, ruminant (cow) and avian (bird) faeces. Results in the estuary showed weak evidence of a ruminant source. The DNA results are categorised from weak to strong. Two sites in the Waiōtahe River showed weak to moderate ruminant sources. Drain results had weak to moderate ruminant sources and one drain had a strong ruminant source. Avian sources were also found in most locations. There was no detectable contamination from human sources. Results conclude that the main types of bacteria found were from ruminants (cows, sheep, deer or goats) with an avian influence at several locations.

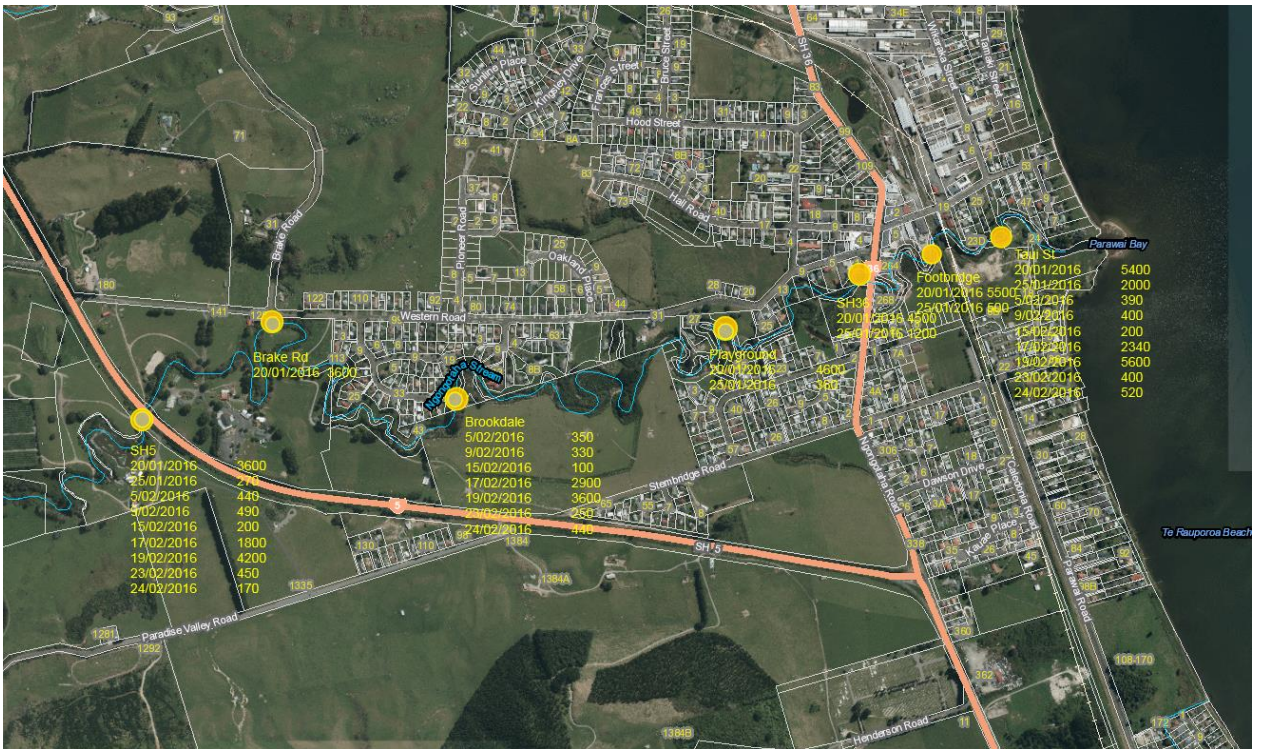
Figure 4.7 *E. coli* concentrations, lower Ngongotahā Catchment in water samples collected in December 2016.

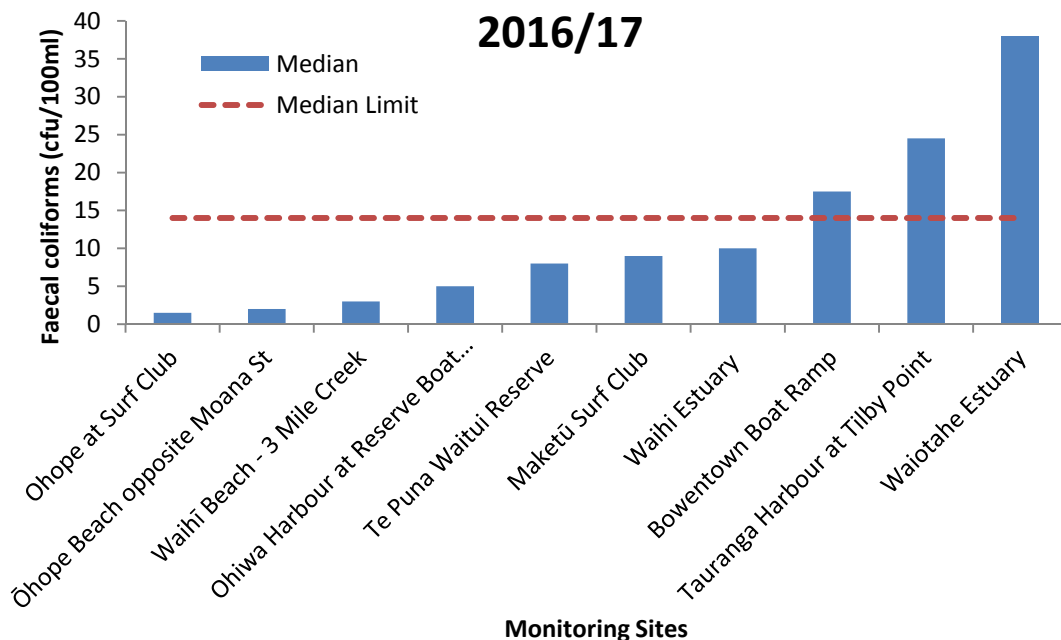
Figure 5.1 Median faecal coliform concentrations at shellfish gathering locations for the 2016/2017 season and guideline median limit for safe shellfish consumption.

Tauranga Harbour at Tilby Point and Waioatahe Estuary were found to exceed the safe consumption guidelines as described above (Figure 5.1). While a health advisory on taking shellfish from Tilby Point has been in place for several years, a new advisory was put in place for the first time at Waioatahe Estuary. Efforts are now focusing on tracking the source of faecal contamination (see section 4.1).

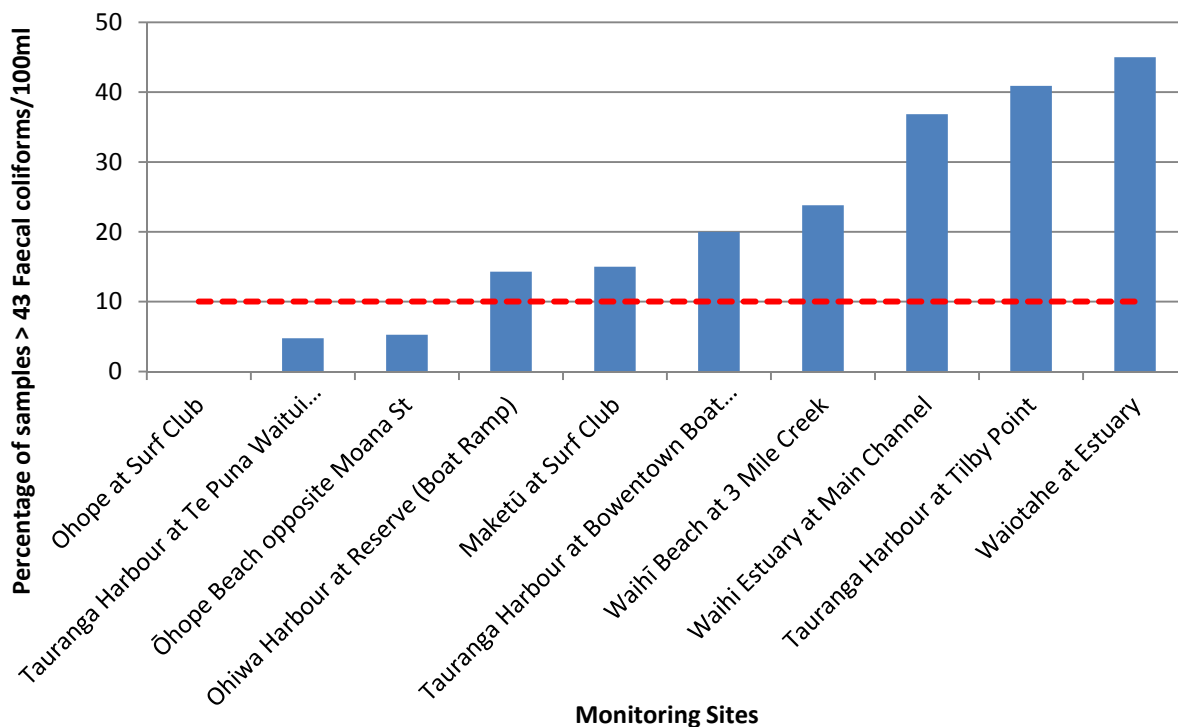
Figure 5.2 Percentage of samples at shellfish gathering locations in the 2016/2017 season exceeding the limit of 43 cfu/100 ml stipulated by the Microbiological Water Quality Guidelines (MfE/MoH 2003) for the 13 marine sites.
