# Assessment of the Rotorua Te Arawa lakes using LakeSPI – 2016

*Prepared for Bay of Plenty Regional Council*

NIWA CLIENT REPORT No: 2016019HN  
Report date: August 2016  
NIWA Project: BOP16203

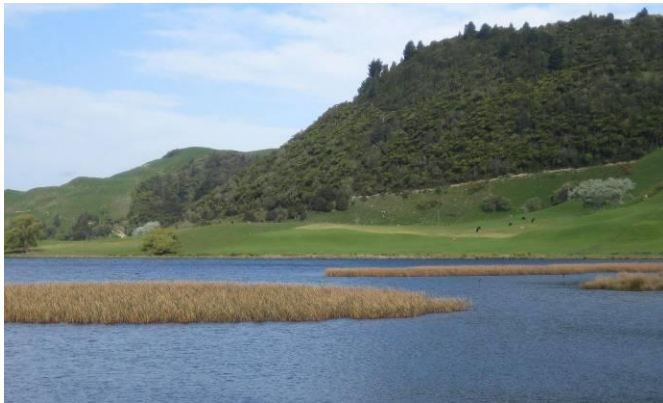
Lake Ōkāreka is currently the highest ranked lake in the Rotorua region and is categorised as being in high ecological condition with a LakeSPI Index of 55% (Figure 4).

**Figure 4:** LakeSPI results for Lake Ōkāreka. LakeSPI Indices expressed as a percentage of lake maximum potential.

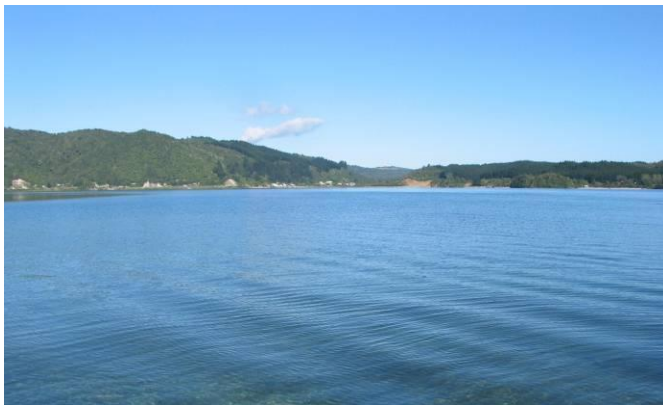
Lake Rotomā is categorised as being in high ecological condition with a LakeSPI Index of 54% (Figure 5).

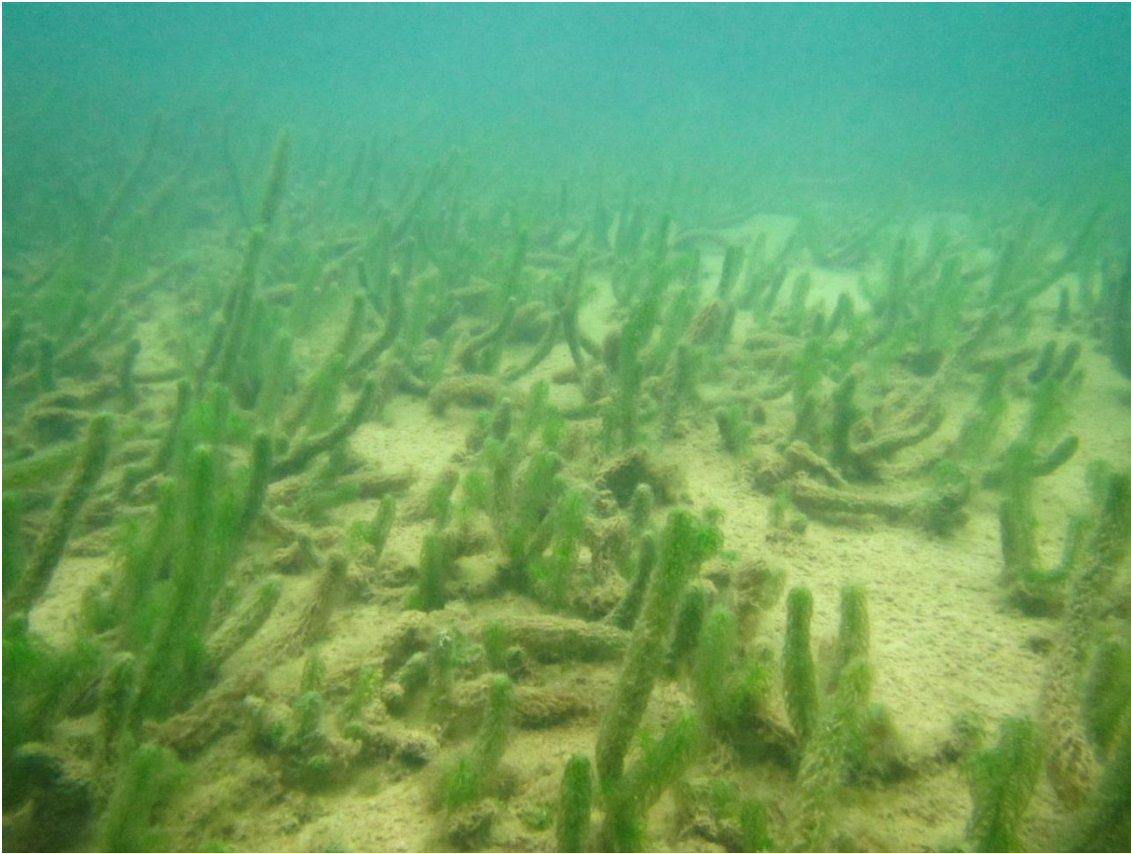
**Figure 8:** Lagarosiphon forms variable covers in Lake Tikitapu, to a maximum depth of 4.7 m.

When the water chemistry of Lake Tikitapu was assessed in the early 1970s it had the lowest alkalinity recorded for any of the Rotorua Te Arawa lakes and it also had low sediment and water nutrient levels (McColl 1972). The reported low alkalinity, calcium and silicon levels may explain the on-going absence of kakahi, the low abundance of snails, koura and planktonic diatoms and the unusual low stature and lax growth habit of lagarosiphon in this lake.

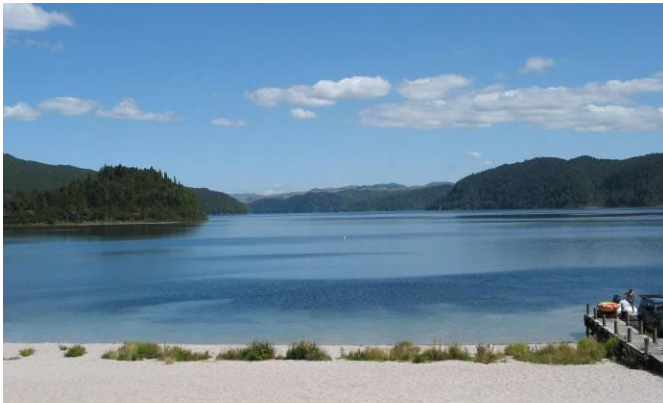
Lake Ōkataina is categorised as being in moderate ecological condition with a LakeSPI Index of 38% (Figure 9).

**Figure 9:** LakeSPI results for Lake Ōkataina. LakeSPI Indices expressed as a percentage of lake maximum potential.

Native charophyte species (*Chara australis*, *Chara globularis*, *Chara fibrosa*, *Nitella sp. aff. cristata*) formed meadows (> 75% cover) at four of the five baseline sites during the 2016 survey, growing down to a maximum depth of 11.3 m (Figure 10). A mixed turf plant community, native pondweeds (*Potamogeton cheesemanii*, *Potamogeton ochreatus*) and a native milfoil (*Myriophyllum triphyllum*) were also present and contributed to a Native Condition Index of 42% (Figure 9).

Lagarosiphon remained the dominant invasive species present, forming high cover weed beds (Figure 10) at all five LakeSPI sites generating an Invasive Impact Index of 67% (Figure 9). For the first time at a LakeSPI site, a hornwort (*Ceratophyllum demersum*) plant was recorded at the northern end of the lake, on the western side of the beach (around from boat ramp). Hornwort continues to pose the most serious threat to the future condition of Lake Ōkātāina. Should hornwort continue to spread, it is likely that we will see a reduction in LakeSPI scores in the future.

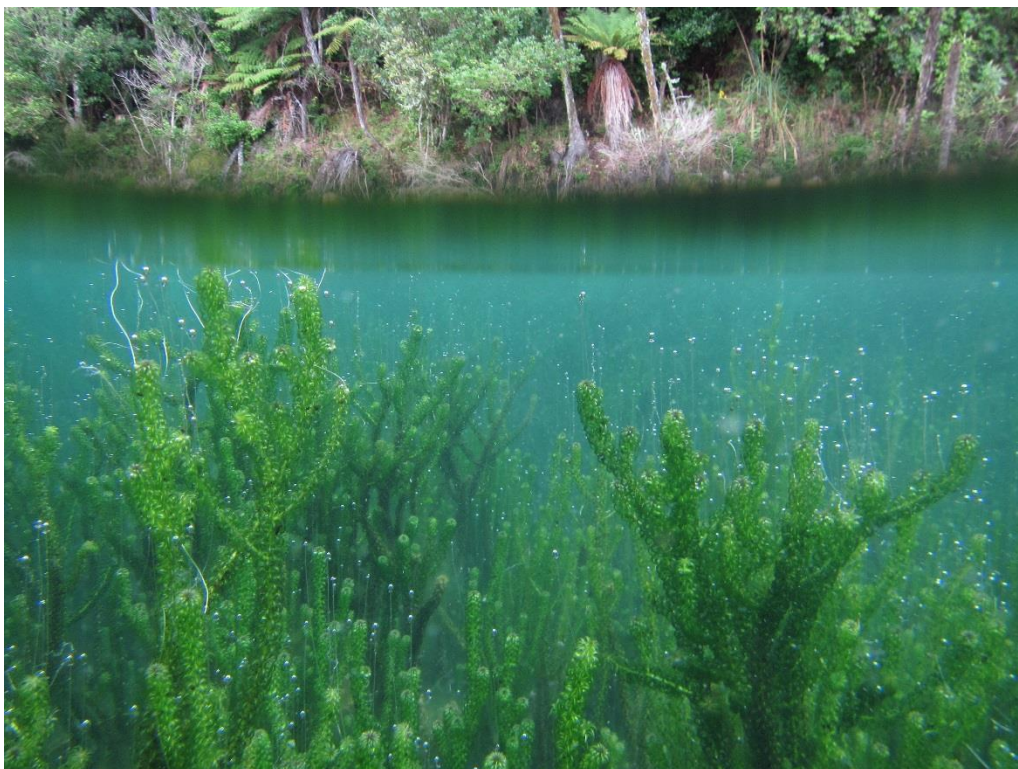
**Figure 11:** Surface reaching bed of lagarosiphon in Lake Okataina.

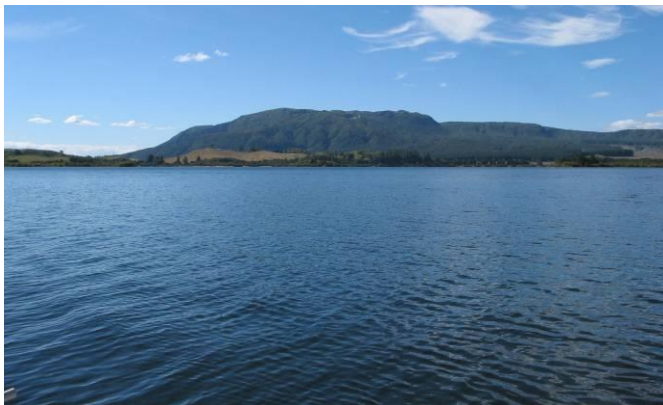
Lake Rerewhakaaitu is categorised as being in moderate ecological condition with a LakeSPI Index of 31% (Figure 12).

**Figure 12:** LakeSPI results for Lake Rerewhakaaitu. LakeSPI Indices expressed as a percentage of lake maximum potential.

The 2016 survey showed a decline in the overall condition of Lake Rerewhakaaitu from the previous 2014 survey. This result predominantly reflects a significant decline in Native Condition scores, from 53% in 2014 to 38% (Figure 12) during the 2016 survey; following an increase in the overall extent and abundance of the invasive weeds egeria (*Egeria densa*) and lagarosiphon (*Lagarosiphon major*).

An Invasive Impact Index of 79% (Figure 12) is the highest recorded for Lake Rerewhakaaitu. Egeria (Figure 13) continues to spread and is the most dominant invasive species in the lake, present at all LakeSPI sites growing down to a maximum depth of 7.2 m.

Egeria further impacted negatively on LakeSPI scores following its introduction and subsequent spread in the 2000's. Egeria was first recorded in Lake Rerewhakaaitu in 2000 (Champion et al. 2006). By 2008, egeria was present at two of the five LakeSPI sites and by the 2010 survey, had spread to all five sites, causing incremental rises in the Invasive Impacts Index to where it is today (Figure 12).

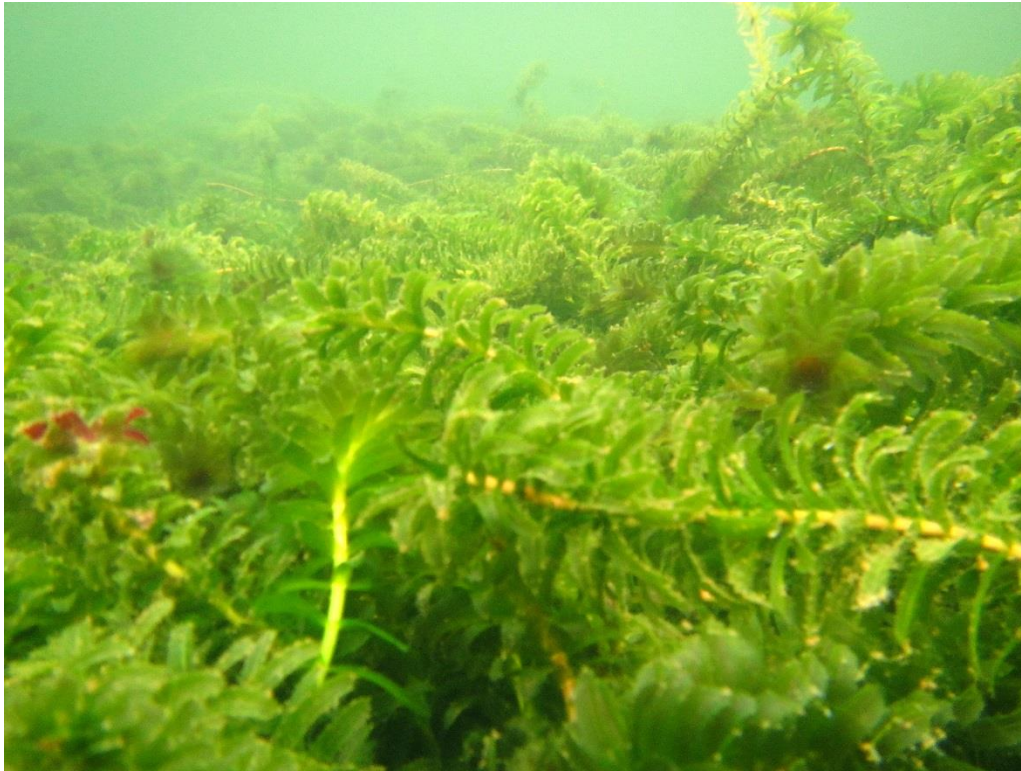
**Figure 13:** Egeria beds dominated much of the vegetation in Lake Rerewhakaaitu.

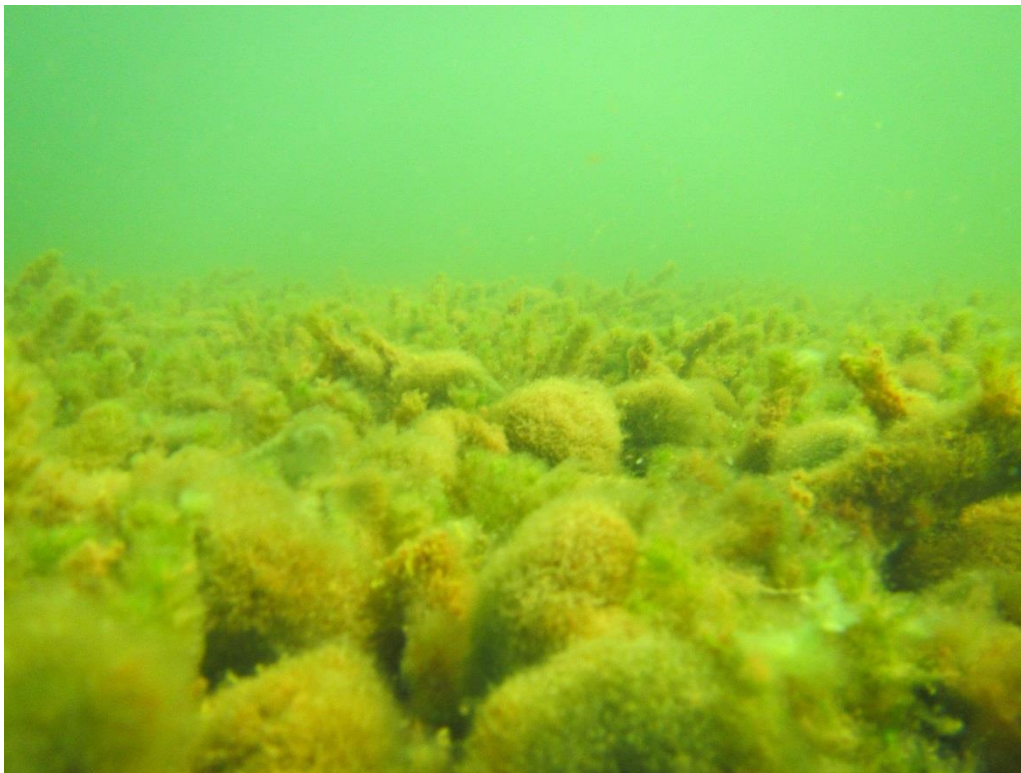
**Figure 14:** Algae covering native plants in Lake Rerewhakaaitu, down to c. 2 m depth.

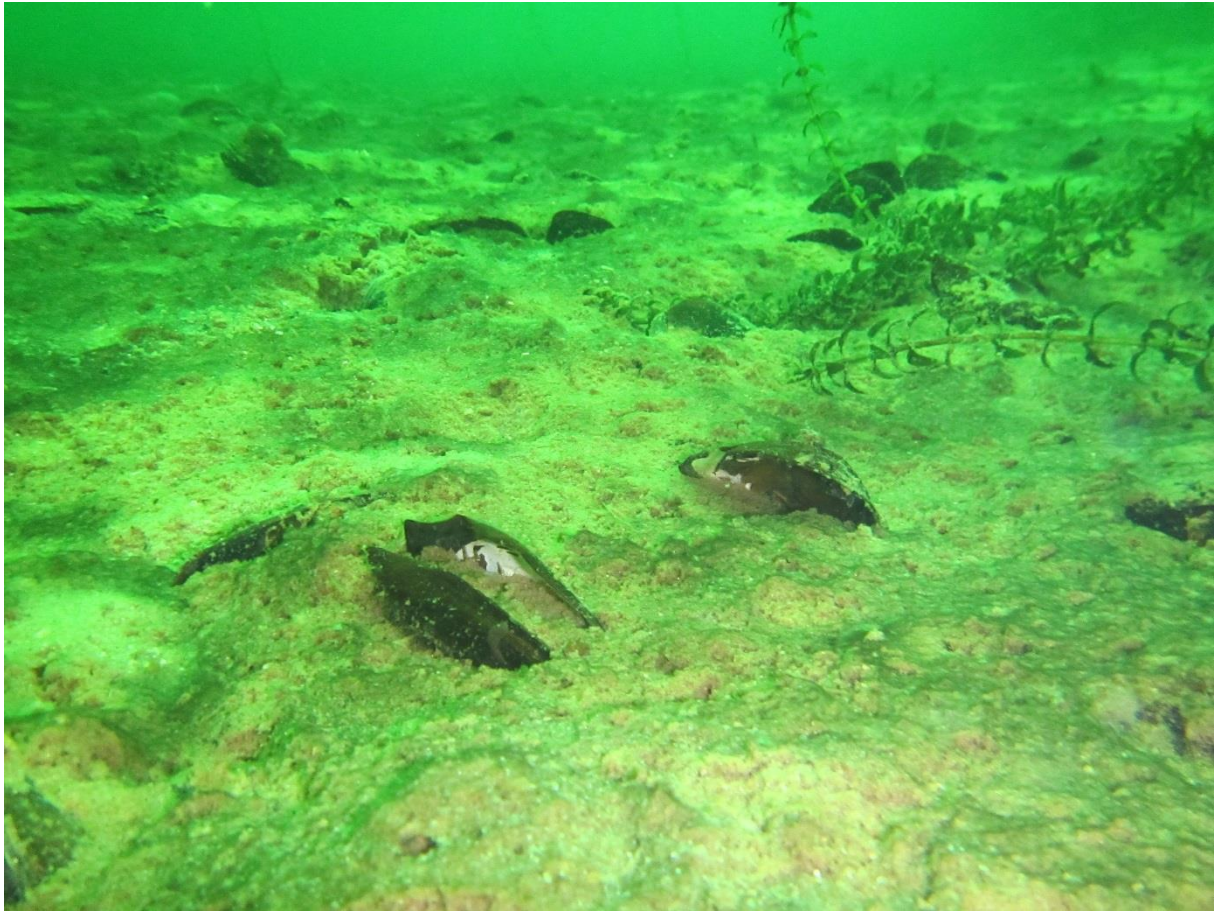
**Figure 16:** Freshwater mussels present beyond the depth of vegetation in Lake Rotokakahi.

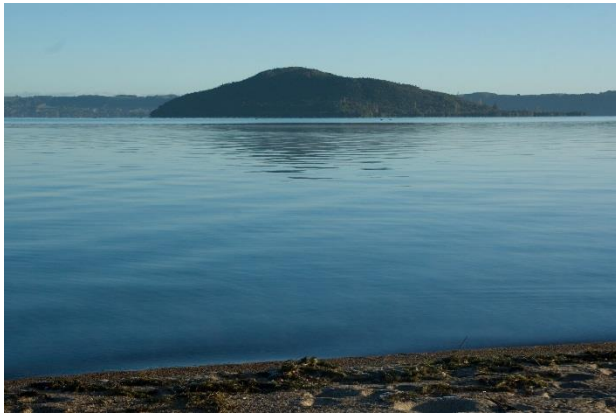
Lake Rotorua is categorised as being in moderate ecological condition with a LakeSPI Index of 28% (Figure 17).

**Figure 17:** LakeSPI results for Lake Rotorua. LakeSPI Indices expressed as a percentage of lake maximum potential.

Having remained in a stable condition since at least 2003, recent LakeSPI results for Lake Rotorua indicate a slight improvement from 2011 to 2015. This is reflected by an increase in the Native Condition Index from 20% in 2011 to 33% in 2015 (Figure 17), similar to results recorded for the lake in 2009. This improvement in Native Condition was largely due to an increase in the depth of native vegetation at all 5 LakeSPI baseline sites.

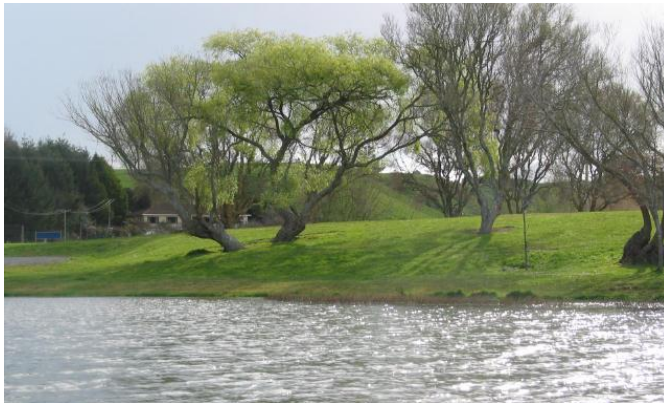
Lake Ōkaro is categorised as being in moderate ecological condition with a LakeSPI Index of 28% (Figure 18).

**Figure 18:** LakeSPI results for Lake Ōkaro. LakeSPI Indices expressed as a percentage of lake maximum potential.

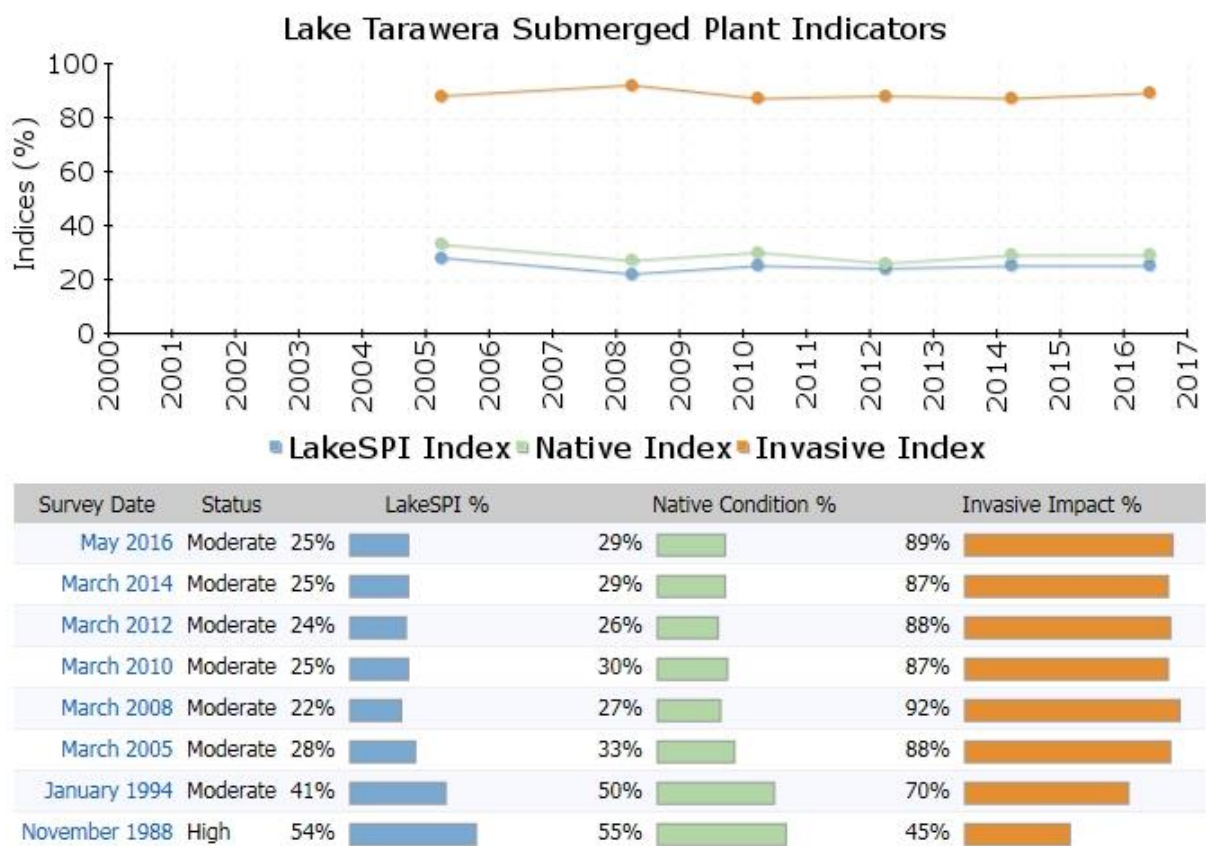
**Figure 19:** LakeSPI results for Lake Tarawera. LakeSPI Indices expressed as a percentage of lake maximum potential.

Lake Tarawera is categorised as being in moderate ecological condition with a LakeSPI Index of 25% (Figure 19).

Lake Tarawera has remained in a moderate but stable condition since 2008. Prior to this, results showed a significant reduction in the LakeSPI Index from 1988 to 2005 (Figure 19) with the invasion of hornwort (*Ceratophyllum demersum*). Today hornwort dominates the submerged vegetation in Lake Tarawera down to a maximum depth of 13 m, and more recent change has been small since the full impact of hornwort has now taken place.

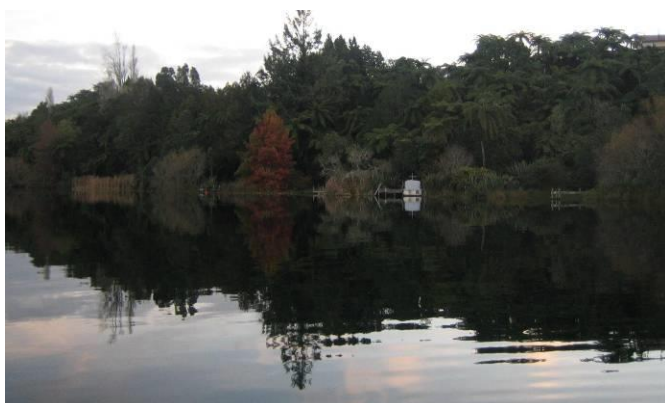
Lake Rotoiti is categorised as being in moderate ecological condition with a LakeSPI Index of 20% (Figure 20).

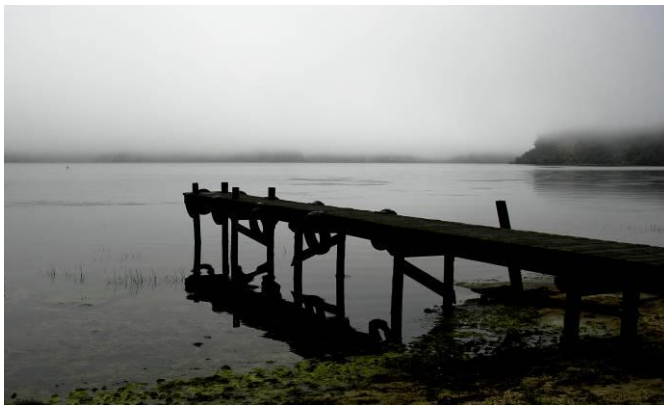
Lake Rotoehu is categorised as being in poor ecological condition with a LakeSPI Index of 19% (Figure 21).

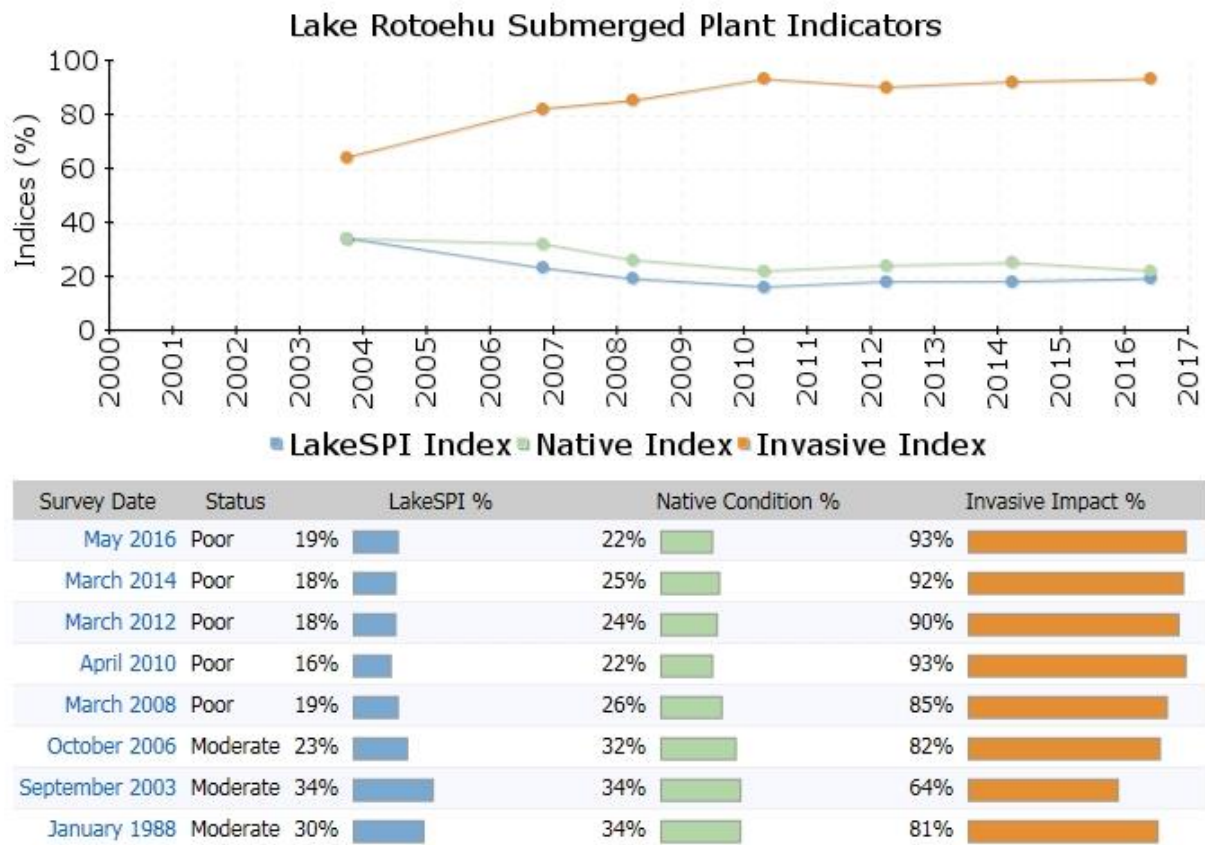
**Figure 21:** LakeSPI results for Lake Rotoehu. LakeSPI Indices expressed as a percentage of lake maximum potential.

Hornwort (*Ceratophyllum demersum*) dominates the submerged vegetation in Lake Rotoehu, which continues to have the lowest LakeSPI Index (19%) and the highest Invasive Impact Index (93%) recorded for any of the 12 Rotorua Te Arawa lakes (Figure 21). In 2016 the lake is in a poor, but stable condition, as the full impact of hornwort has taken place.

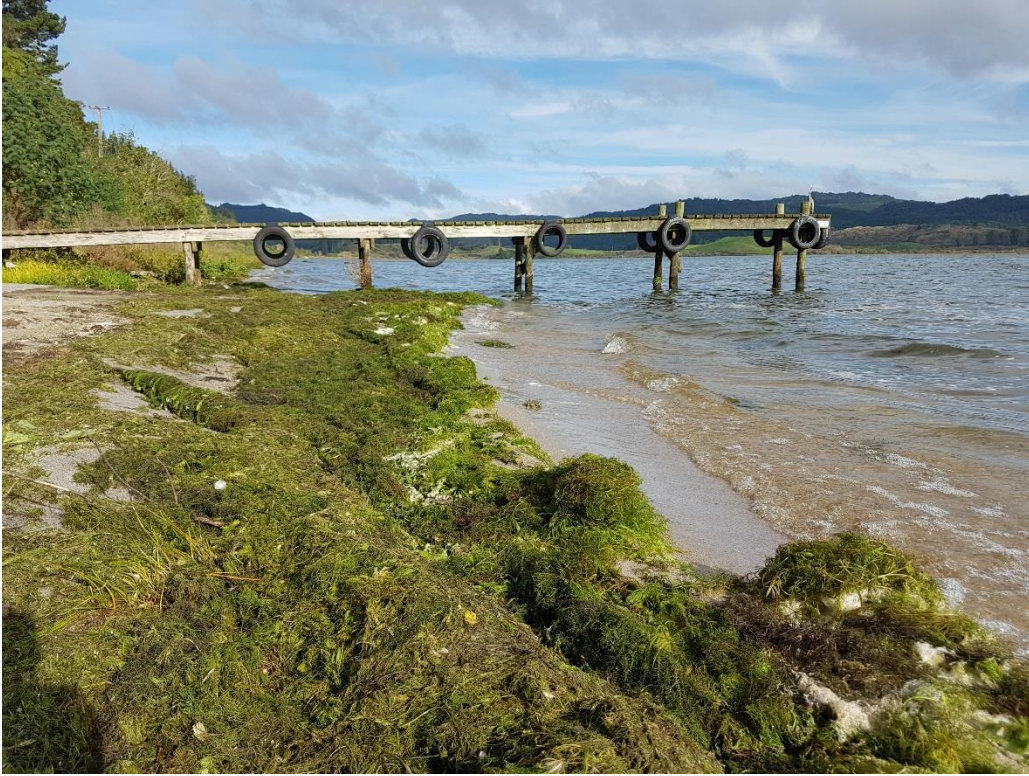
**Figure 22:** Hornwort strandings on the shore of Lake Rotoehu in 2016.
