Assessment of the Rotorua Te Arawa lakes using LakeSPI – 2017

Prepared for Bay of Plenty Regional Council

NIWA CLIENT REPORT No: 2017336HN
Report date: September 2017
NIWA Project: BOP17224

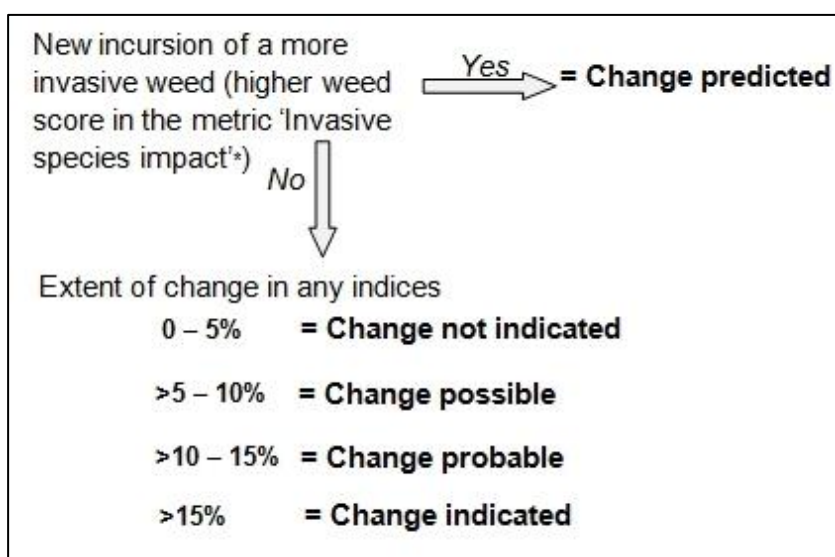
Figure 2-1: Guidelines assessing the significance of change in LakeSPI Indices over multiple surveys of a lake.

Change can also be assessed over longer time frames and multiple surveys. Guidelines (Figure 3) based on expert judgement suggest a scale of probabilities for determining the ecologically significance of change in lake condition, using averaged LakeSPI indices over repeated surveys. These guidelines have considered variation by different observers and the response of LakeSPI scores to major ecological events in lakes. The significance for the various levels of change are:

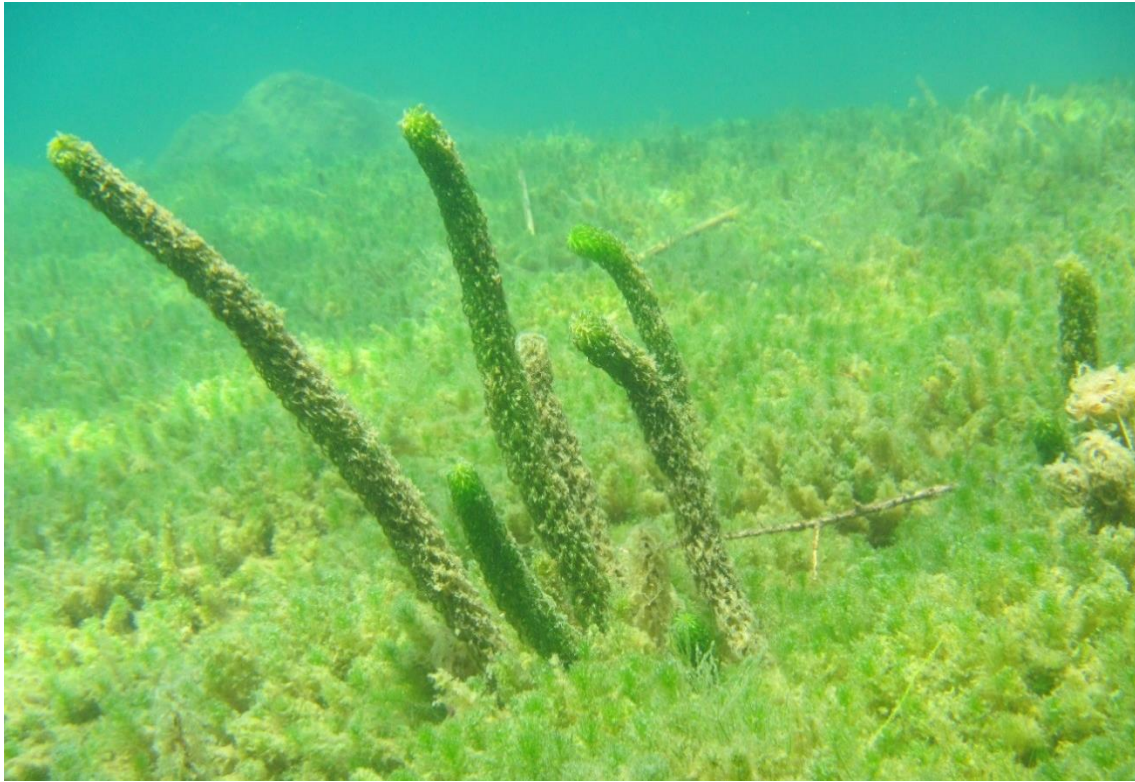
Figure 3-5: Lagarosiphon shoots growing amongst charophyte (*Chara fibrosa*) meadows in Lake Rotomā.

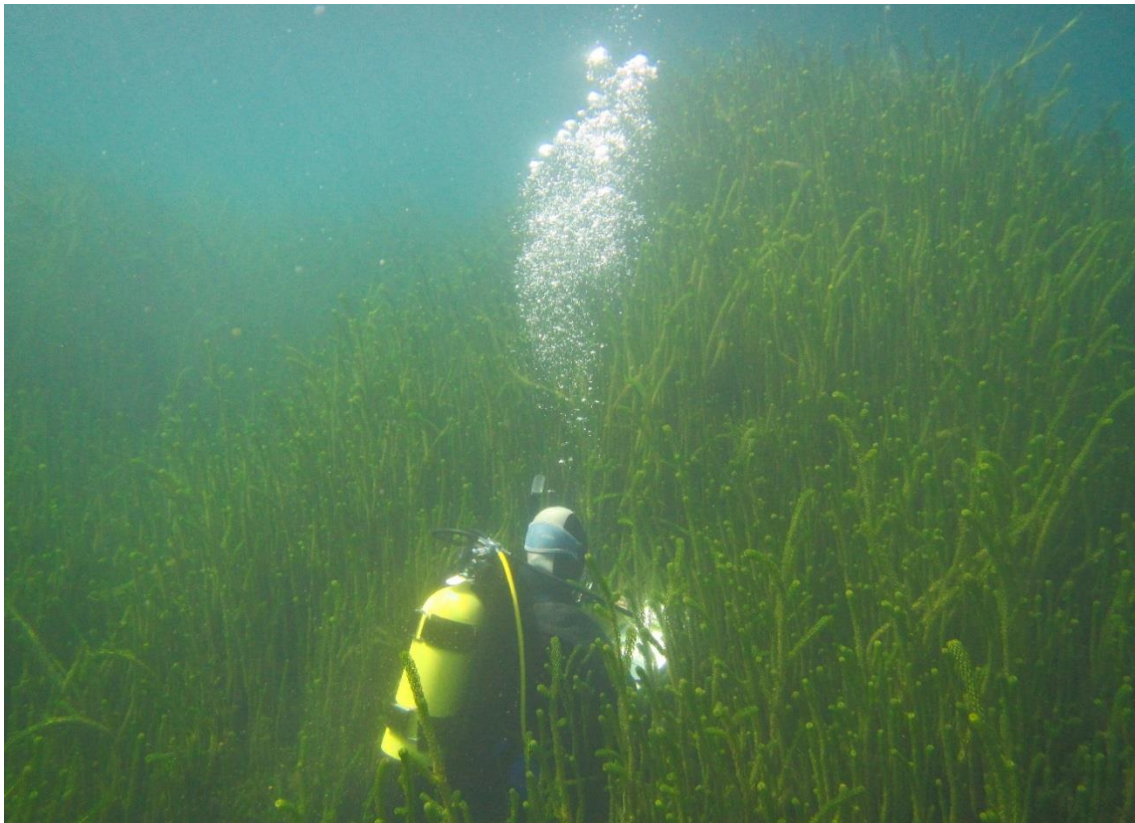
Figure 3-6: Lagarosiphon forming a dense tall weed bed in Lake Rotomā.

Lagarosiphon (*Lagarosiphon major*) was the only invasive weed species observed during the survey and was present at all five LakeSPI sites. It formed high cover weed beds at four of the five sites to a maximum depth of 6.1 m, with low covers at one other. At most sites, it did not grow particularly tall (c. 1.3 m in height), but did grow up to 3 m tall at one site on the northern side of lake (Figure 3-6).

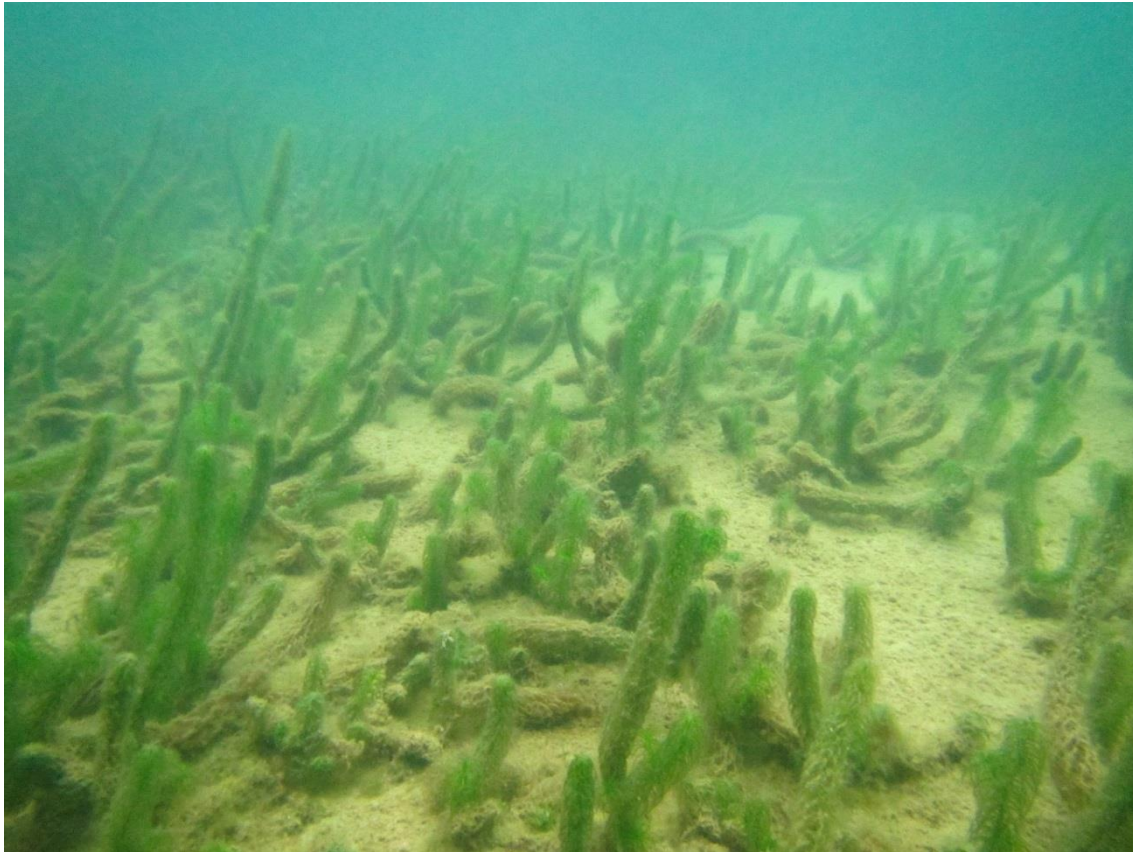
Figure 3-13: Lagarosiphon forms variable covers in Lake Tikitapu to a maximum depth of 4.7 m..

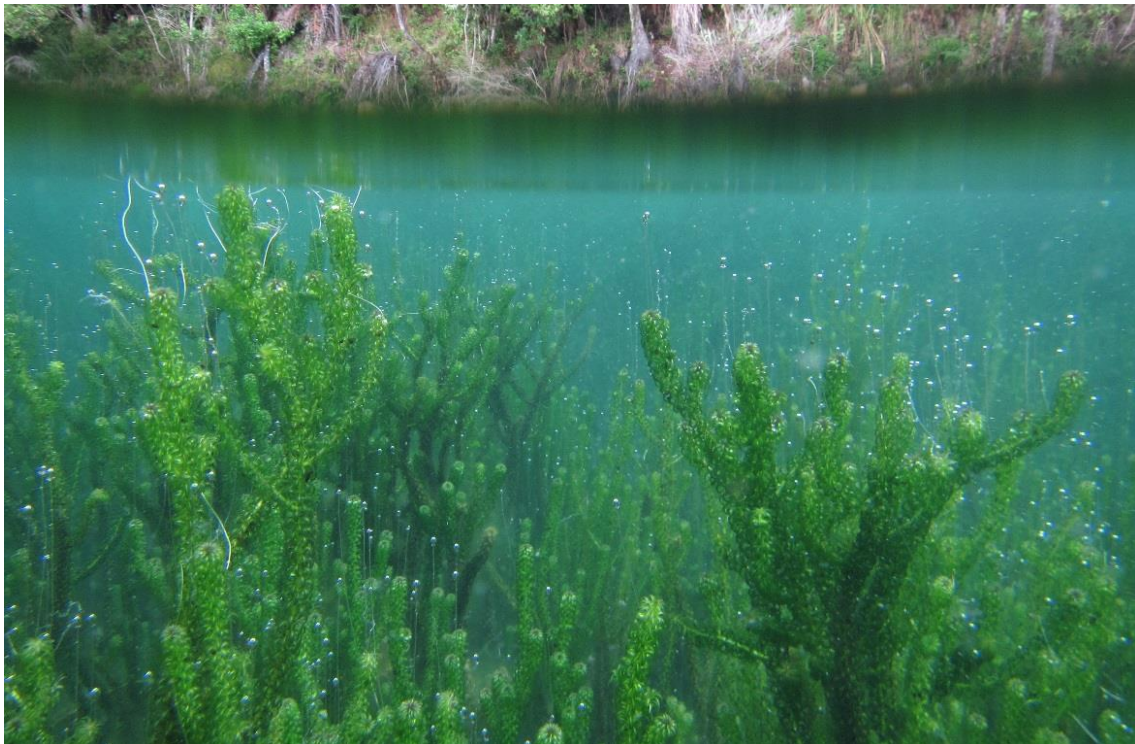
Figure 3-16: Surface reaching weed bed of lagarosiphon in Lake Ōkataina.

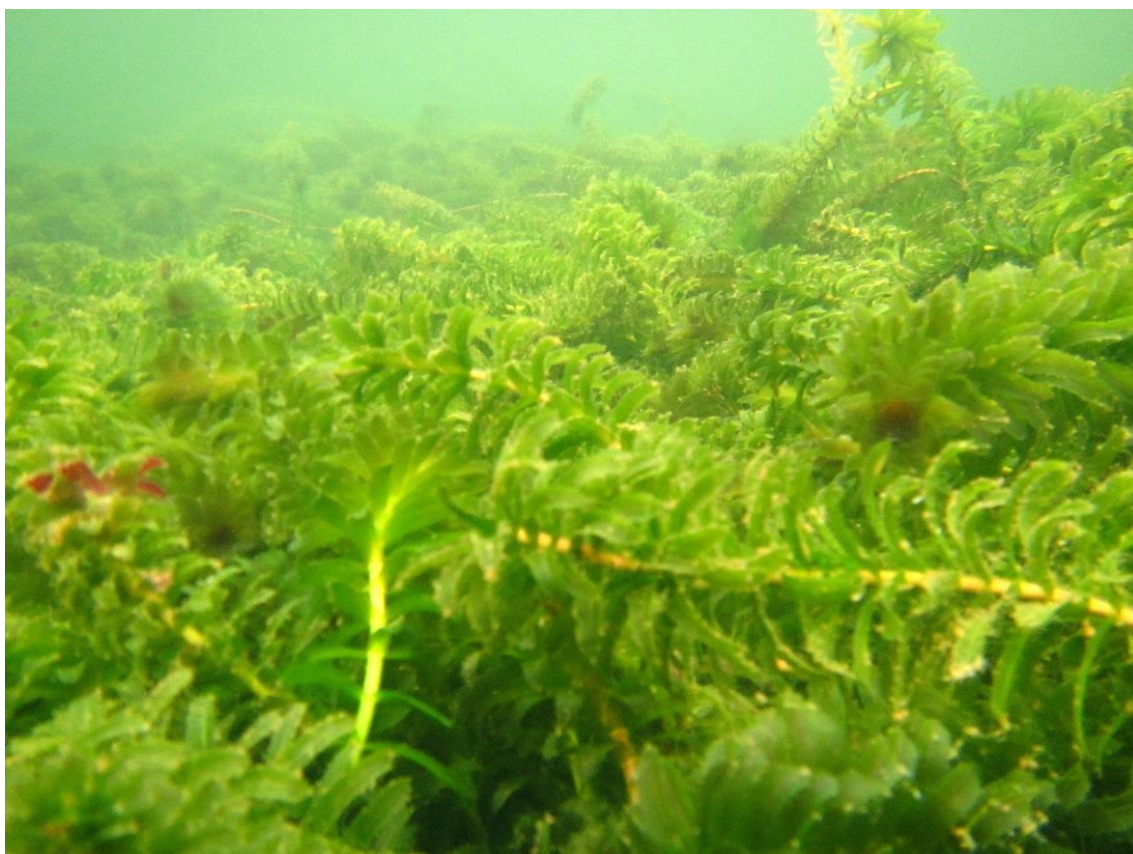
Figure 3-18: Egeria beds dominated the vegetation in Lake Rerewhakaaitu.

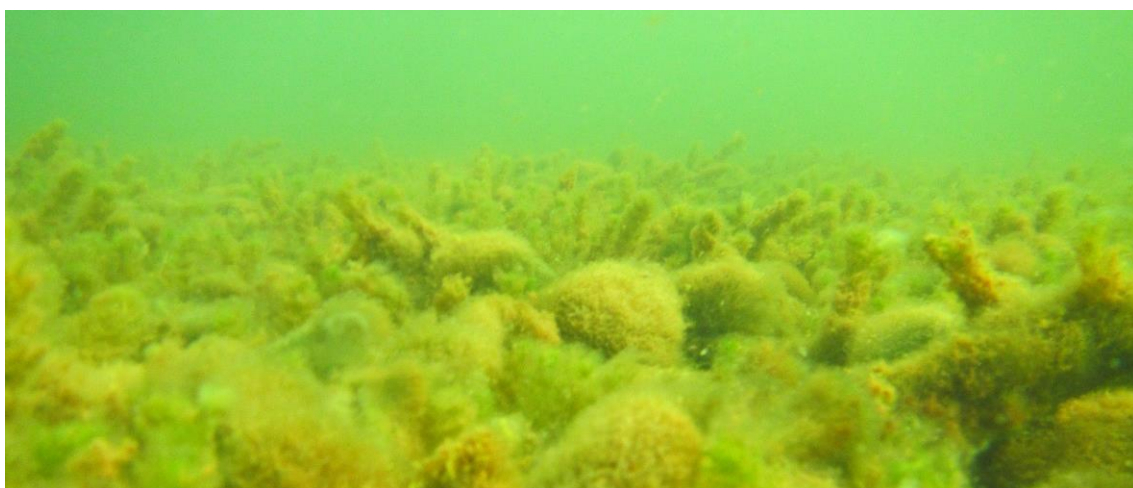
Figure 3-19: Algae covering native plants in the shallows (<2 m depth) of Lake Rerewhakaaitu.

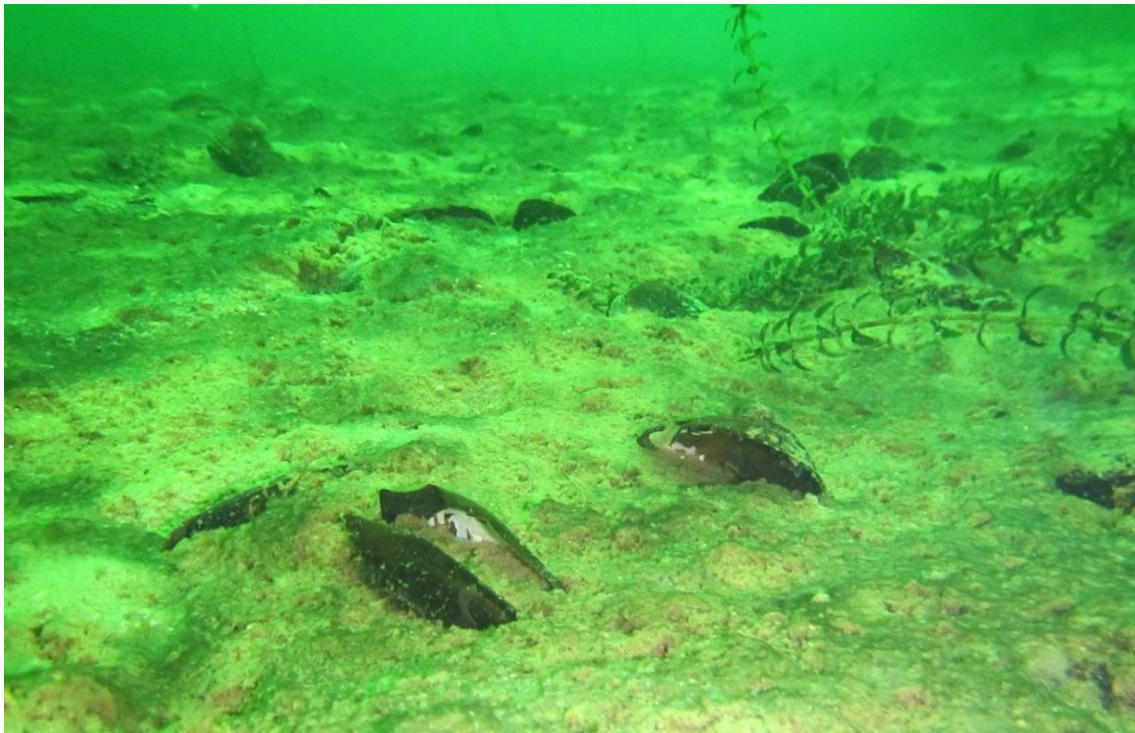
Figure 3-22: Freshwater mussels present beyond the depth of vegetation in Lake Rotokakahi at c. 8.5 m.

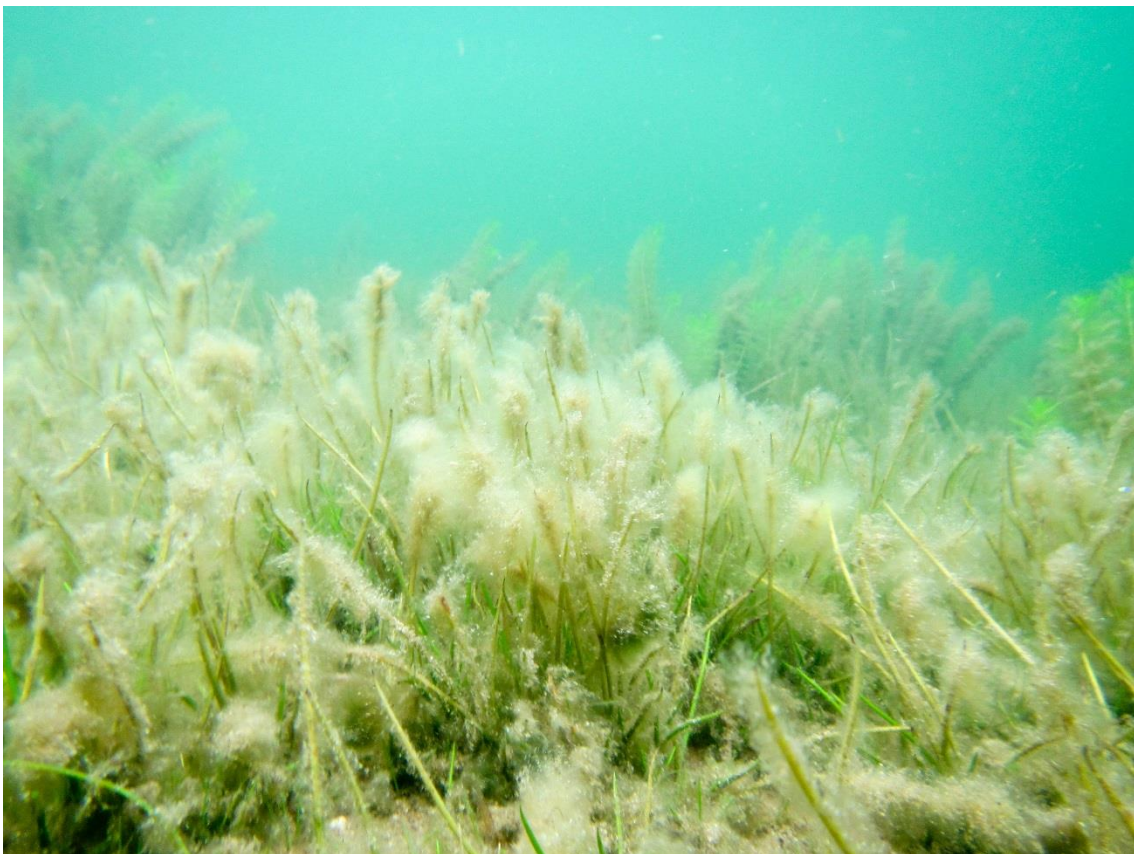
Figure 3-29: A thick layer of algae covers Isoetes growing in the shallows of Lake Rotoiti.

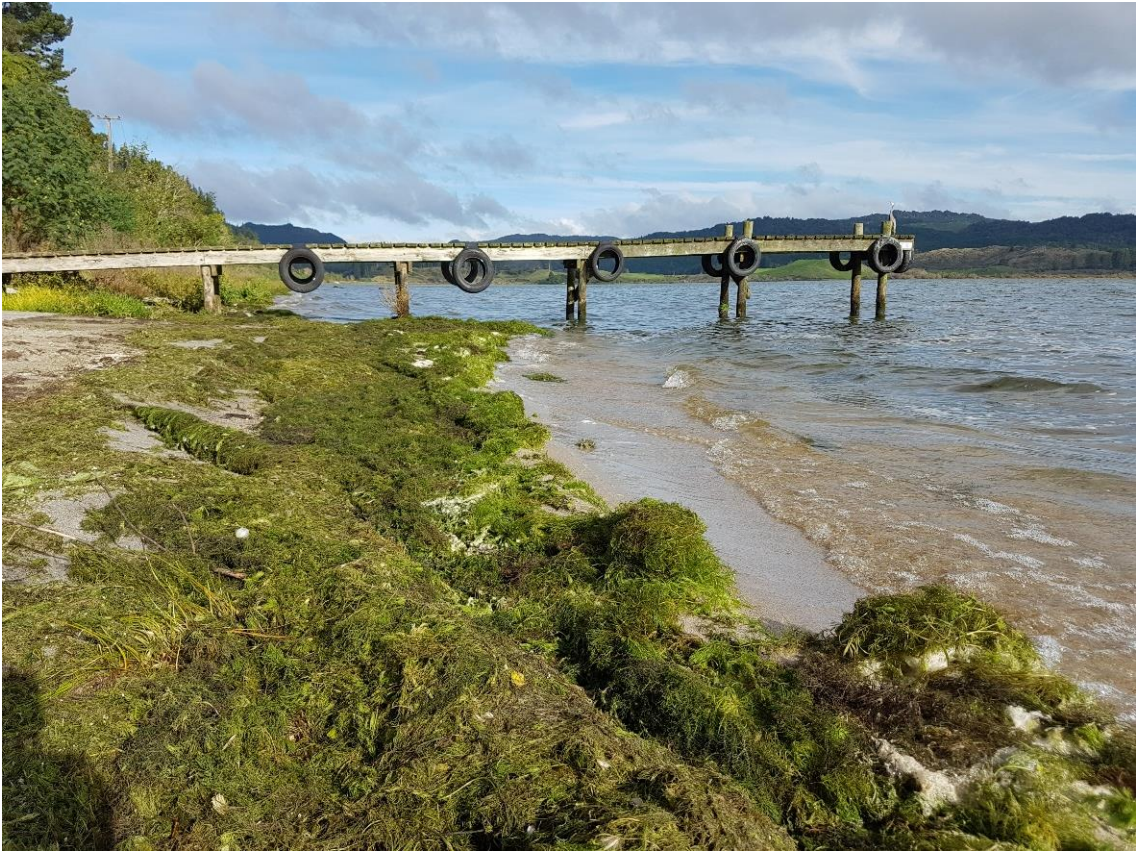
Figure 3-31: Hornwort stranding on the shore of Lake Rotoehu in 2016.

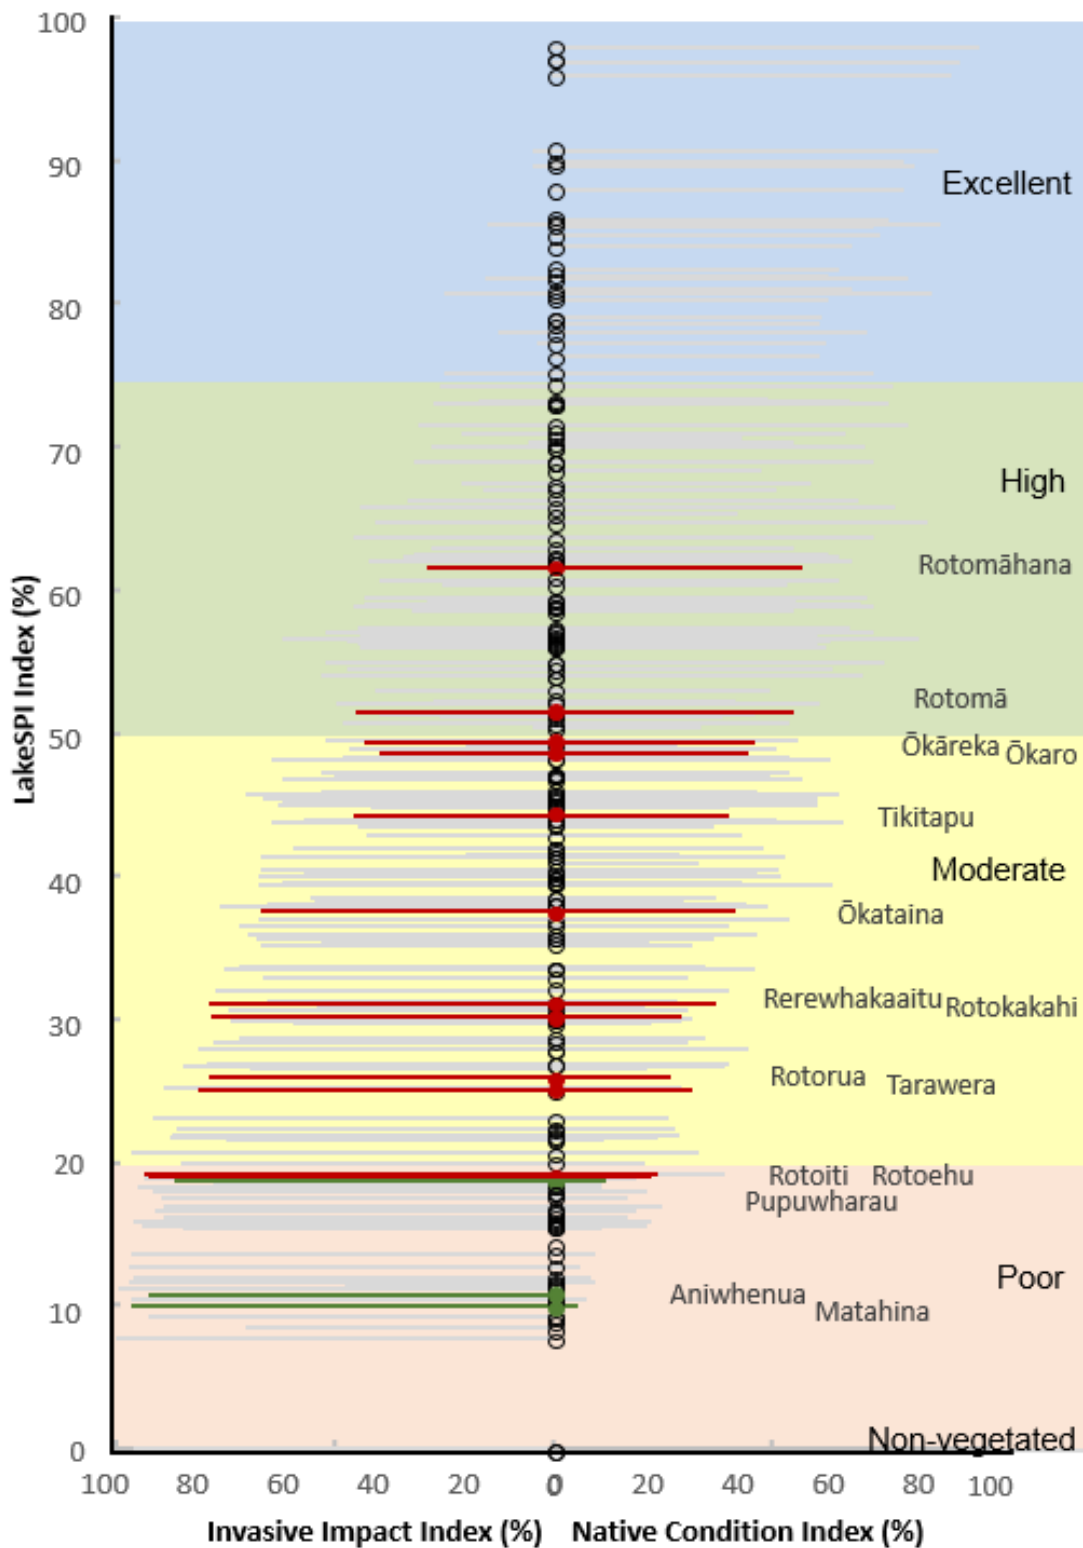
Figure 4-2: Rotorua Te Arawa Lakes (red lines) and 3 other lakes in the Bay of Plenty Region (green lines) are plotted with scores for a total of 283 New Zealand lakes. The most recent LakeSPI scores for lakes for the Rotorua the LakeSPI Index is plotted on the y-axis (points), Native Condition Index as lines to the right and Invasive Impact Index lines to the left of the x-axis. Five categories of LakeSPI condition are indicated by labelled colour bands.

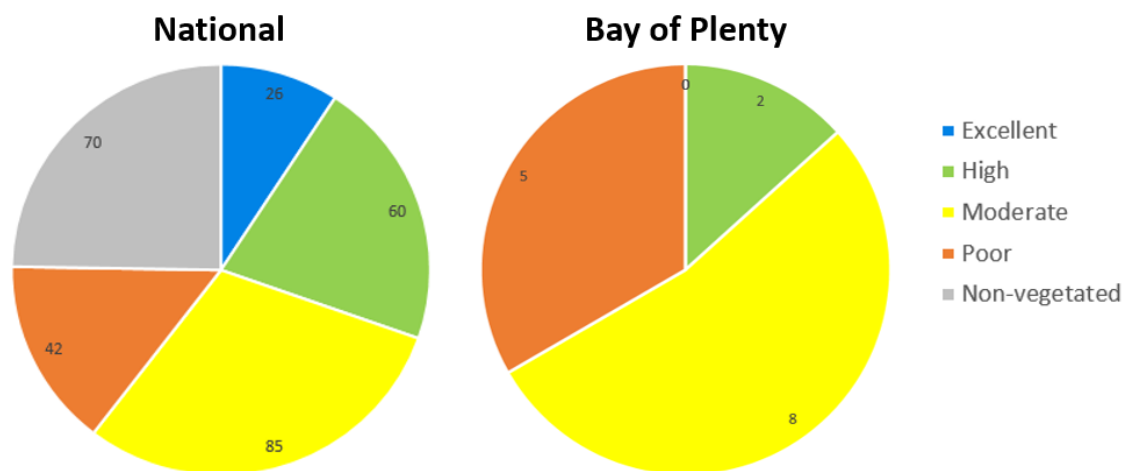
Figure 4-3: Proportion of lakes that fall into each of five categories of LakeSPI Index for the region (15) and nationally (283), with the number of lakes assessed shown in parenthesis.
