**Peer review of report: "The significance of sediment stored behind log jams to the 2005 Awatarariki debris flow; implications for risk management" by Prof. Tim Davies**

Prepared for: Whakatāne District Council

**April 2018**

### **THE SIGNIFICANCE OF SEDIMENT STORED BEHIND LOG DAMS TO THE 2005 AWATARARIKI DEBRIS FLOW; IMPLICATIONS FOR RISK MANAGEMENT**

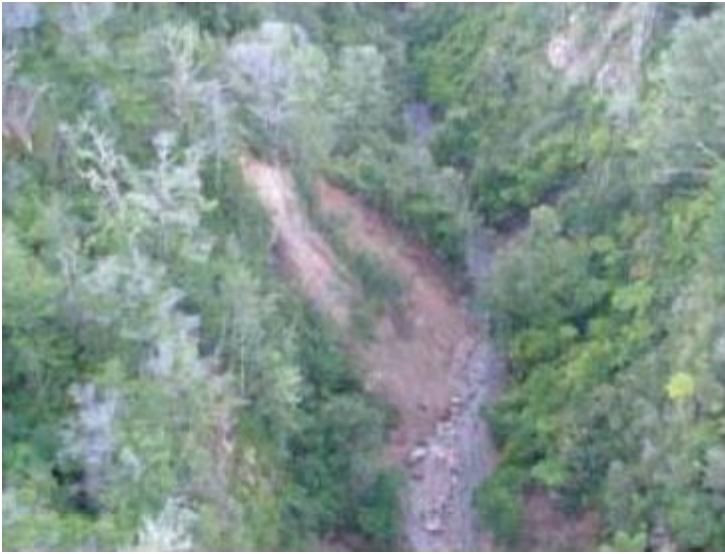
**Figure A1. Debris avalanche from slope into stream.**

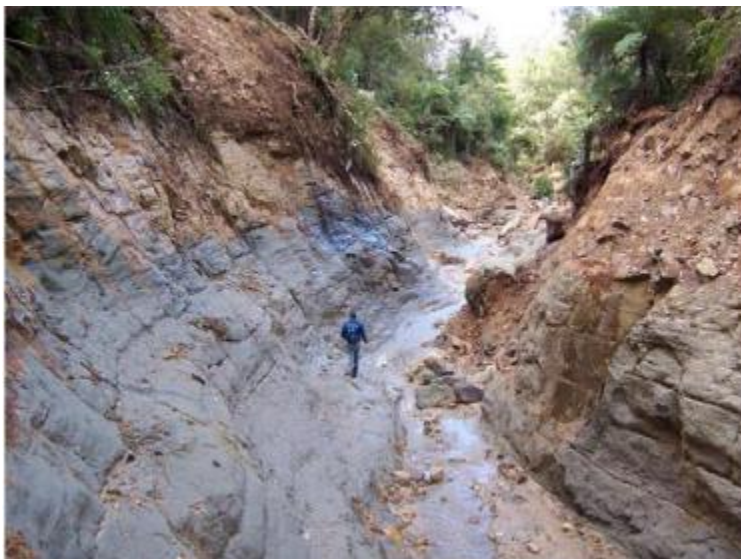
**Figure A2. Stream bed sediment several meters deep eroded to bedrock by debris flow**

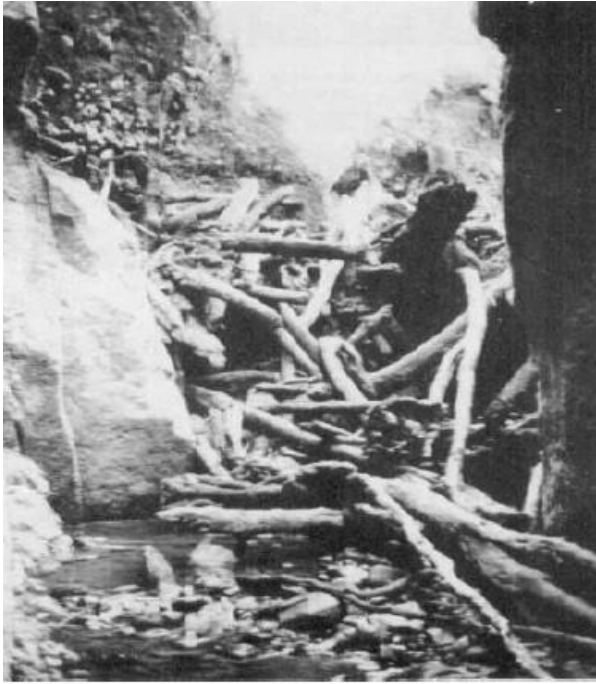
**Figure A3. Log-jam in Blackjacks Creek, Notown in 1979. Jam height is 6.4 m (Pearce and Watson, 1983)**
