**BEFORE THE BAY OF PLENTY REGIONAL COUNCIL**

**IN THE MATTER OF** resource consent applications by the Western Bay of  
Plenty District Council for the continued operation of,  
and discharge of treated wastewater from, the Te Puke  
Wastewater Treatment Plant

**STATEMENT OF EVIDENCE OF FIONA DAVIES  
ON BEHALF OF WESTERN BAY OF PLENTY DISTRICT COUNCIL**

**Ecology**

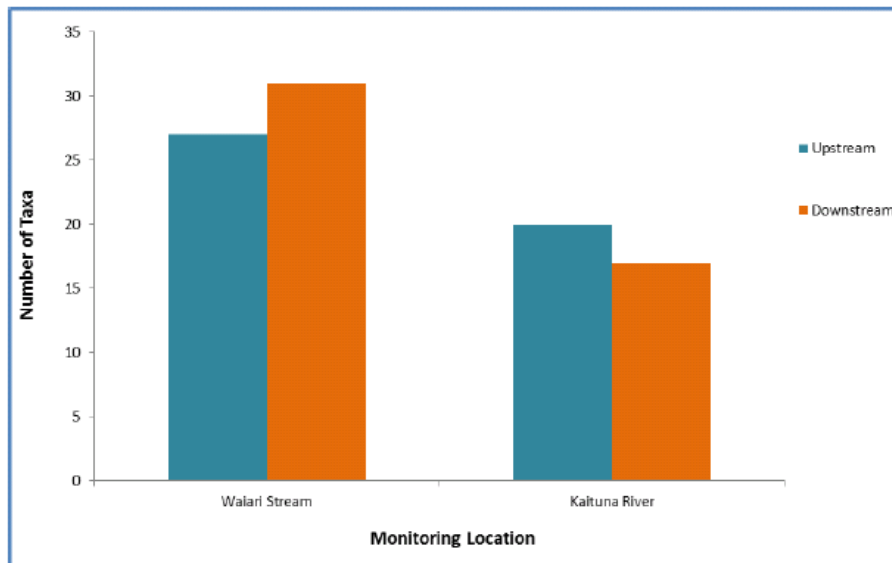
**Figure 1 – Taxonomic Richness Recorded in 2015**

21. Figure 1 in Schedule 1 to my evidence shows the results with respect to taxonomic diversity. The diversity of macroinvertebrate communities is much greater at the Waiari Stream locations compared to the Kaituna River. However, the diversity is similar between upstream and downstream sites within the same waterbody.

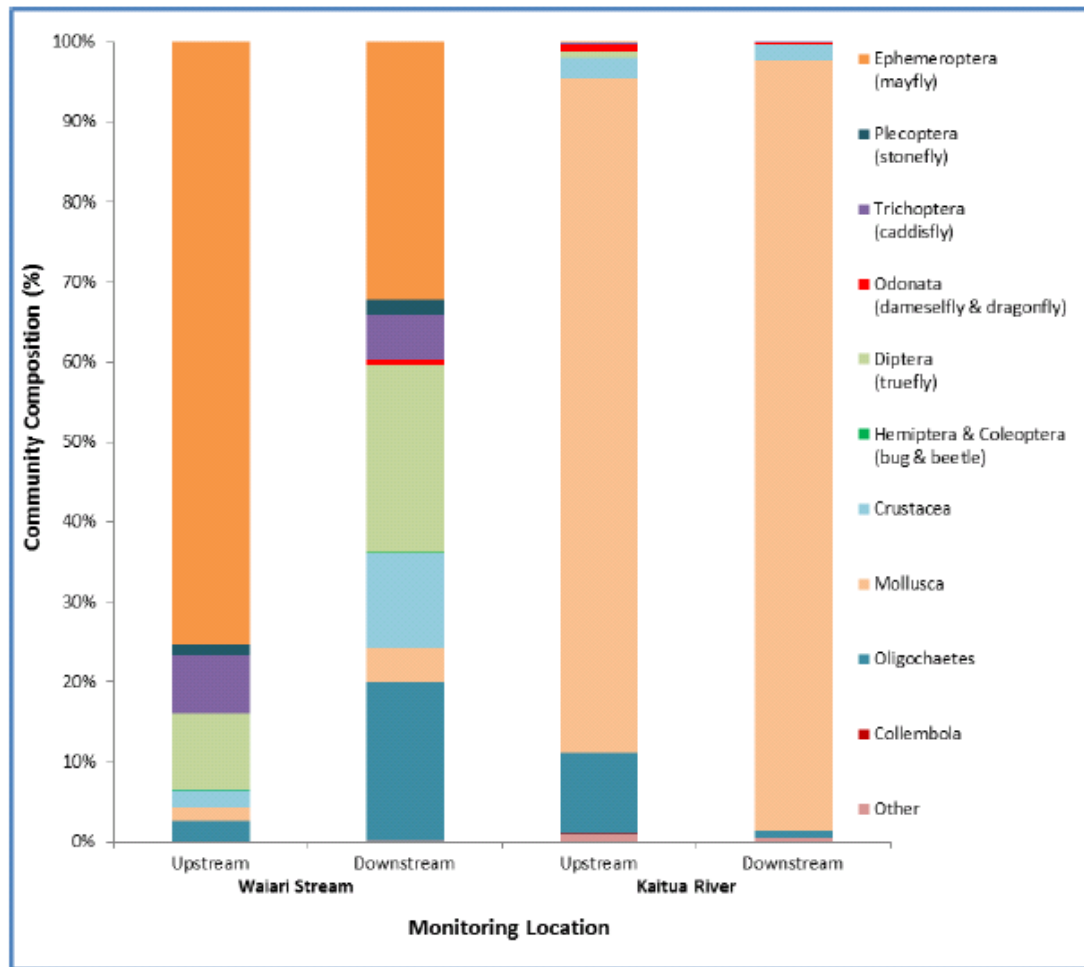
**Figure 3 – Macroinvertebrate Community Composition (%) Recorded in 2015**

23. Figure 3 in Schedule 1 to my evidence shows the results with respect to community composition. There were differences in the macroinvertebrate community composition between the Waiari Stream upstream and downstream sites, as follows:

- (a) The upstream site had a higher proportion of Ephemeroptera/mayfly, Plecoptera/stonefly, Trichoptera/caddisfly (EPT) species that are generally associated with higher quality streams (84% for upstream and 40% downstream). Mayfly was found to be the most dominant species at both sites (75% upstream and 32% downstream).

- (b) The upstream site had a smaller proportion of pollution tolerant taxa such as the truefly, oligochaetes, crustacea and mollusca compared with the downstream site (16% and 60% respectively). Based on these results, the upstream site consisted of a greater proportion of higher scoring species.

24. In comparison, the Kaituna River was absent of EPT species and was dominated by molluscs, oligochaetes and crustacea which are species that are tolerant of nutrient enriched waters. The results show a similar composition between upstream and downstream sites.

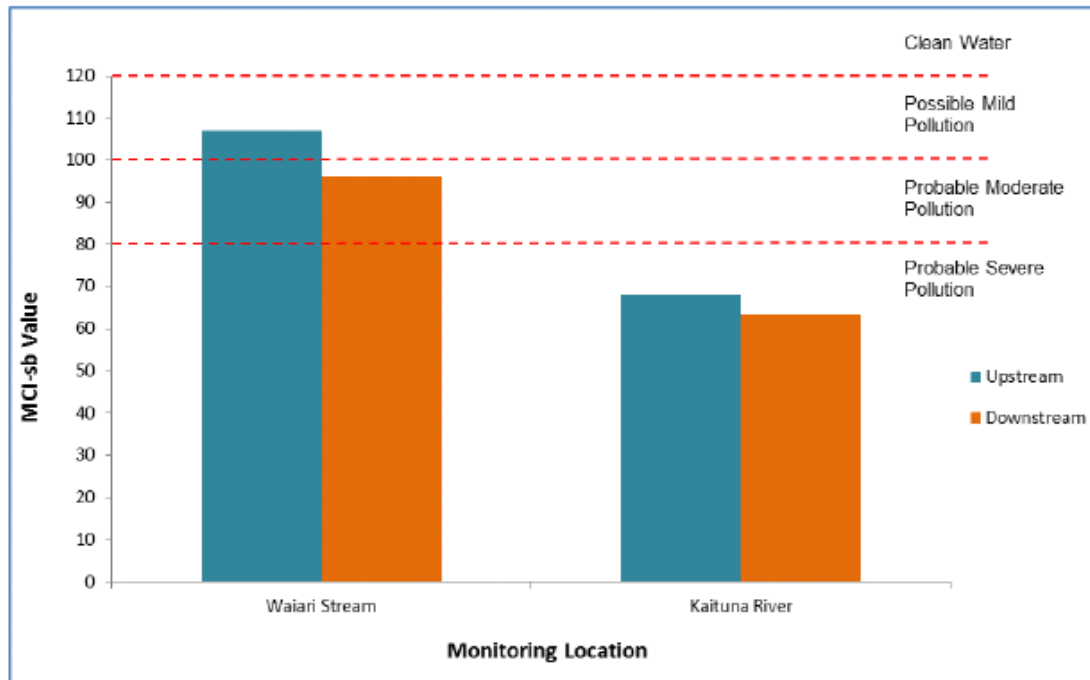
**Figure 4 – MCI-Sb Values Calculated from Macroinvertebrate Community Data Recorded in 2015**

25. Figure 4 in Schedule 1 to my evidence shows the results with respect to MCI-sb values, taken from the WQ Assessment. The MCI-sb results (macroinvertebrate community index, soft bottomed streams) between the Waiari Stream upstream and downstream sites differed by 10 points (out of 120 = 8%). The upstream value was 107, indicating a stream with 'Possible Mild Pollution'. The downstream value was 97, indicating a stream with 'Probable Moderate Pollution'. Species presence alone (and not abundance) is used in the scoring of MCI values.

26. The MCI-sb results for the Kaituna River were considerably lower than for the Waiari Stream. The upstream and downstream sites were both indicative of a watercourse with Probable Severe Pollution (scoring 68 and 64 respectively).

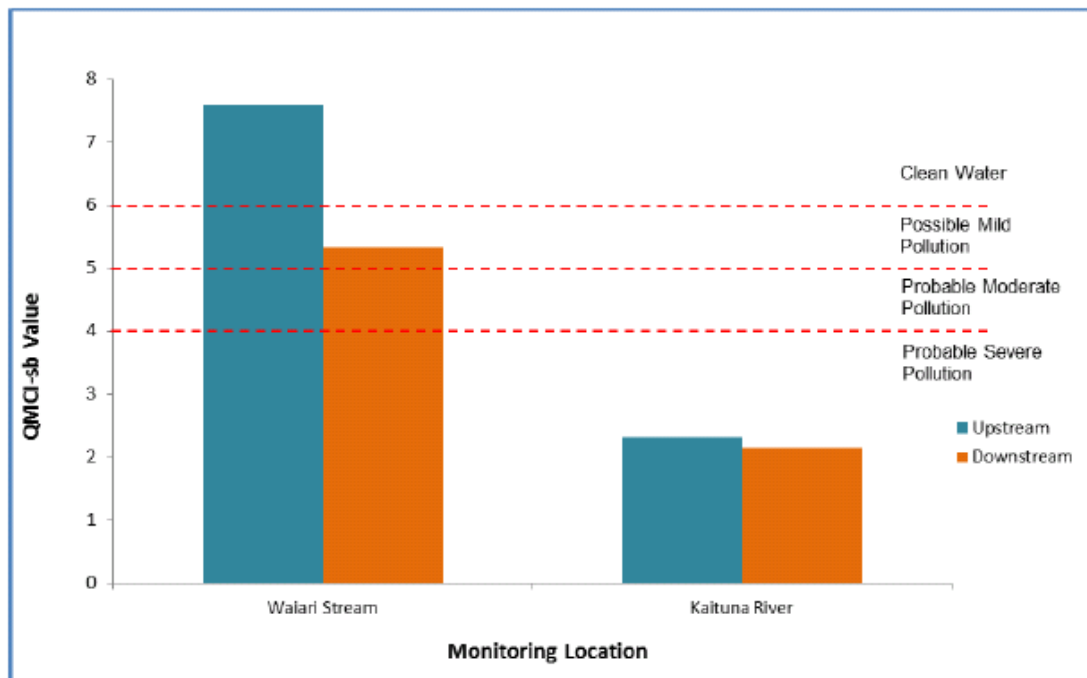
**Figure 5 – QMCI-sb Values Calculated from Macroinvertebrate Community Data Recorded in 2015**

27. Figure 5 in Schedule 1 to my evidence shows the results with respect to QMCI-sb values. The QMCI-sb results (quantitative macroinvertebrate community index, soft bottomed streams) show more obvious differences between the Waiari Stream upstream and downstream sites, which differ by 2.3 (out of 8 = 29%). The upstream value was 7.6, indicating 'Clean Water'. The downstream value was 5.2, indicating 'Possible Mild Pollution'. The QMCI index uses abundance in the scoring and is often used for long term monitoring programmes.

28. The QMCI-sb results for the Kaituna River were considerably lower than for the Waiari Stream. The upstream and downstream sites were both indicative of a watercourse with 'Probable Severe Pollution' (scoring 7.6 and 5.3 respectively).
29. I note that sampling for macroinvertebrates at the upstream and downstream Waiari Stream sites was made up of approximately the same amount of substrate type (10 fixed areas of 0.3m<sup>2</sup>) – wood debris, submerged macrophytes, emergent macrophytes and bankside vegetation. I consider that this means any differences between samples are not due to differences in substrate sampled.

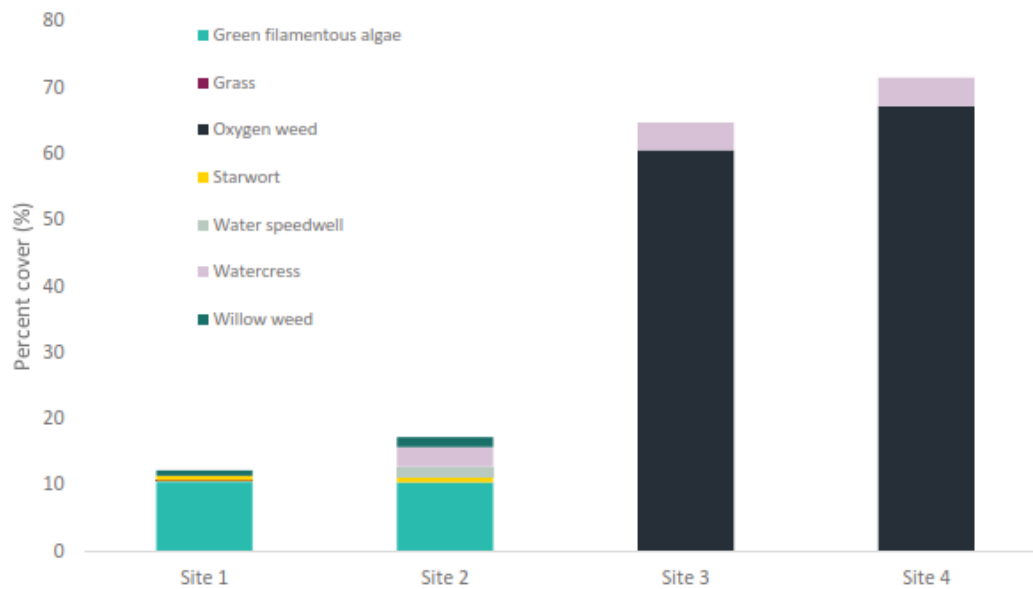
**Figure 11 – Macrophyte community composition and percentage stream cover**

49. At Sites 3 and 4 the exotic oxygen weed *Elodea canadensis* was the dominant macrophyte, covering 60-70% of the Waiari Stream width at each site (Figure 11, Schedule 1). Excessive macrophyte cover (i.e. over 50%) such as this are often indicative of nutrient enriched waters and can have adverse effects on stream ecological health.
50. High water quality was recorded at Sites 3 and 4 (Temperature, Dissolved Oxygen (**DO**), Conductivity, pH and Turbidity were measured) (Figure 12, Schedule 1). No differences between upstream and downstream sites were observed within the results which would indicate an influence from the Te Puke WWTP.
51. Fish species recorded during the survey are included in the fish desktop review below.

63. High densities of macrophyte cover (i.e. over 50%) is often a sign of nutrient loading (particularly in summer low flow) to a stream that contributes to decreased stream ecological health and can effect fish. Extensive oxygen weed (*Elodea*) was observed in the 4Sight 2017 Survey at upstream and downstream sites from the Te Puke WWTP, forming thick expansive beds along stream edges. In my opinion this may be a result of nutrient enrichment and lack of shading, but to some degree also provides valuable shelter for fish.

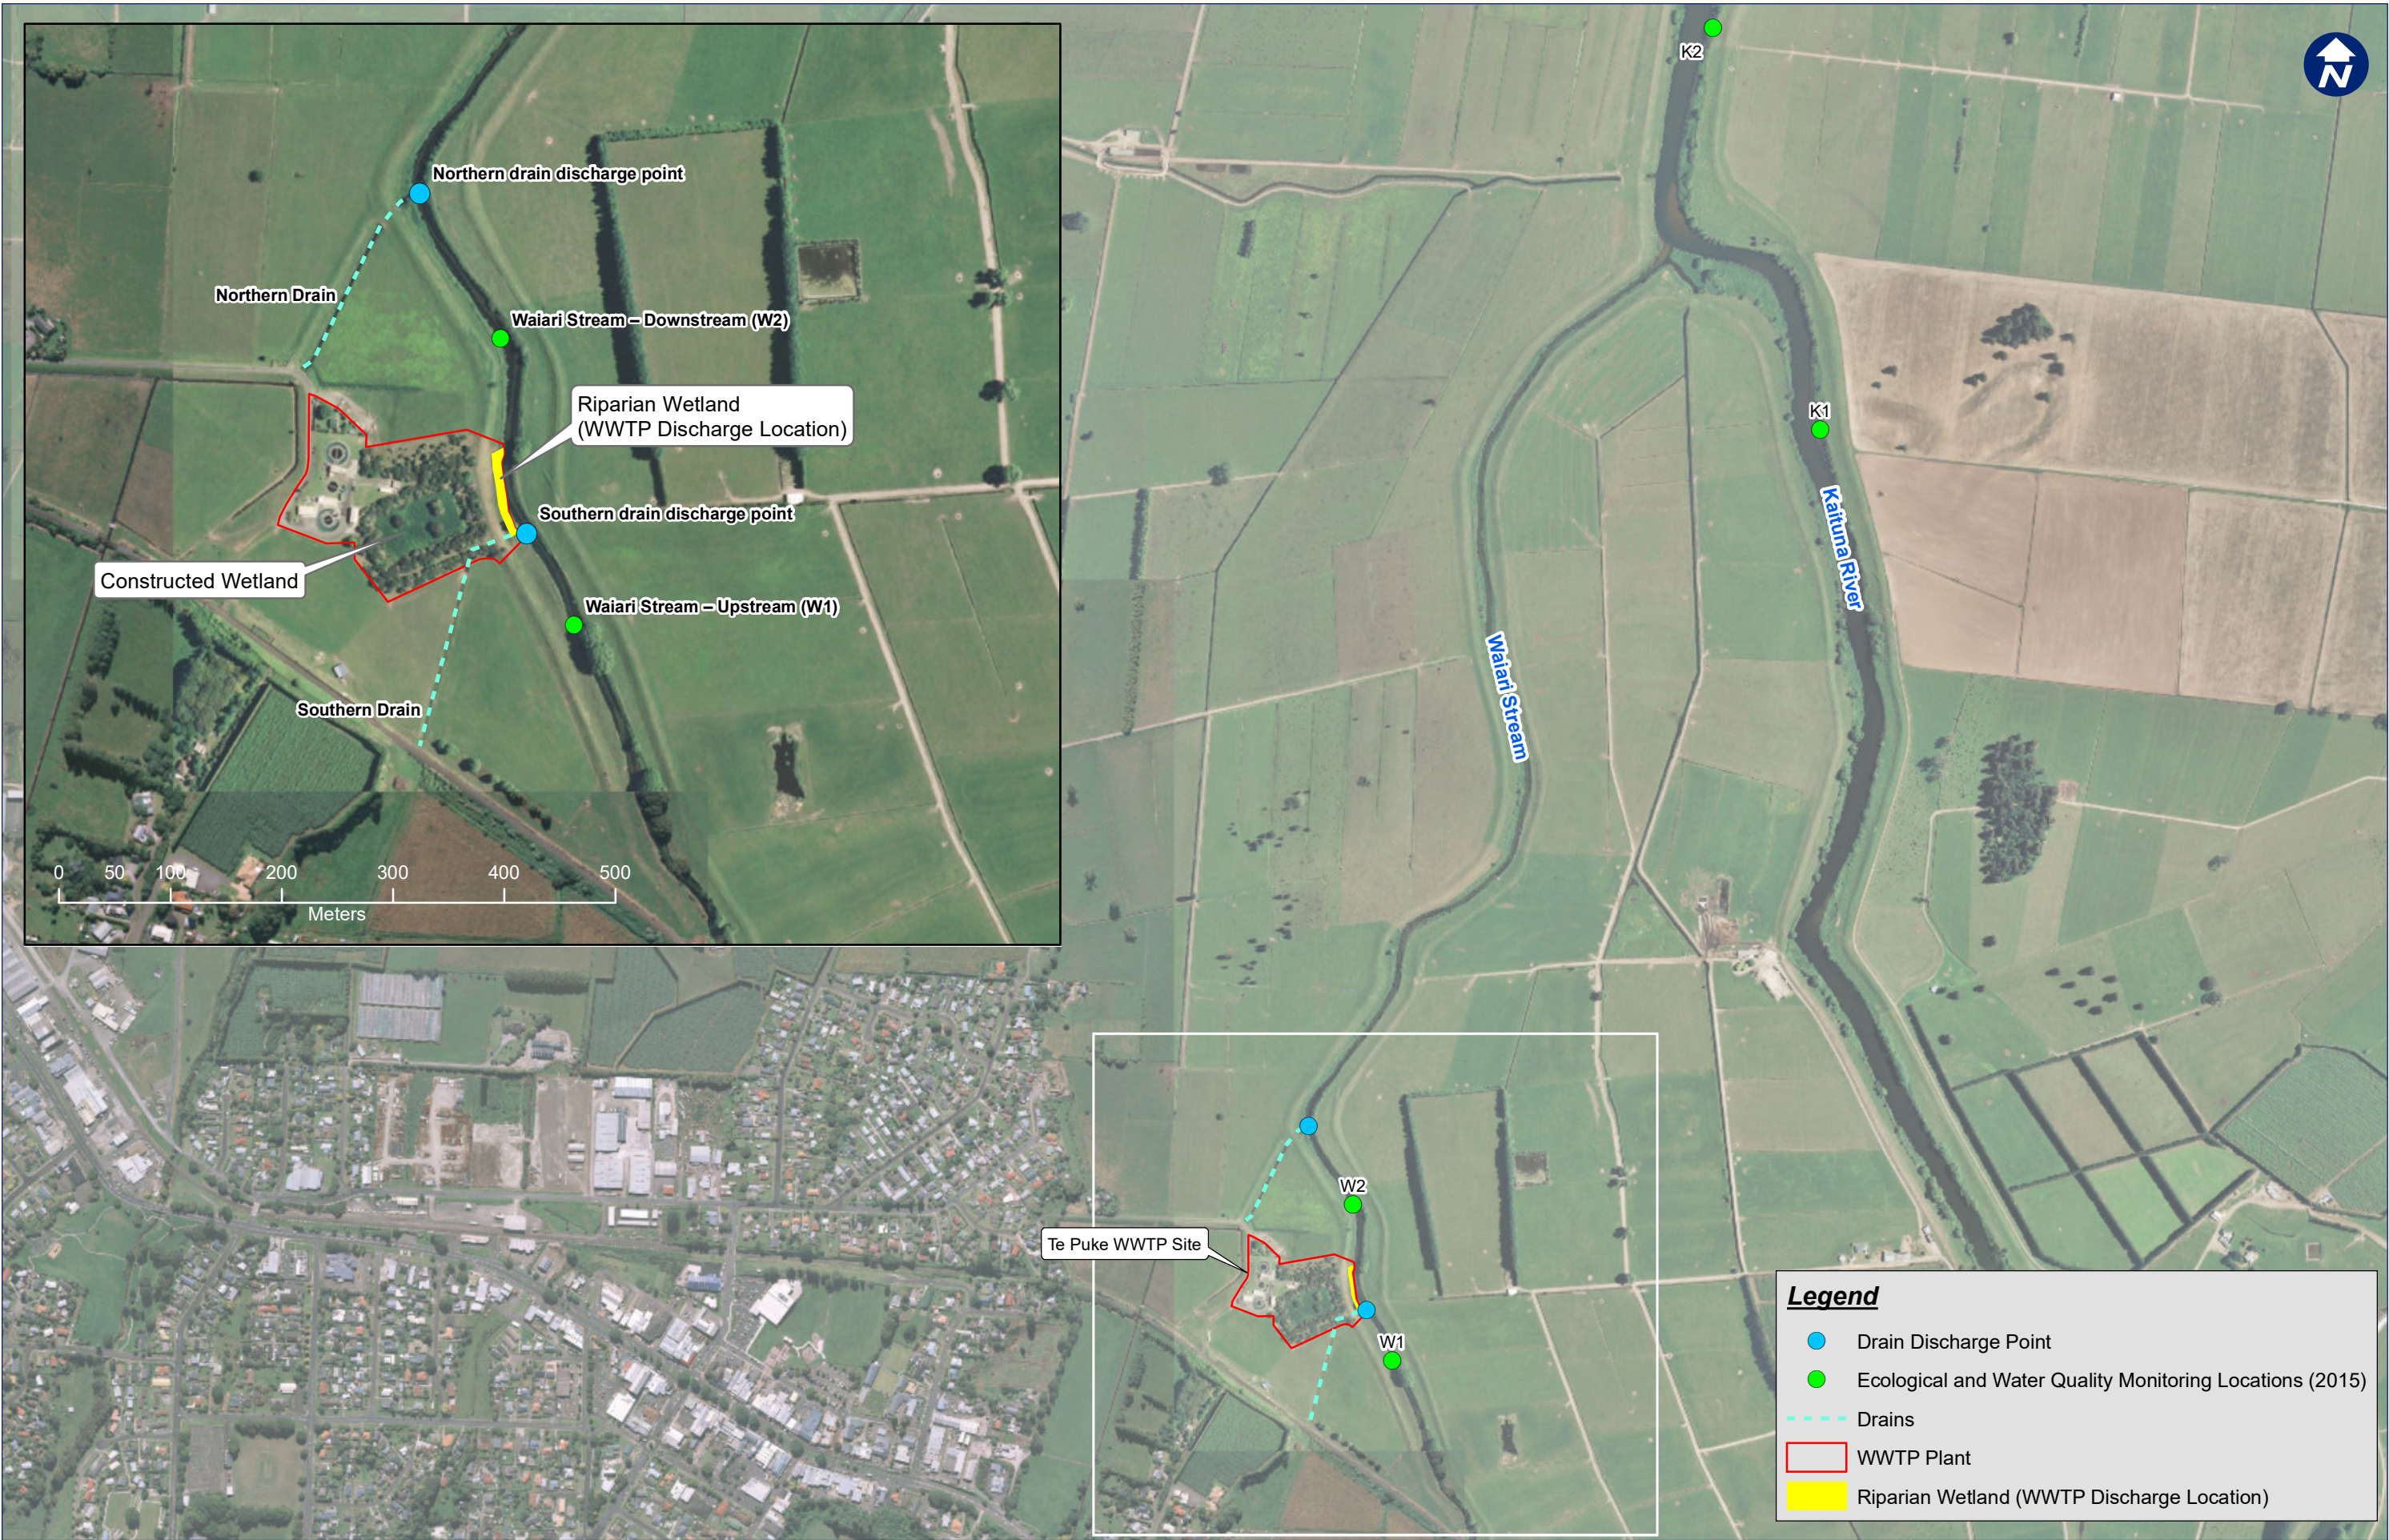
## **Appendix A – Surface Water Monitoring Locations**

Northern Drain”), located approximately 170m downstream of the Te Puke WWTP (refer to Appendix A). This discharge point was further downstream from the W2 downstream monitoring location.

- (a) W1 – Waiari Stream, approximately 100 m upstream of WWTP discharge point.
- (b) W2 – Waiari Stream, approximately 100 m downstream of the Te Puke WWTP discharge point.
- (c) K1 – Kaituna River, approximately 400 m upstream of the Waiari Stream confluence.
- (d) K2 – Kaituna River, approximately 400 m downstream of the Waiari Stream confluence. The Kaituna River was sampled to ascertain whether the effects of the WWTP were having any discernible effects on the downstream reach of the Kaituna River.
