What has been happening?

Mount Maunganui Air Quality

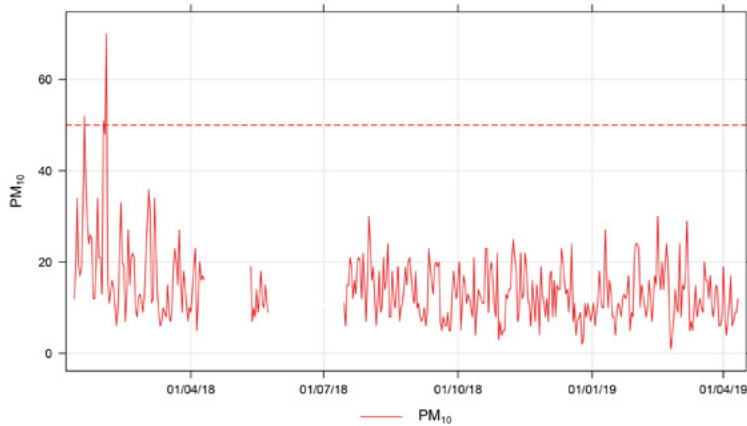
Moses Road 24 hour PM₁₀ (µg m⁻³)

On 9 January 2018, following discussions with local residents, Council staff installed a PM10 monitor. During this time three exceedances of the National Environmental Standards for Air Quality (NES-AQ) were recorded. For the most part though the readings have plateaued with an average value of 14ug/m2.

Note, due to instrument malfunction there are two periods of missing records.

Full 24 hour PM₁₀ timeseries recorded at Moses Road. NES-AQ PM₁₀ standard shown with dashed line.

This is unlike other locations within Rotorua whereby a strong winter time domestic heating signature is present.

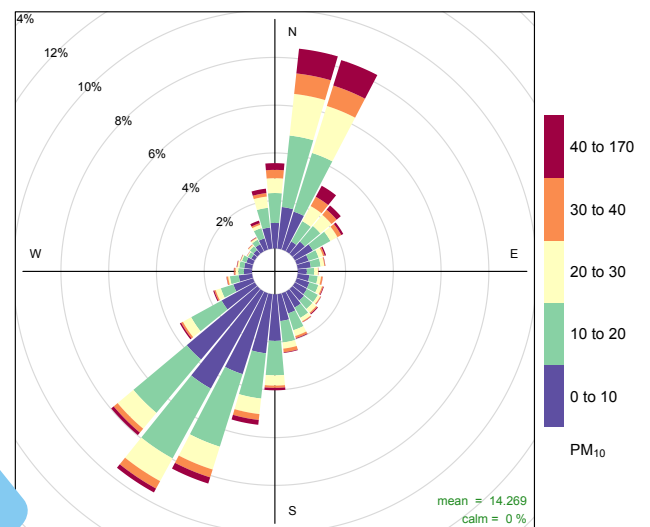
Moses Road 30 minute PM₁₀ (µg m⁻³)

At the Moses Road monitoring location, winds from the northern quadrant could potentially transport particulate matter from McAlpines Ltd timber processing plant to the monitor, if site processes and practices are not well managed (see plot on the right).

The pollution rose for the full period of record shows the typical pattern of wind direction for this area of the region. Directions depending on the time of year are prevalent from the NNE quadrant and the SW quadrant. Winds are less common from the true W and E quadrants. In general windspeeds on average are typically stronger when associated with these prevailing directions.

Elevated levels of PM₁₀ can be recorded from most quadrants which is a result of the activities within this locale (a mixture of residential and industrial zoning).

Pollution rose for full 30 minute PM₁₀ and meteorological recorded at Moses Road.

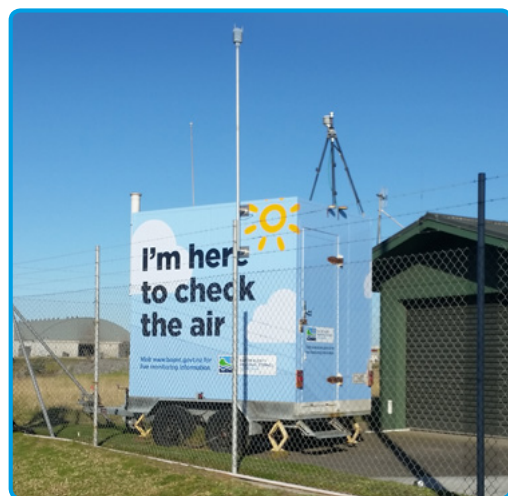
Otumoetai Road, Tauranga

■ Excellent (<10%)
 ■ Good (10-33%)
 ■ Acceptable (33-66%)
 ■ Alert (66-100%)
 ■ Action (100+%)

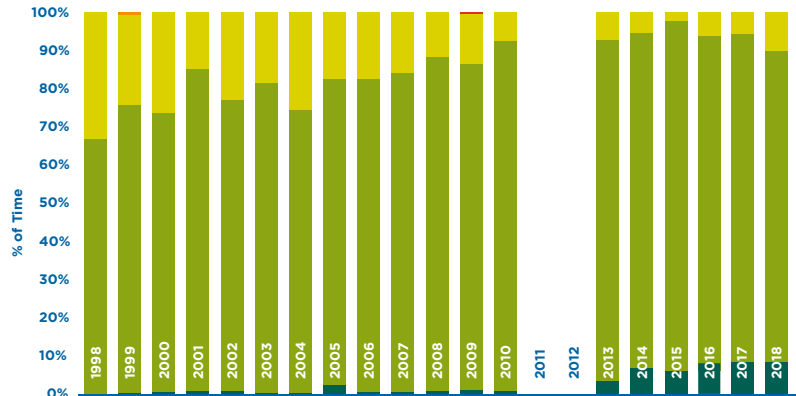
A summary of PM₁₀ data in relation to the NES-AQ and state indicators are presented below.
