# **Kaituna Catchment Control Scheme Advisory Group Meeting**

**Wednesday 4 September 2019 at 10am**

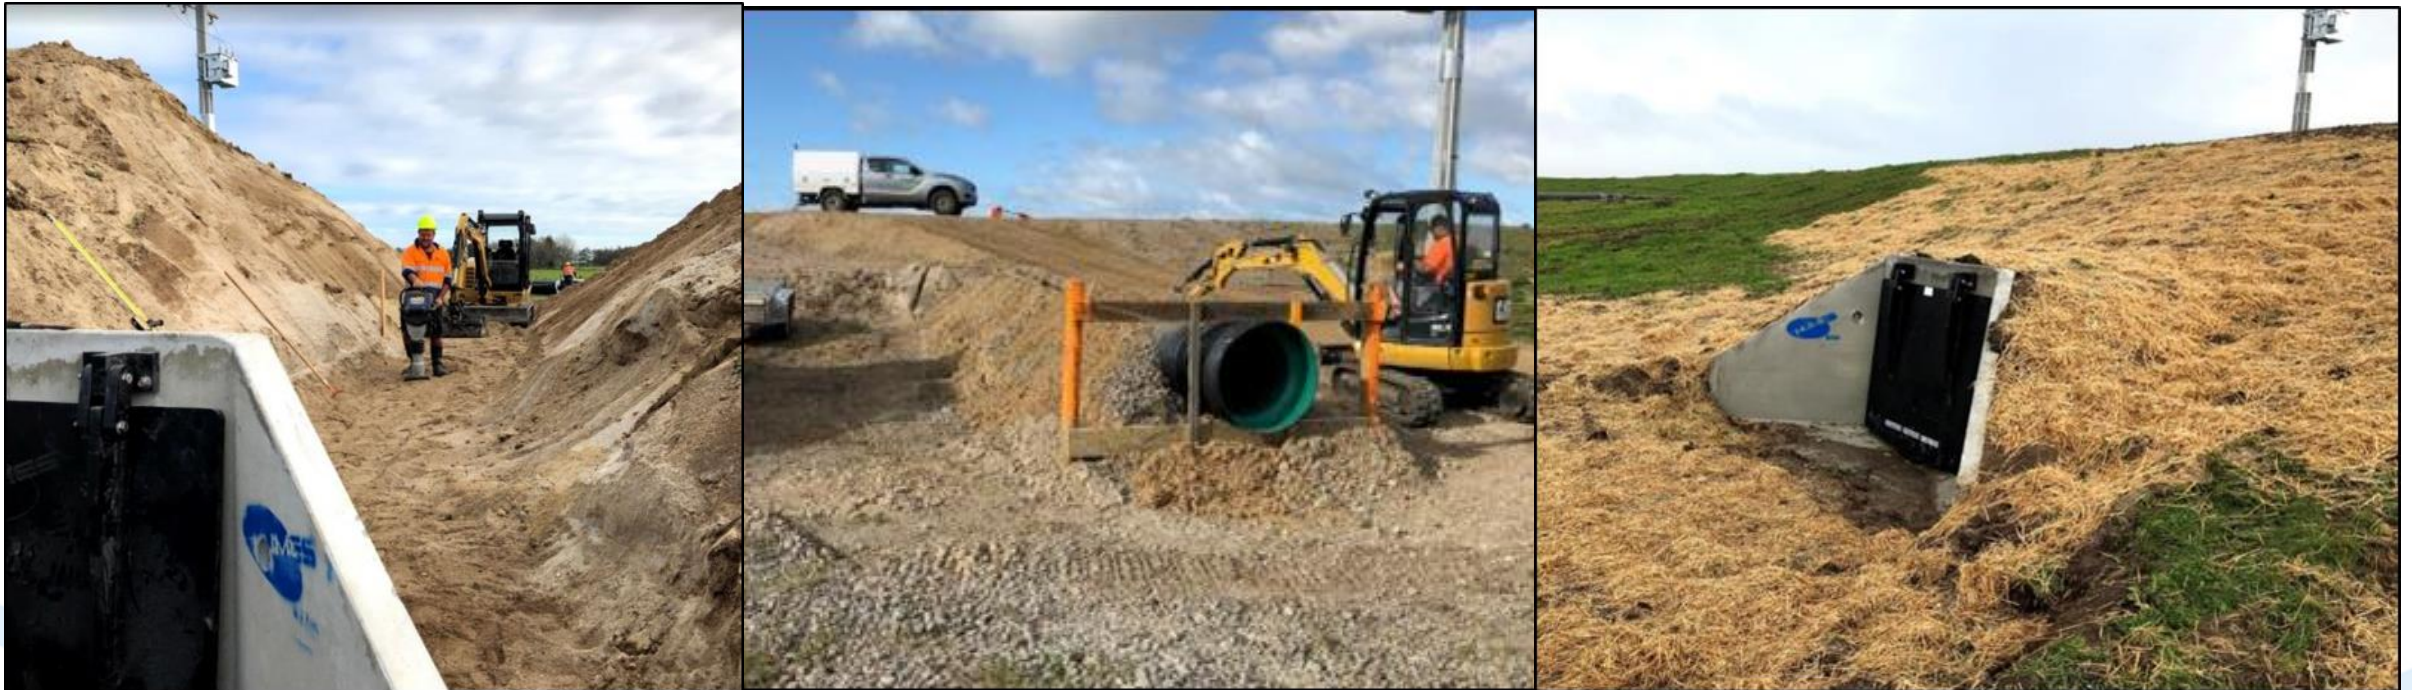
# Bell Road A Pumpstation

- Permanent temporary EuroFlow HD-PE 800mm pumping with Humes concrete 600-1050mm wing wall PE flapped outlet

Bell Rd A pump station mobile pump outlet. Completed on Capital Works.			\$35,000	Culvert completed
112						
113	<b>Stopbanks</b>	Stopbank Miscellaneous Maintenance	<b>\$4,500</b>		\$2,000	Completed
114		Minor Flood Gates	<b>\$1,200</b>		\$600	Completed
115						
116		<b>Pump Station Maintenance:</b>				
117	<b>Kopuaroa (No. 3)</b>	Pump Maintenance	<b>\$19,600</b>		\$2,000	Deferred
118		Replace chain No 2 pump and replace seals			\$500	Deferred
119		Lift No 1 pump riser sand blast and paint			\$3,000	Deferred
120						
121	<b>Bell Road A (No.1)</b>	Pump Maintenance	<b>\$7,000</b>			Completed
		Yard fencing and access improvements			\$2,000	Completed
122		No1 replace lifting chain			\$500	Completed
123		No 2 Replace cable lifting chain and oil			\$800	Completed
124		Shed requires maint			\$1,000	Deferred
125		Lift No1 pump riser sand blast and paint and refit			\$3,000	Completed
126						
127						
128

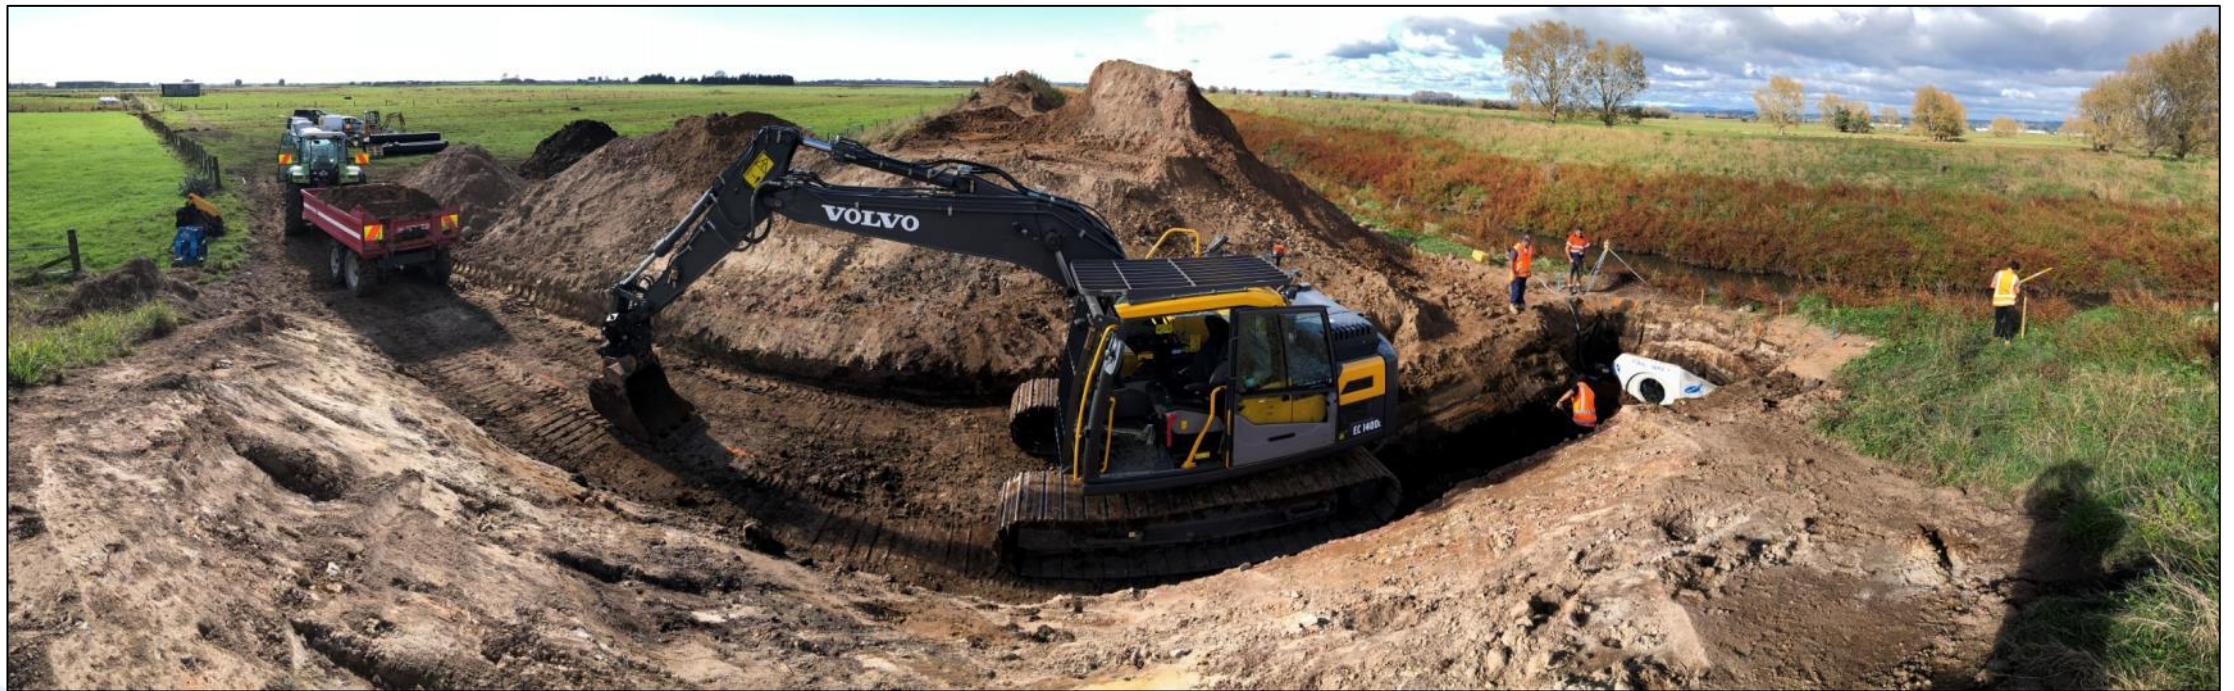
# McLeod's Outlet into Kopuaroa

600mm EuroFlow HD-PE piped gravity outlet with Humes concrete 600-1050mm wing wall and 800mm PE flap

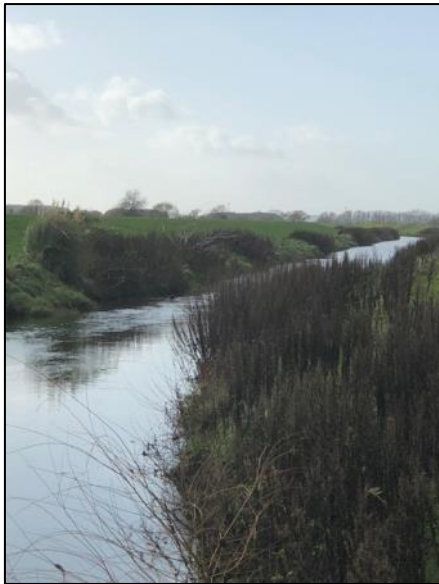
## Raparapahoe Canal

Before

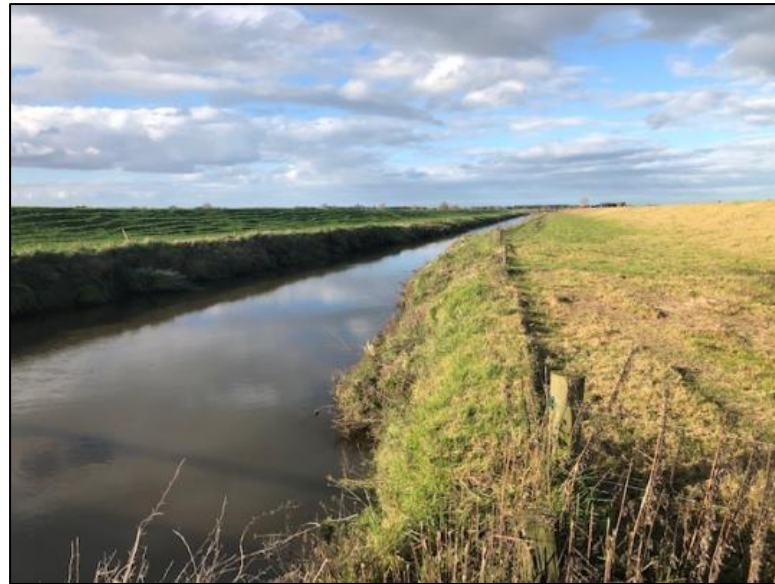
After

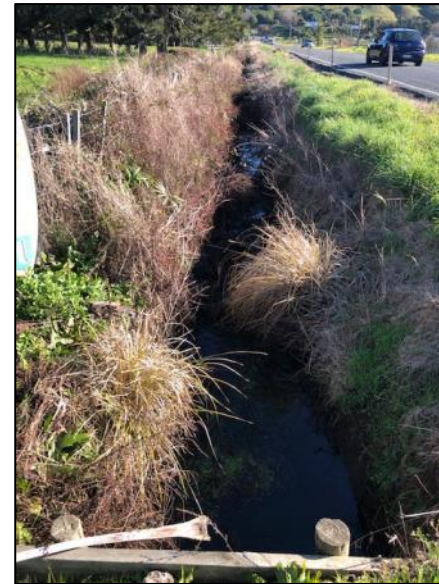
## Bell Road No2 Drain

Before

77						
78		<b>Drain Desilting</b>	<b>\$66,300</b>			
79		Bell Rd No 1 drain		L/b 3.2- 5.2 km	\$5,500	Completed
80		Bell Rd No 2 drain: Remove trees, install 6 gates		R/b 0.0 - 1.2 km	\$12,400	Completed
81		and install 6 culverts to allow excavator access				Deferred
82		Managh's Drain		R/b 0.0-0.9 km	\$1,200	Deferred
83						
		<b>Parawhenuamea</b>				
		Desilt twice yearly				Completed
		Parrots Feather spraying x4 yearly				Completed
84		<b>Waiari Stream</b>				
85		Bank erosion repairs. Deferred to complete with desilt in 2020.		L/b 2.55 - 2.65 km	\$28,000	Deferred
86						
87		<b>Kopuaroa Canal</b>				
88		Remove silt from canal edge and reshape		R/b-L/b 4.2- 4.9km	\$3,600	Completed
89		Mulch gorse & blackberry - Dovastons		L/B 1.6-2.2 km	\$1,200	Completed
90						
91		<b>Raparapahoe Canal</b>				
92		Willow maint various properties		R/b 3.9 - 5.7 km	\$4,200	Deferred
93						
94		<b>Ohineangaanga Canal</b>

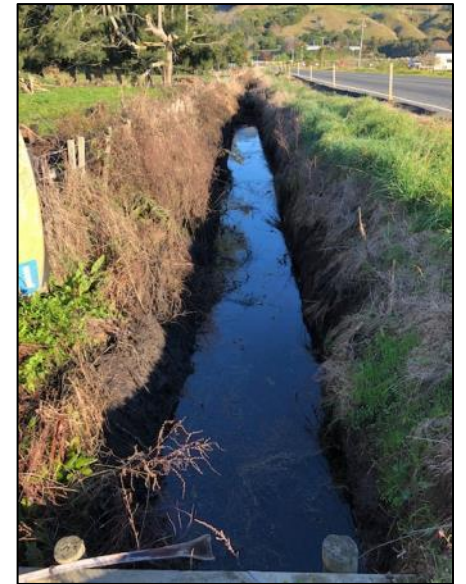
After

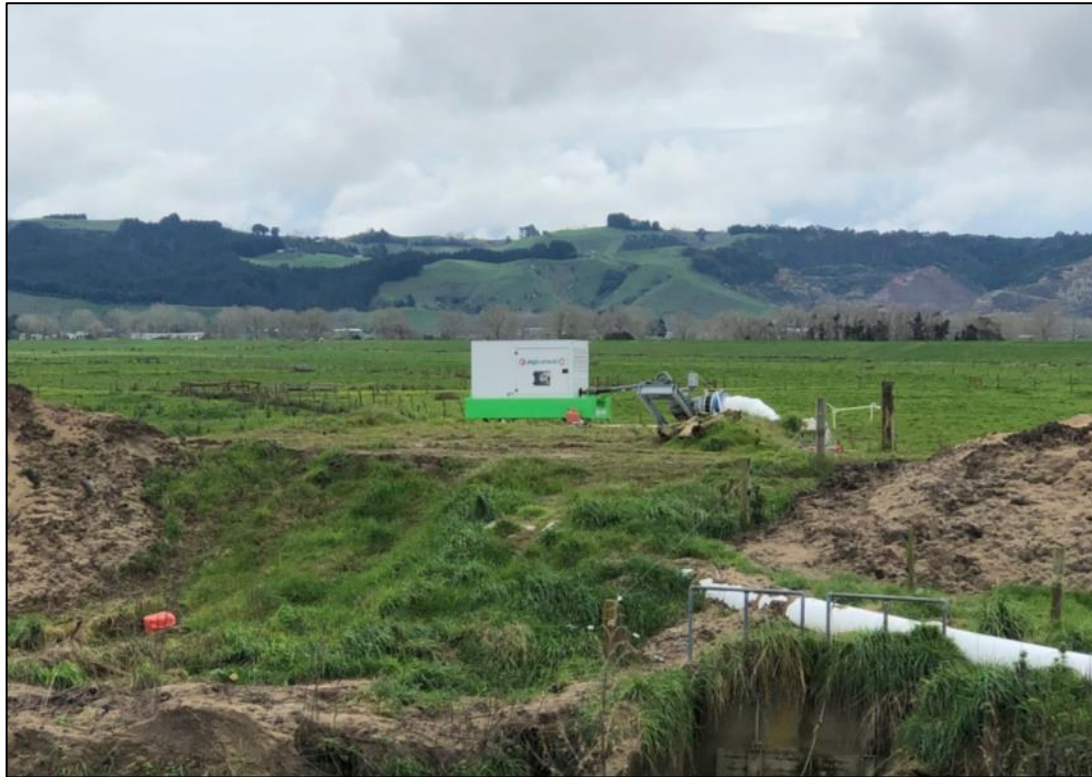
Marshall's Pump

# Armer's and Marshall's Pumps

Proposed Presto Shed installation for both sites. With a solar panel or small transformer for lighting etc.

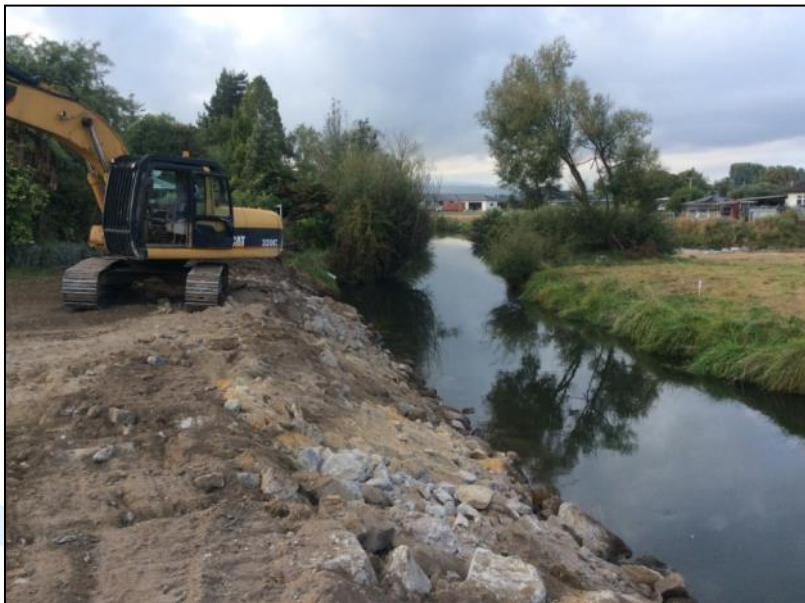
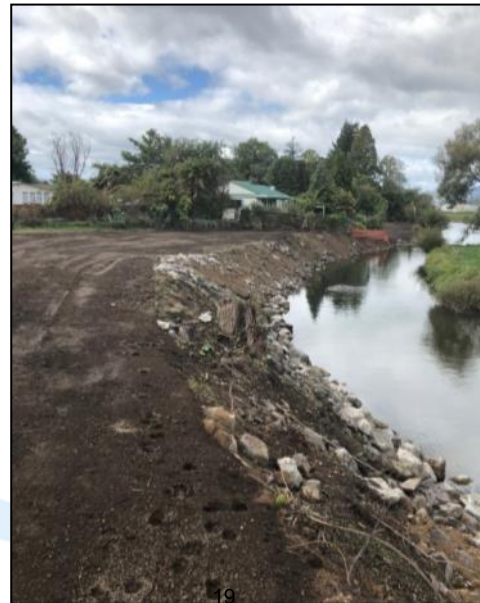
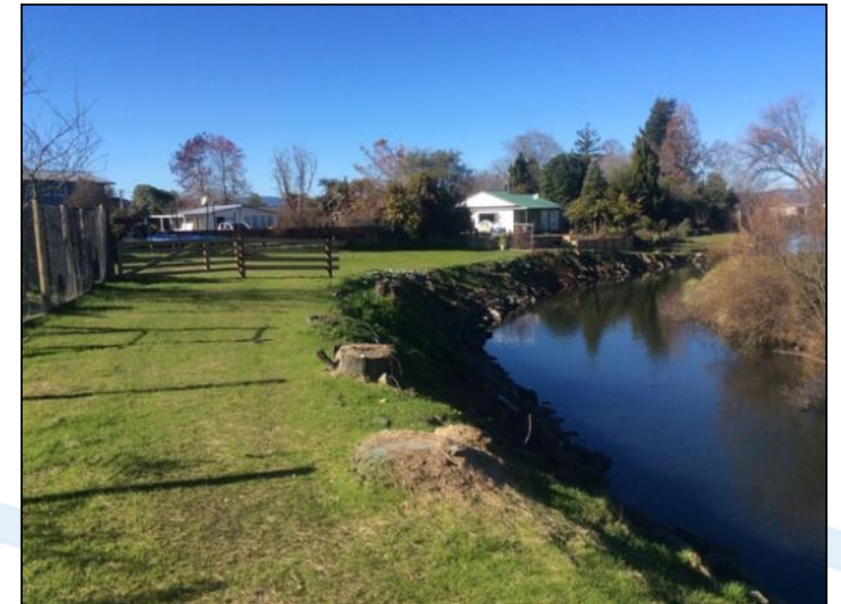
# Ngongotaha

- Since the April 29 flood, 118 sites requiring action have been logged in Fulcrum from stream inspections.
- 75 of the highest risk/priority sites have been repaired, these include both erosion and vegetation removal sites.
- Since the March advisory group meeting further works in the lower reaches at Tau Street have been completed.
- Large rotten vegetation removed, undercut bank repaired and future access for maintenance works re-established.

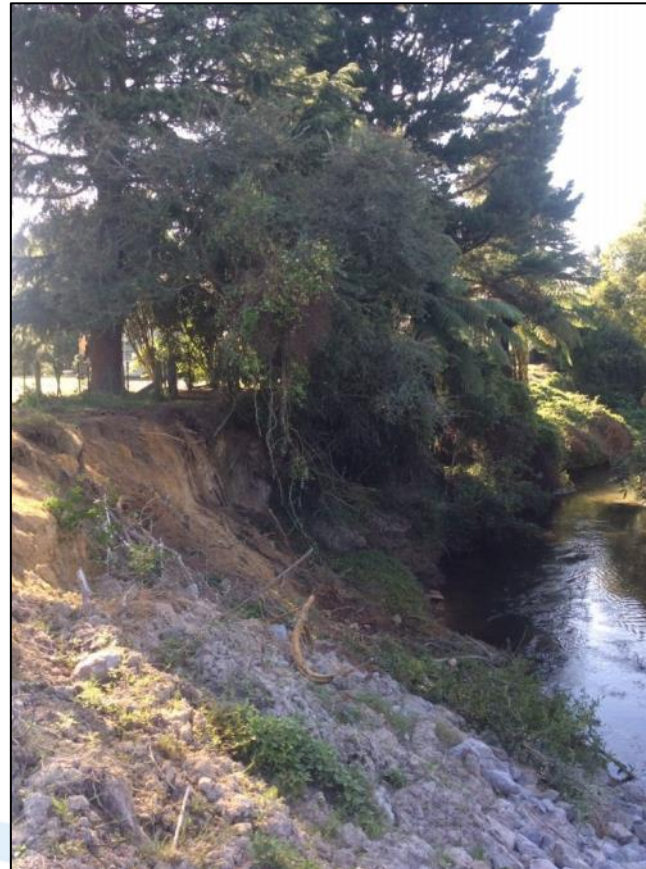
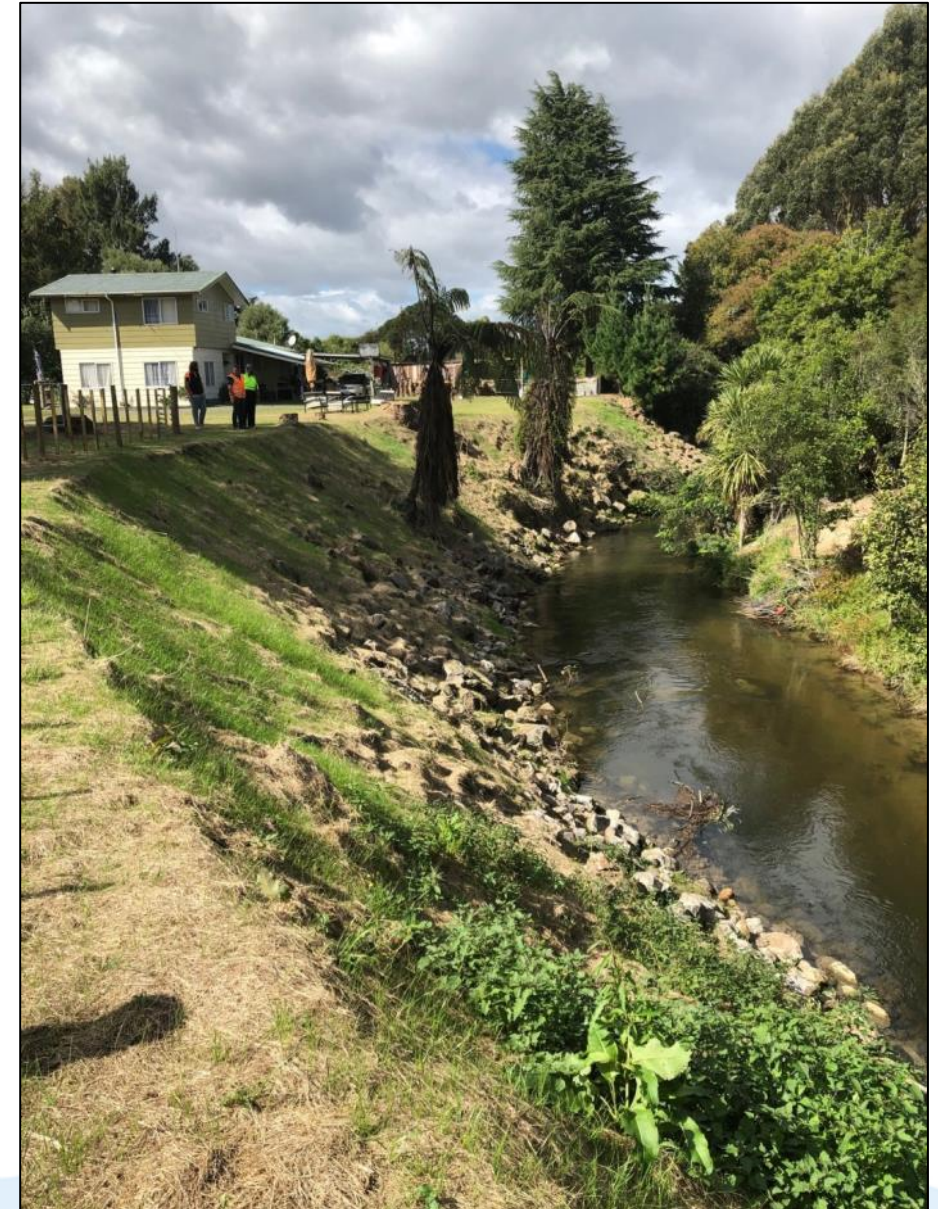
Arborist removed large trees, BOPRC undertook erosion works, then site was hay mulched.

To date 4800 tonne of graded rock spawls have been utilized in rock armouring erosion damage repairs on the Ngongotahā channel since the April 2017 flood.

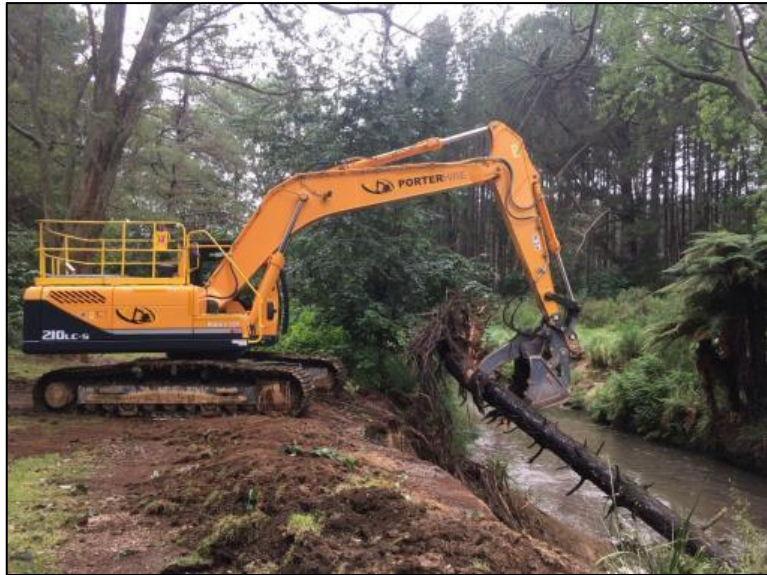
Vegetation removal  
Puarenga Stream

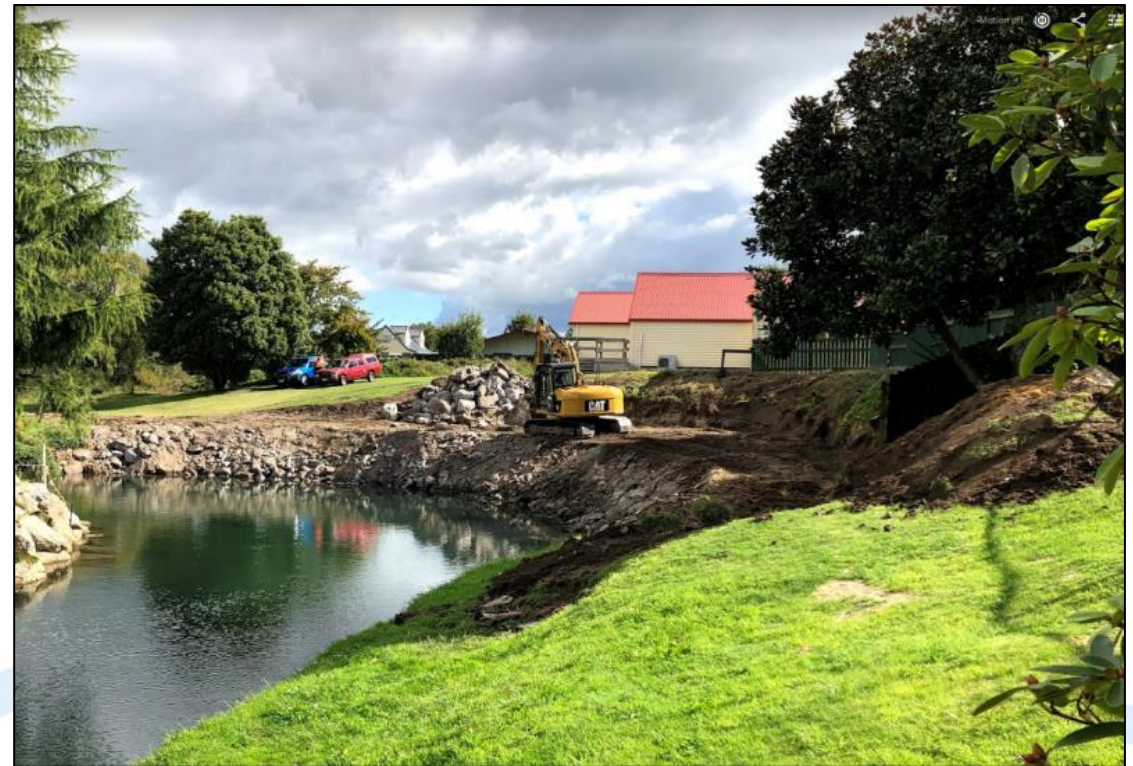
There is a further 172 sites identified in the scheme area on other Rotorua streams.

46 are erosion sites and 22 of these have been completed. 900 tonne of rock spawls have been placed to repair these sites.
