The Science Story
Environmental Summary Report

Kaituna - Pongakawa - Waitahanui Water Management Area

This report summarises our science information on current state and trends for water quality, quantity, freshwater ecosystems and estuary health in the Kaituna- Pongakawa- Waitahanui WMA. Detailed information on which this summary is based can be found in the reports in the reference list.

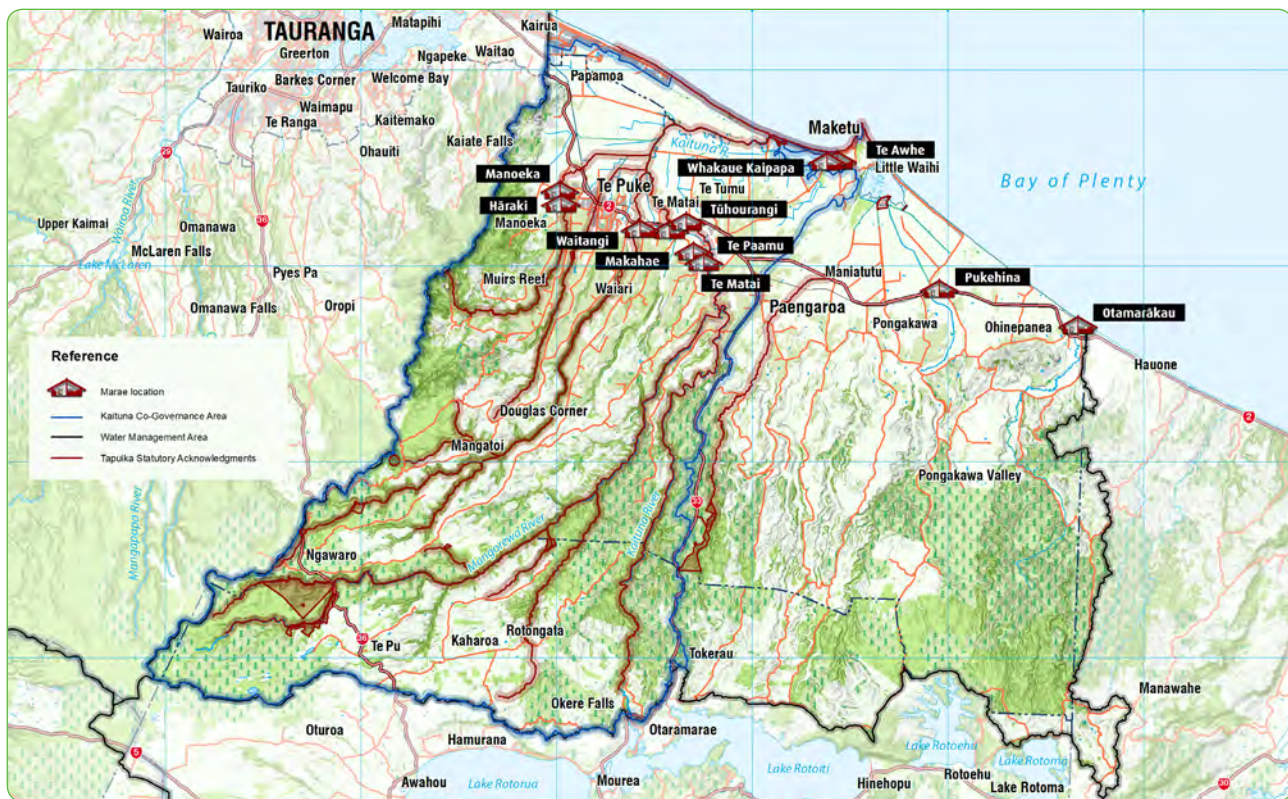
Physical extent of the WMA.

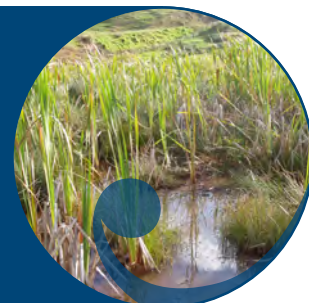
A **FEN** is a wetland with mostly peat substrate that receives inputs of groundwater and nutrients from adjacent mineral soils. It has low to moderate acidity and oligotrophic (low) to mesotrophic (medium) nutrient inputs.

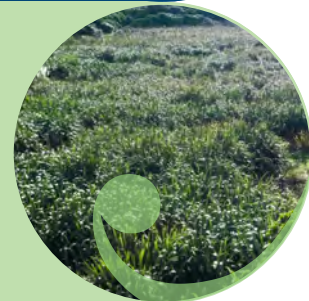
A **SWAMP** is a wetland located on peatland or mineral soils that has a moderate flow of surface water and/or groundwater. The water table is generally above ground, giving characteristic open water areas and permanent wetness. Swamps have moderate to high nutrient levels.

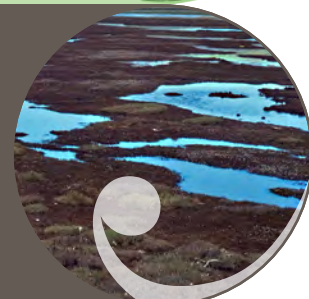
A **MARSH** is a wetland located on mineral soils with a slow to moderate flow of surface water and groundwater. Drainage is better than in swamps, and the water table is usually just at or below the surface of the ground. Marsh wetlands are subject to high fluctuations of the water table. They experience temporary wetness and dryness throughout the year. Nutrient levels are generally high.

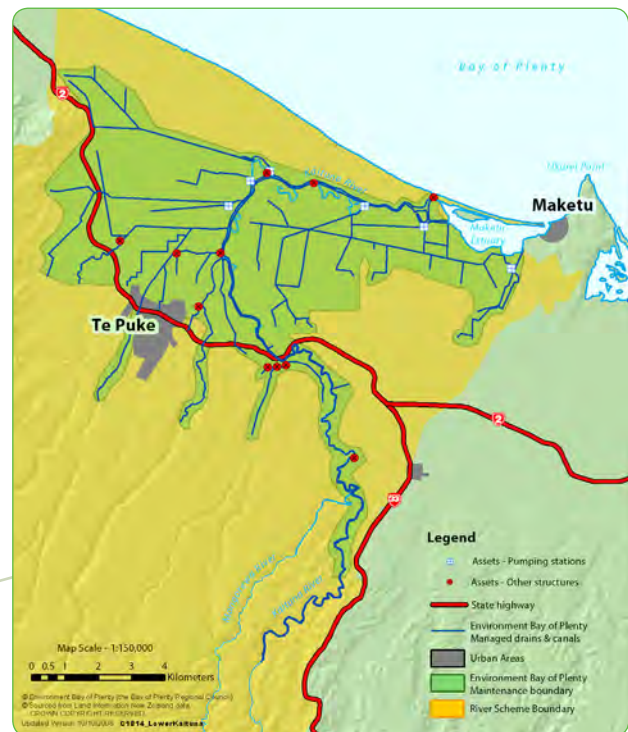
Lower Kaituna River scheme maintenance area.

The Kaituna Catchment Control Scheme has 99 km of canals and drains and seven pump stations (14 pumps) in place to reduce flood impacts for low-lying landowners within the scheme service area.

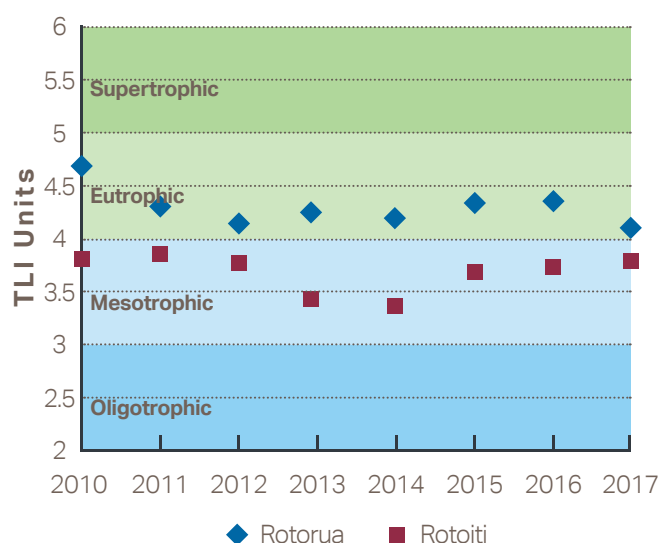
Trophic level index of Lakes Rotorua and Rotoiti 2010 - 2017

Lake health is described by using the trophic level index (TLI). TLI is calculated using total nitrogen, total phosphorous, water clarity, and chlorophyll-a (the pigment in algae). TLI results show Lake Rotorua to be eutrophic (nutrient enriched) which leads to poor water quality. Lake Rotoiti is classed as mesotrophic (average water quality). Lake and estuary eutrophication can produce unsightly scums of algae on the water surface, lead to decreased animal and plant diversity, and can also affect recreational water use.

Extensive work to reduce nutrient run-off and improve water quality in the lakes is ongoing. The TLI for both lakes has improved because of this work.

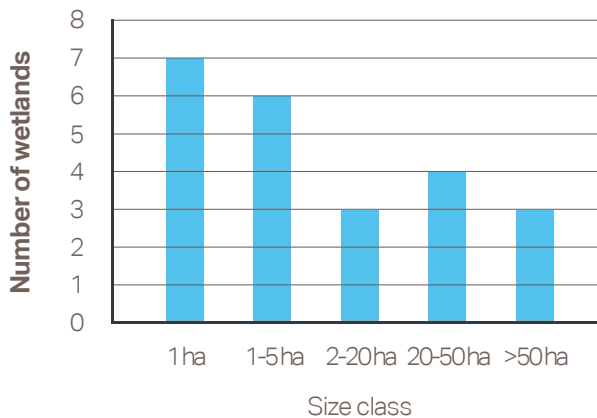
Size distribution of remaining wetlands in the WMA.

Most (56%) of the remaining wetlands in the WMA are smaller than five hectares, highlighting the loss of large ecologically important areas of wetlands.

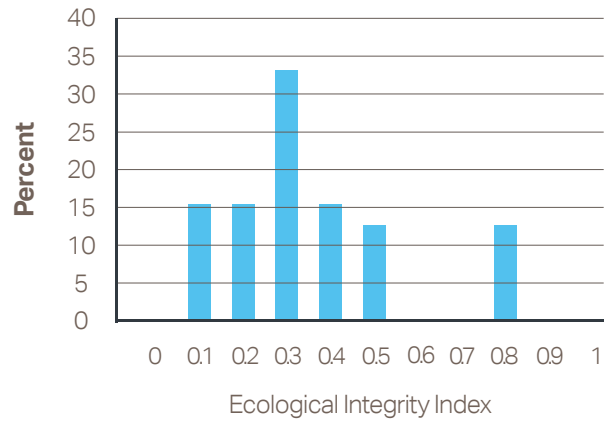
Ecological Integrity Index for the 13 WMA wetlands. A low EI Index means the wetland is likely to have been subject to greater levels of human disturbance.

Wetland ecologists have created an Ecological Integrity (EI) index to assess wetland health. This is a measure of the naturalness of catchment cover, impervious cover, nutrient enrichment, introduced fish, woody weeds and drainage. A high EI score (closer to 1) predicts good condition and low scores (closer to 0) poor condition. The average EI index for the WMA is only 0.32 (compared with 0.38 for the entire region). This highlights the degree to which wetlands have been modified in not only the WMA, but the entire region.
