# **Whakatāne-Tauranga Rivers Scheme Advisory Group Meeting**

**Wednesday 18 September 2019  
at 10am**

**To:** Whakatāne-Tauranga Rivers Scheme  
Advisory Group

**From:** Mark Townsend  
Engineering Manager

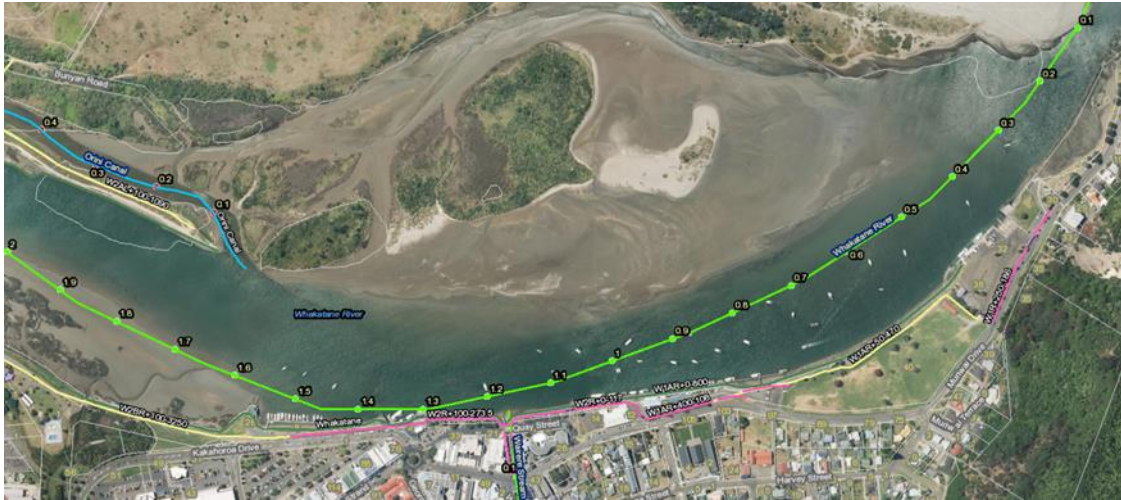
Figure 1: Proposed stop bank raising extent

Stopbank sections of the lower Whakatāne that are proposed for raising are outlined below. Construction will be undertaken as part of the overall project in combination with floodwall and seepage control work.

- The design level for urban Whakatāne stopbanks is 1% AEP + 800mm freeboard. The criteria for initiating stopbank raising is if the existing stopbank level is within 50% of the freeboard level. A number of areas from the Heads to McAlister Street met the criteria and need raising.
- No construction will be undertaken this financial year and any unspent funds will be transferred to 2019-2020. It is highly likely that additional budget will be required for this work.

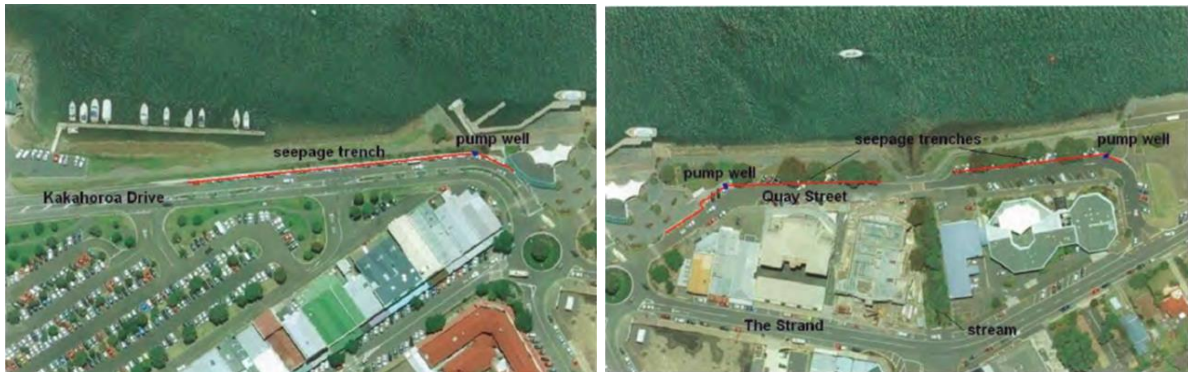
Figure 2: Proposed locations of seepage trenches

This work responds to excessive seepage observed in the 2011 and April 2017 flood events. A series of seepage trenches is proposed to intercept the flow. Detailed design of the work is underway and the work will be undertaken as part of the overall project in combination with floodwall and stopbank.

- To control seepage observed along Kakaharoa Drive and Quay Street during the 2011 and 2017 flood events, a series of seepage trenches are proposed to intercept the flow.
- Geotechnical assessments are complete and detailed design is about to commence.
- 2018-2019 budget contained \$270k for design and construction. No construction will be undertaken this year, and any unspent funds will be transferred to 2019-2020. It is highly likely that additional budget will be required for this work.
