Lake Tarawera

CULTURAL MAPPING REPORT

Prepared by Te Arawa Lakes Trust

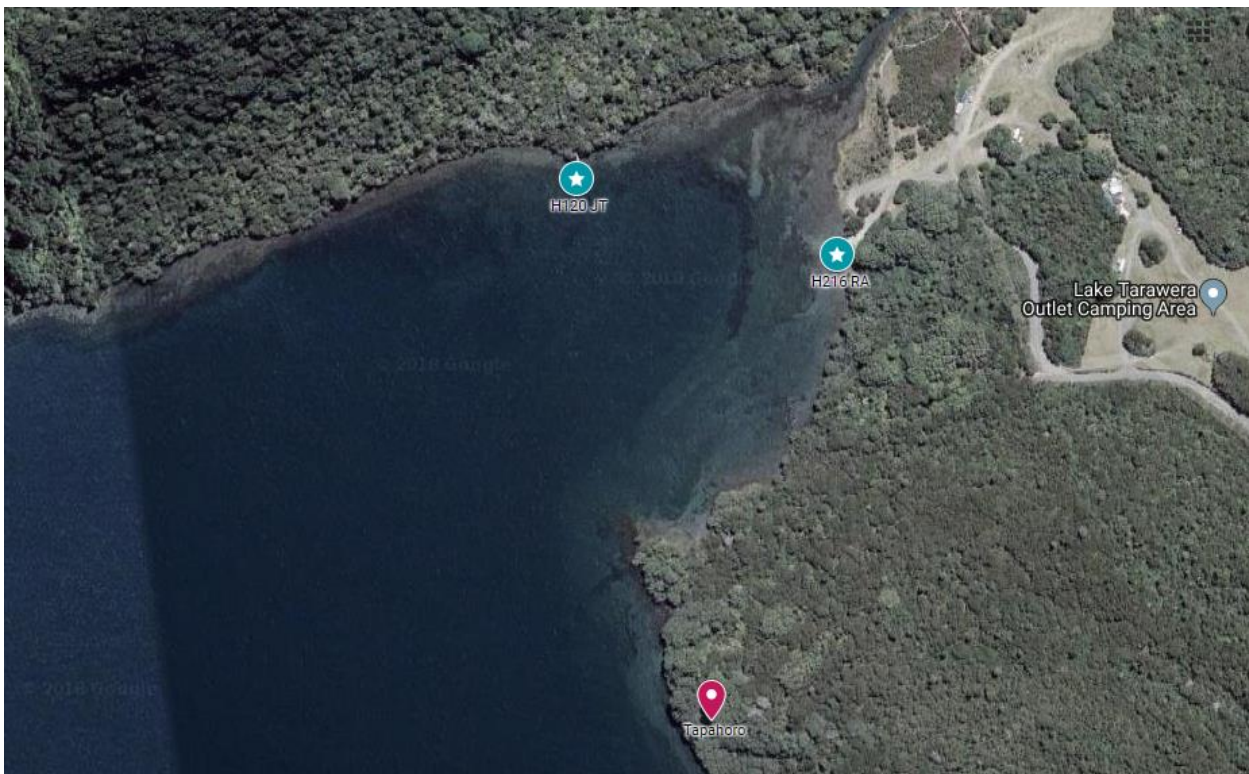
Map 2. Te Tapahoro Bay

Tapahoro pa is a registered NZAA archaeological site and of significance to Ngāti Rangitihi. Koura and inanga traditionally and currently harvested from this area

Type	Plate ID	Consent holder	Location	Assessment
Ramp	H216 RA	██████████ ██████████	Te Tapahoro Recreation Reserve Lake Tarawera	Less than minor effects. Public structures provide lake access for our people. Structure is within 400m of pa site Tapahoro, recommend DOC work with Ngāti Rangitihi to mitigate negative impacts of the structure on the cultural values of this site.
Jetty	H120 JT	██████████	Te Tapahoro Bay Lake	Less than minor effects. Public structures

██████████	Tarawera	provide lake access for our people. Structure is within 400m of pa site Tapahoro, recommend DOC work with Ngāti Rangitihi to mitigate negative impacts on the cultural values of this site.
--	--	------------	----------	---

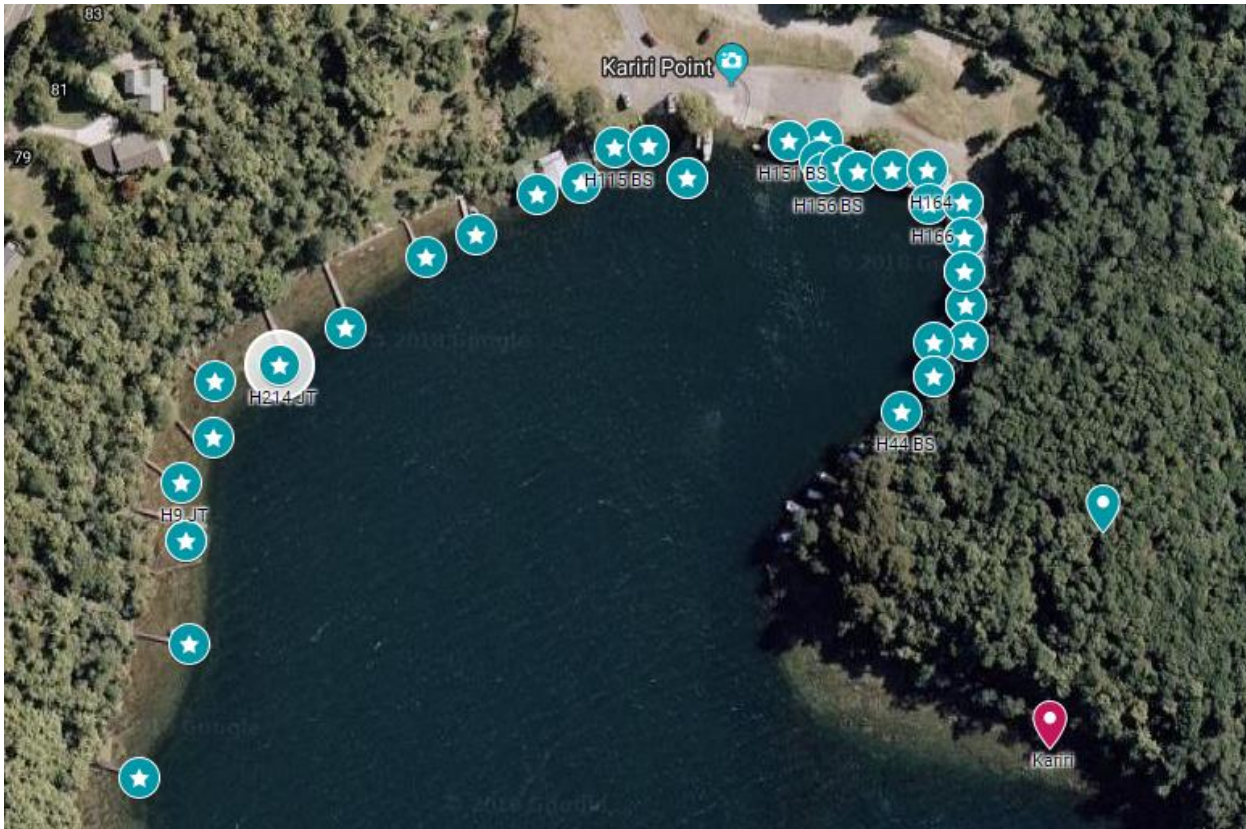
Map 4. Kariri (Tawaroa/Boatshed Bay)

The traditional name for this pa kāinga is Tawaroa which later became known as Kariri, transliteration of ‘Galilee’. This pa kāinga belonged to Tuhourangi and is the site of traditional urupā (burial sites). Existing boat sheds at Kariri Point on Lake Tarawera are probably the most culturally sensitive and inappropriate. Although not registered with the NZ Historic Places Trust as such, the site is regarded as waahi tapu by the Tuhourangi people. The offending boatsheds are attached to the waahi tapu, which was set aside as ‘an inalienable cemetery reserve in 1895’. Boatshed owners trespass over waahi tapu land whenever they use the boatsheds. The cultural impact of structures in this area is high and incompatible with the cultural values. Trustees of the land block, Rotomahana Parekarangi 6G2B, could file court proceedings to pursue the aim of having existing structures removed. Freshwater inanga and koura flourished around its shoreline as well as raupo.

Type	Plate ID	Consent holder	Location	Assessment
Jetty	H192	██████████	45 Spencer Road, Tarawera	Minor adverse effects. Based on current information sources, the structure is

located within 400m of a cultural site of significance and within 100m of an existing structure
<p>Note - appears to be an unmarked/unconsented boatshed between boatsheds H124 and H115 – request further information.</p>			 	<p>Minor adverse effects. Based on current information sources, the structure is located within 400m of a cultural site of significance and within 100m of an existing structure. Recommend that structure be removed if no longer in use.</p>
Boatshed	H115 BS	██████████	252 Spencer Road Lake Tarawera	<p>Minor adverse effects. Based on current information sources, the structure is located within 400m of a cultural site of significance and within 100m of an existing structure</p>
Ramp	H13D RA	██████████	Kariri, Lake Tarawera	<p>Less than minor adverse effects. Public structures enable access for our people however based on current information sources, the structure is located within 400m of a cultural site of significance and within 100m of an existing structure</p>

effects. Based on current information sources, the structure is located less than 100m of a cultural site of significance and within 100m of an existing structure
Boatshed	H163	██████████ ██████████	Spencer Road Lake Tarawera	More than Minor adverse effects. Based on current information sources, the structure is located less than 100m of a cultural site of significance and within 100m of an existing structure
Boatshed	H164	██████████ ██████████	Spencer Road Lake Tarawera	More than Minor adverse effects. Based on current information sources, the structure is located less than 100m of a cultural site of significance and within 100m of an existing structure
Boatshed	H166	██████████ ██████████	Boatshed Bay Lake Tarawera	More than Minor adverse effects. Based on current information sources, the structure is located less than 100m of a cultural site of significance and within 100m of an existing structure

Refer above assessment and recommendation for all existing structures located on Kariri Point. Please also note there appears to be unconsented/unauthorized structures with no plate number. Request stock take/ further information. From H166/167 to southern mooring area.
