# Recreational Waters Surveillance Report

## 2018/2019 Bathing Season

Bay of Plenty Regional Council  
Environmental Publication 2019/06  
October 2019

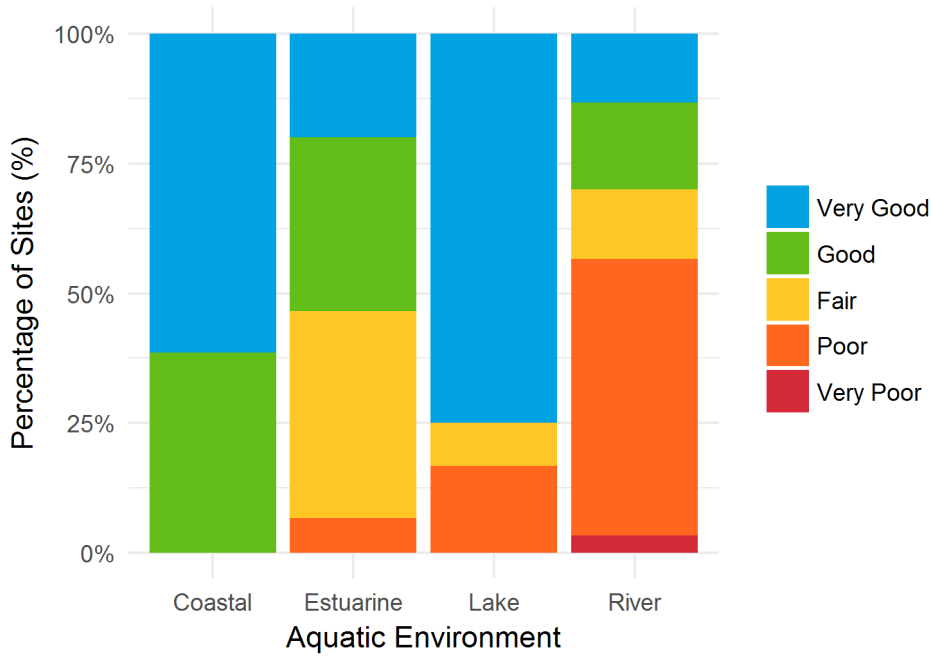
Figure 3.2 Comparison of the 2018/19 results for the SFRG across aquatic environments.

Detailed results of the monitoring are presented in tabular form in Appendix 1a–1d. These tables give information on the 95th percentile value, MAC score, SIC score, SFRG, as well as NPS-FM attribute banding (where applicable). The SFRG's are presented in Figures 3.1 and 3.2.

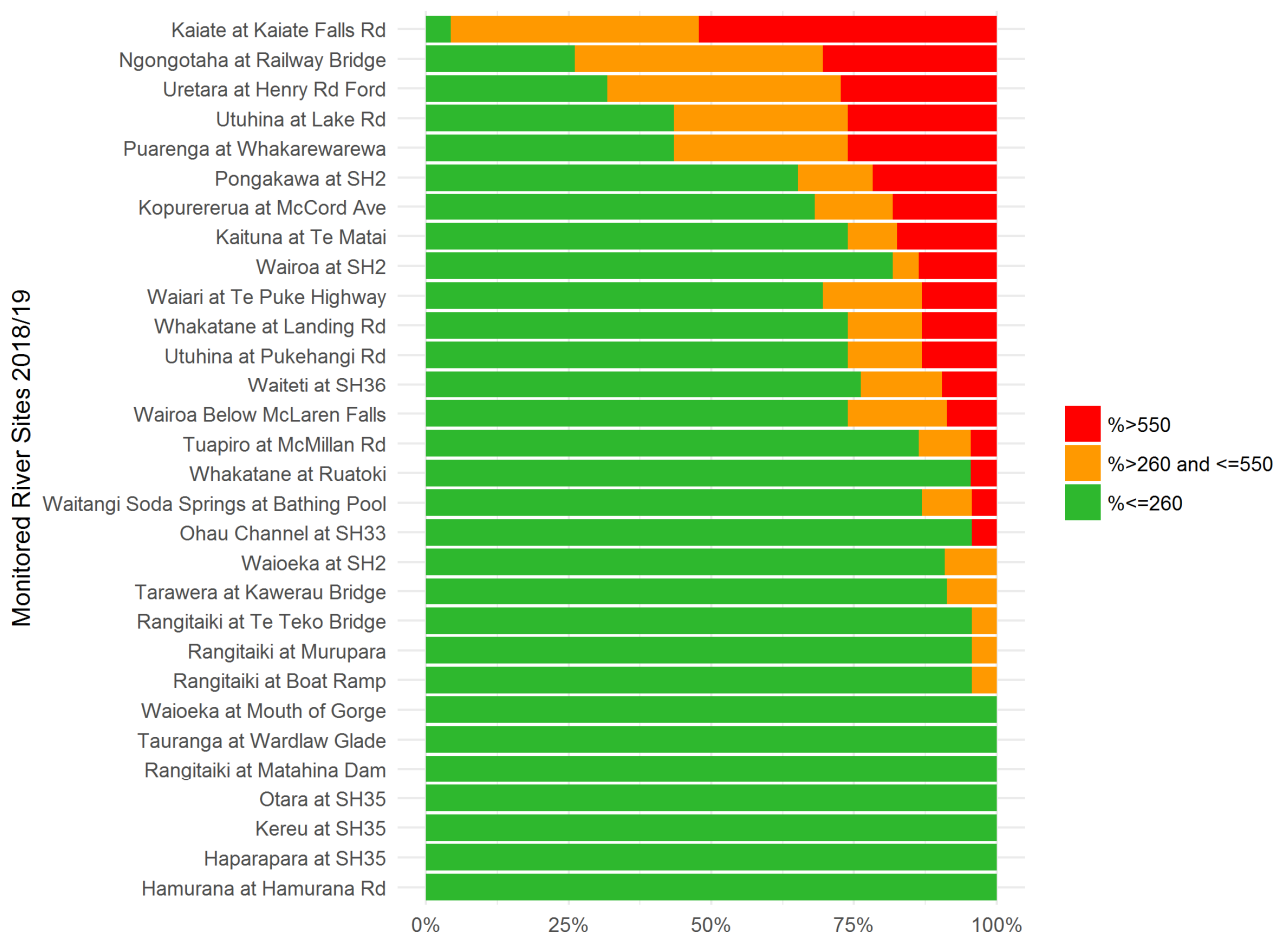
**Figure 3.3** Percentage of samples from river and stream sites with *E. coli* concentrations (cfu/100ml) in each of the modes in the Microbial Water Quality Guidelines (MfE, 2003), 2018/19 bathing season.

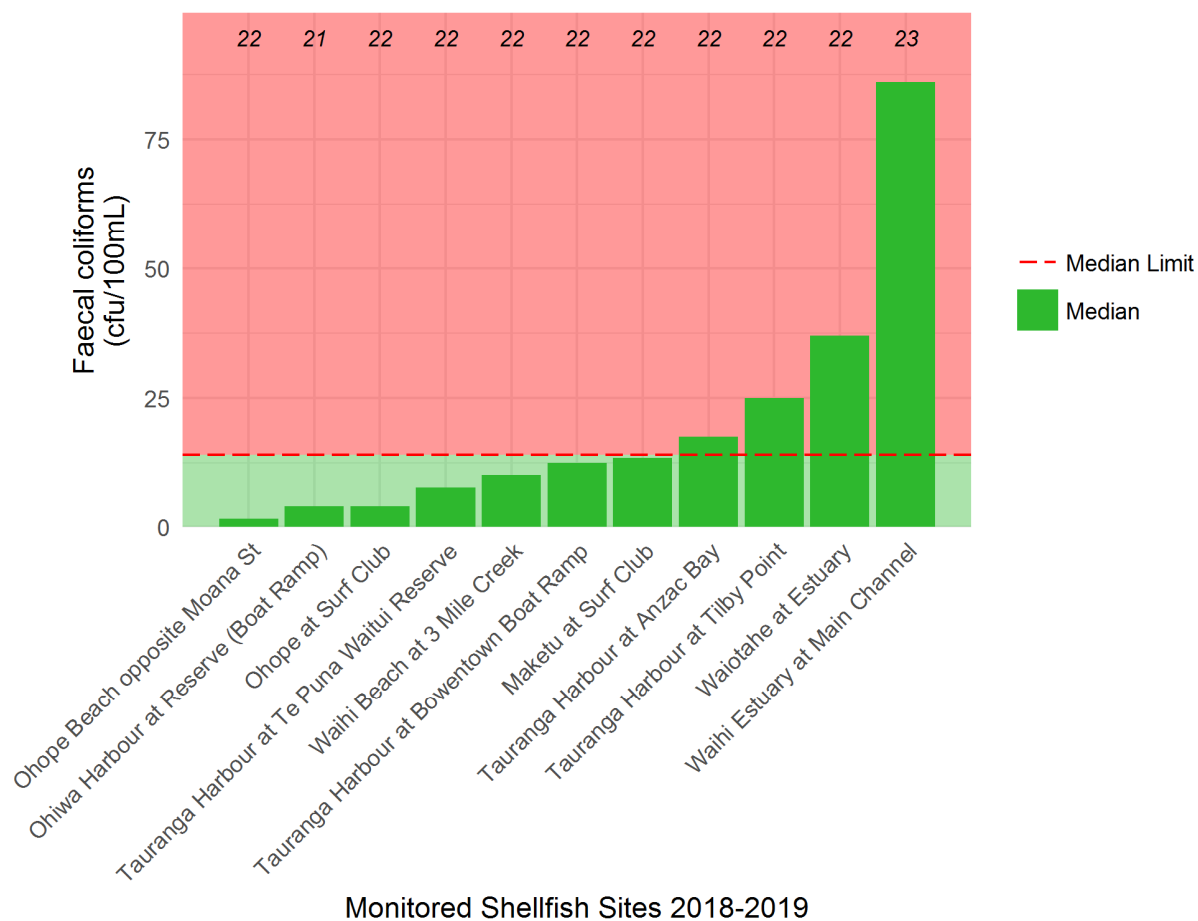
**Figure 4.1** Median faecal coliform concentrations at shellfish gathering locations for the 2018/19 season and guideline median limit for safe shellfish consumption. The black numbers represent the number of samples available for the analysis period.

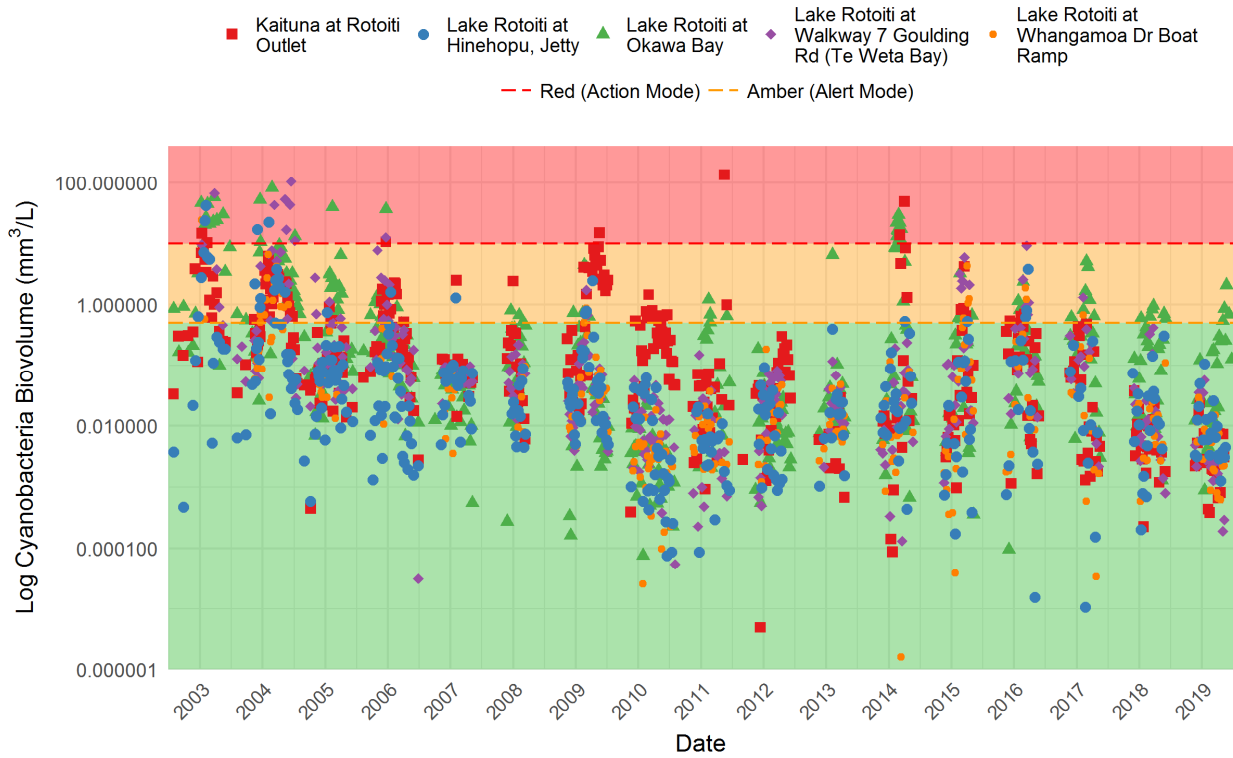
Figure 5.4 Total cyanobacteria biovolume sampled at Hinehopu, Okawa Bay, Okere Arm, and Te Weta Bay, Lake Rotoiti, 2003 to 2019.

All of the samples collected at four of the five monitored sites on Lake Rotoiti were lower than the amber (alert) threshold in the New Zealand Guidelines for Cyanobacteria in Recreational Fresh Waters (MfE, 2009) (Figure 5.4). The exception was Lake Rotoiti at Okawa Bay, which had consistently higher biovolumes than other sites for the majority of the season, as well as a short-lived bloom of *Anabaena cf. planctonica* and *Aphanizomenon sp.* in early May 2019. A public health warning was issued at this time, and removed in July 2019.
