## Additional clauses applying to areas with pumiceous soils

# Stopbank seepage and piping

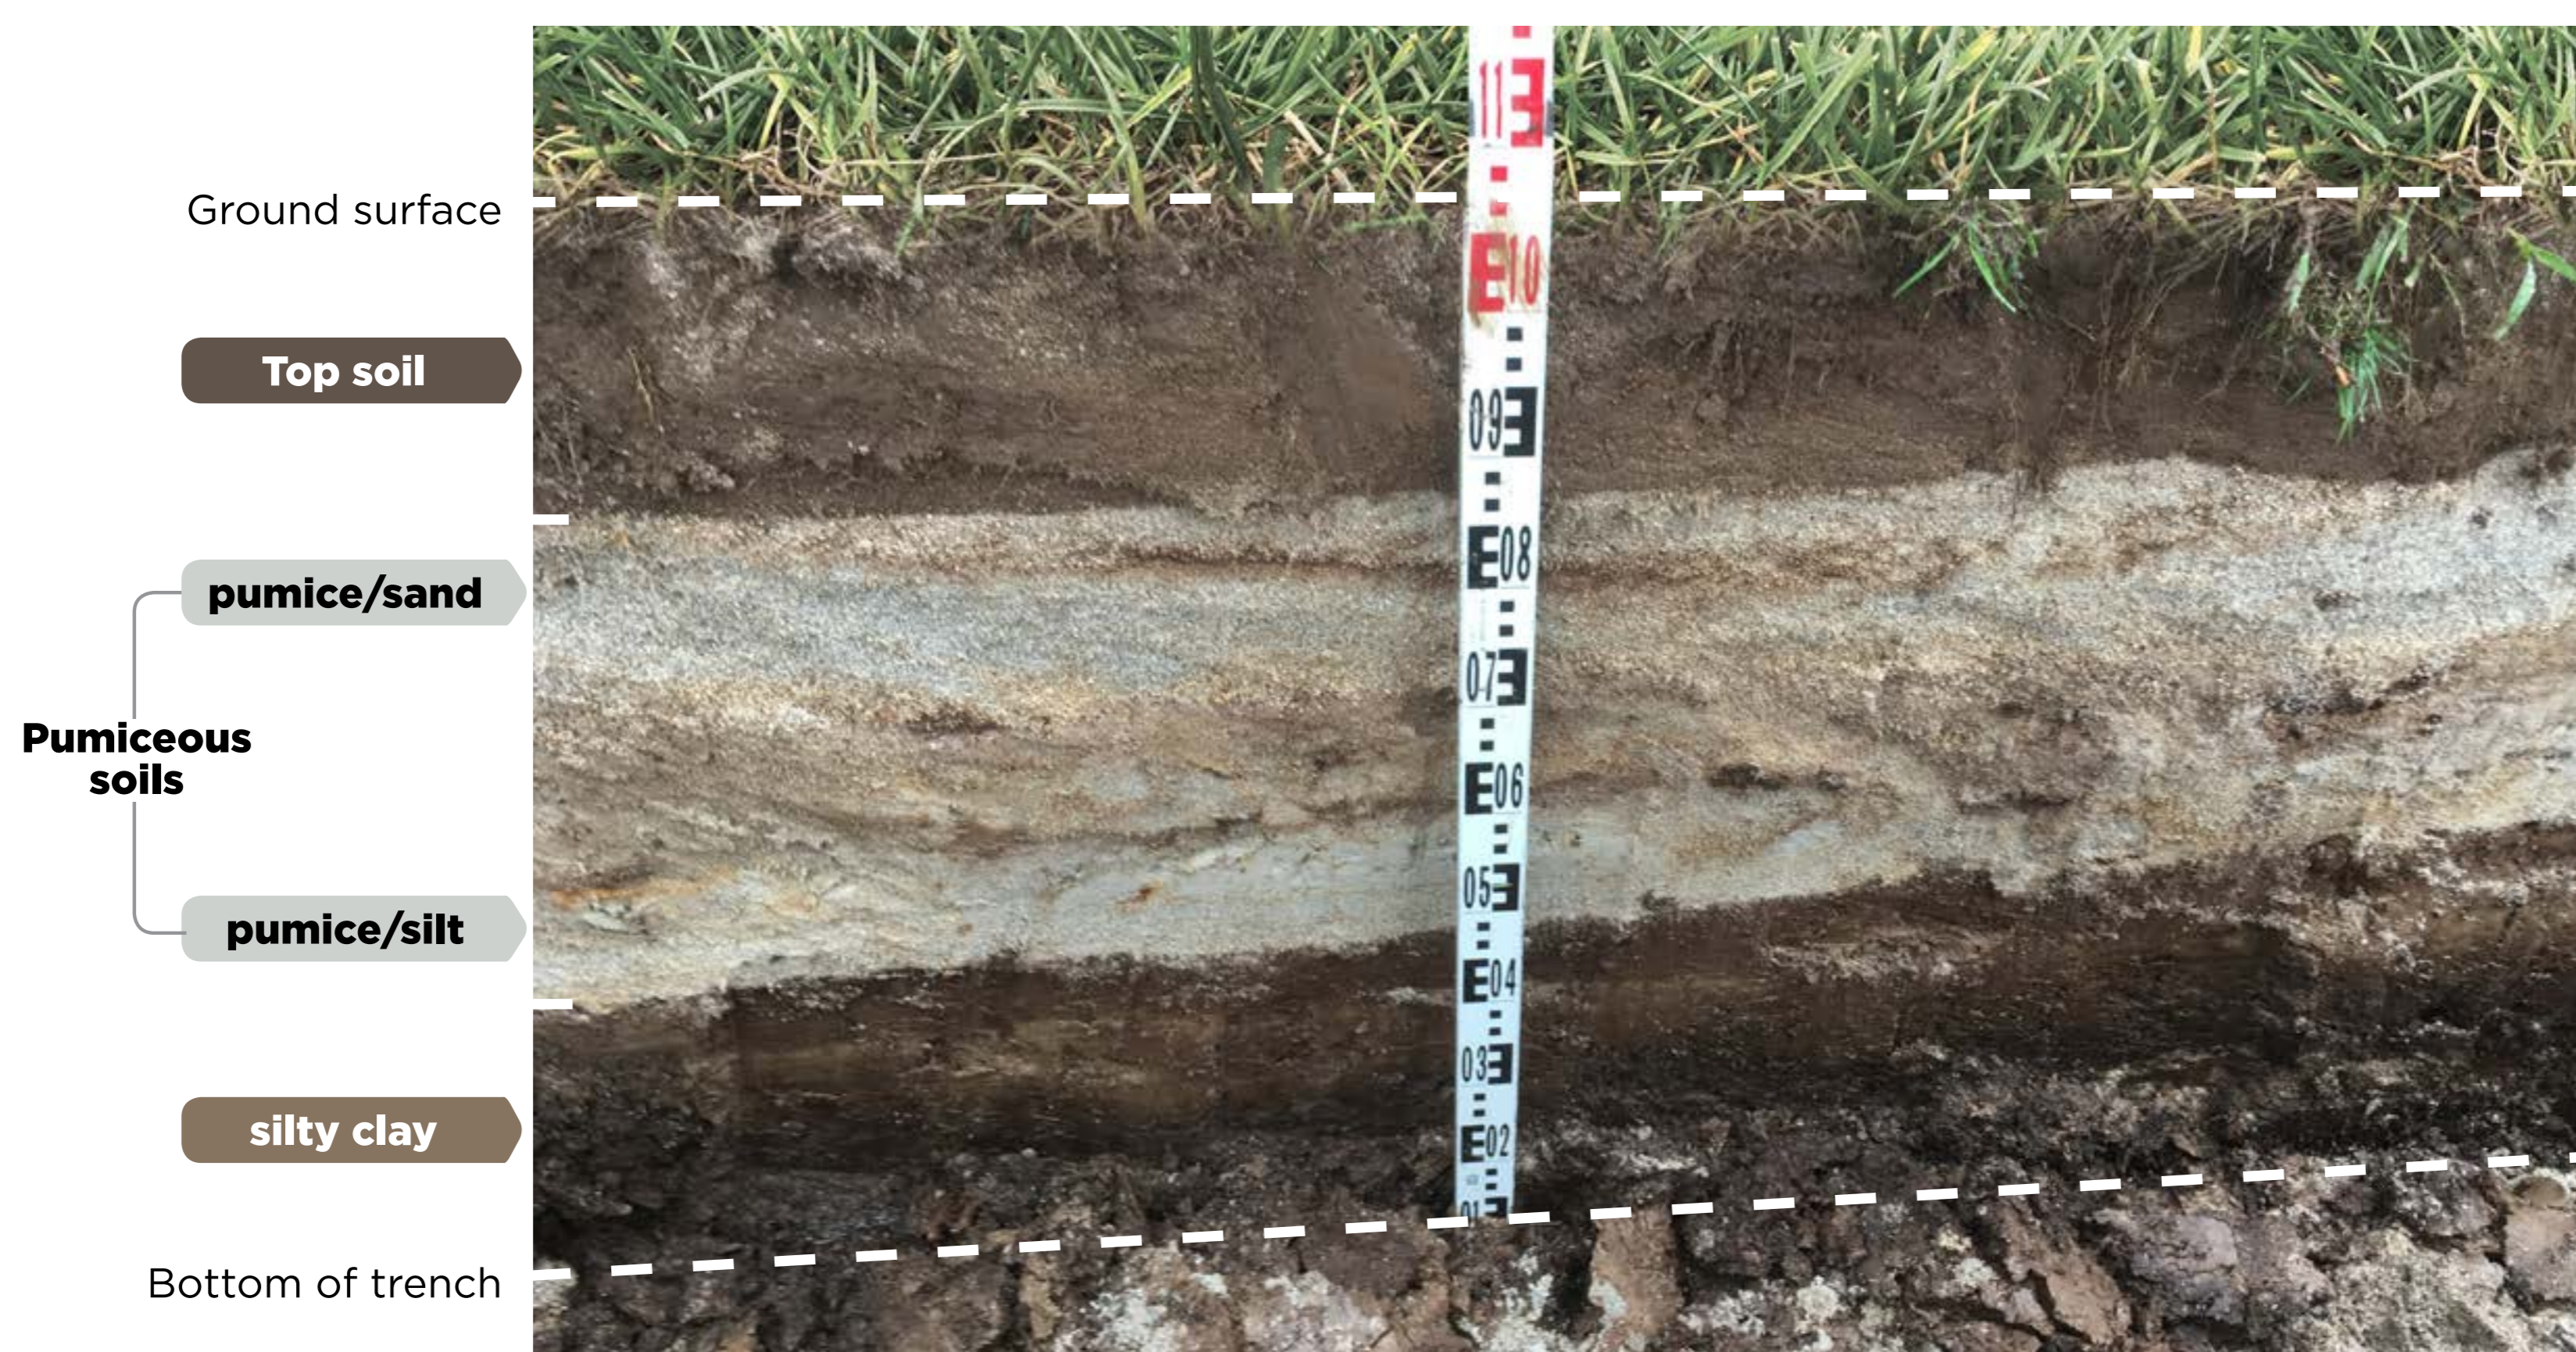
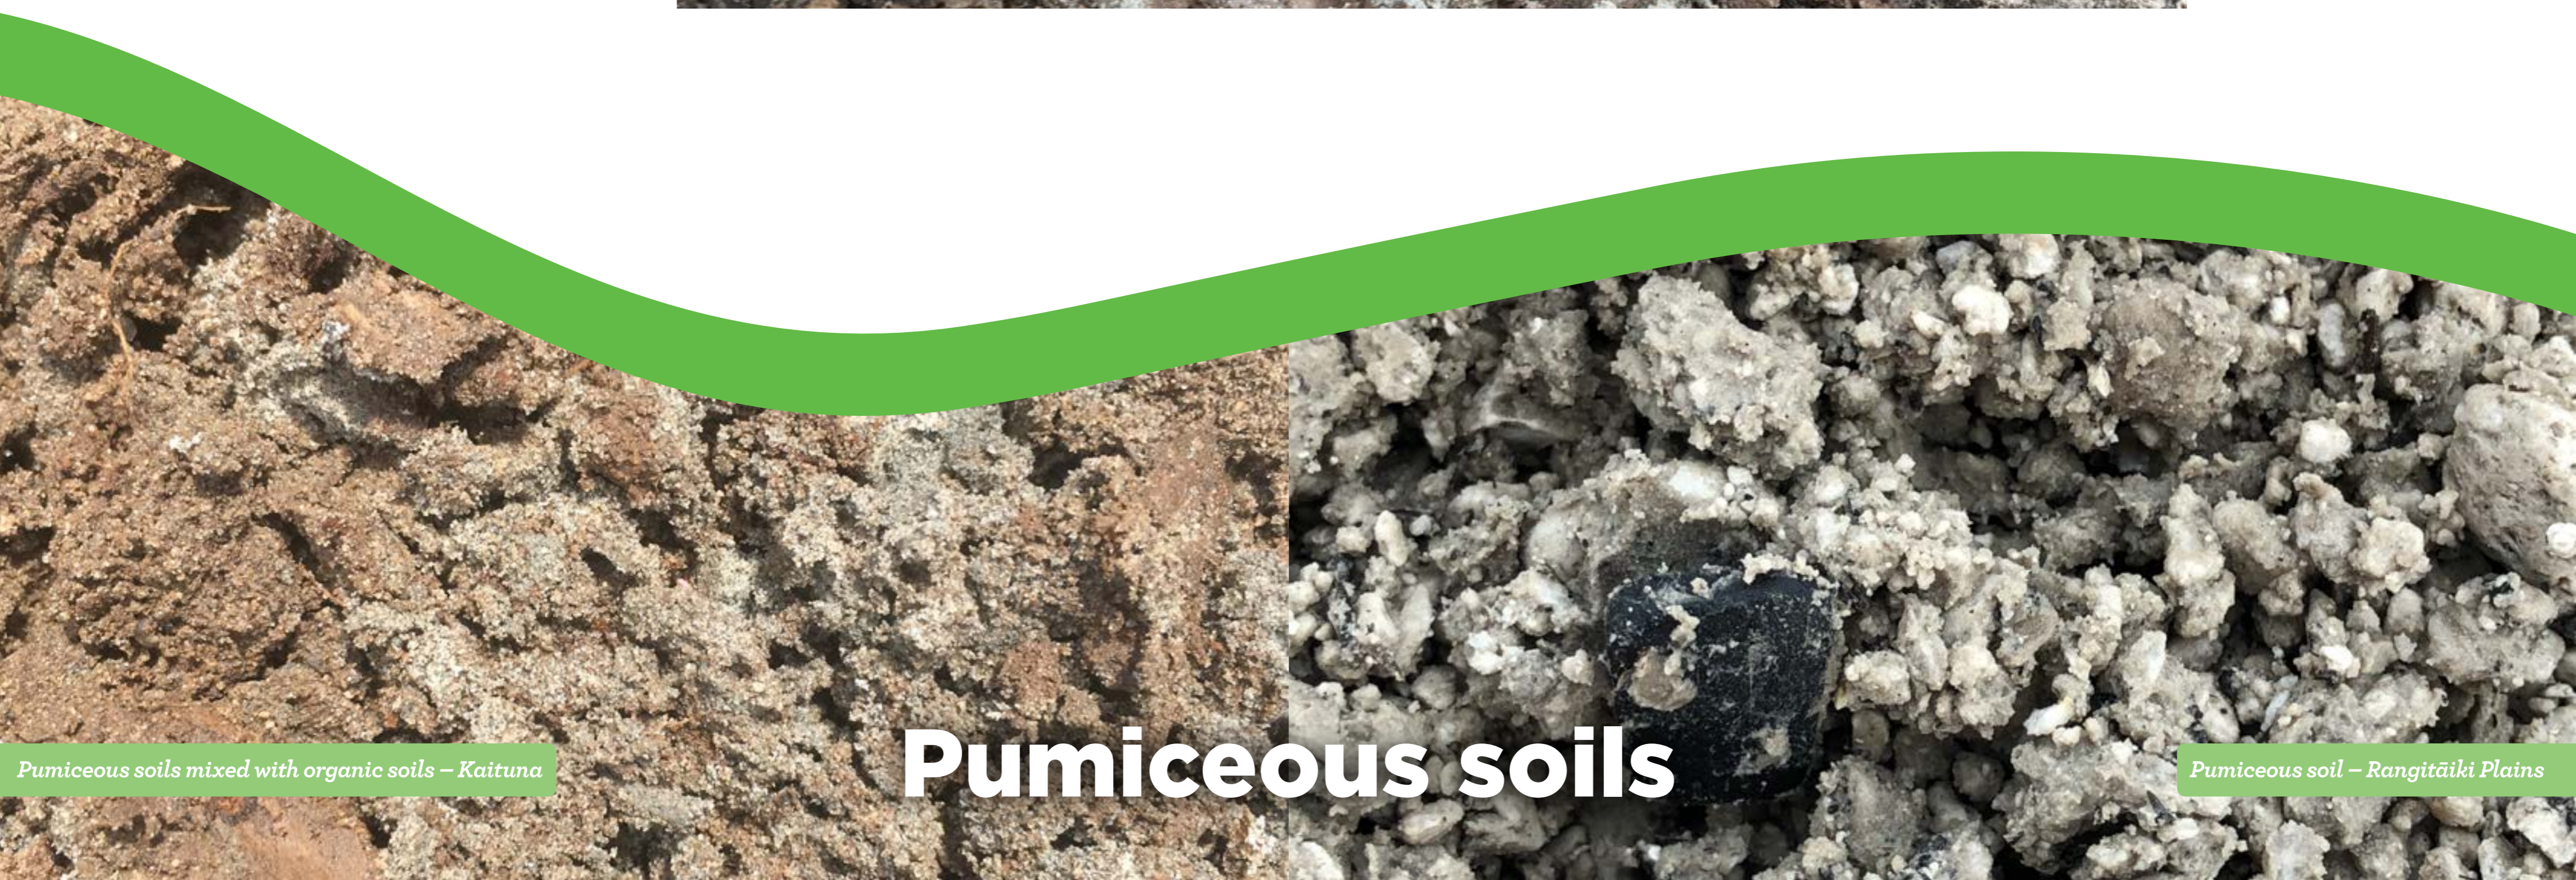
### SOIL PROFILE FROM NEAR THE CONFLUENCE OF WAIARI STREAM AND KAITUNA RIVER

The lower reaches of the **Kaituna, Rangitāiki** and **Tarawera Rivers** have layers of pumiceous soils that are more susceptible to piping failures beneath the stopbanks during flood events. The purpose of these specific clauses is to minimise the risk of such failures occurring.

Piping usually develops where there are soils with contrasting permeability. This is common in the Bay of Plenty with permeable volcanic and sandy alluvial deposits layered between impermeable peat, silt and clay layers. In the lower Kaituna, Tarawera and Rangitāiki Rivers however these soils are also underlain by pumiceous, highly permeable, sands and gravels.

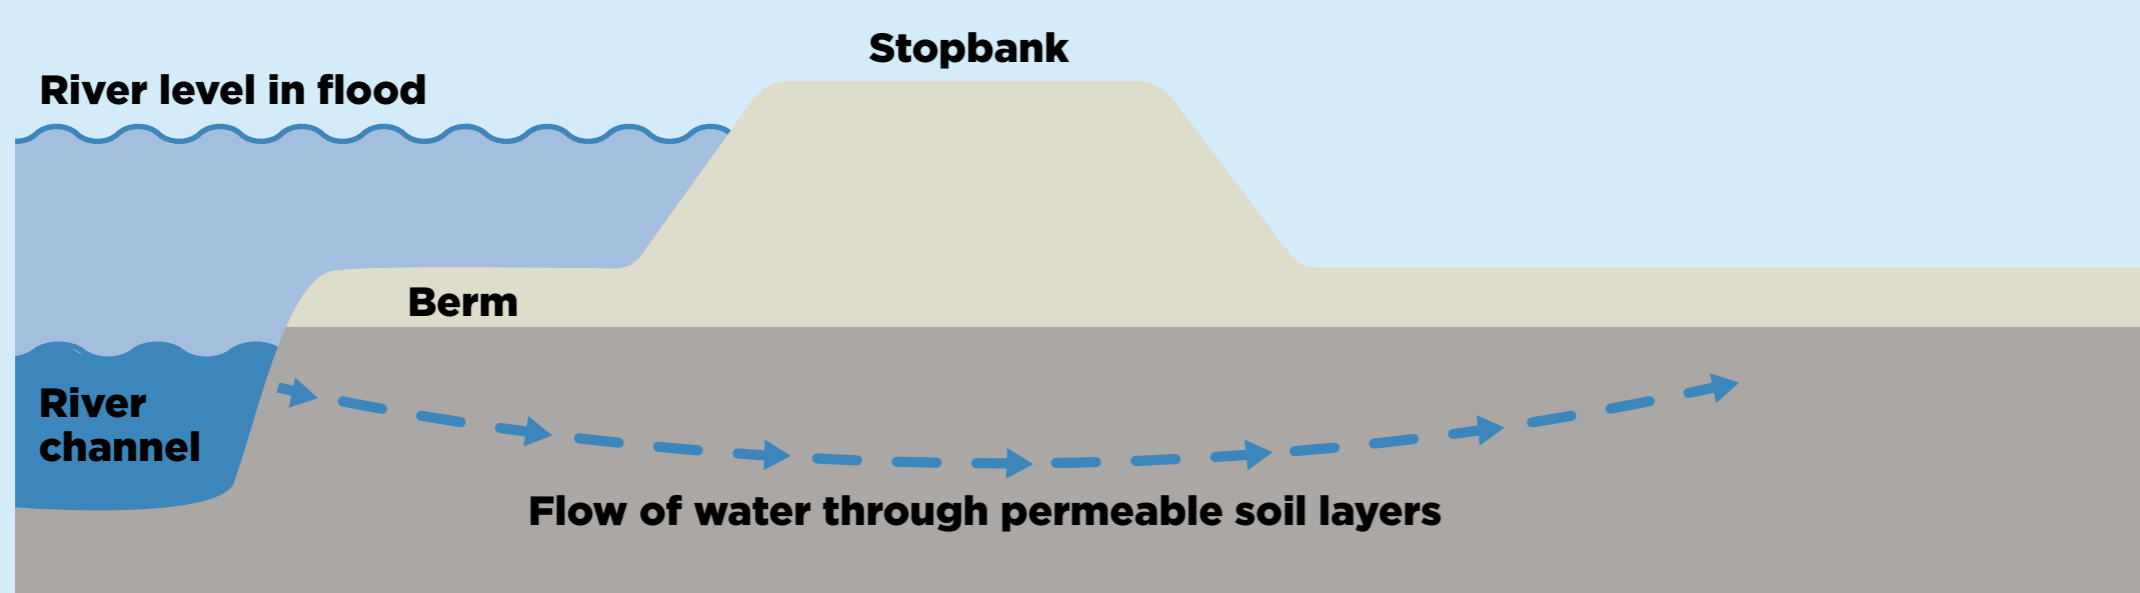
As river levels rise during a flood event there is more pressure on the river bank, berm and stopbank and this increases the rate of water flowing through permeable soil layers beneath the stopbank. (Permeable soils allow water to easily flow through them e.g. sand, pumice.)

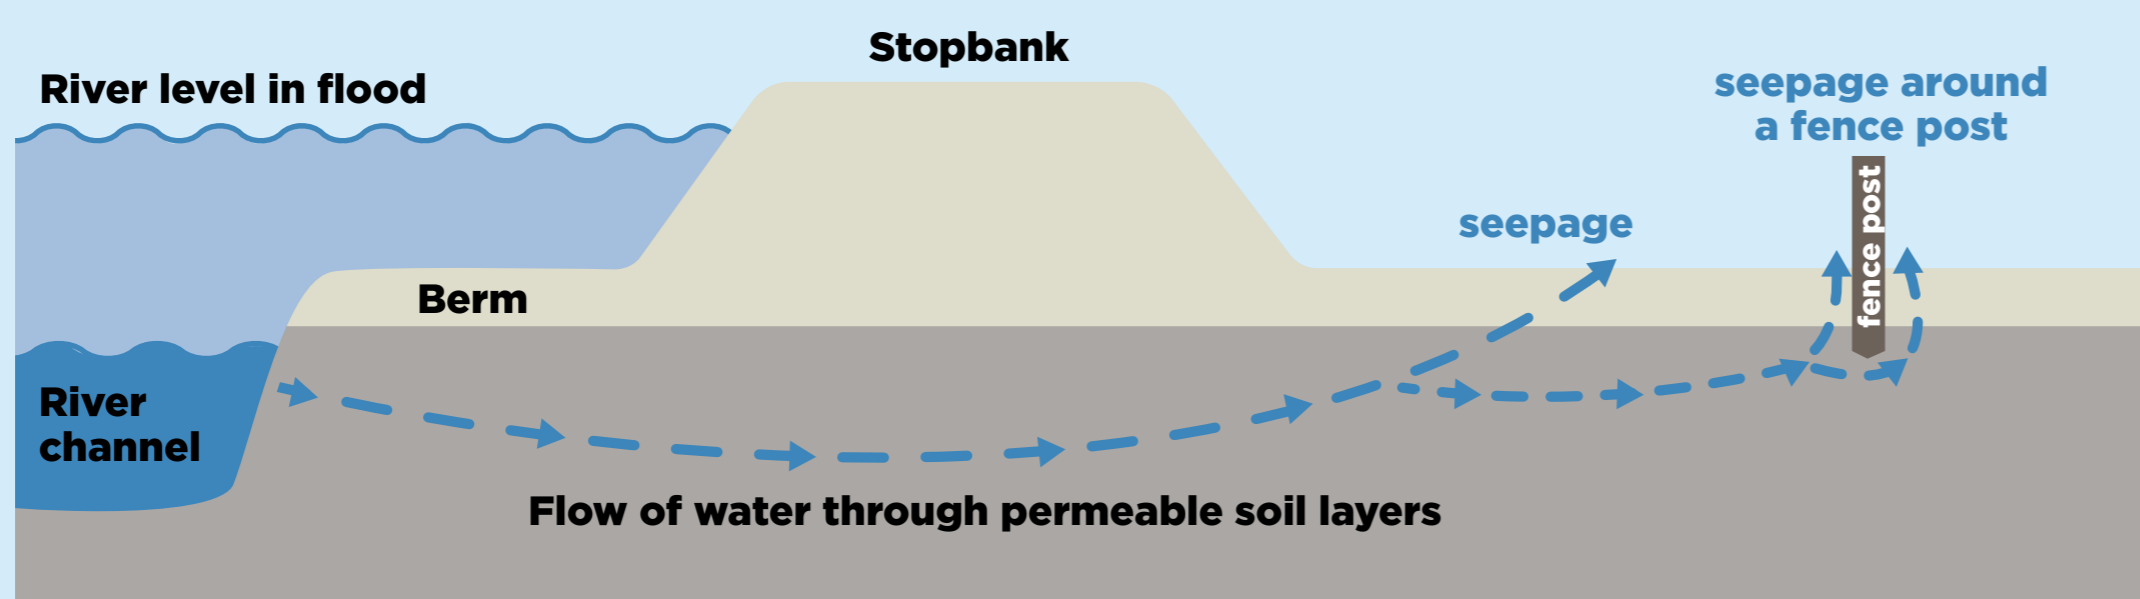
This water can seep out to the ground surface when a permeable soil layer comes close to the surface, or where something penetrates into a permeable soil layer creating a pathway to the surface (e.g. fence post, building foundations or a tree).

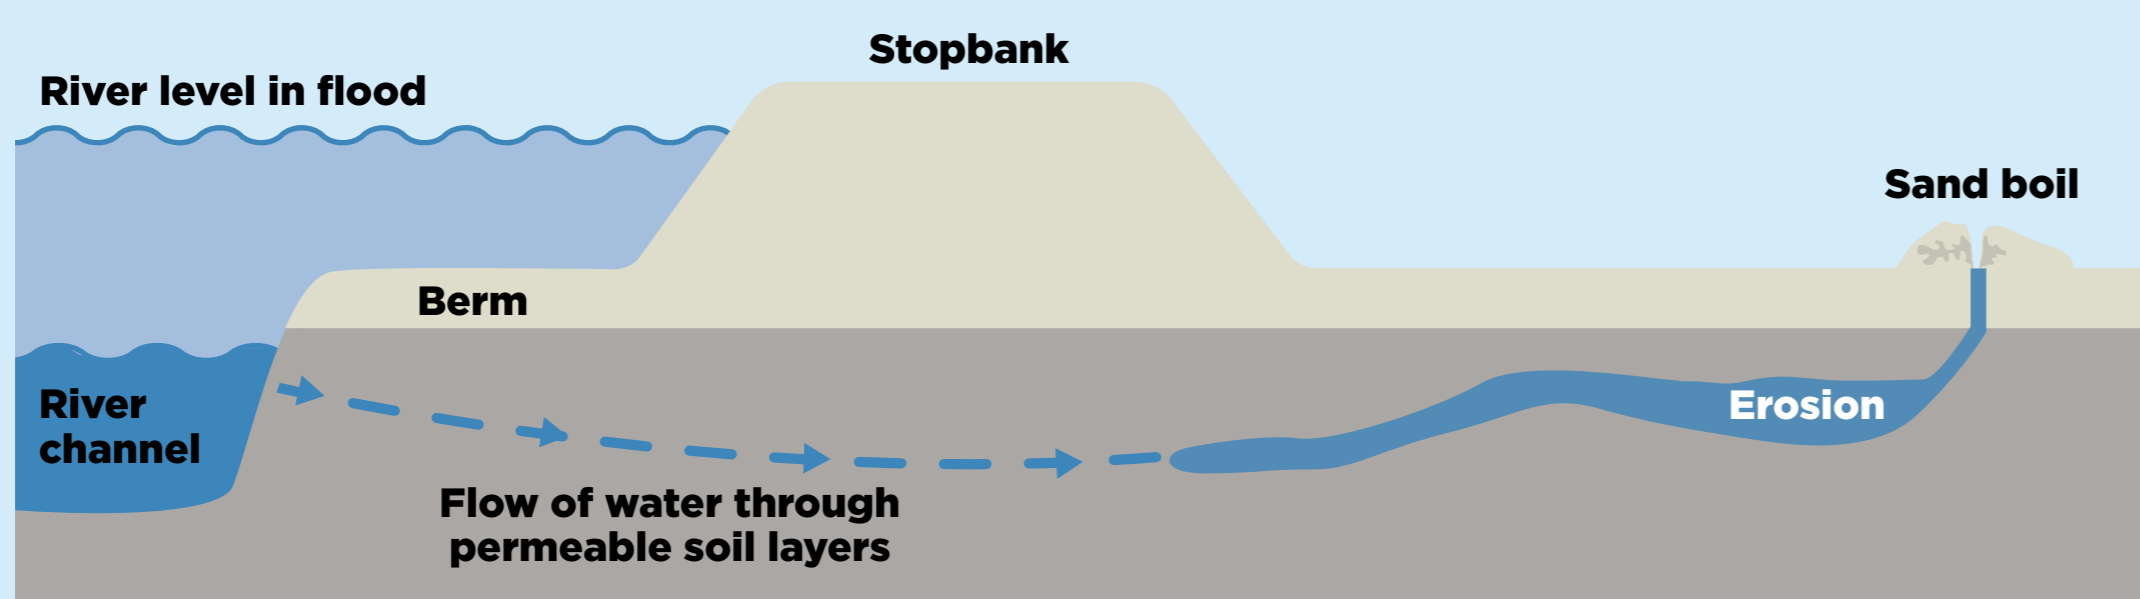
When seepage flow is sufficient enough to carry soil particles to the surface we see 'sand boils' forming and resulting in 'piping' or backward erosion of soil from the foundations of the stopbank.

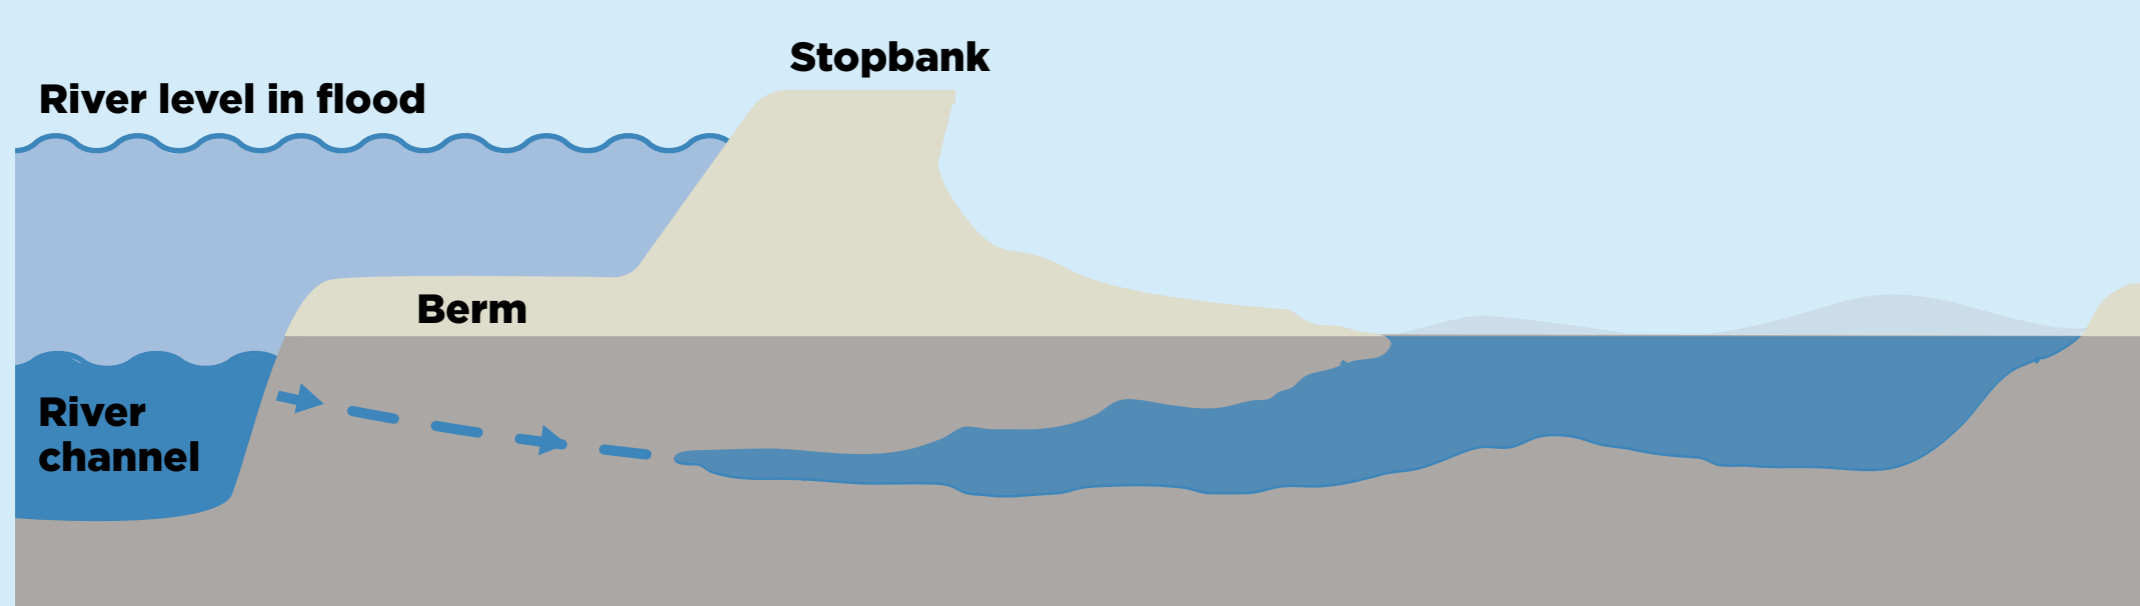
Piping can enlarge very quickly and potentially result in stopbank instability and collapse.

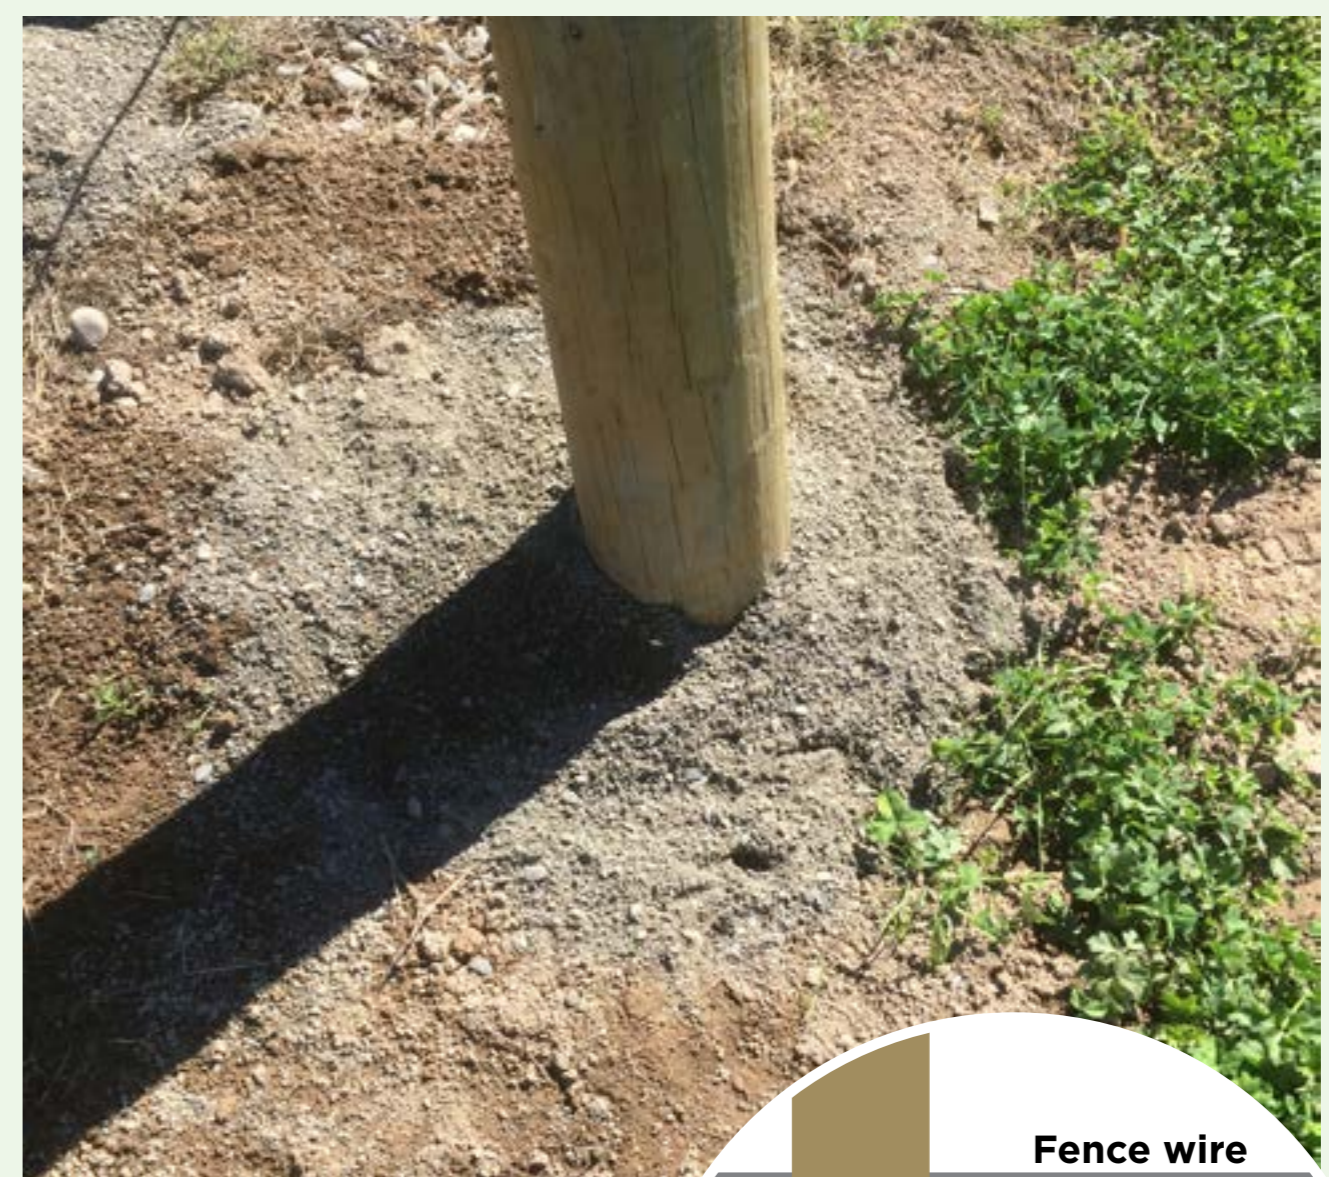
If there is any risk of posts penetrating permeable sand layers, and creating a seepage path to the surface, a filter collar of NZTA F/2 drainage aggregate can be installed around the post at ground level. Filter collars allow water to escape while trapping soil particles and preventing backward piping erosion.
