**APPENDIX C**

# Sediment Volume Calculations from Geotube<sup>®</sup> Bags

# Kope Drain Road (CS1) - 7 January, 2019

### **Kope Canal Containment Site 3**

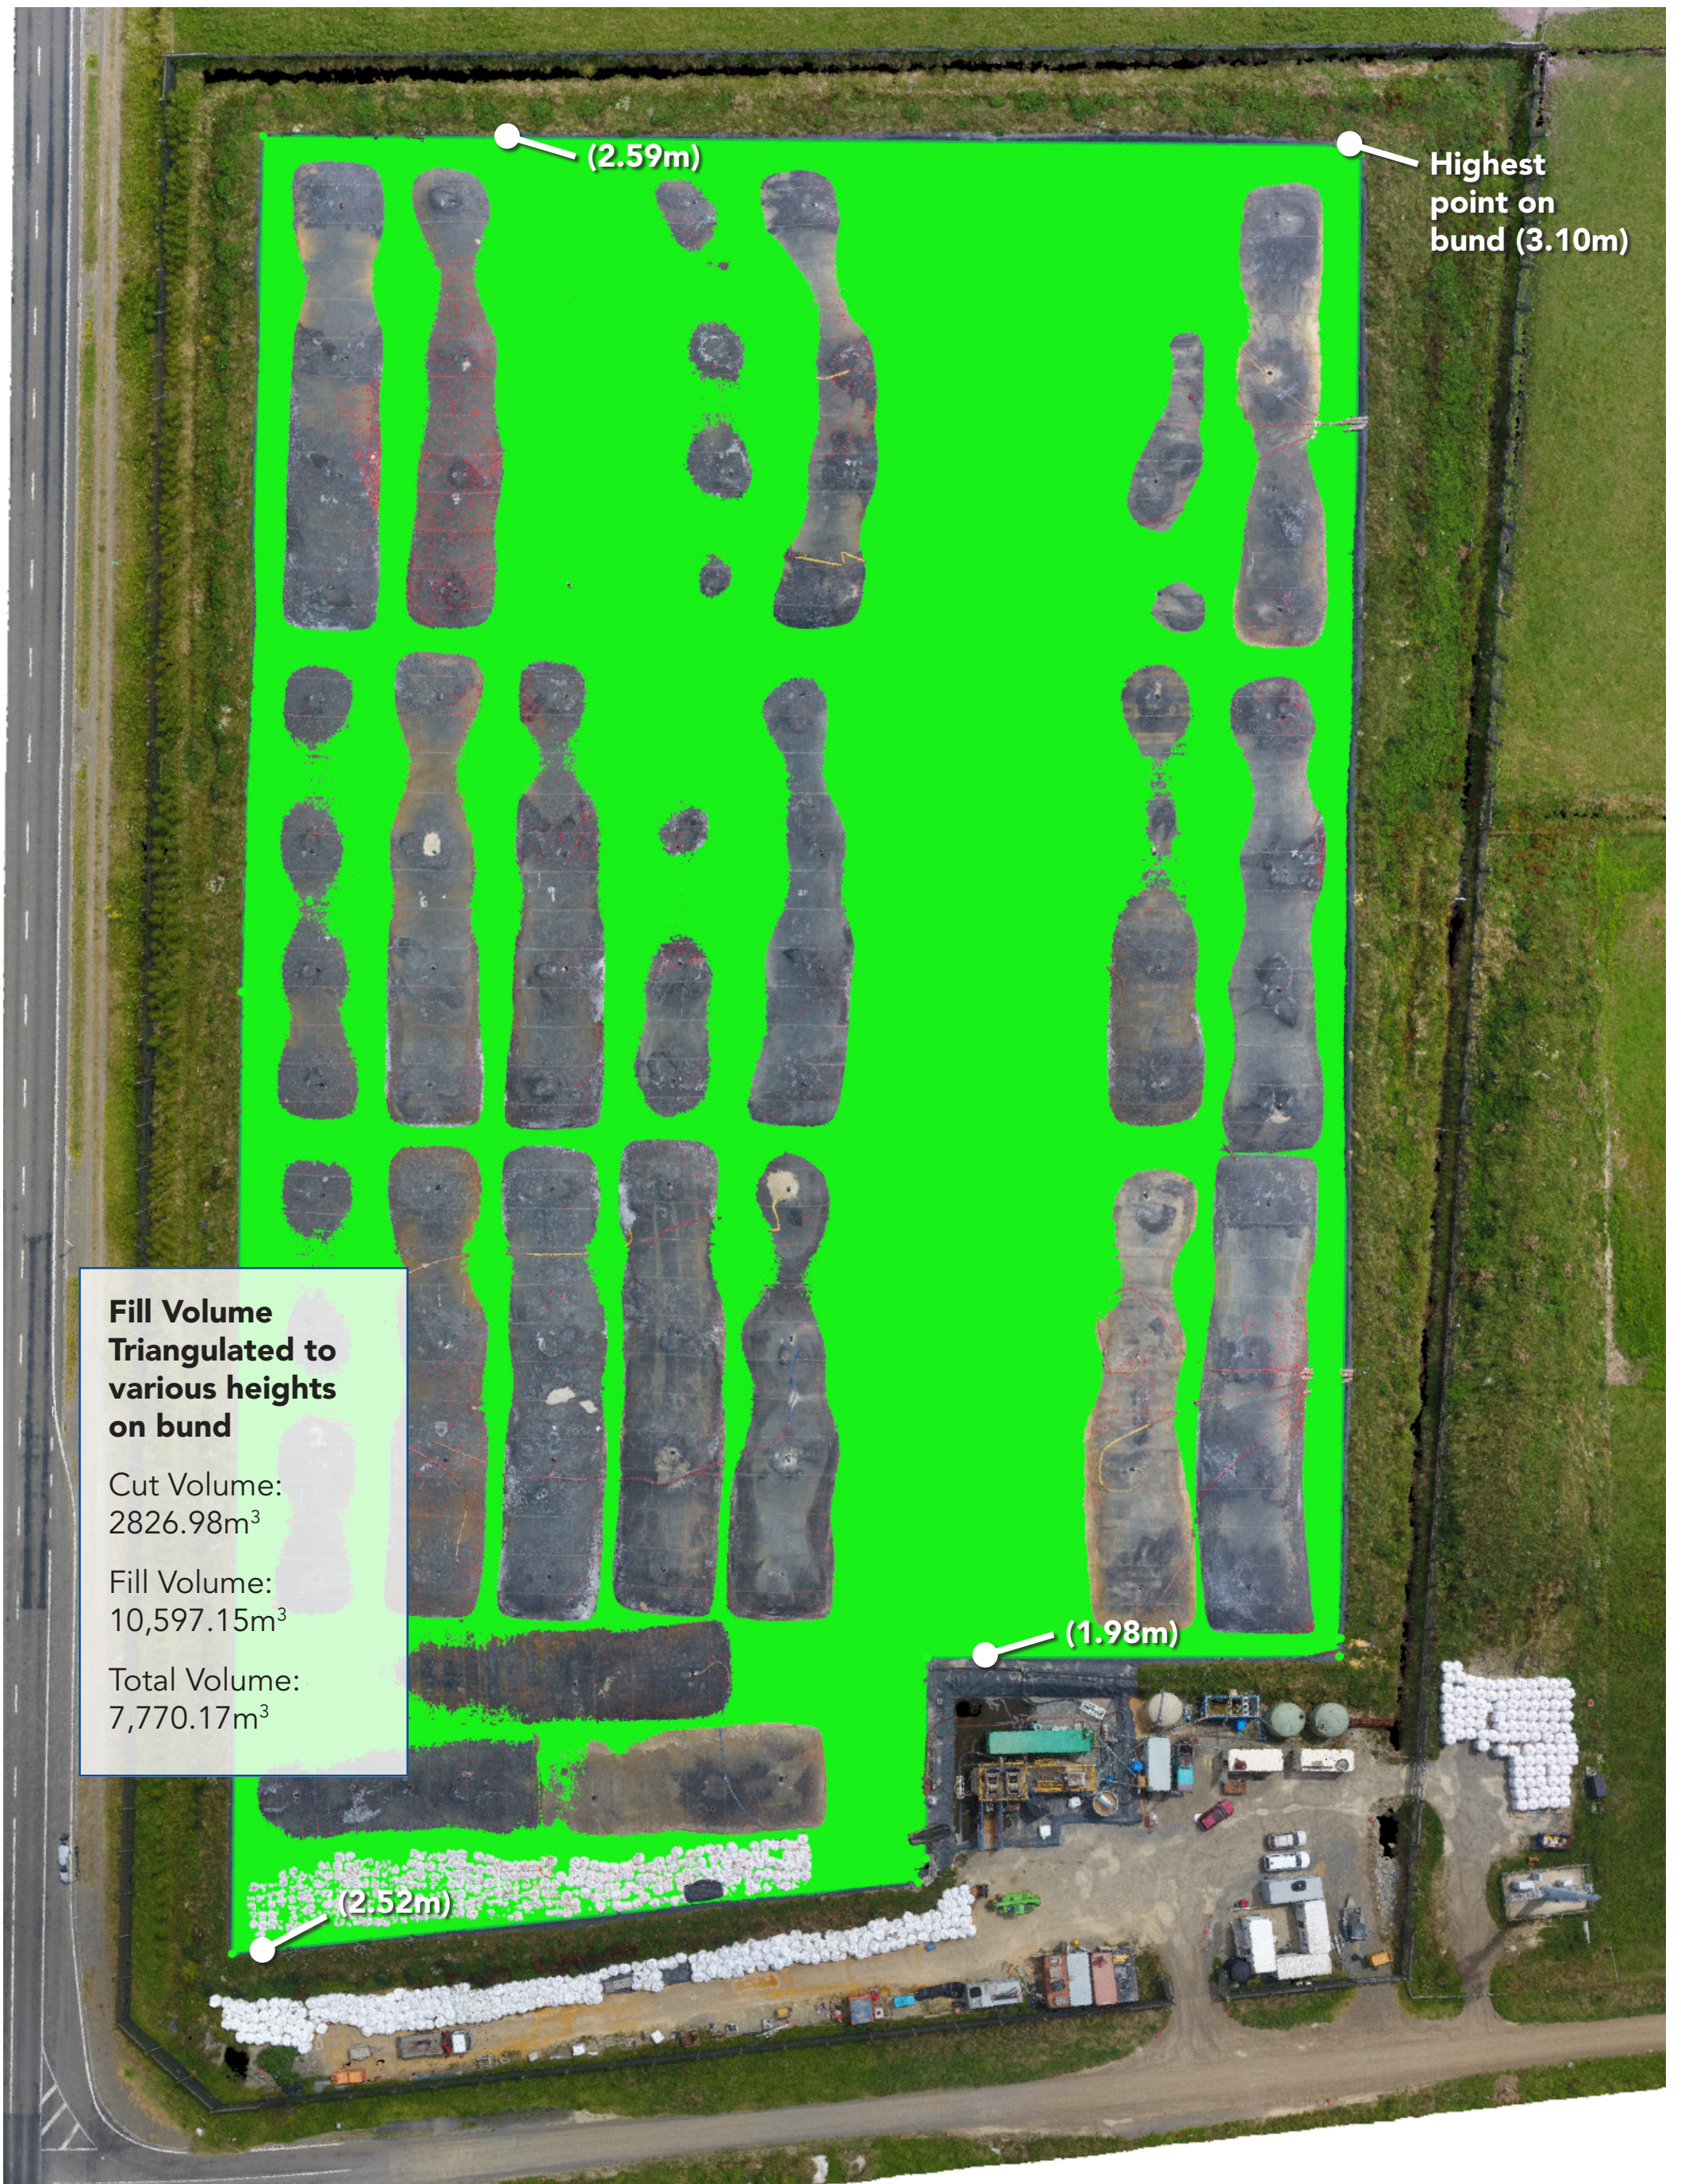
**Fill Volume  
Triangulated to  
various heights  
on bund**

Cut Volume:  
2826.98m<sup>3</sup>

Fill Volume:  
10,597.15m<sup>3</sup>

Total Volume:  
7,770.17m<sup>3</sup>

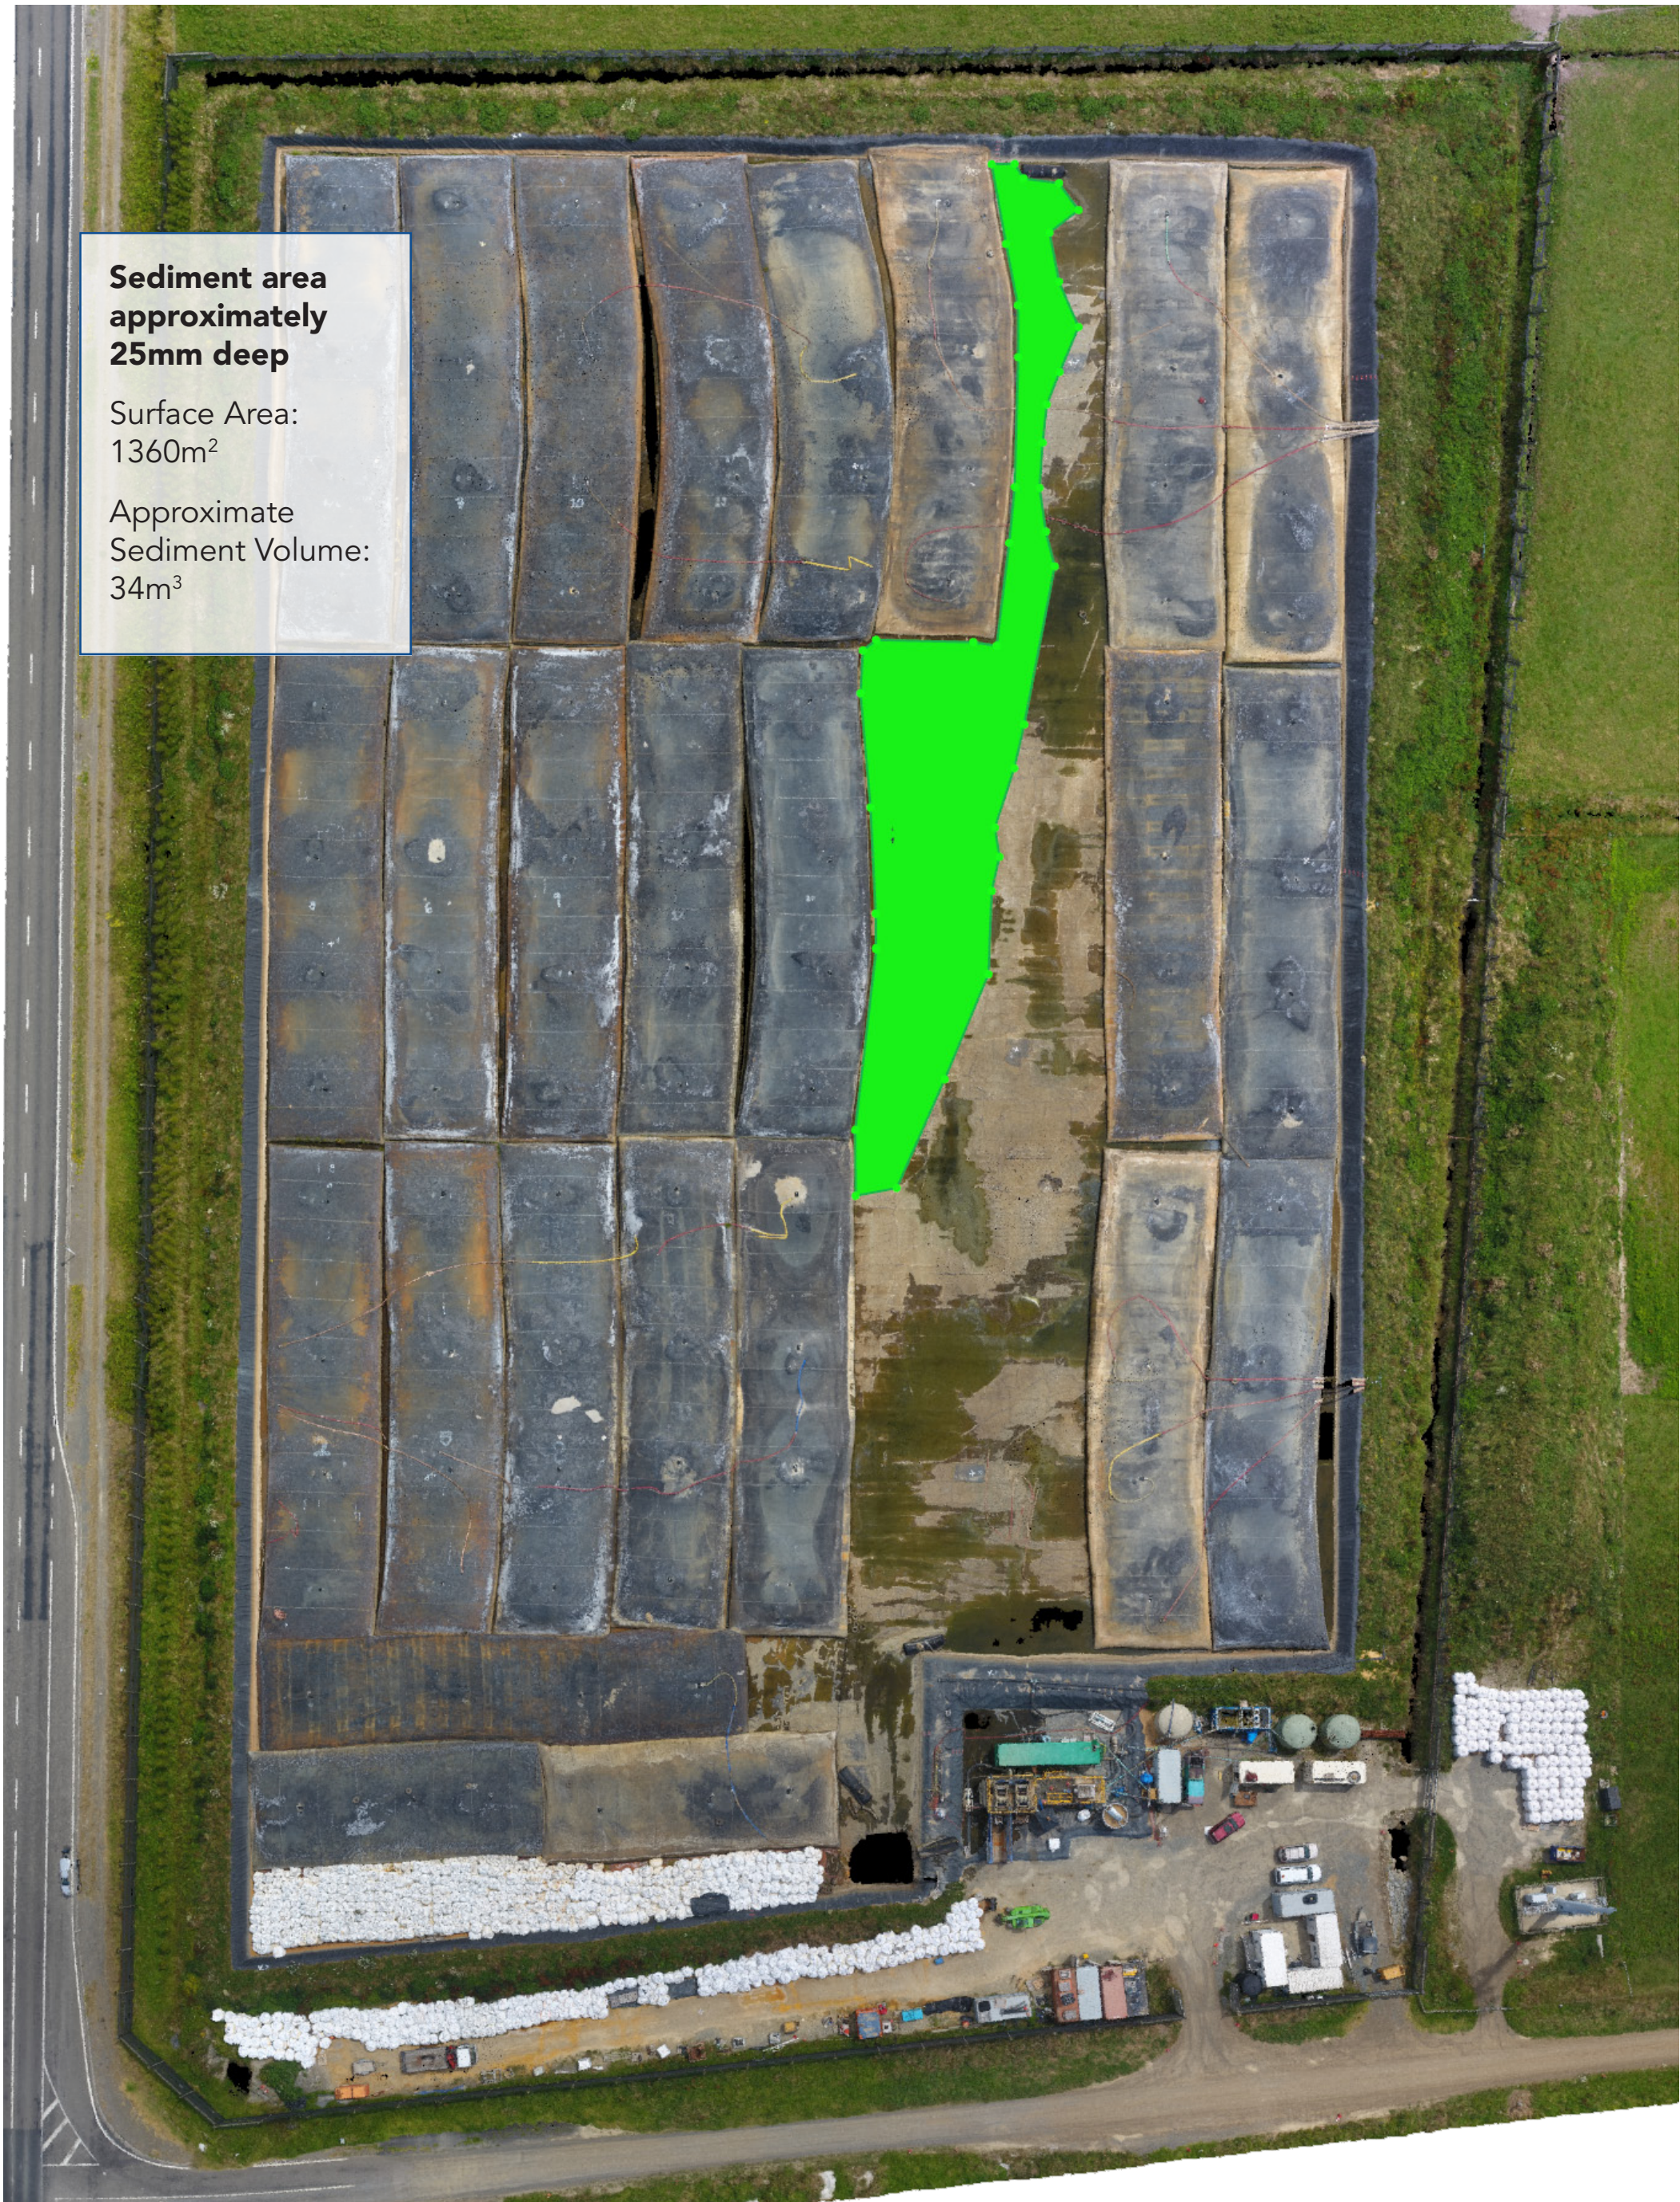
**Sediment area  
approximately  
25mm deep**

Surface Area:  
1360m<sup>2</sup>

Approximate  
Sediment Volume:  
34m<sup>3</sup>

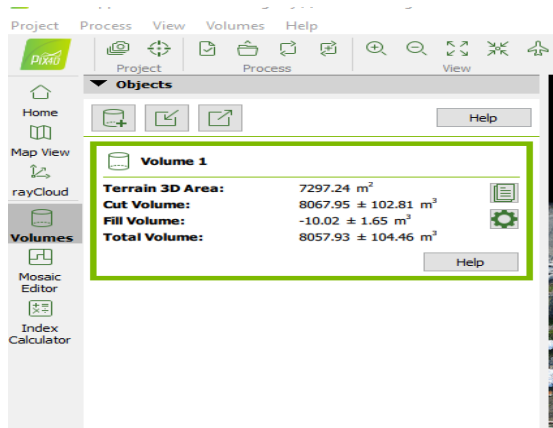
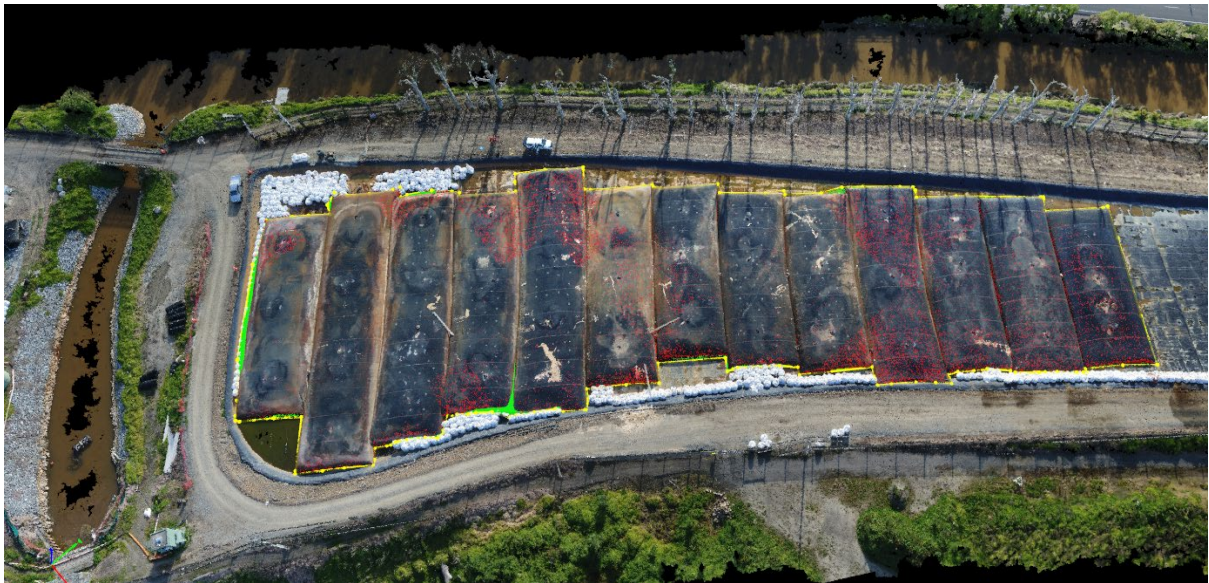
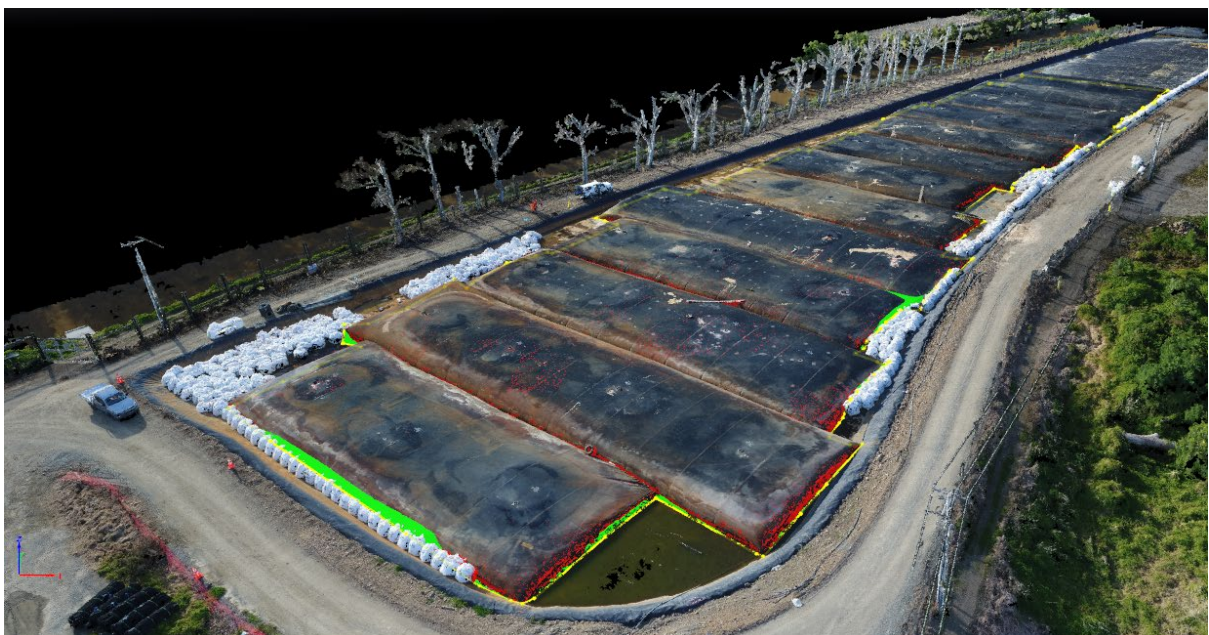
## FLIGHT 1

Bags 1-13	Bags 14-16
Flight 1: 08/08 at 2:58 pm	8057.83 m <sup>3</sup> ± 104.46 m <sup>3</sup>	
Flight 2: 28/08 at 2:58 pm		1935.28 ± 27.12 m <sup>3</sup>

Dan flew the Drone over the Geo Bags using the following specifications: DJI Matrice 210 v2 flown at an altitude of 35m above ground level. Overlap of images was set to 80/80. Flight control using DJI Pilot.

Imagery and surfaces were generated using Pix4D. The calculations for volume were processed using the DSM processed in Pix4D.

This process uses the **Cut/Fill** Geo-processing tool in Pix4D to calculate the volume. Cut/Fill is a procedure in which the elevation of a landform surface is modified by the removal or addition of surface material.

Base surface settings allows to select the base plane for the volume calculation. In this case, it is recommended to select the **Triangulated** option for the base surface. This option is recommended especially when the terrain around the volume is not flat and the entire boundary is visible.
