Validation Report for Sediment Dredging and Placement in Containment Sites

Kopeopeo Canal Remediation Project

Golder Associates (NZ) Limited

1894562-005-R-Rev0

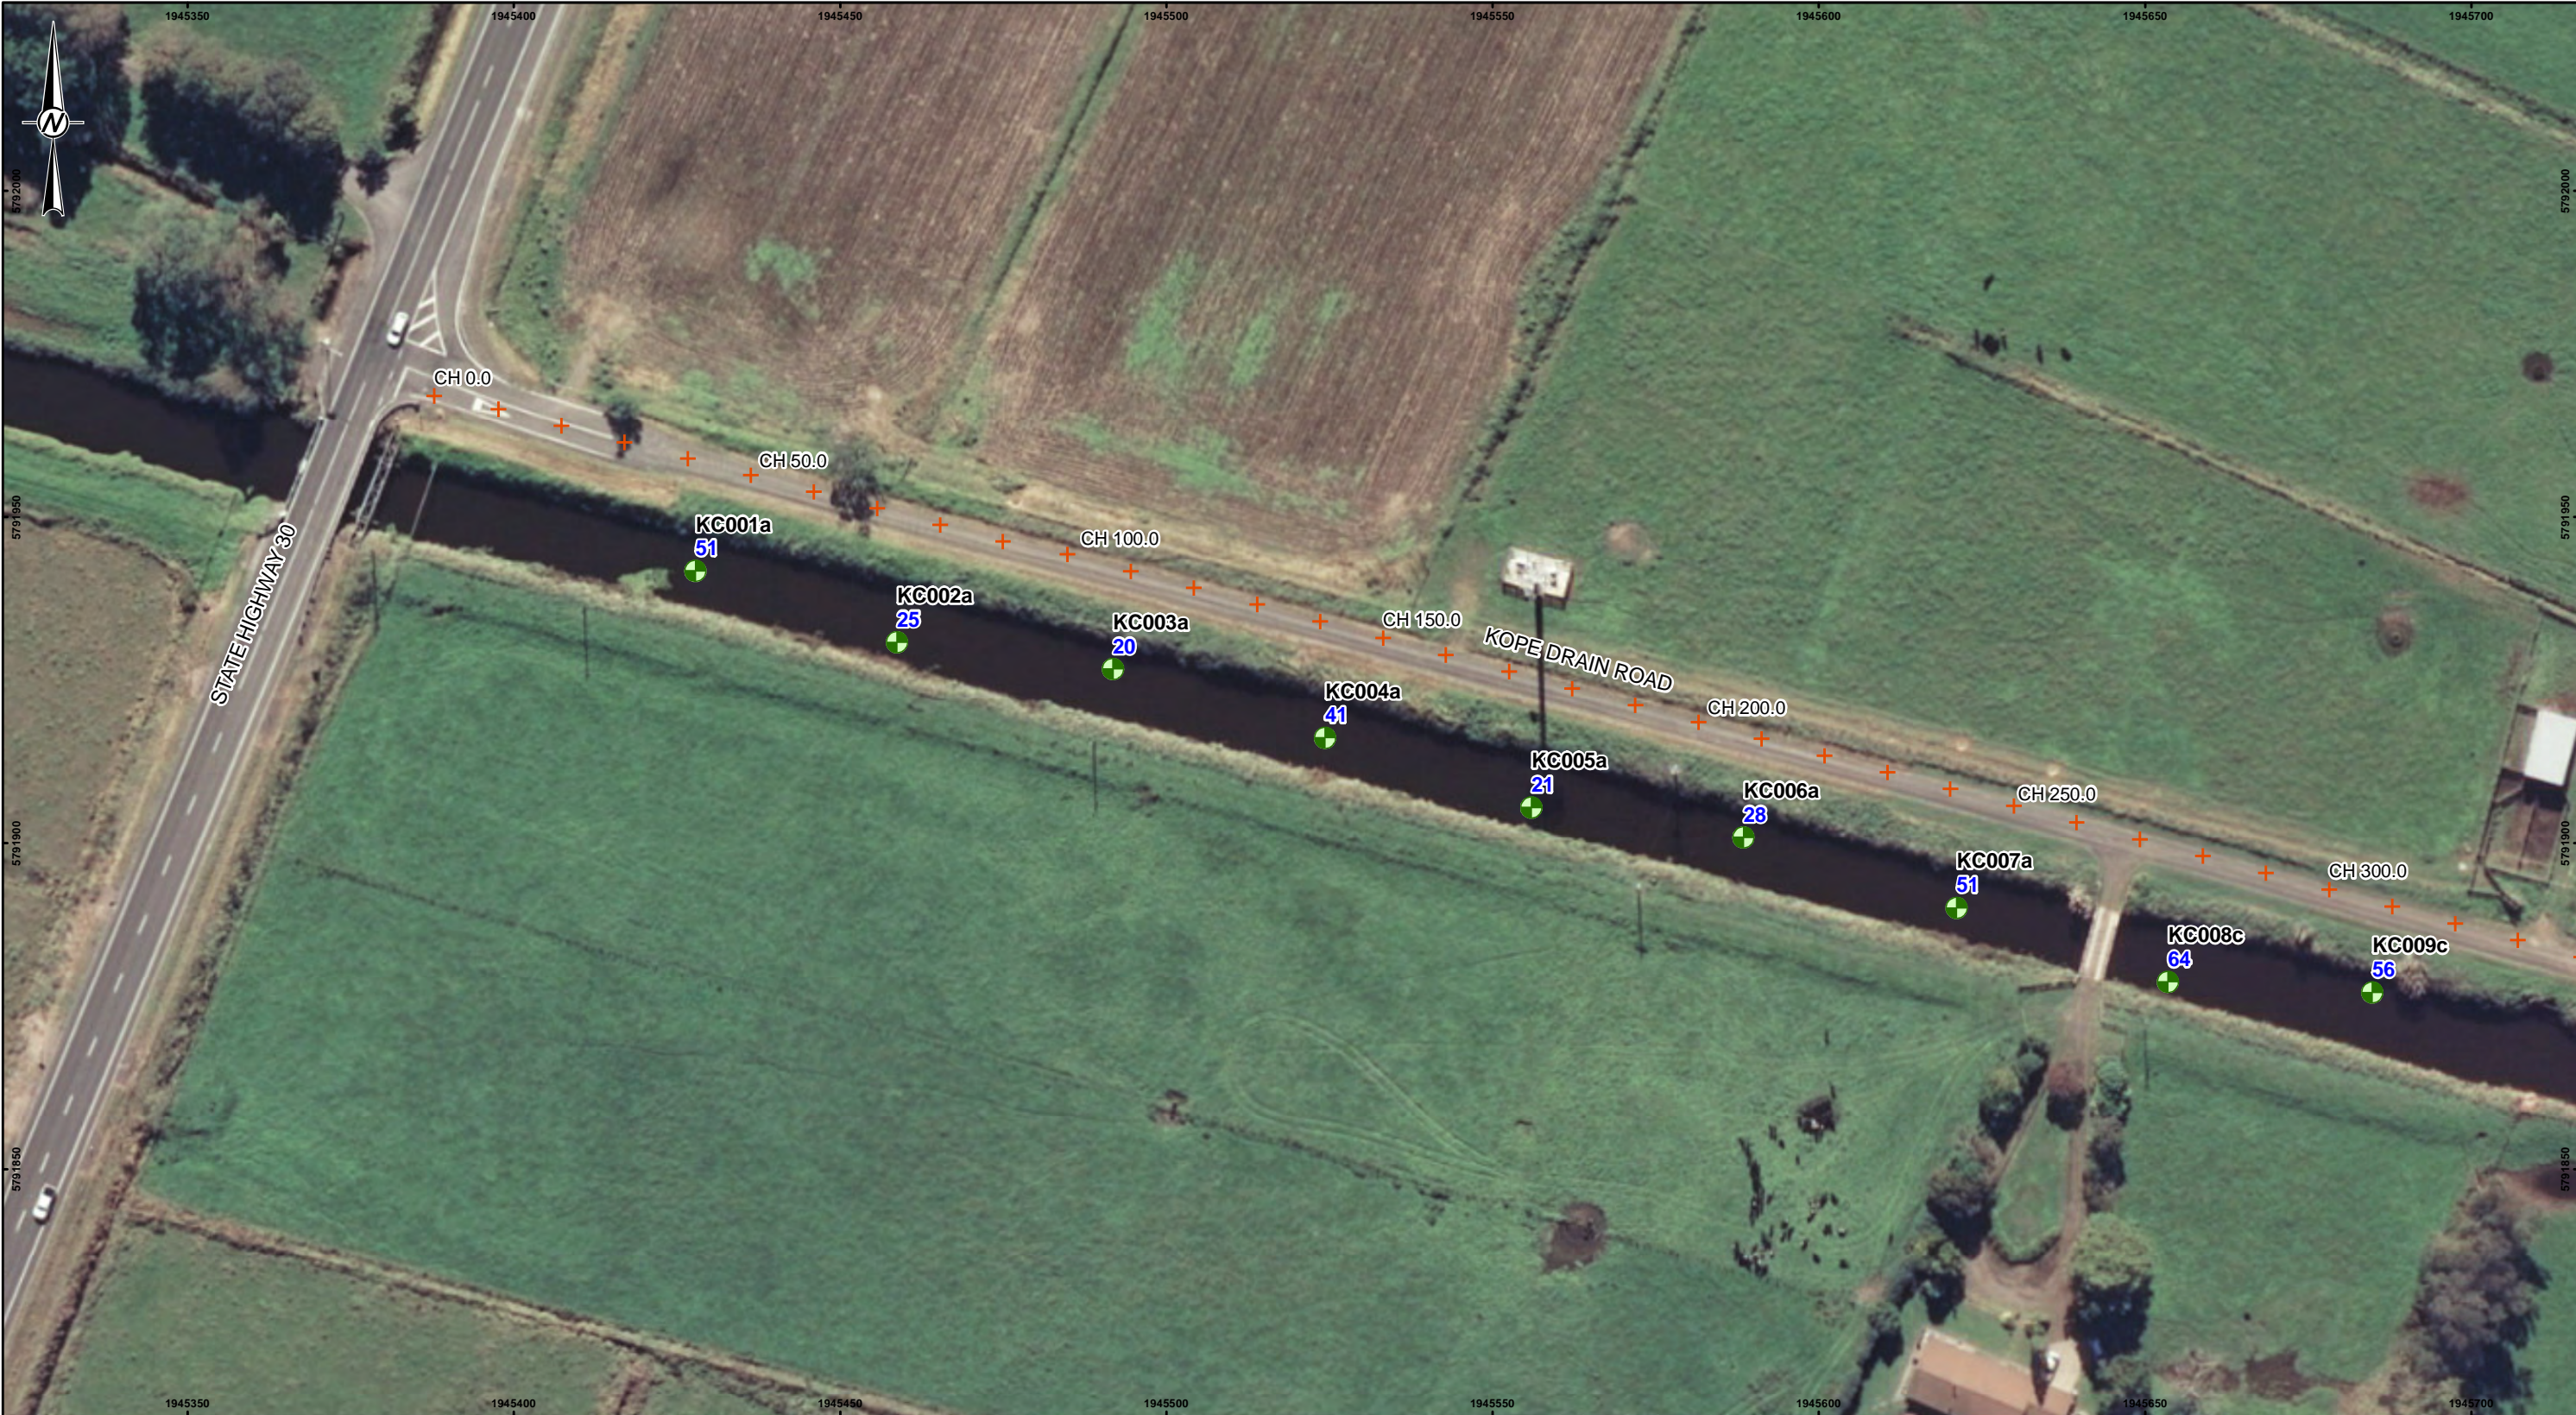
The dioxin concentrations in the sediment samples representative of residual canal base sediment are presented in Figure 5 to Figure 18.

- Sediment validation sample -
Sediment dioxin concentration
- Chainage

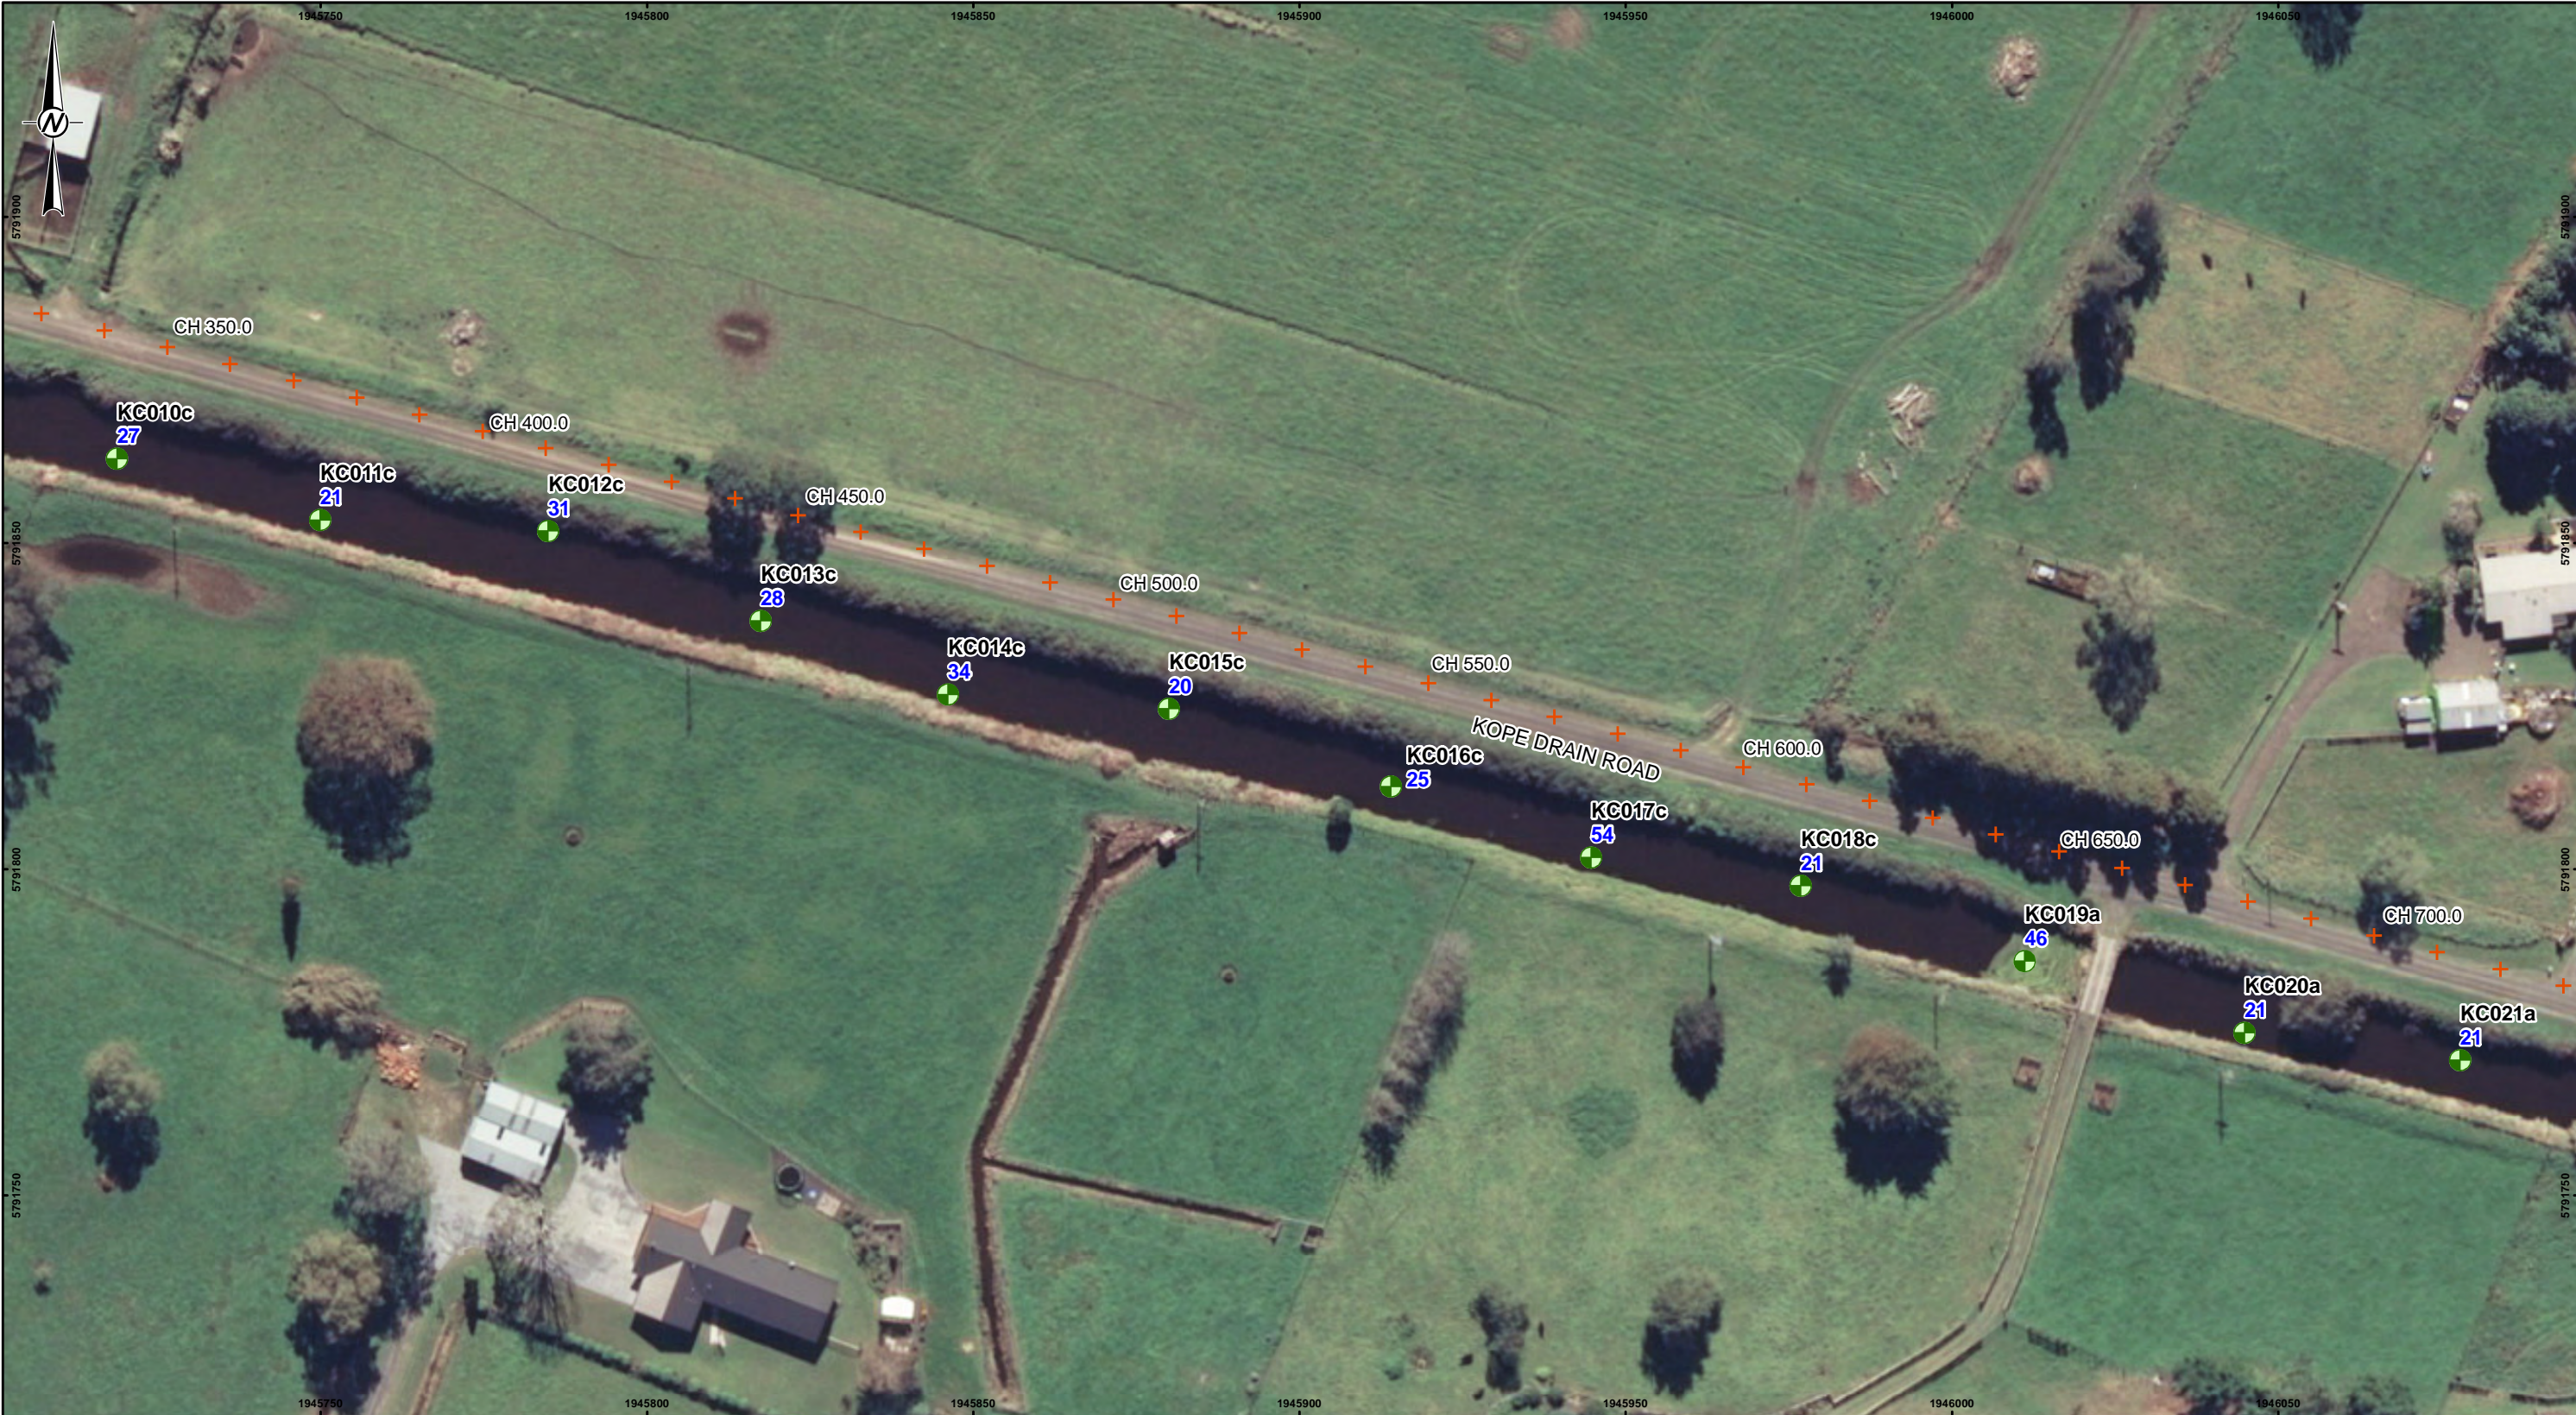
- Sediment validation sample -
Sediment dioxin concentration
- Chainage

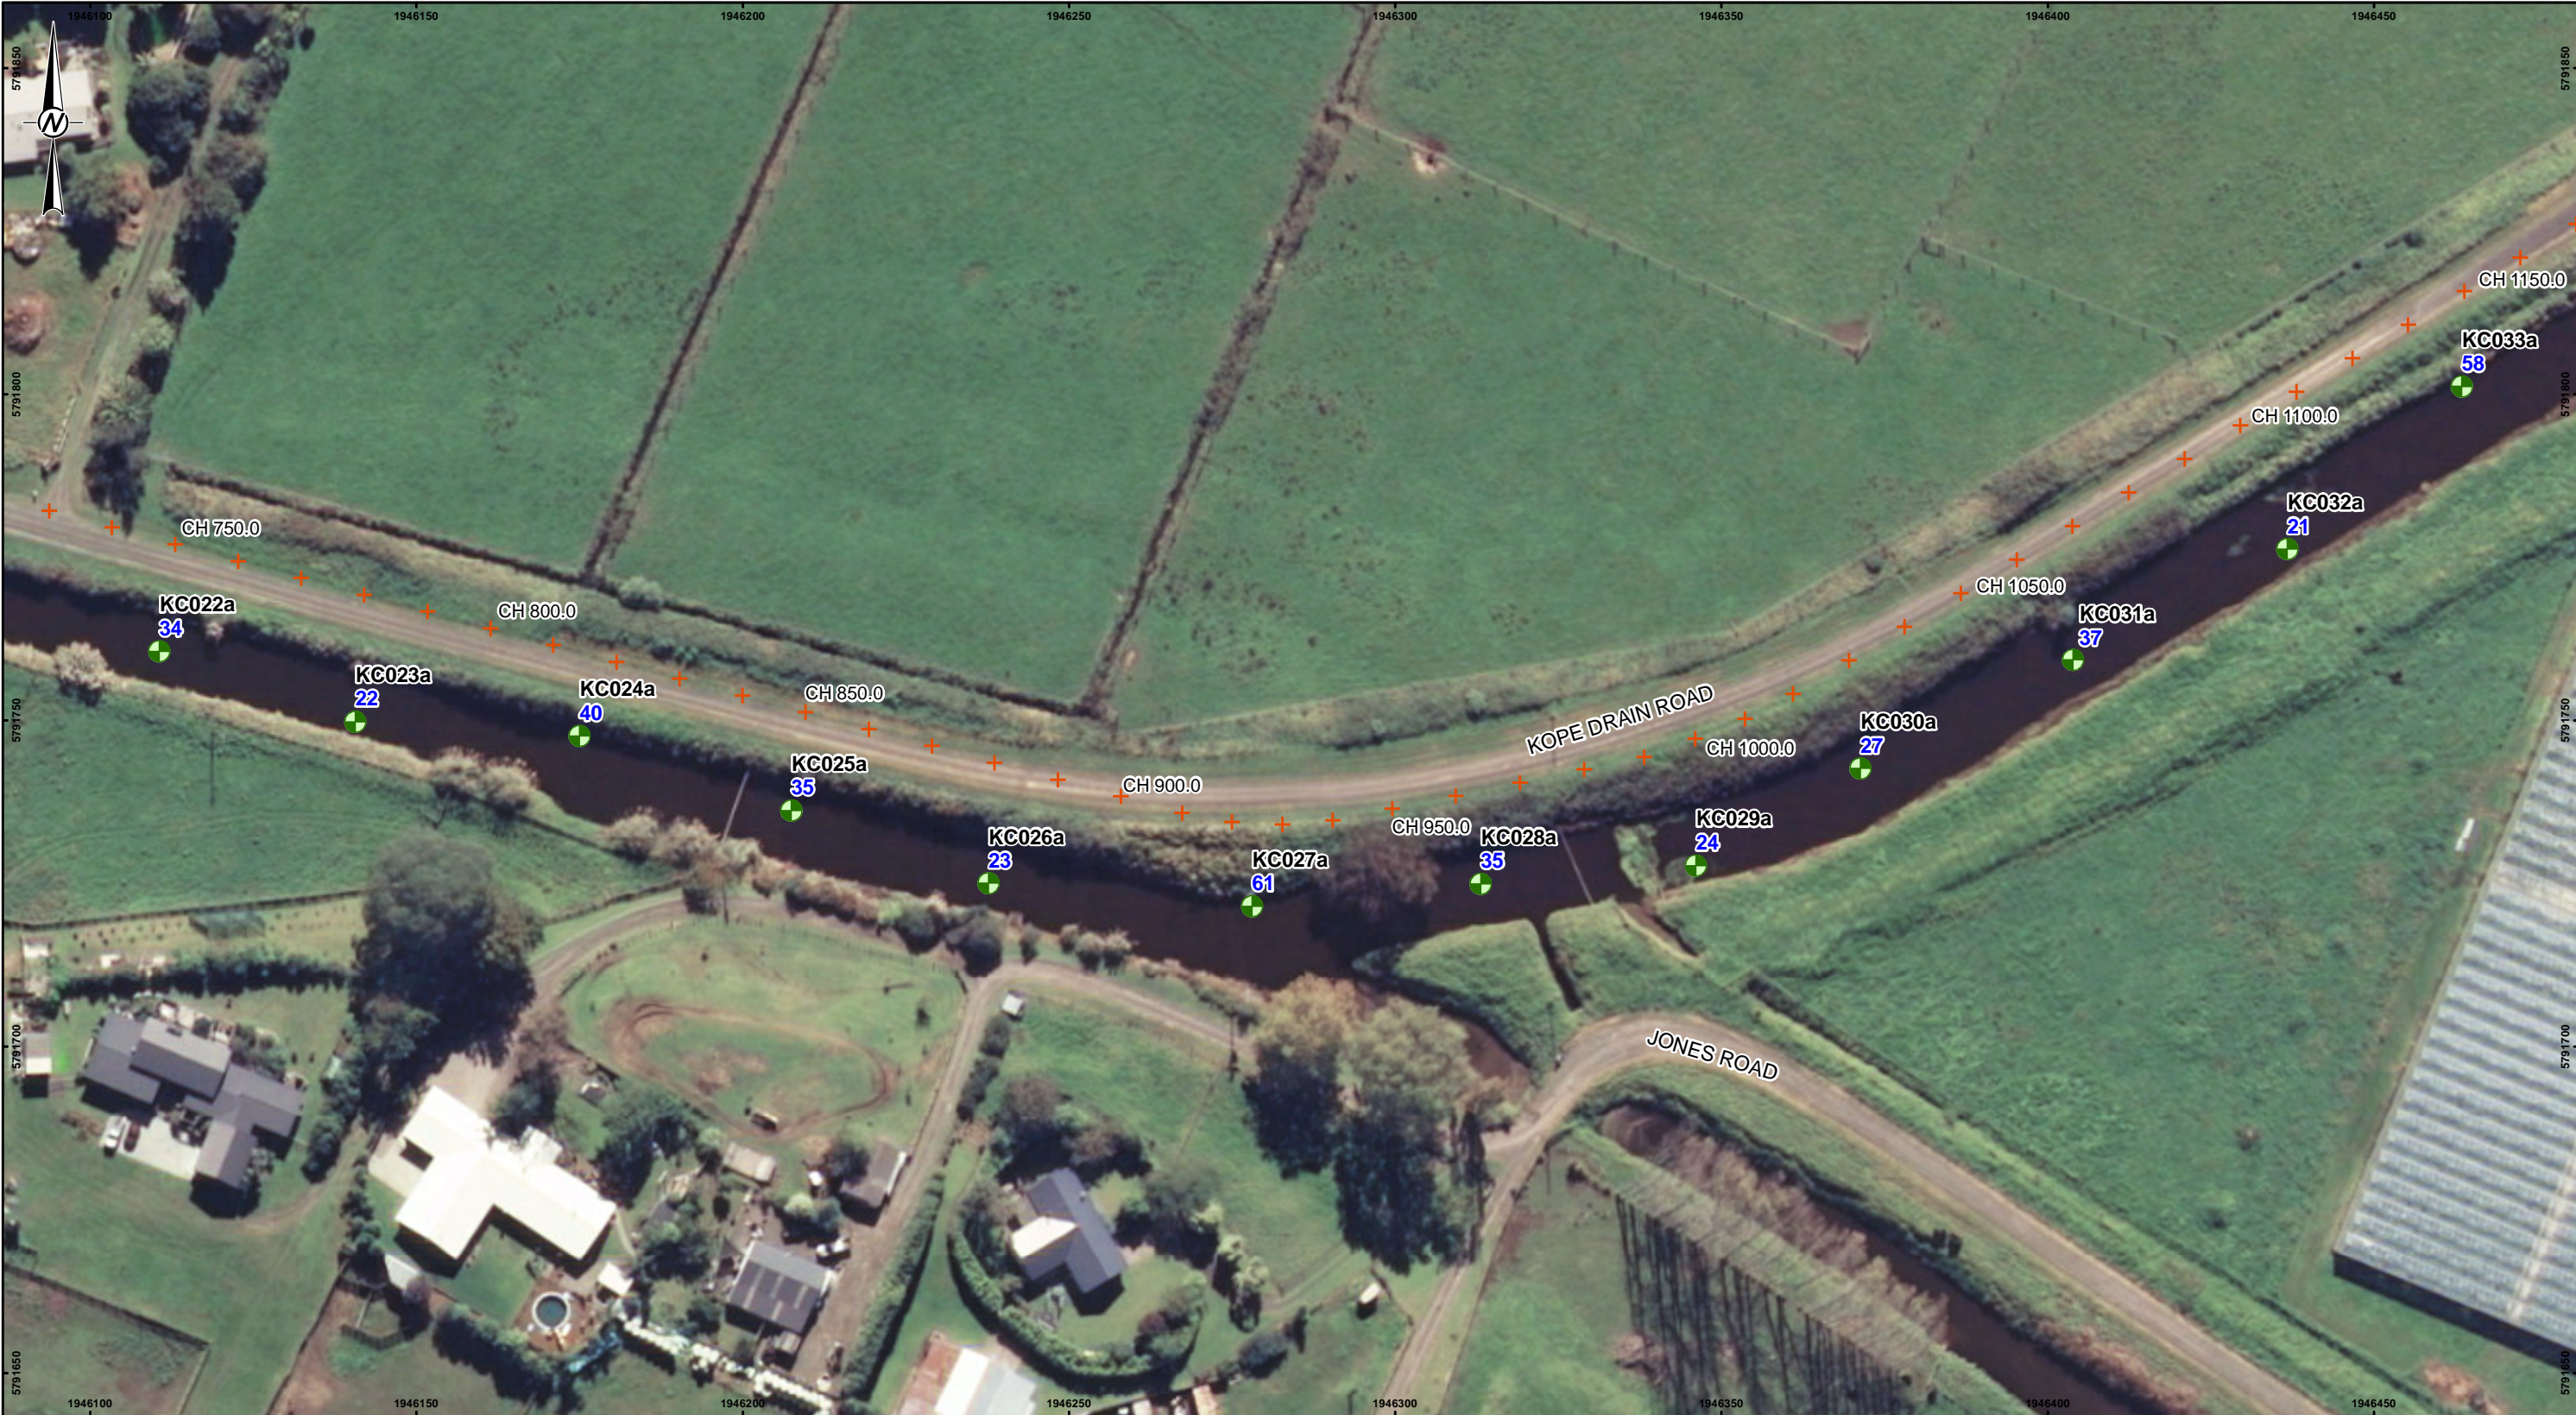
- Sediment validation sample -
Sediment dioxin concentration
- Chainage

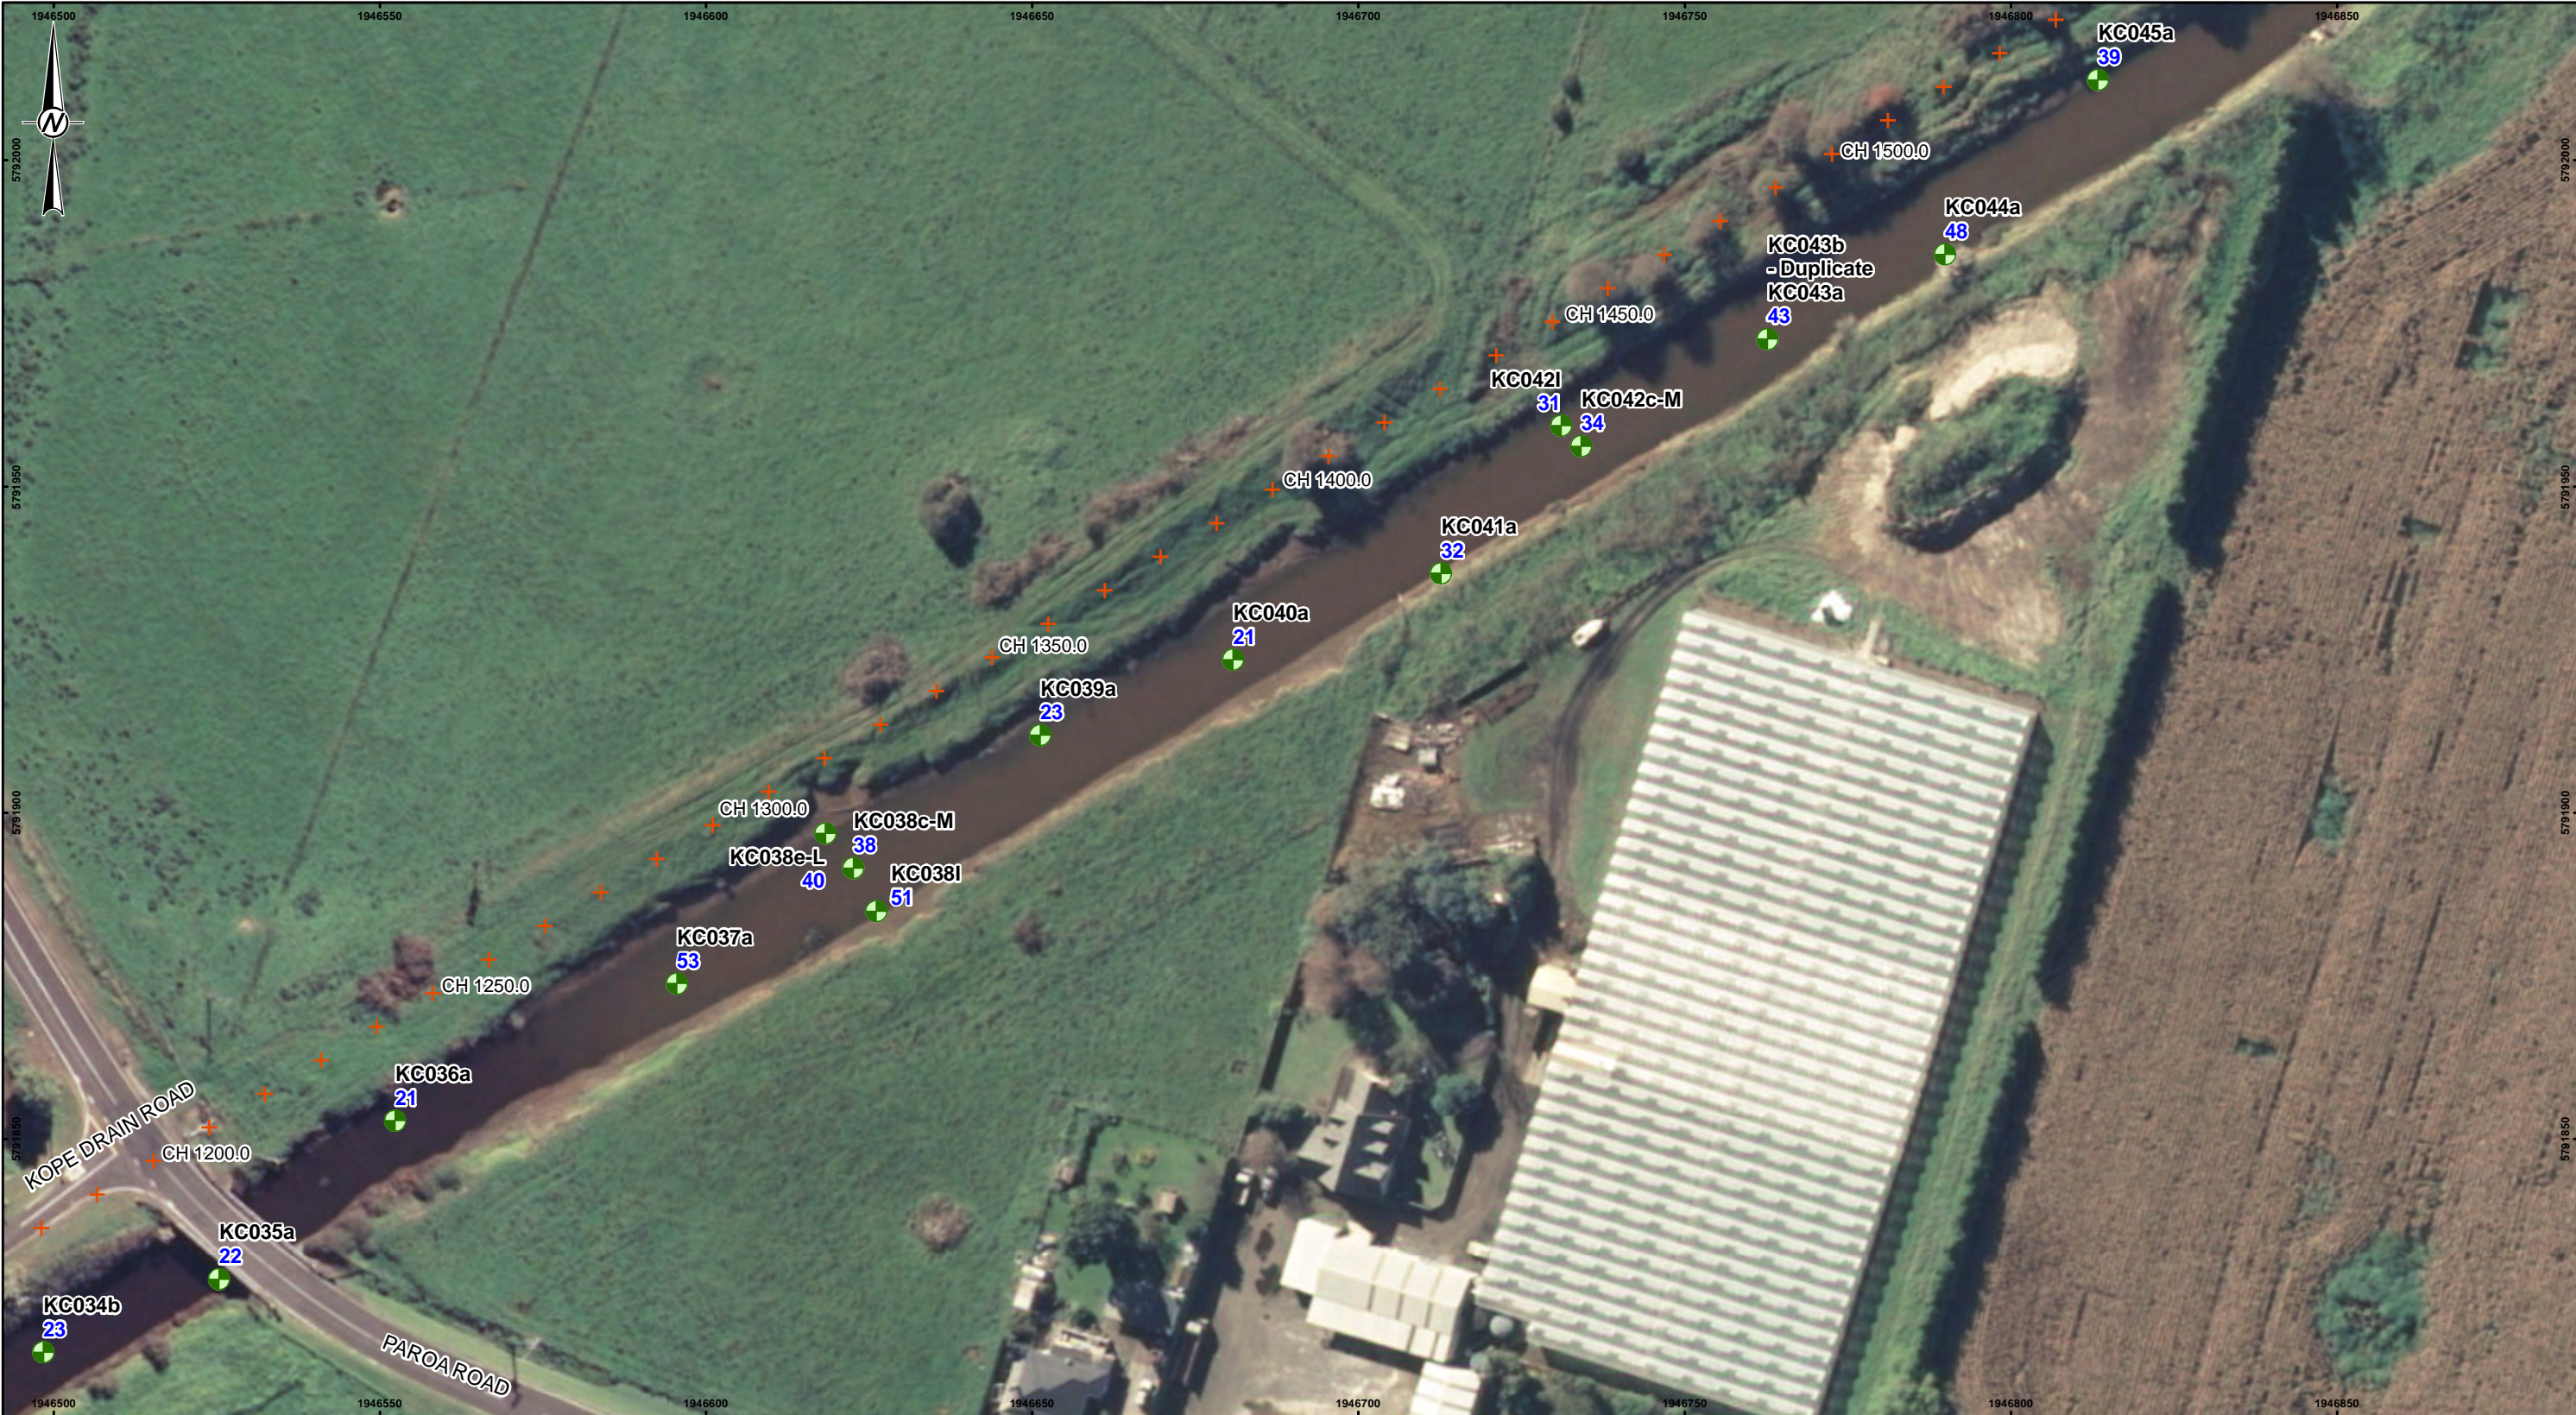
CLIENT			
ENVIRO (NZ) LIMITED			
PROJECT			
KOPEOPEO CANAL REMEDIATION			
TITLE			
SEDIMENT VALIDATION RESULTS - CH1180 TO CH1540			
CONSULTANT		YYYY-MM-DD	2019-12-05
		PREPARED	AE
		REVIEW	AH
		APPROVED	AH
PROJECT NO.	REPORT	REV.	FIGURE
1894562	005	0	08

- Sediment validation sample -
Sediment dioxin concentration
- Chainage

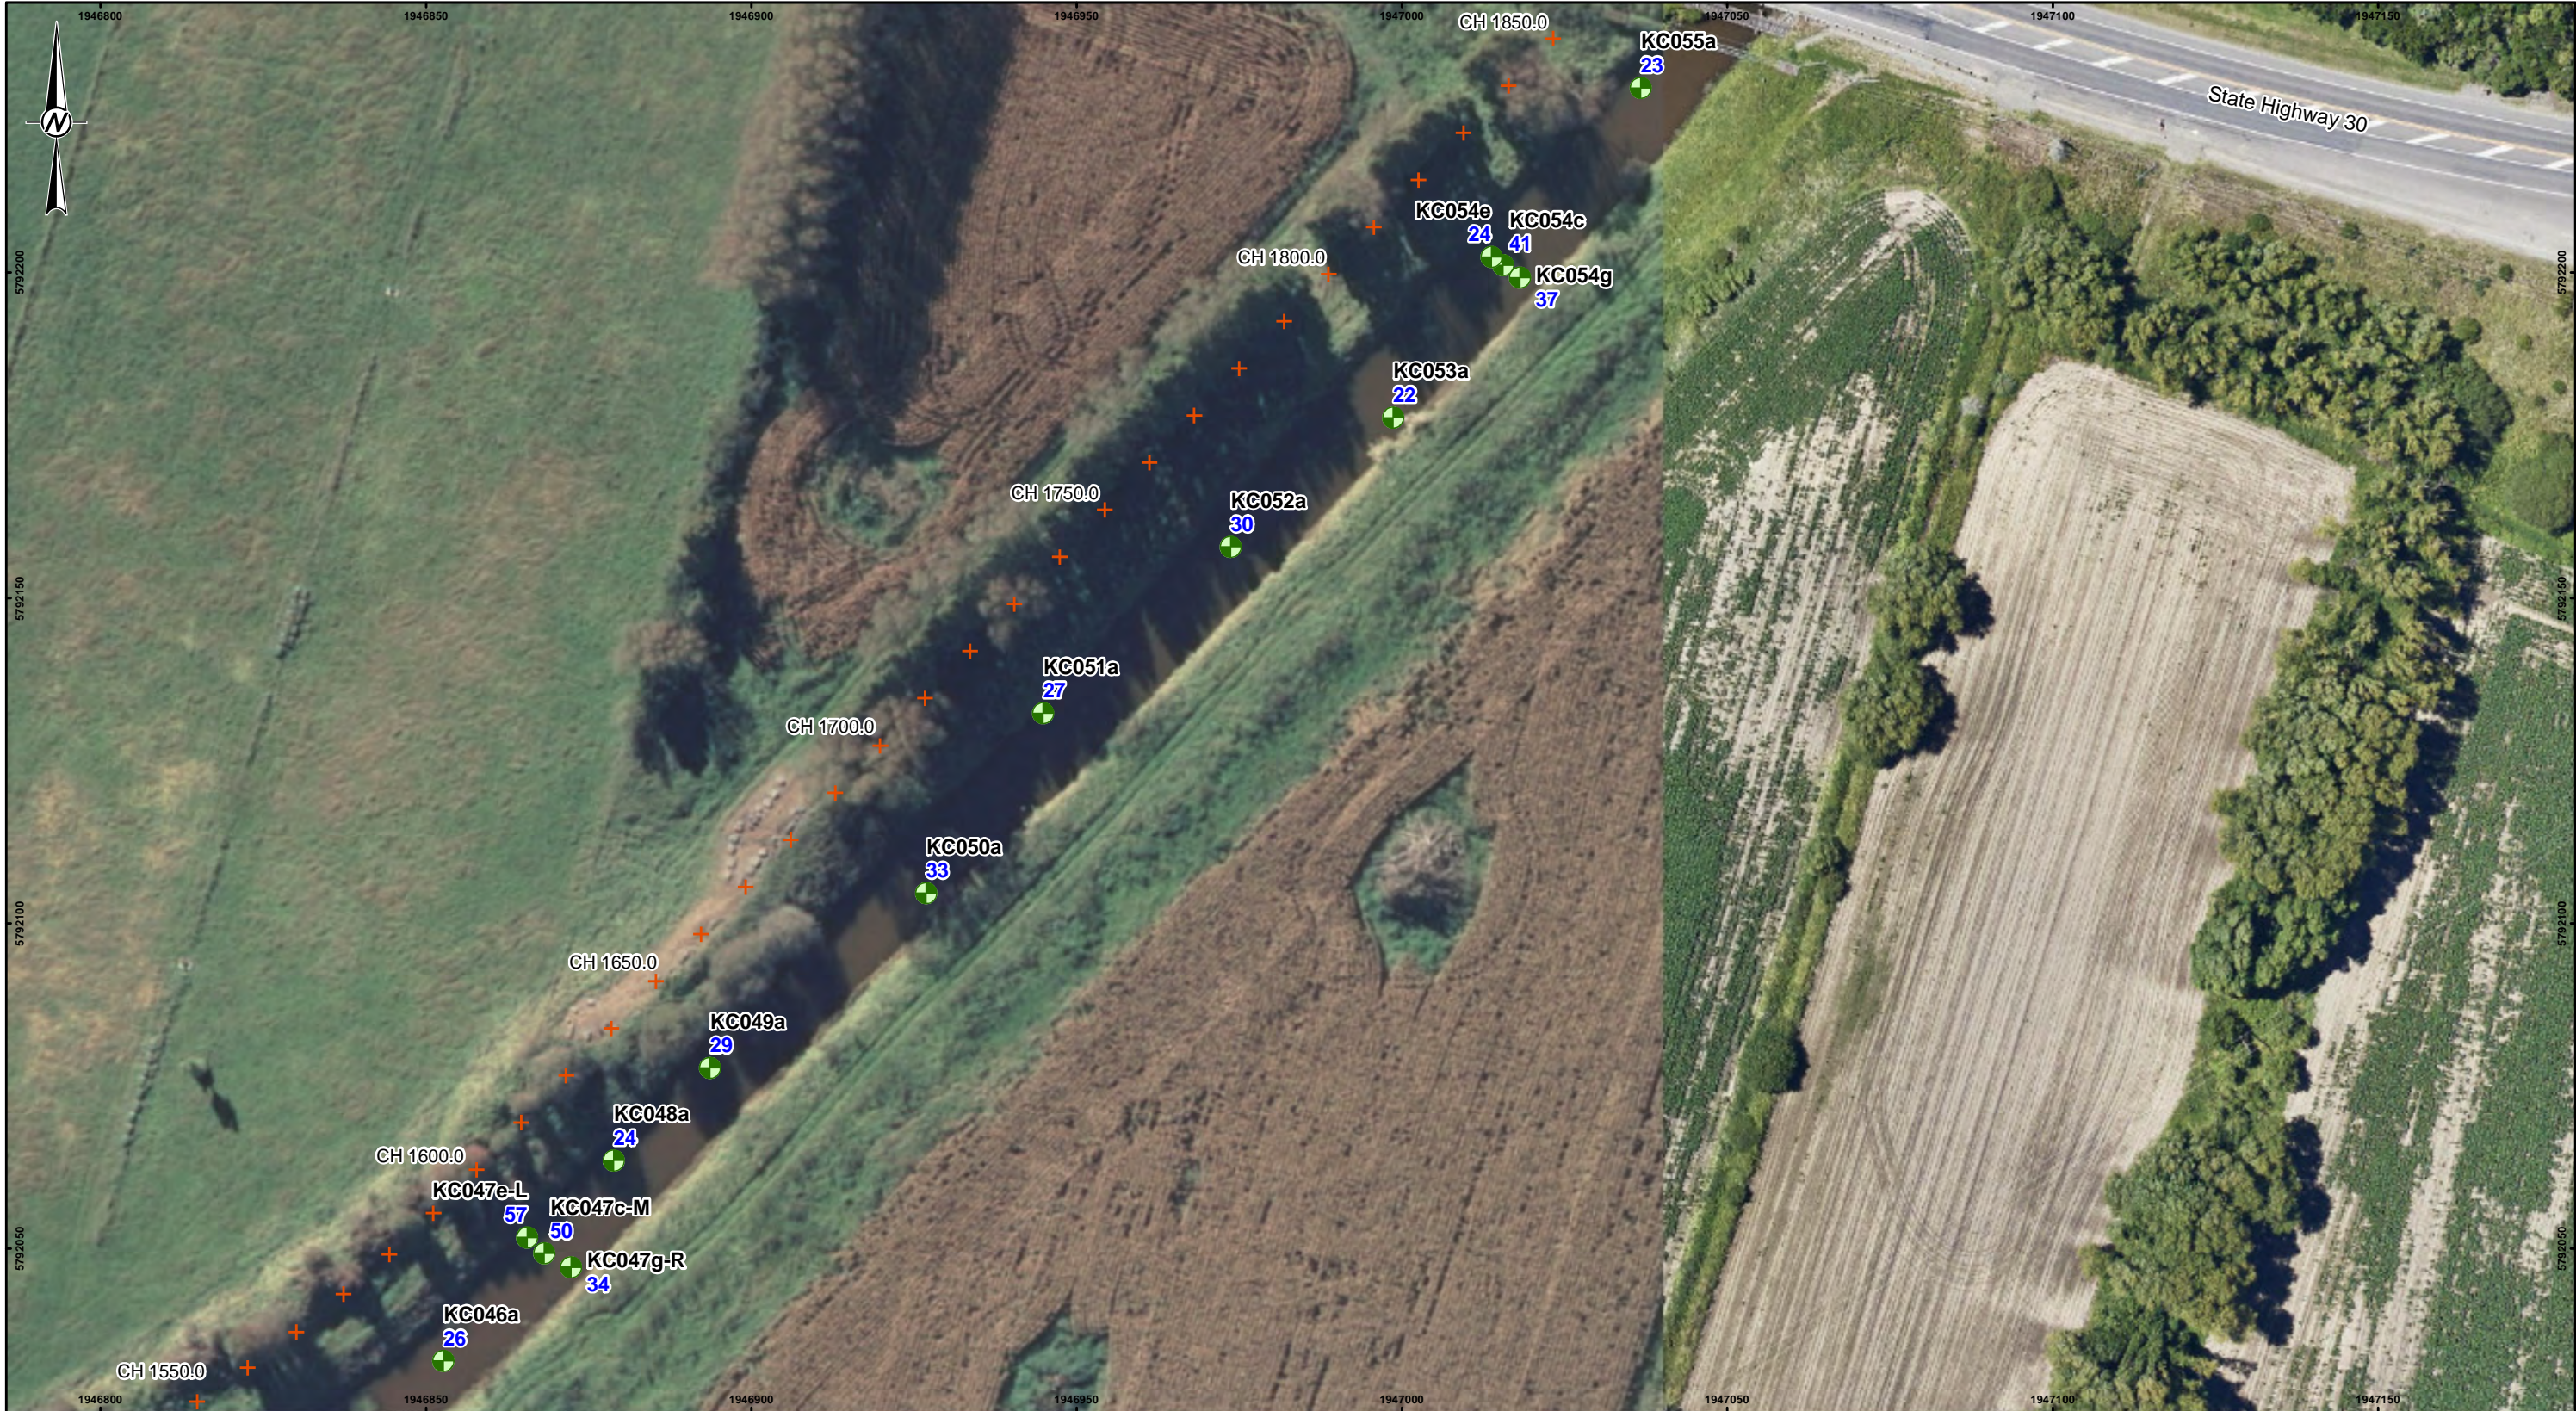
CLIENT			
ENVIRO (NZ) LIMITED			
PROJECT			
KOPEOPEO CANAL REMEDIATION			
TITLE			
SEDIMENT VALIDATION RESULTS - CH1540 TO CH1850			
CONSULTANT		YYYY-MM-DD	2019-12-05
		PREPARED	AE
		REVIEW	AH
		APPROVED	AH
PROJECT NO.	REPORT	REV.	FIGURE
1894562	005	0	09

- Sediment validation sample -
Sediment dioxin concentration
- Chainage

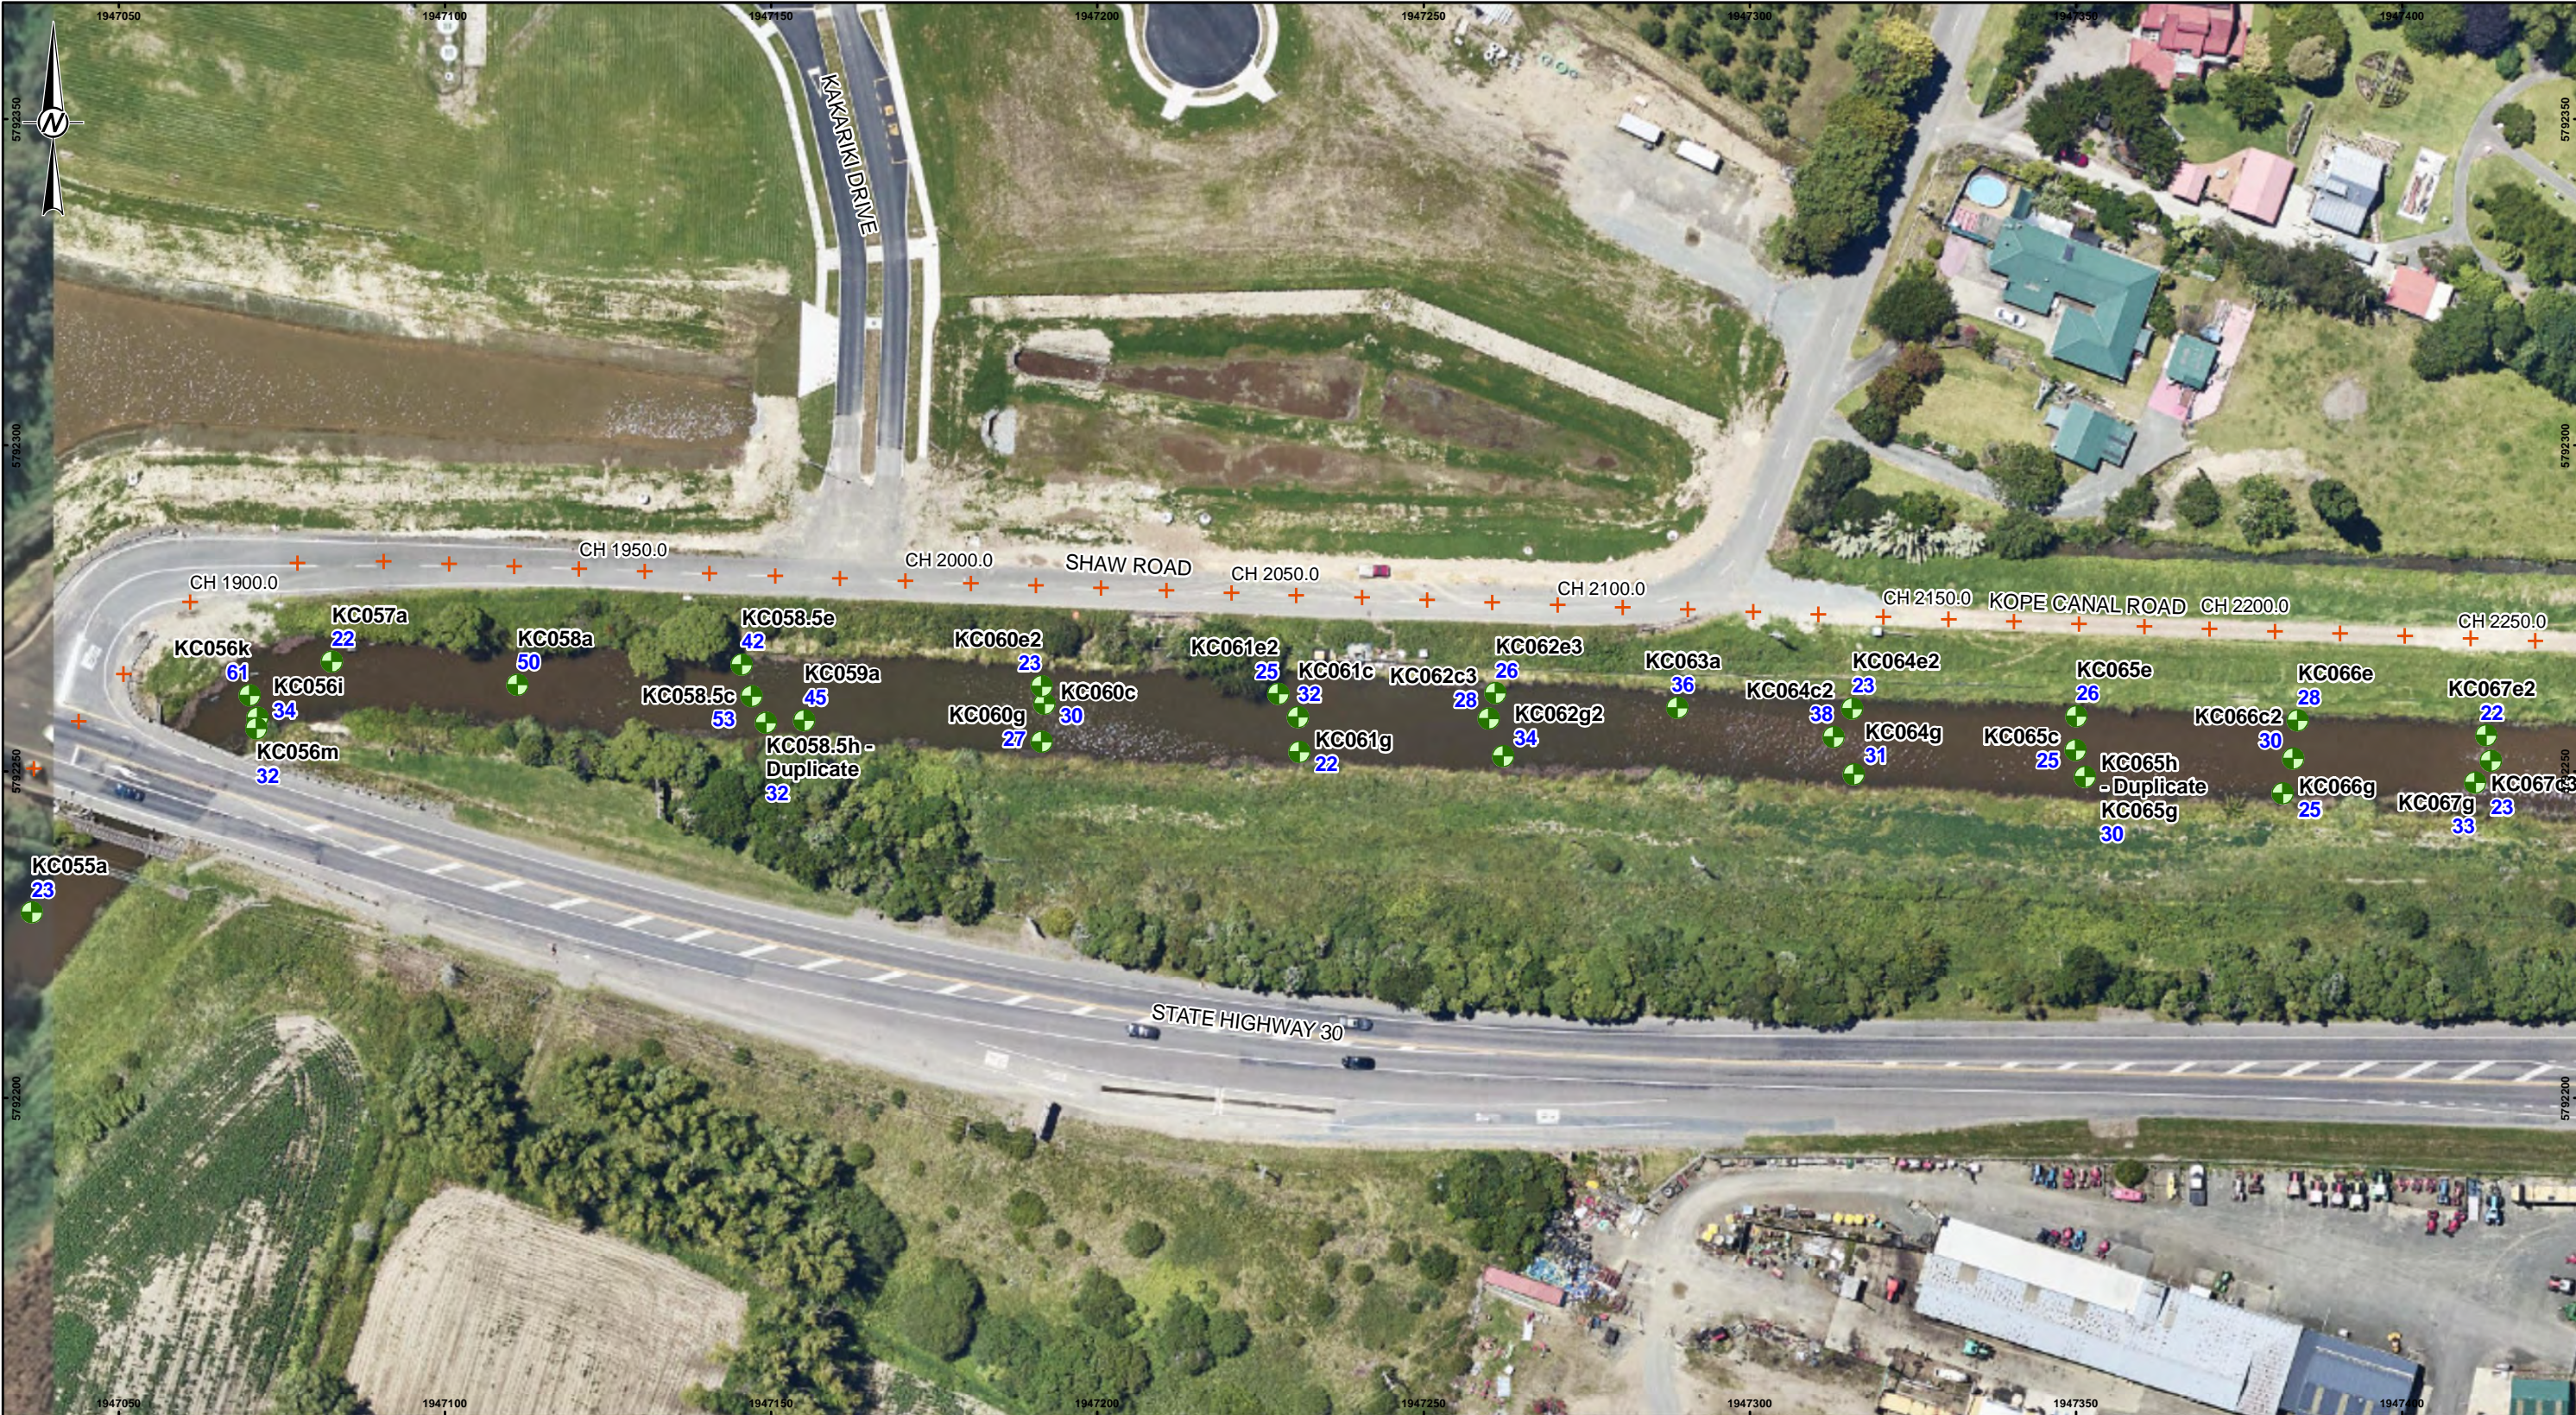
CLIENT			
ENVIRO (NZ) LIMITED			
PROJECT			
KOPEOPEO CANAL REMEDIATION			
TITLE			
SEDIMENT VALIDATION RESULTS - CH2250 TO CH2630			
CONSULTANT			
		YYYY-MM-DD	2019-12-05
		PREPARED	AE
		REVIEW	AH
		APPROVED	AH
PROJECT NO.	REPORT	REV.	FIGURE
1894562	005	0	11

- Sediment validation sample -
Sediment dioxin concentration
- Chainage
