Validation Report for Sediment Dredging and Placement in Containment Sites

Kopeopeo Canal Remediation Project

Golder Associates (NZ) Limited

1894562-005-R-Rev0

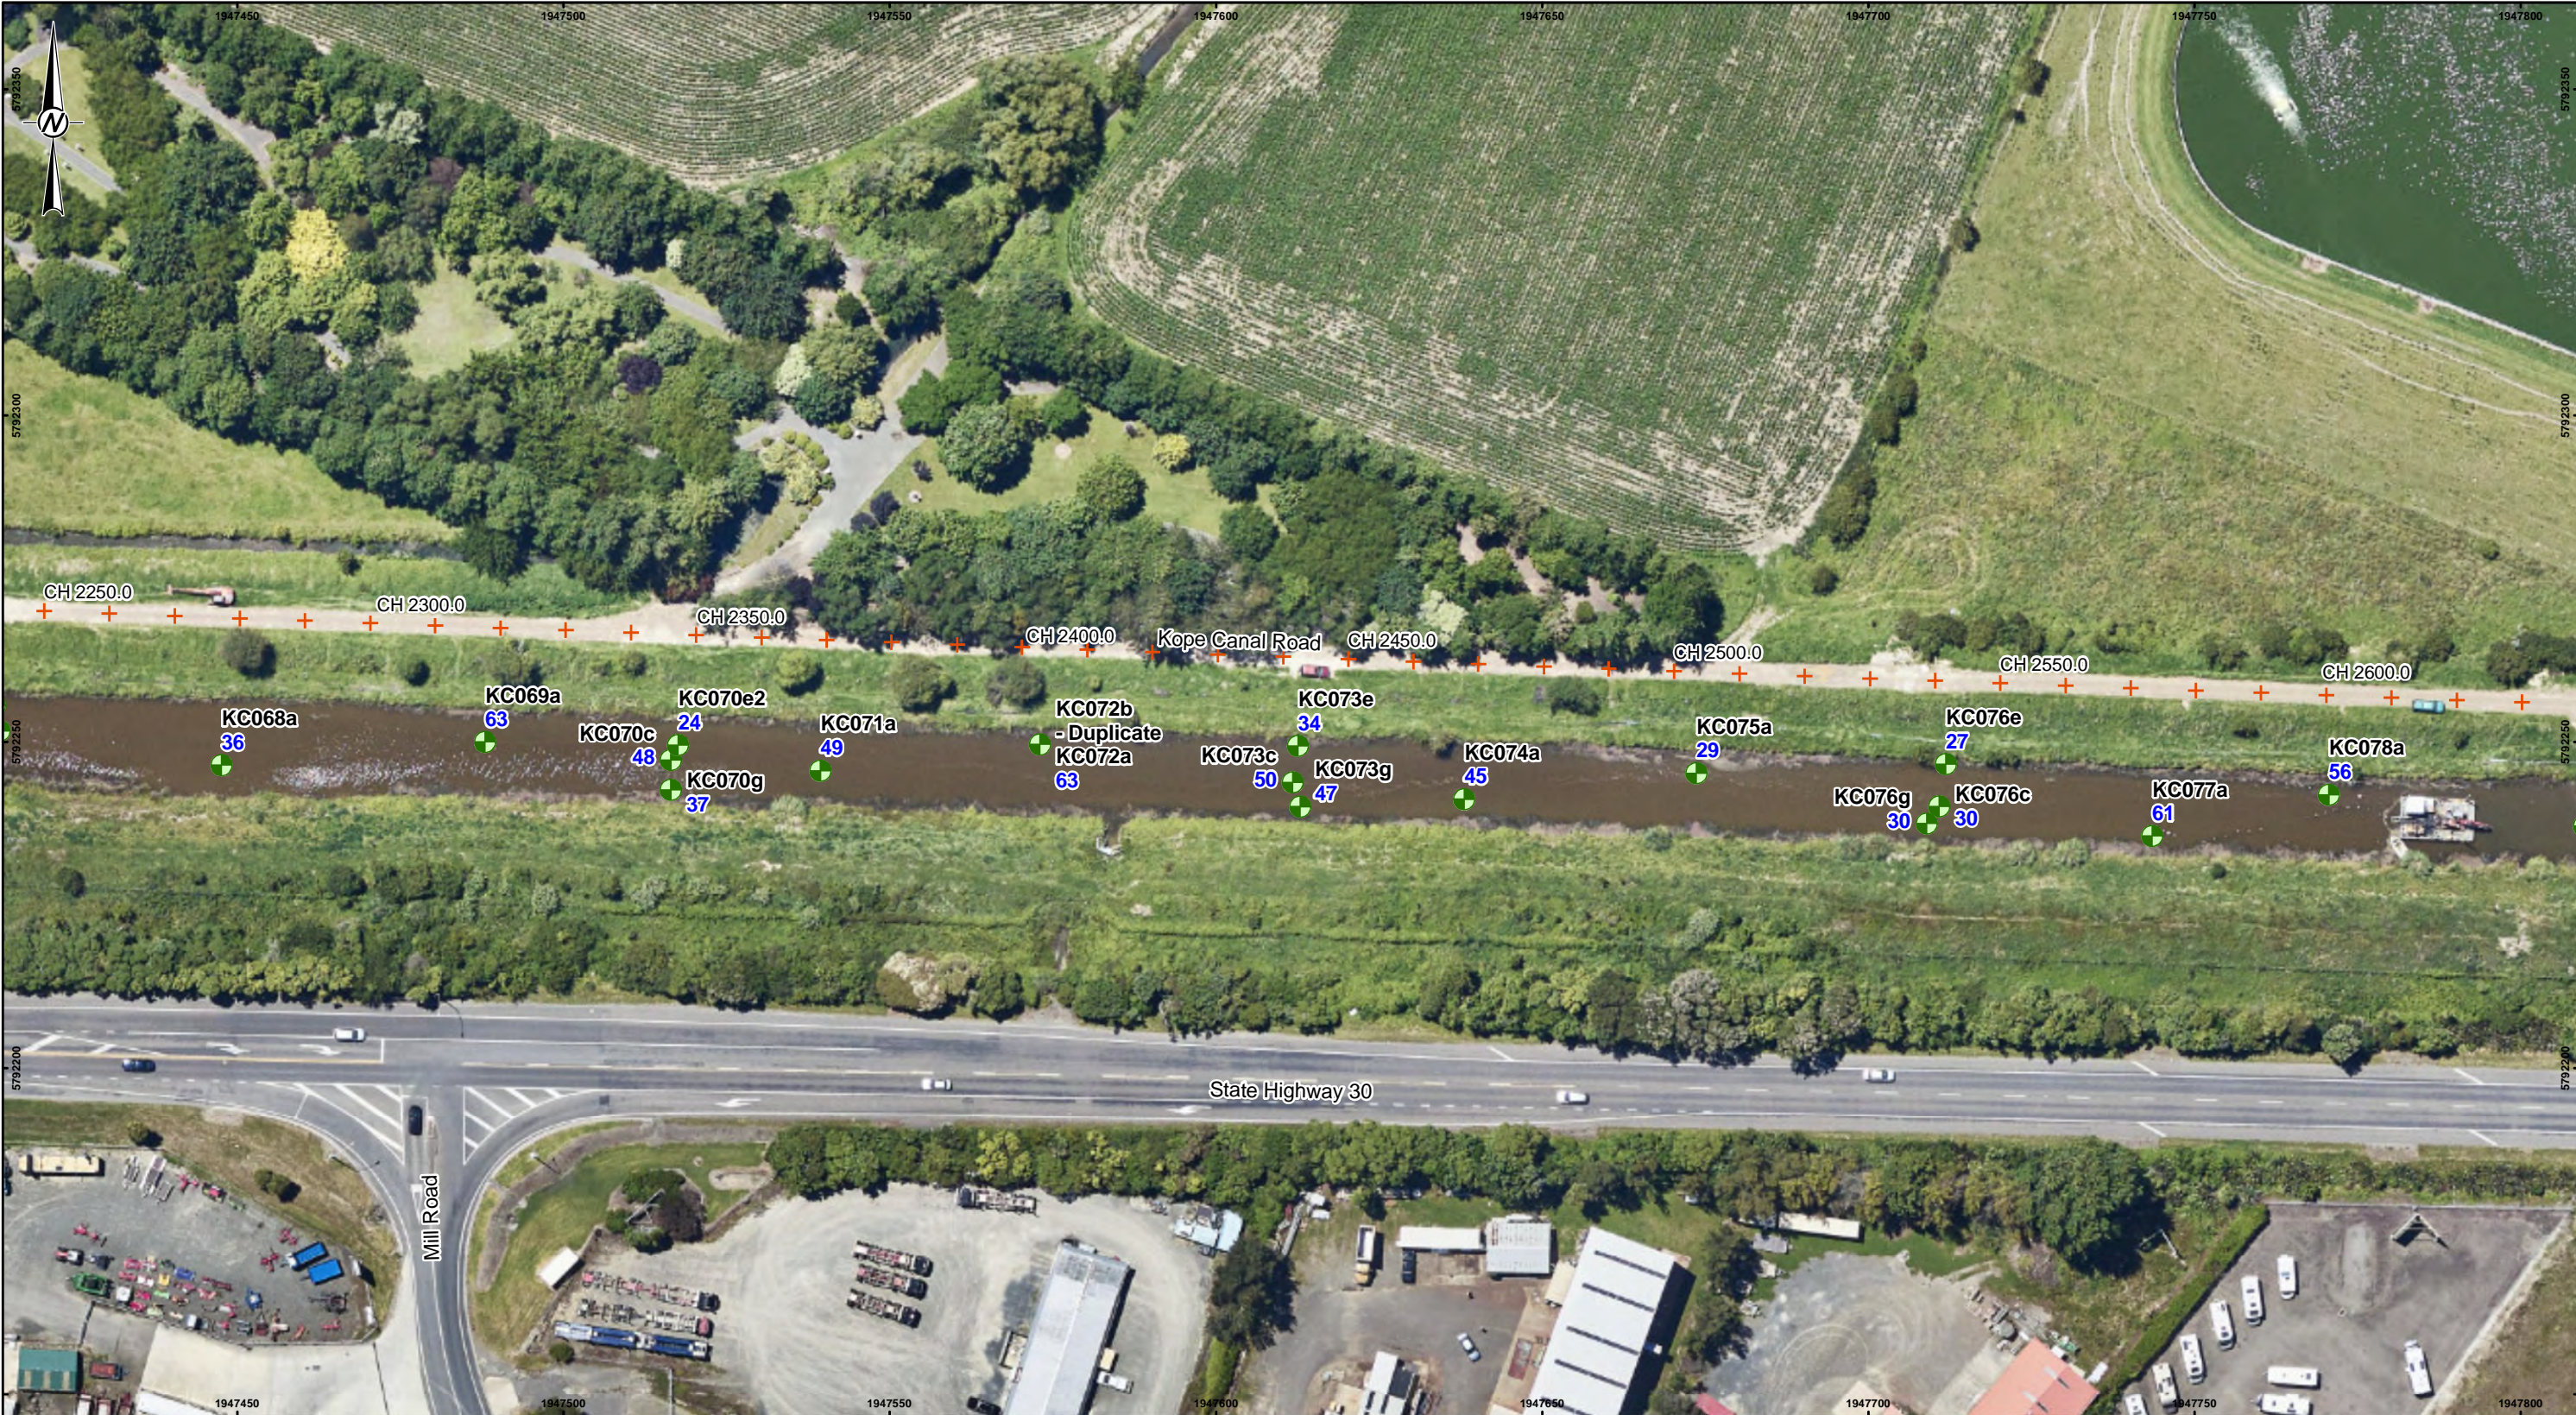
CLIENT			
ENVIRO (NZ) LIMITED			
PROJECT			
KOPEOPEO CANAL REMEDIATION			
TITLE			
SEDIMENT VALIDATION RESULTS - CH2250 TO CH2630			
CONSULTANT			
		YYYY-MM-DD	2019-12-05
		PREPARED	AE
		REVIEW	AH
		APPROVED	AH
PROJECT NO.	REPORT	REV.	FIGURE
1894562	005	0	11

- Sediment validation sample -
Sediment dioxin concentration
- Chainage

The dioxin concentrations in the sediment samples representative of residual canal base sediment are presented in Figure 5 to Figure 18.

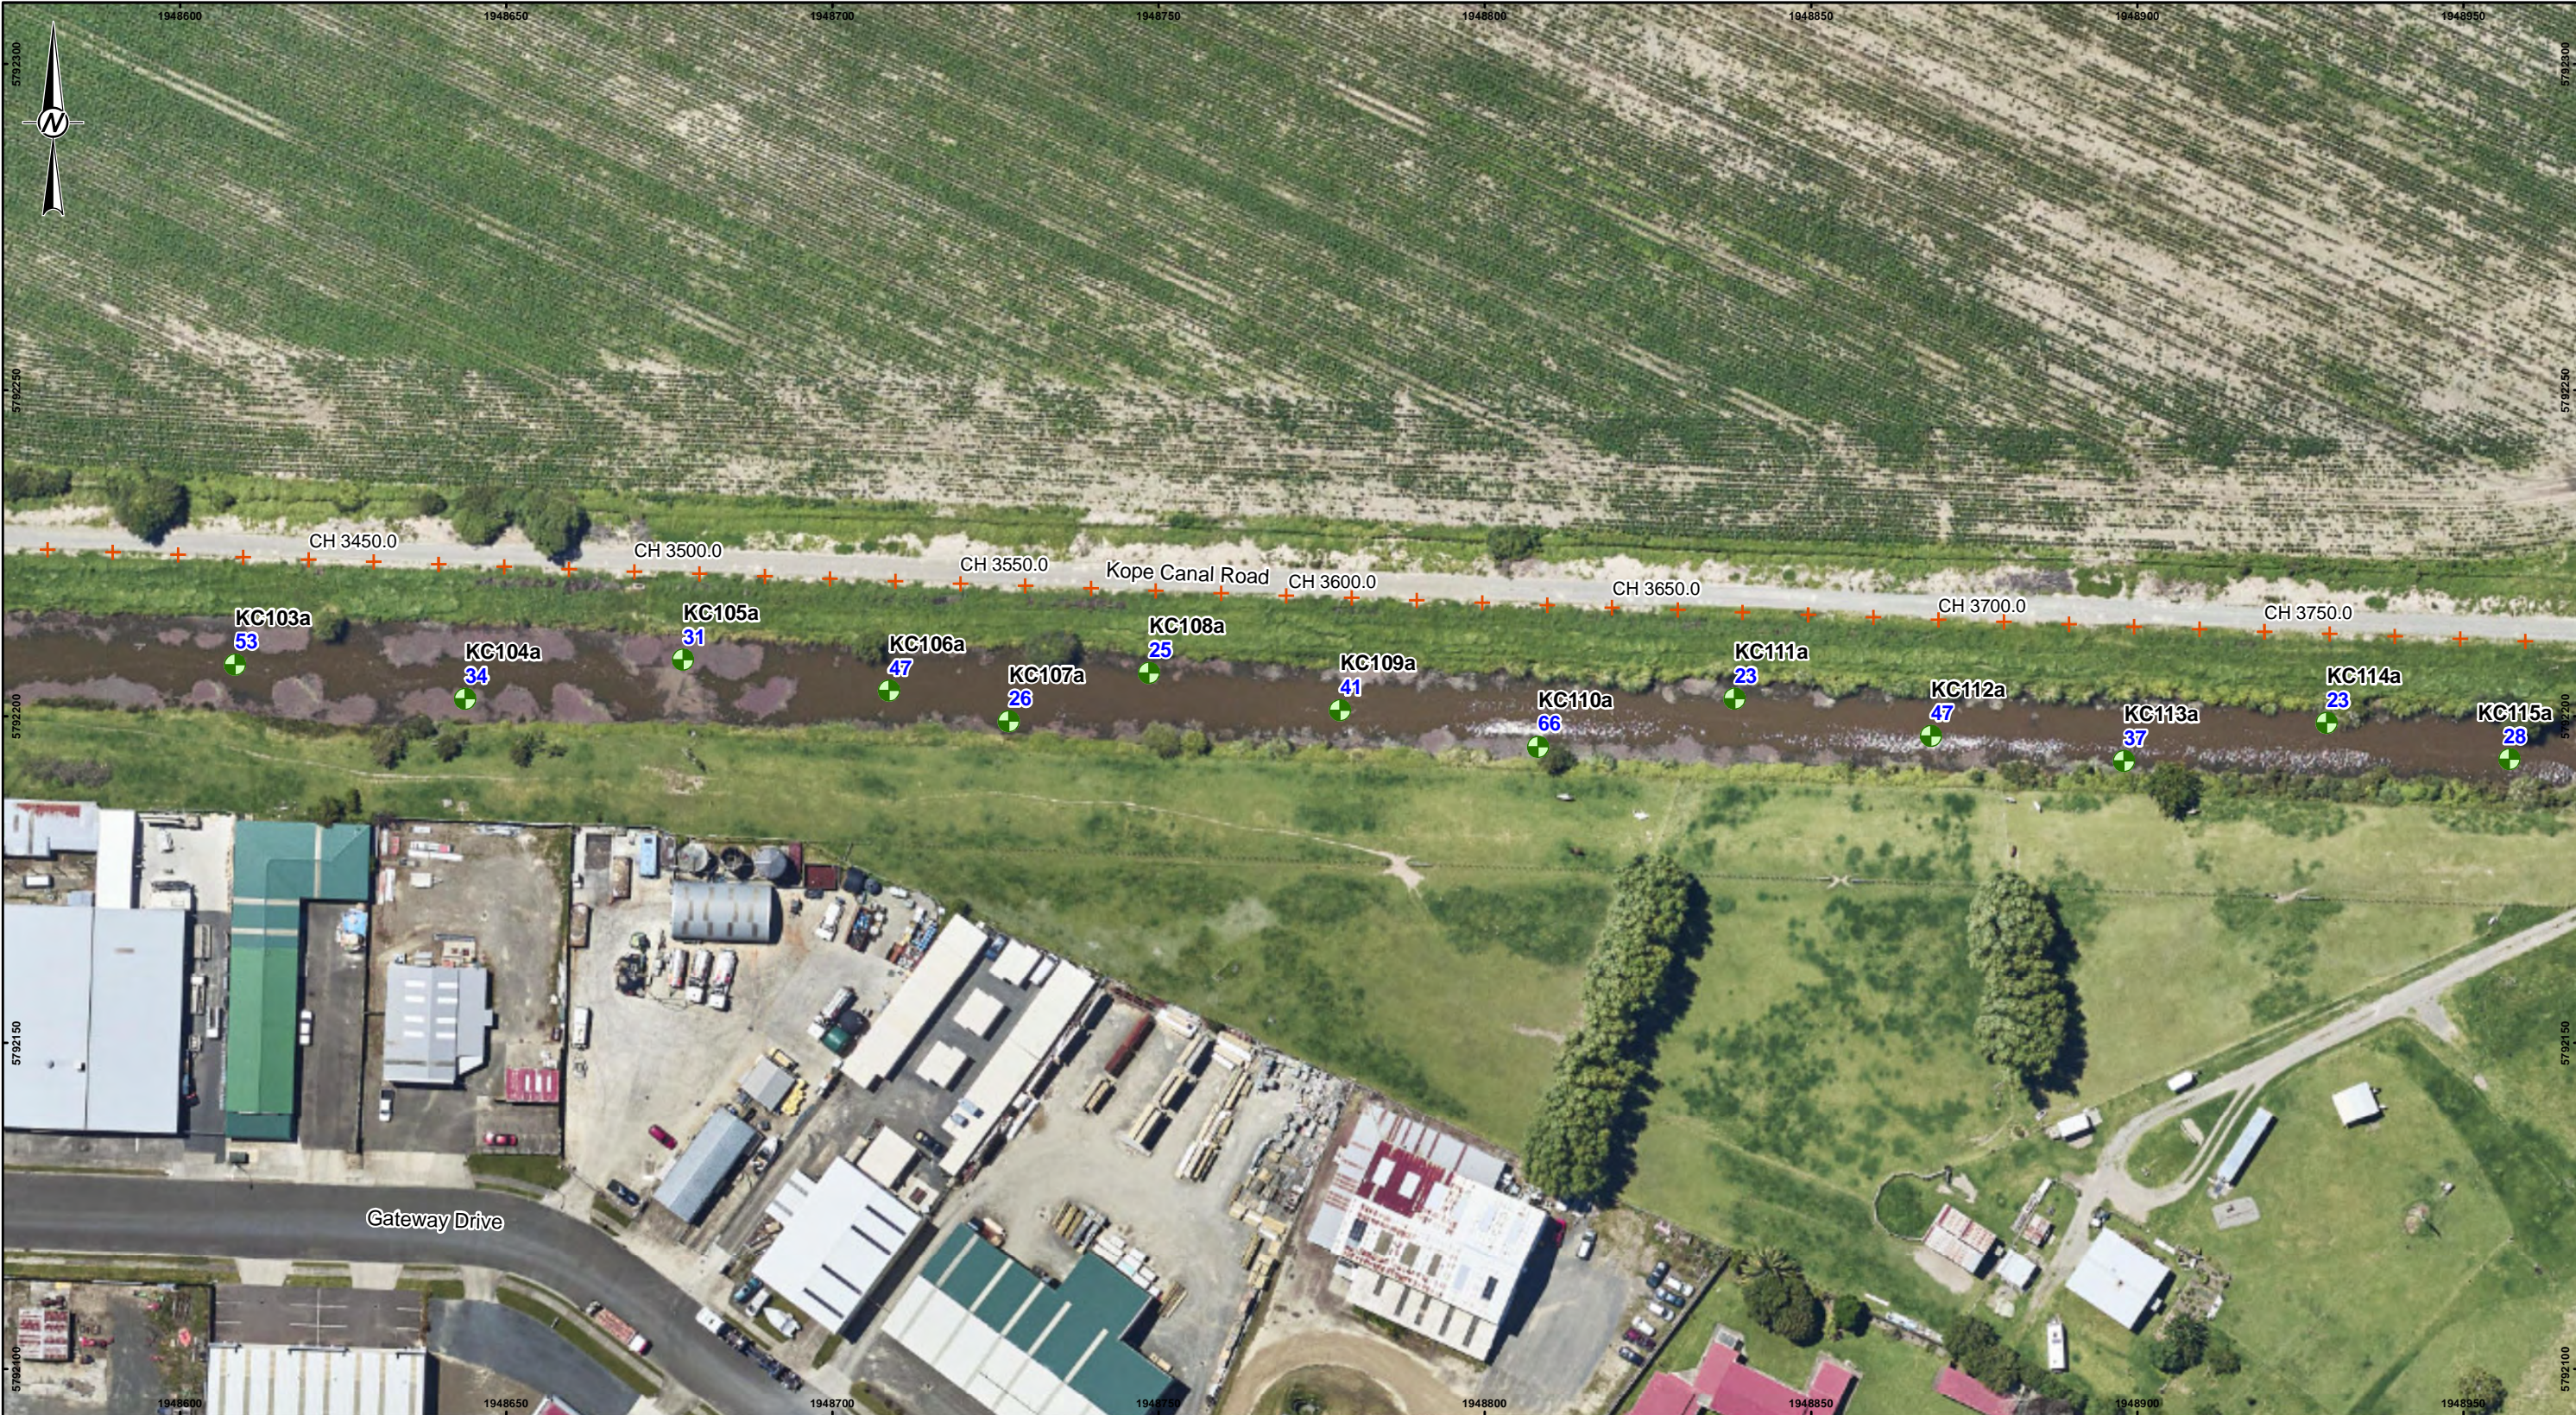
PROJECT NO. 1894562
REPORT 005
REV. 0
FIGURE 15

- Sediment validation sample -
Sediment dioxin concentration
- Chainage

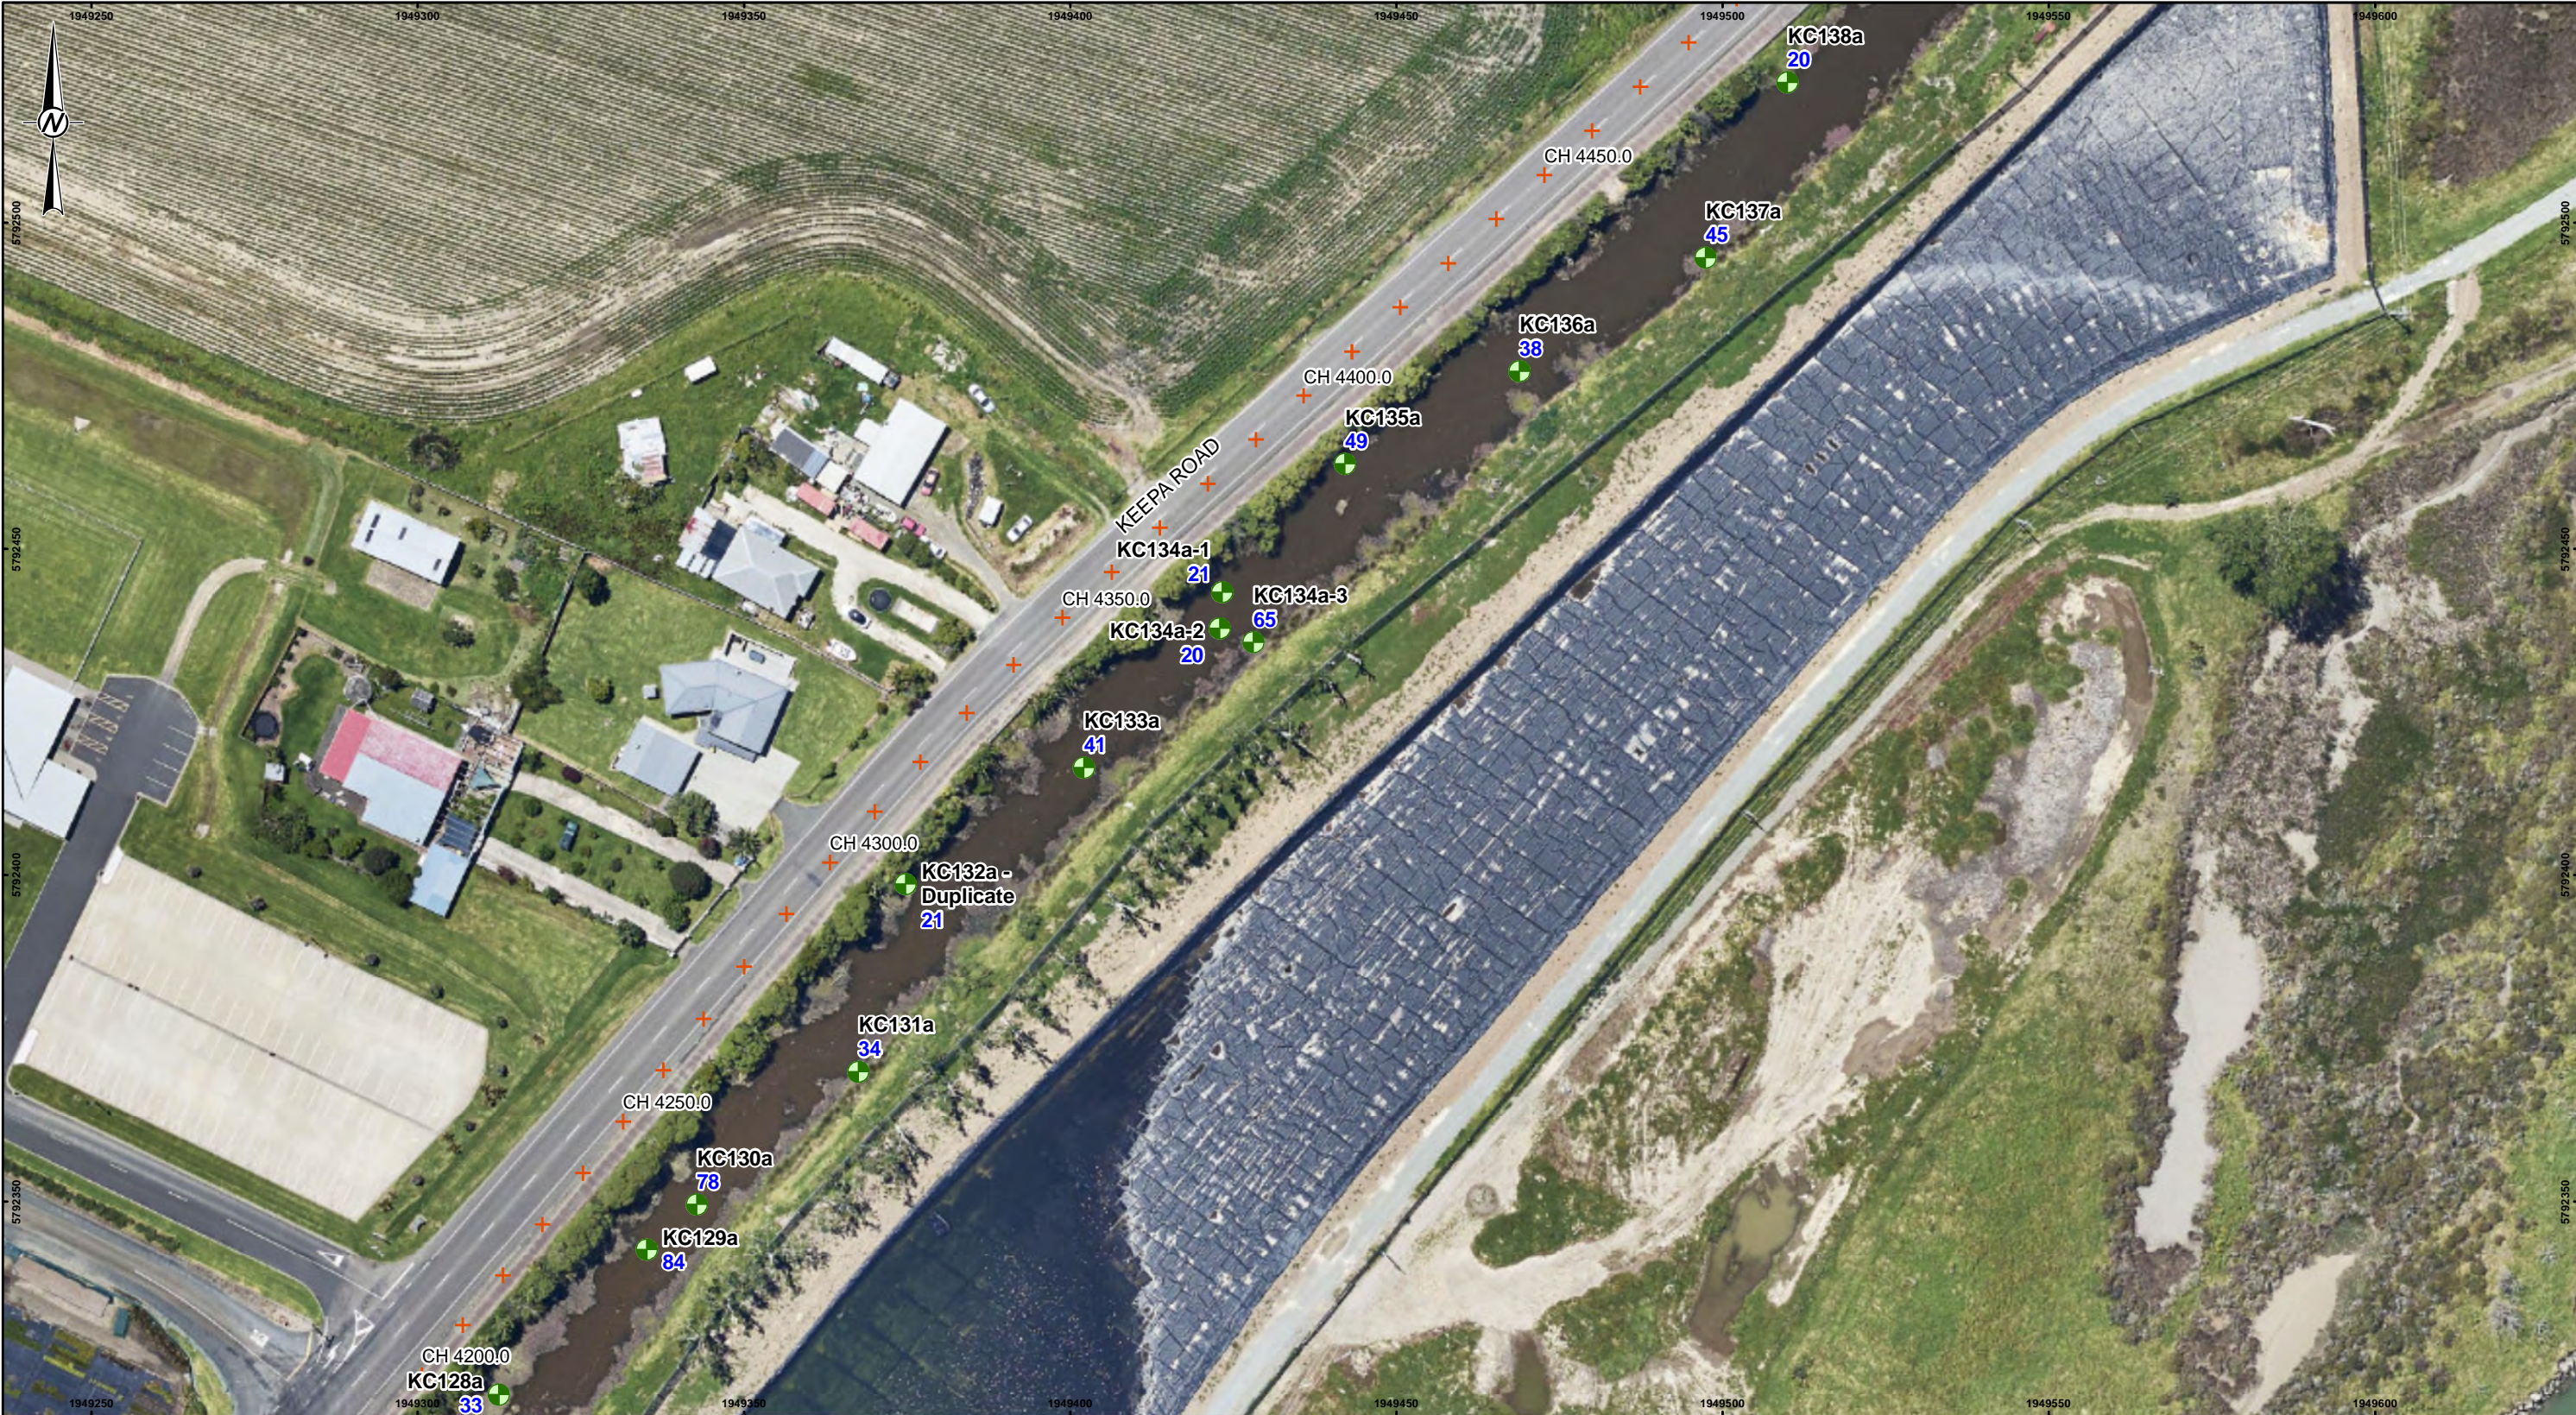
CLIENT			
ENVIRO (NZ) LIMITED			
PROJECT			
KOPEOPEO CANAL REMEDIATION			
TITLE			
SEDIMENT VALIDATION RESULTS - CH4230 TO CH4520			
CONSULTANT		YYYY-MM-DD	2019-12-05
		PREPARED	AE
		REVIEW	AH
		APPROVED	AH
PROJECT NO.	REPORT	REV.	FIGURE
1894562	005	0	16

- Sediment validation sample -
Sediment dioxin concentration
- Chainage

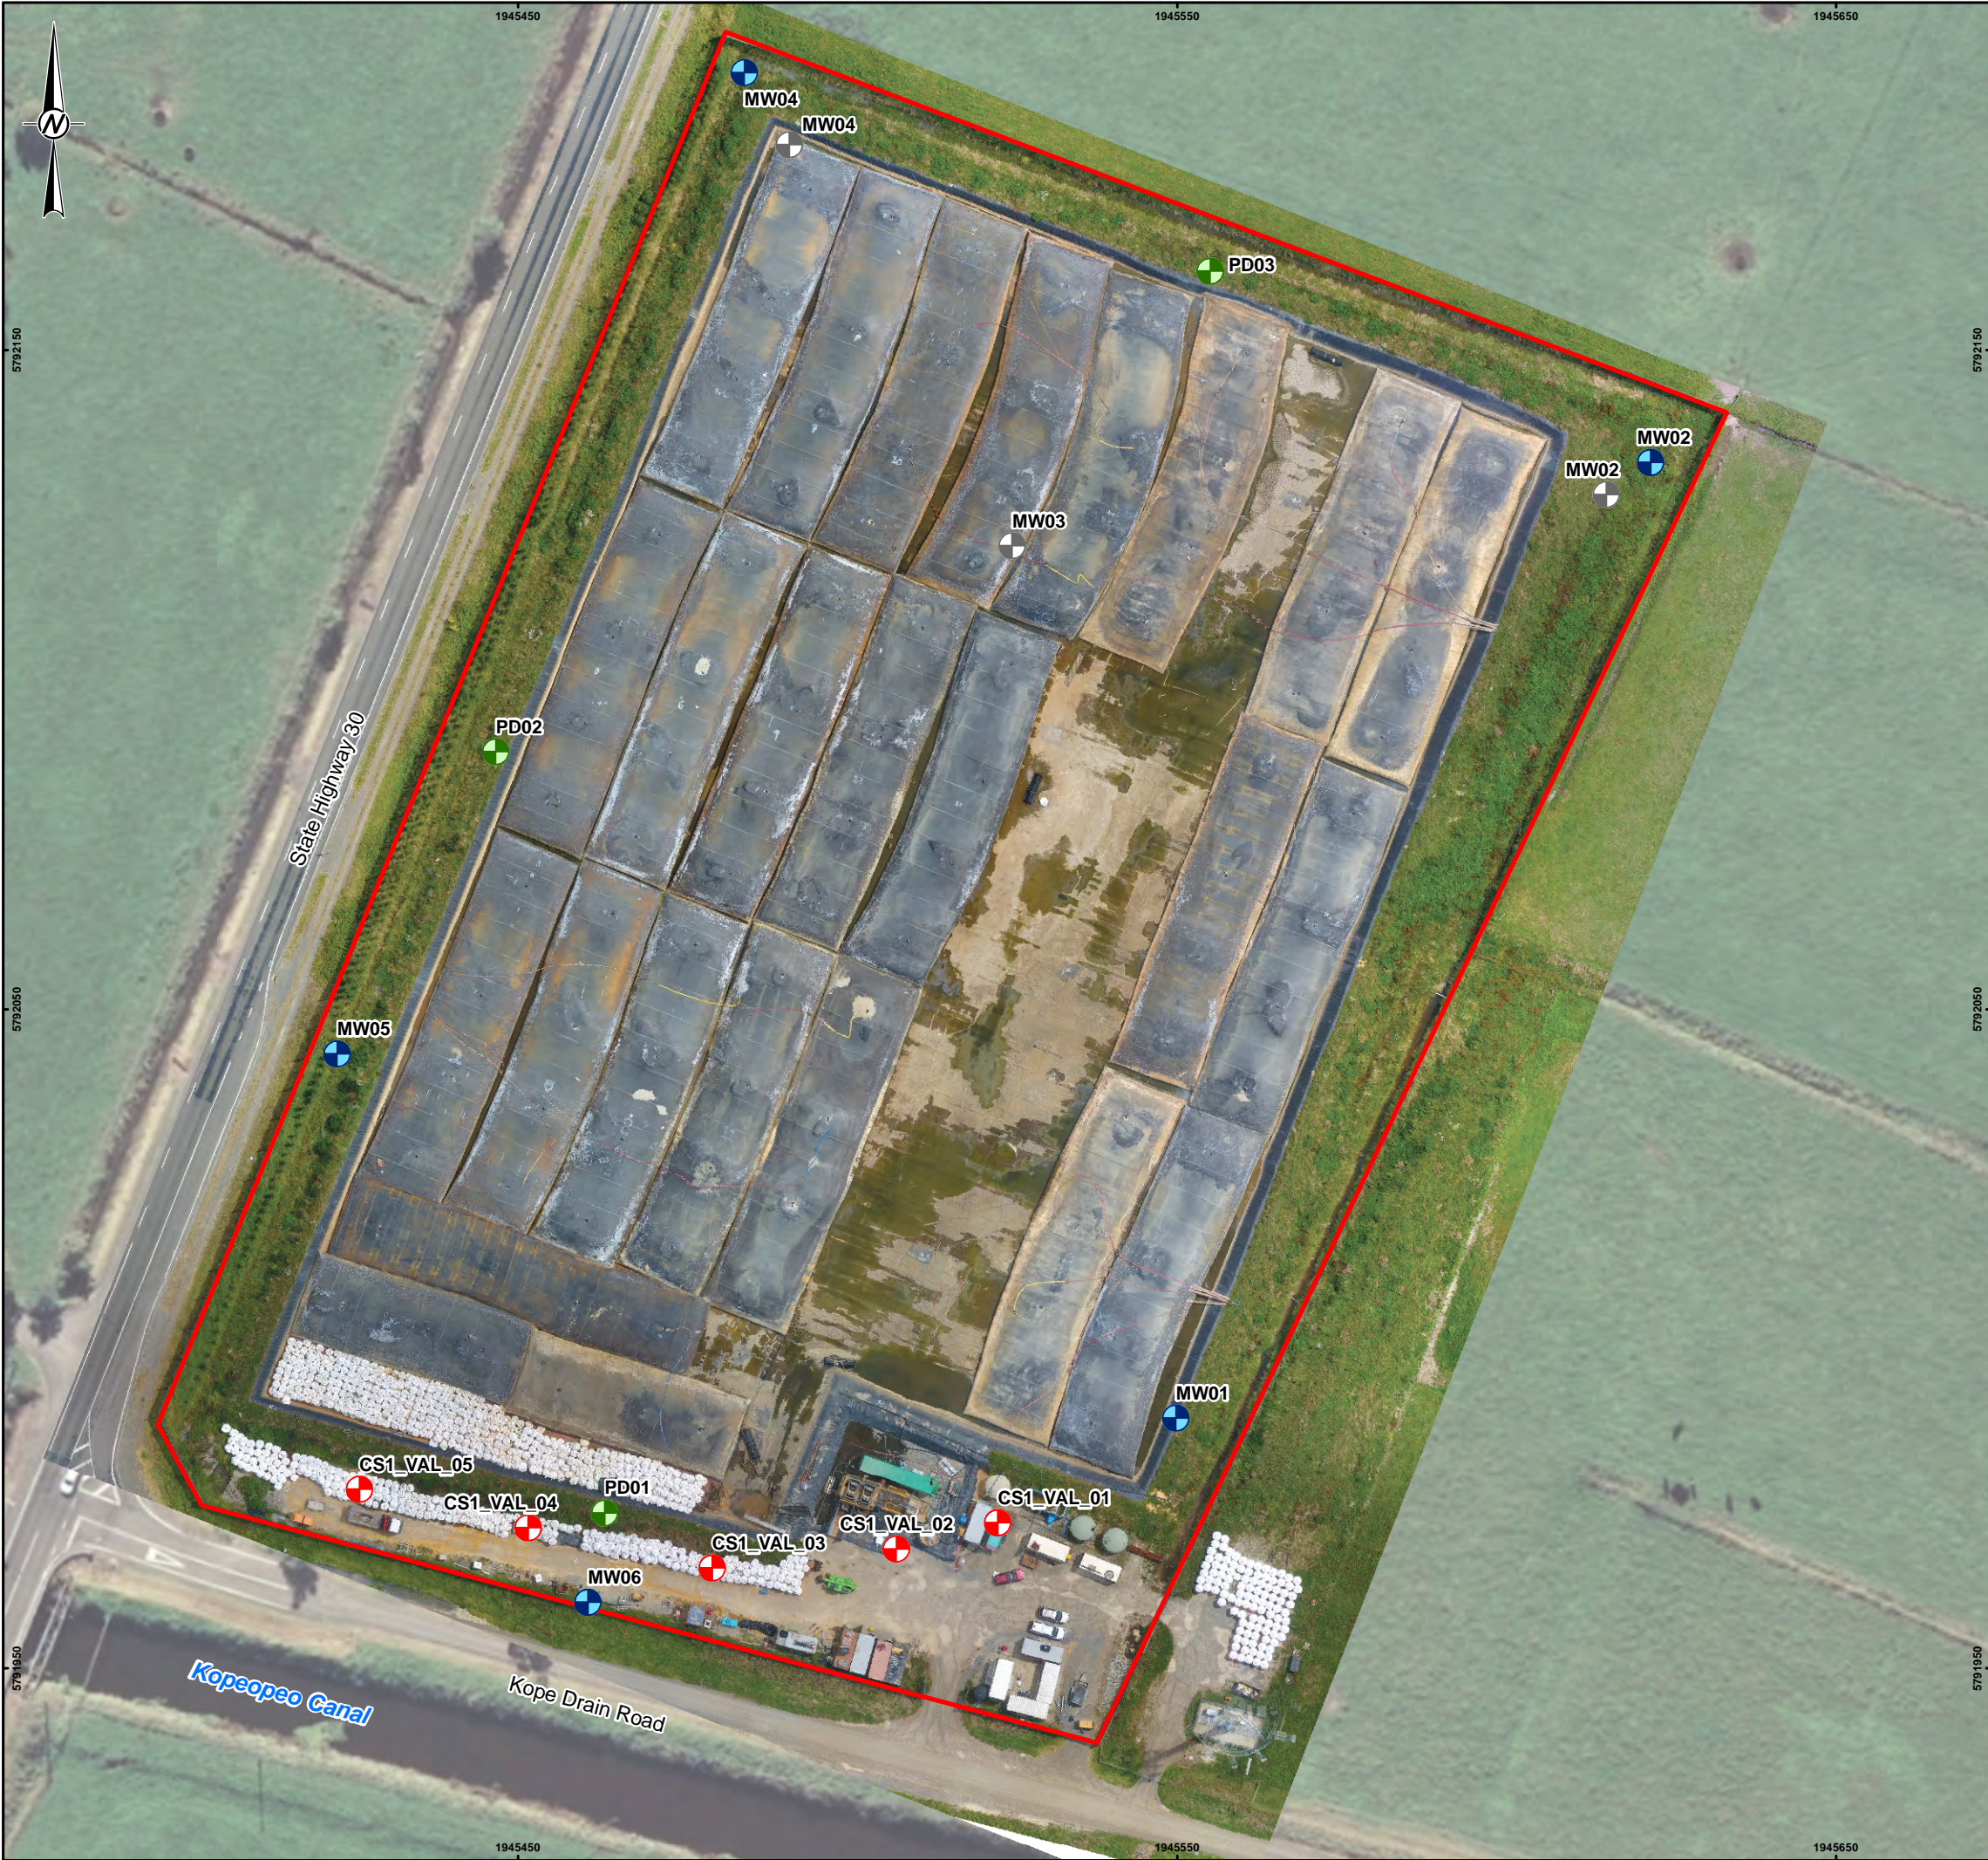
- Groundwater monitoring well
- Monitoring well - decommissioned
- Site boundary
- Soil validation sample (GHD 2019)
- Perimeter drain sample

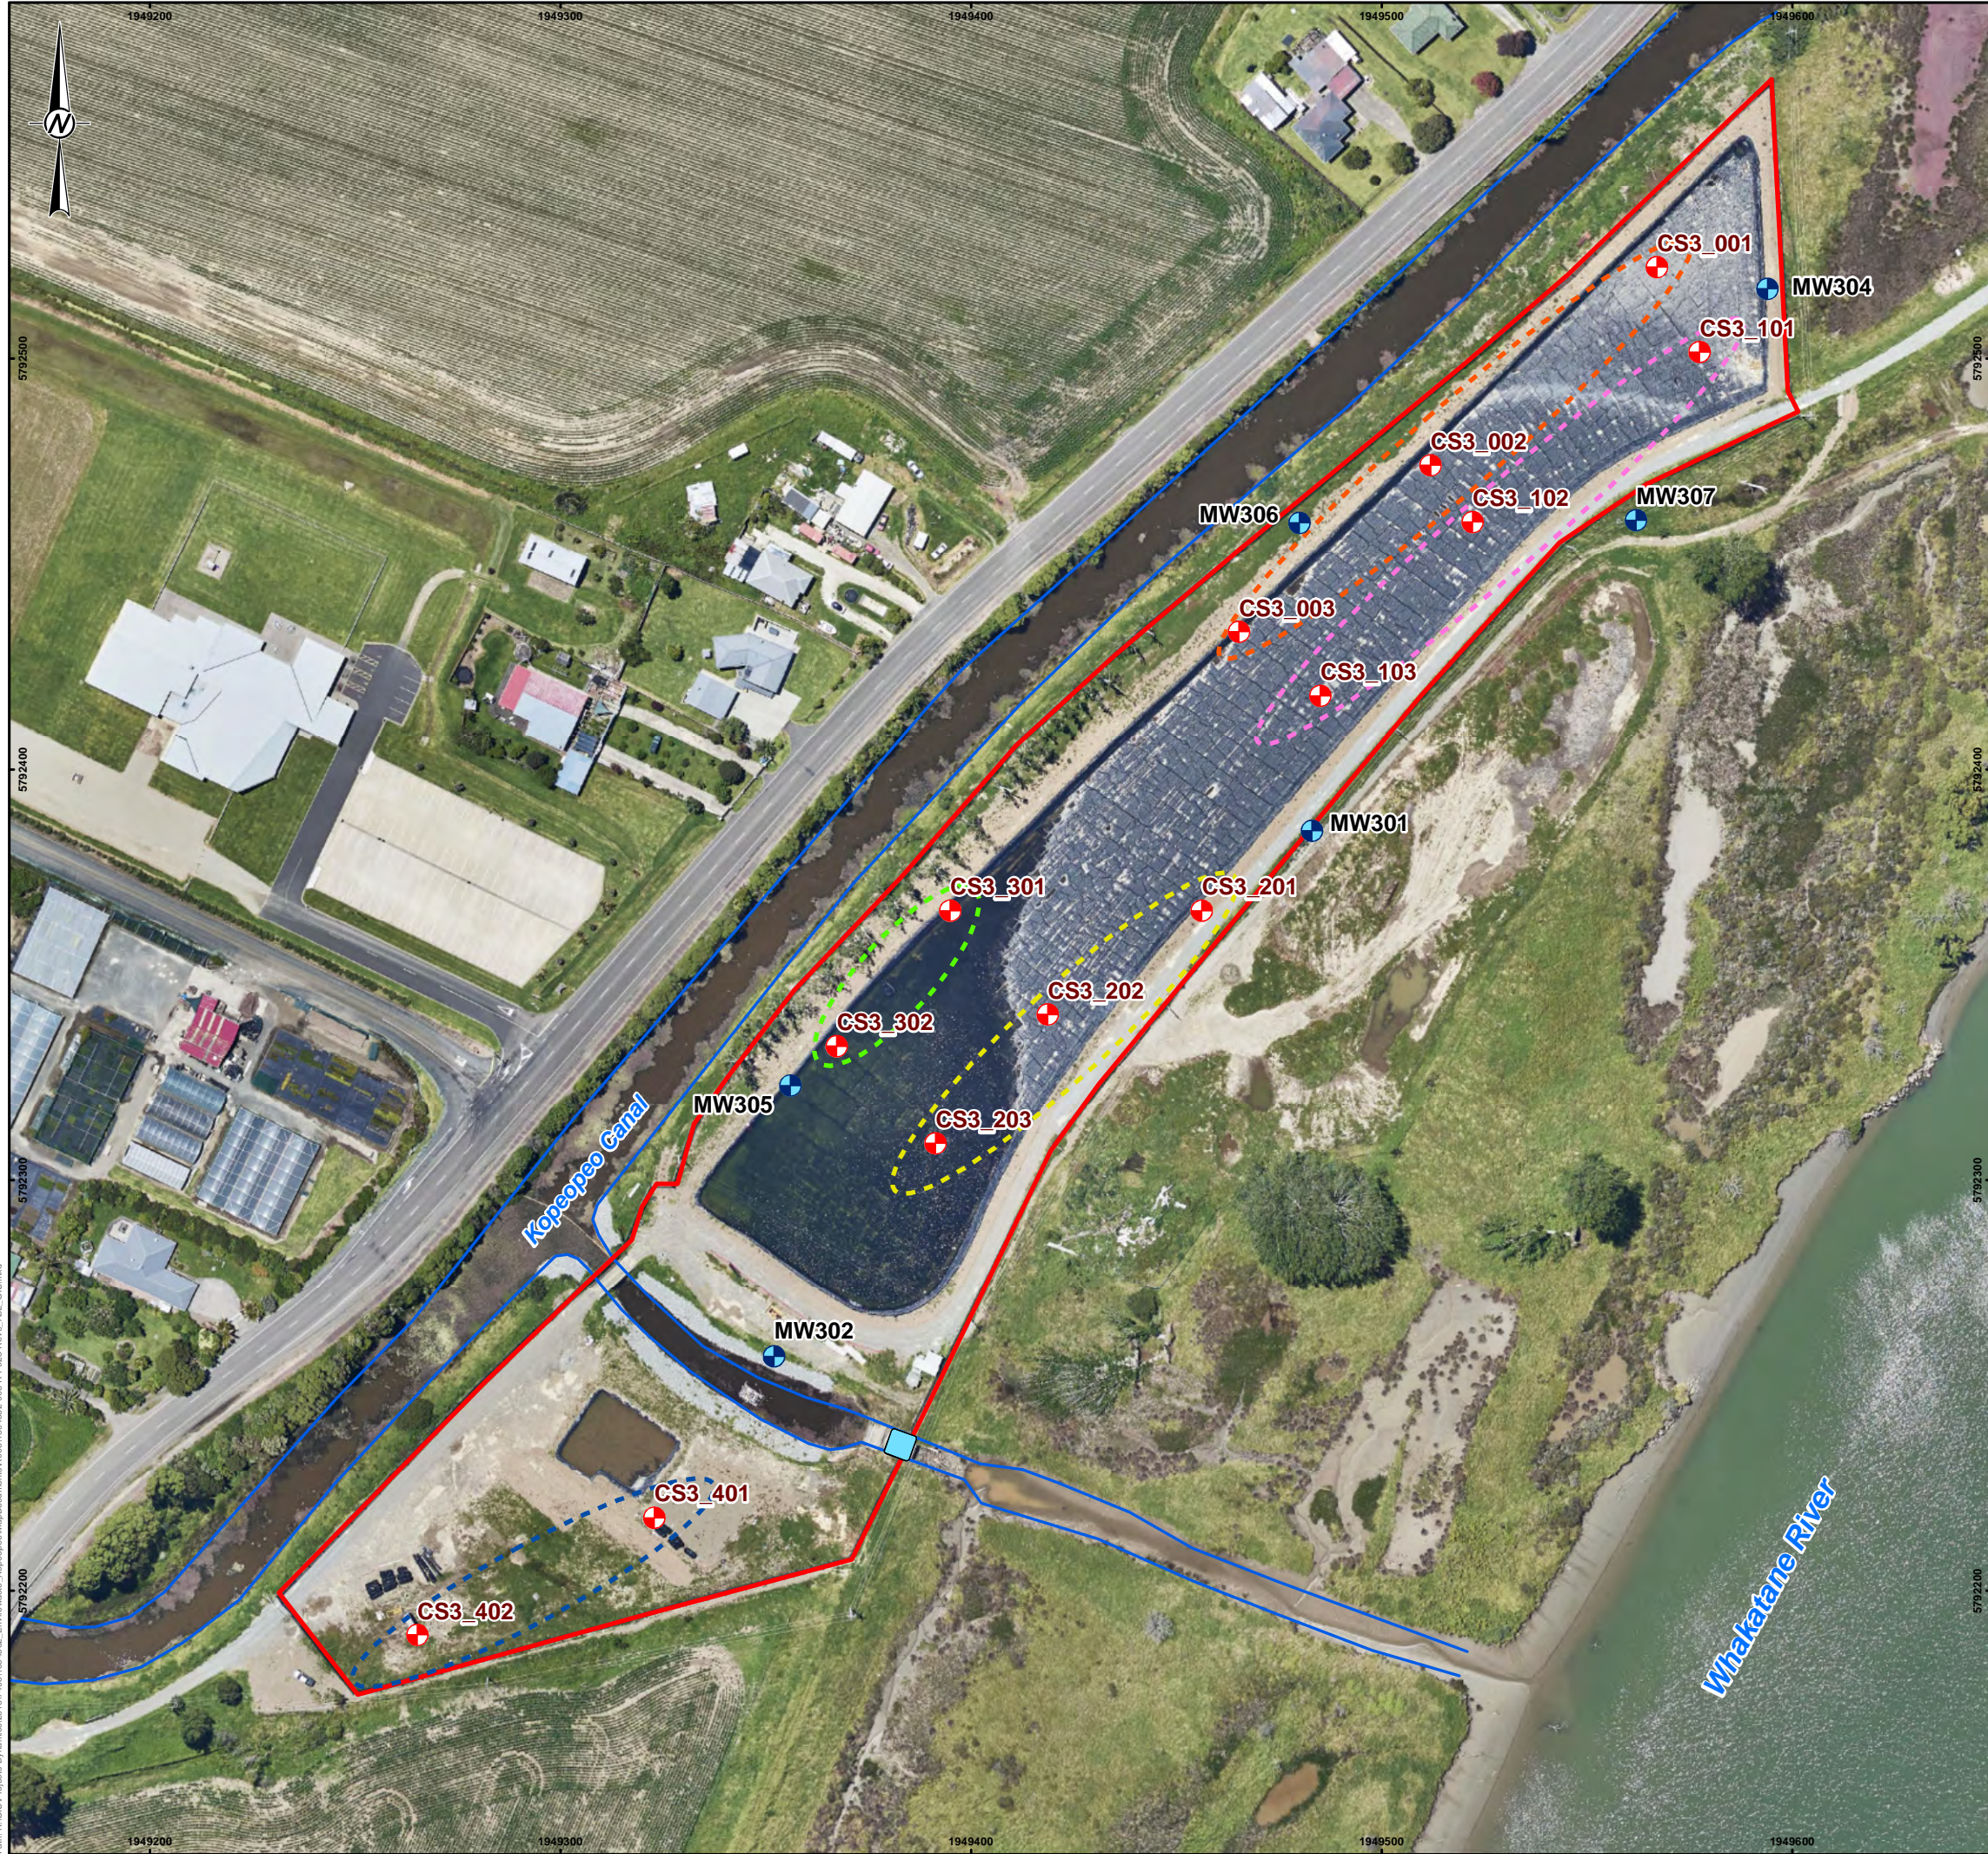
- CS3 Area
- Soil sample locations
- Monitoring well
- Composite 1A 17 April
- Composite 1A 23 April
- Composite 2A 17 April
- Composite 2A 23 April
- Composite 3A 17 April
- Canal outline
- Pump station

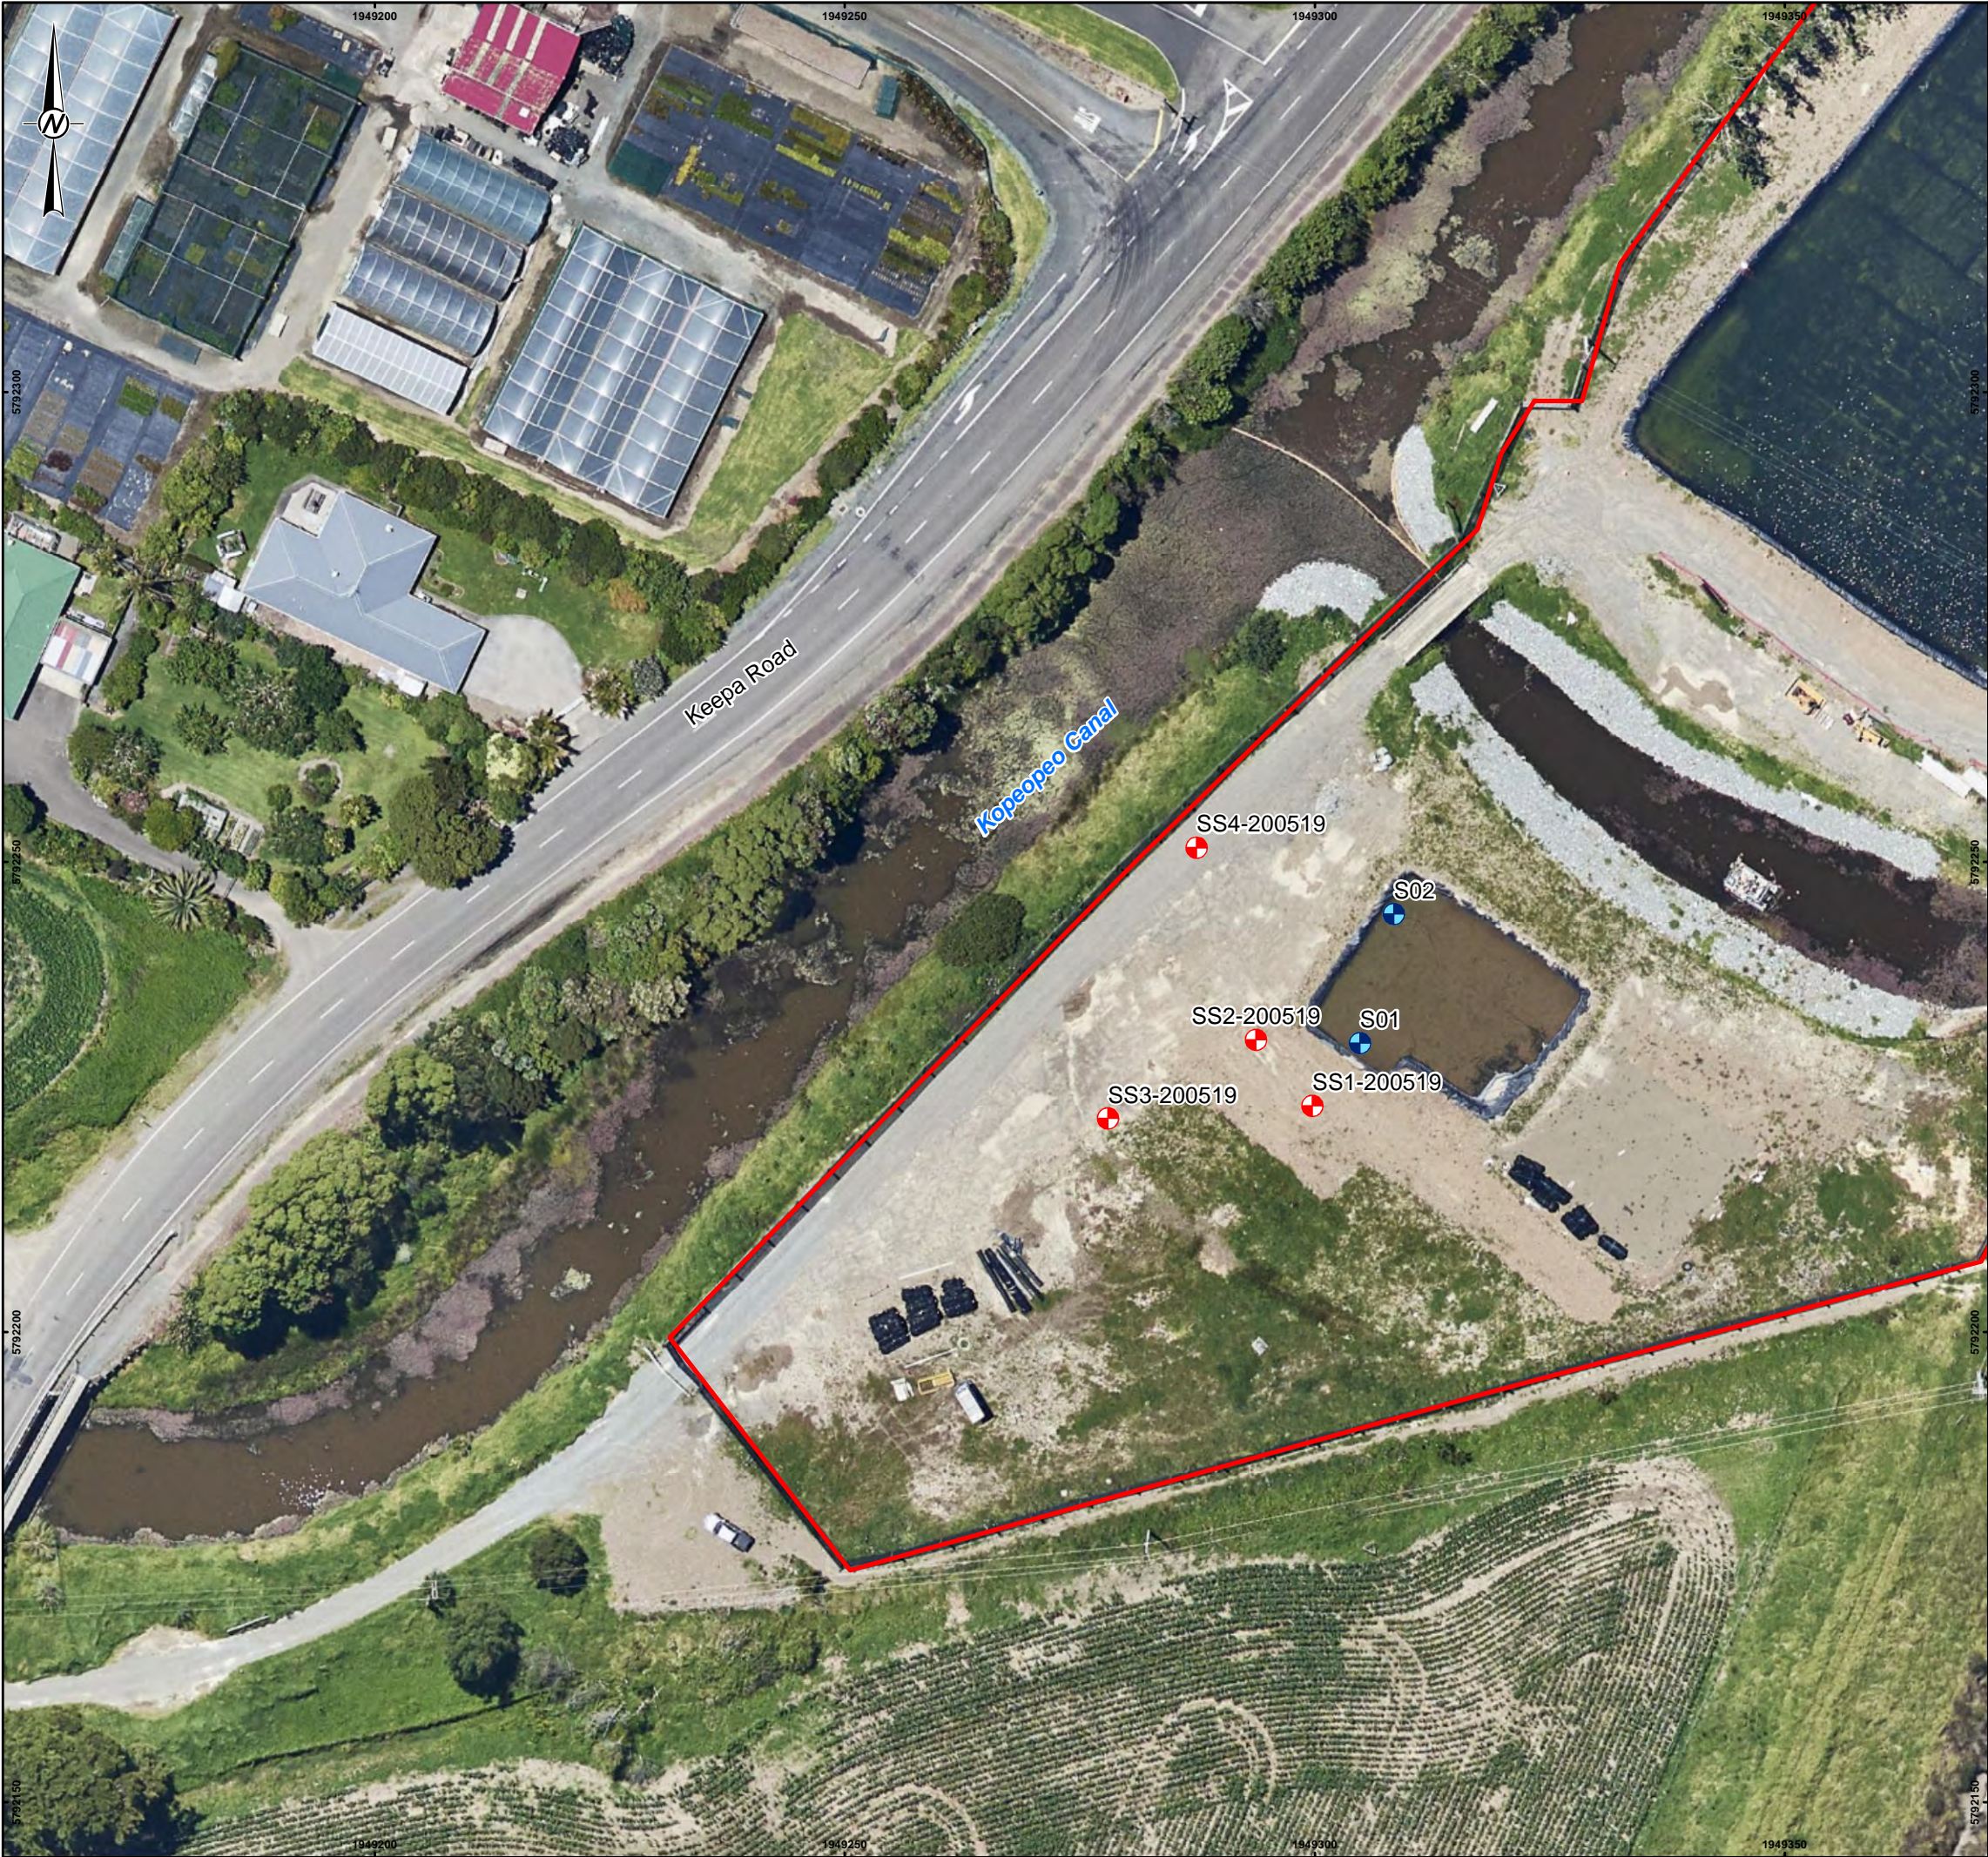
Dioxins, as Total PCDD/F I-TEQ Upperbound, were reported at the laboratory LOR of 20 pg/g I-TEQ (Table 16). The detected concentrations of Total PCDD/F I-TEQ were below the SCS_{health} of 600 pg/g for a recreational land use exposure scenario previously adopted as part of the Kopeopeo Canal Remediation Project (GHD 2019).

- CS3 boundary
- Spillage soil validation sample
- Water treatment plant validation sample
