# **Kaituna Catchment Control Scheme Advisory Group Meeting**

**Wednesday 4 March 2020 at 10am**

**Subject:** Status Report - April 2017 Flood Repair Project

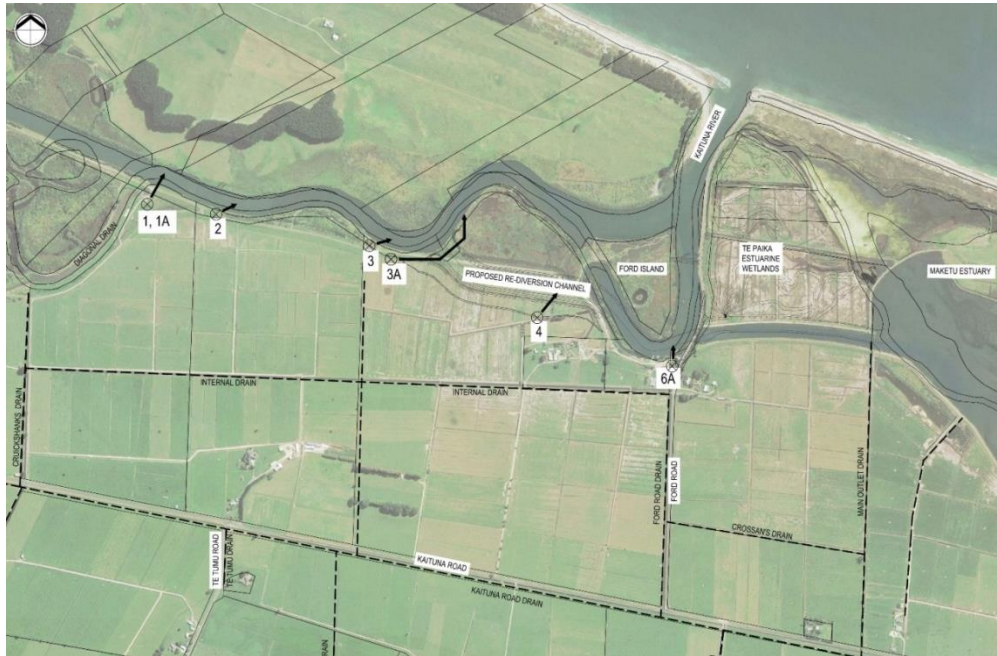
**Fig 2: Possible New Pump Station Locations**

That option, as shown above, is to move the Ford Road discharge to alongside the Diagonal Drain pump station.

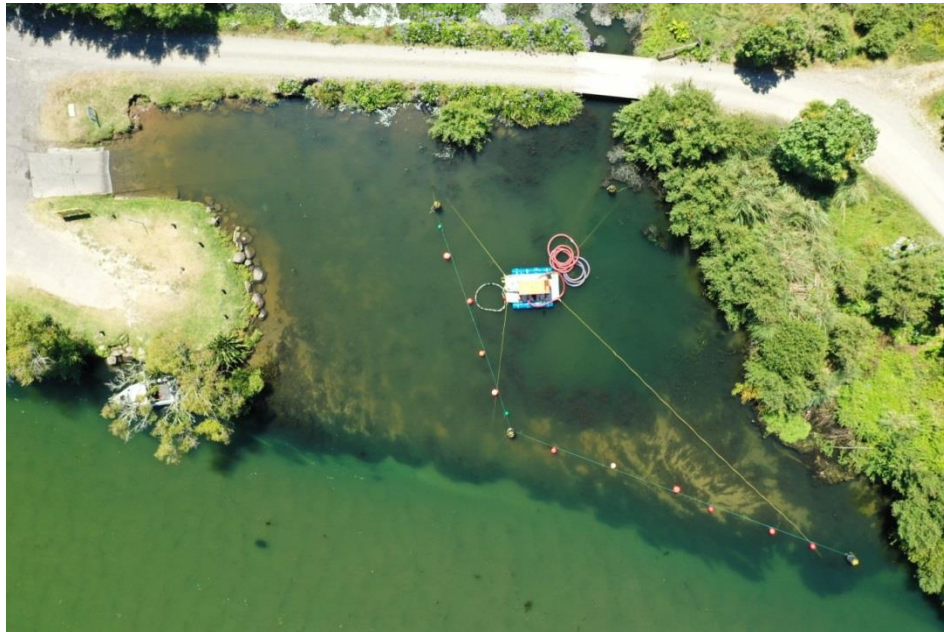
Weed has been dredged and removed from site. The sediment build-up has been removed, re-establishing the natural bed.

Fig 3: Sandbar prior to dredging works – Bell Road

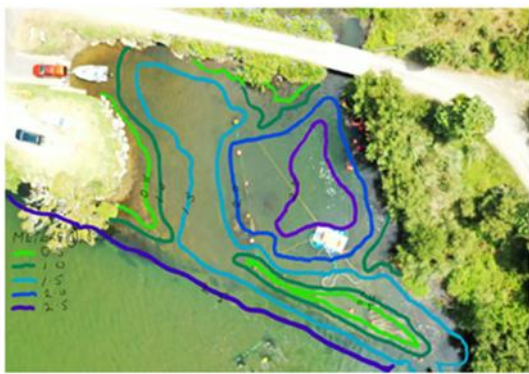
Fig 4: Depth contours (approx.) of Bell Road site prior to dredging works

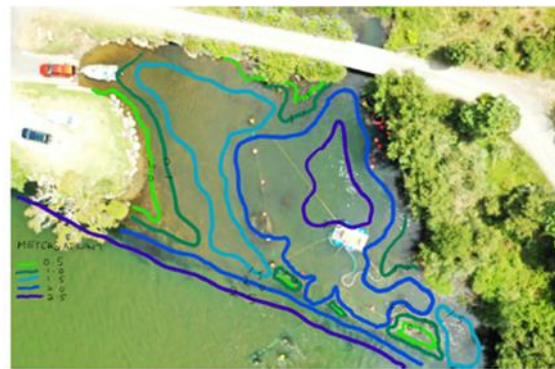
Fig 5: Depth contours (approx.) of Bell Road site after dredging works

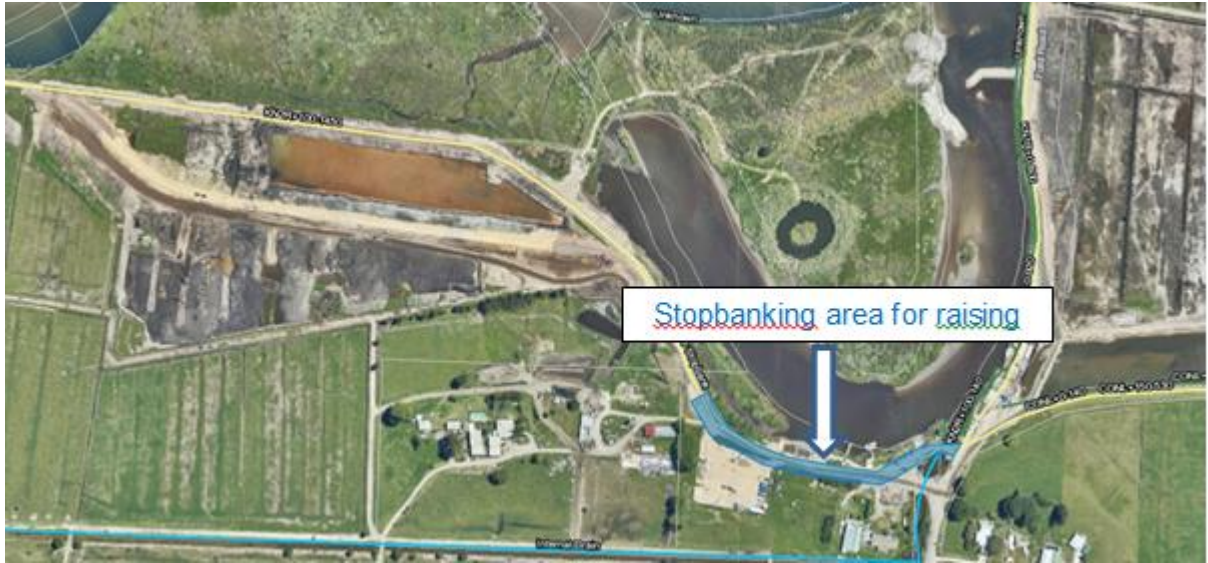
**Fig 6: Location of stopbank upgrade**

A section of stopbank near the Kaituna River Rediversion Project needed upgrading to meet the scheme's required level of service.

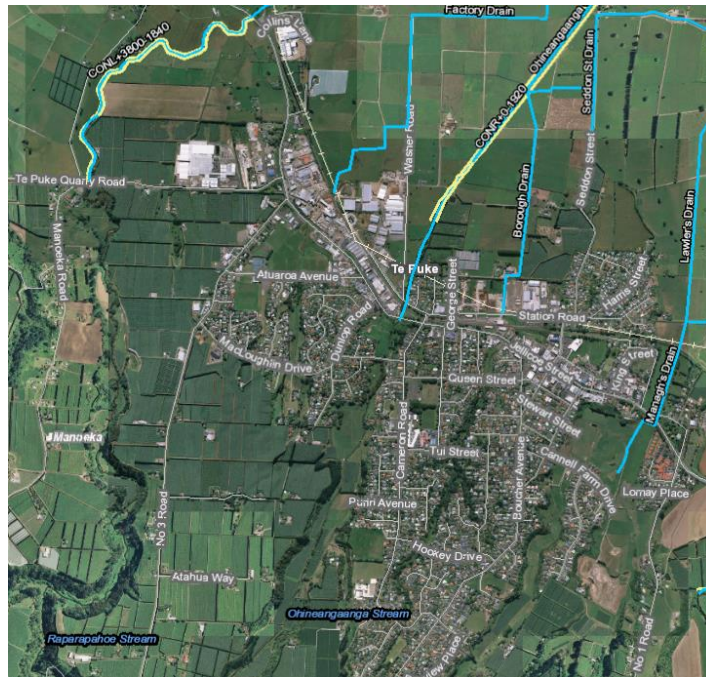
Fig 7: Te Puke township and the drainage network
