Whakatāne-Tauranga Rivers Scheme Advisory Group Meeting

Whakatāne-Tauranga Rivers Scheme Advisory Group Meeting Wednesday 18 March 2020 at 10am

Agenda

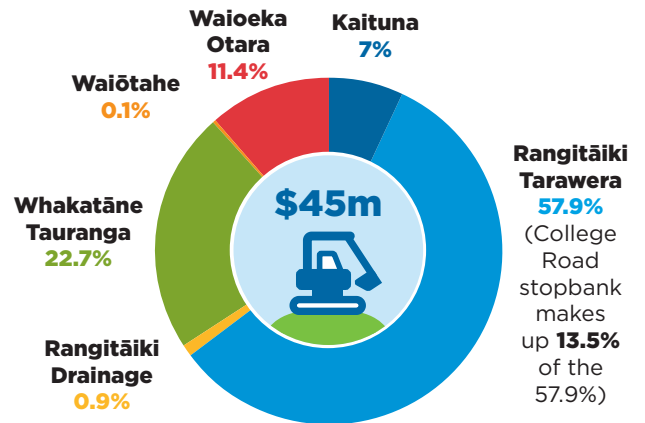
Repair costs by River Scheme

The **Rangitāiki-Tarawera Rivers Scheme**
was the worst affected, accounting for
more than half the repair budget.

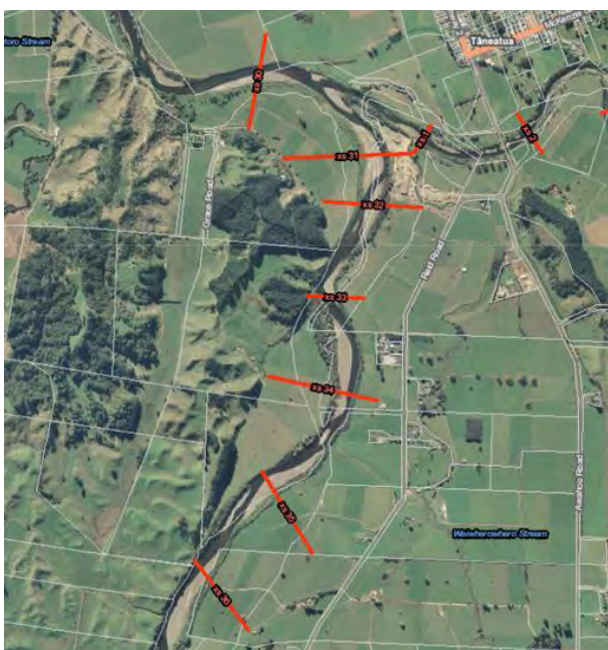
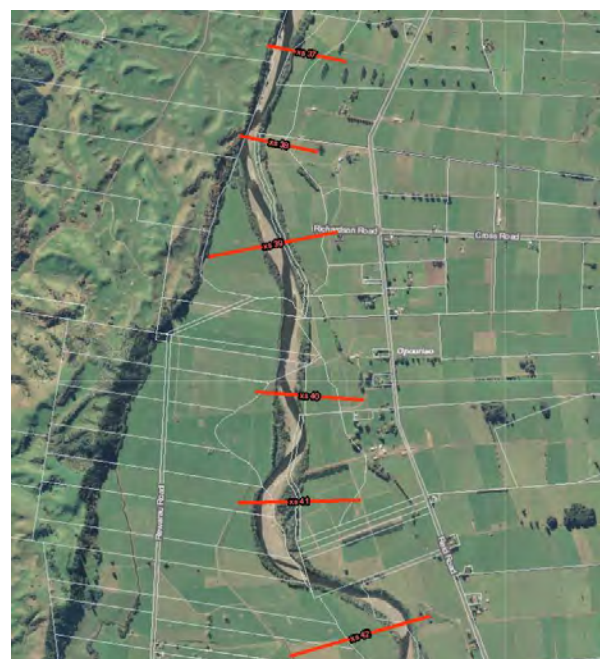
From the recent assessment of mean bed levels, using Waterscape’s (Gary Williams) active channel definition, it can be seen that bed levels appear to have recovered over the reach with the mean bed level now within or above the guideline envelope (with the exception of cross-section 40). Extractions should now be limited to locations where mean bed levels exceed the guideline envelope, particularly in the lower reach around Peketahi Bridge up to cross-section 35.

In April 2018 Council made a decision that due to bed levels having declined in the top section of the reach above Ohotū Bridge that gravel extraction in this section would only be undertaken for river management purposes until recovery has taken place and desired bed levels achieved. More recent technical analysis confirms this approach due to bed level degradation between Ohotū Bridge and Limeworks (cross-sections 47 to 57).

When bed levels are too low, banks are high and have to take the full force of the flow during a flood. Banks can erode, protection works are undermined, more gravel is transported downstream to build up elsewhere, and bank protection repair works are more costly.

The recommendation in the last published NERMN report (Natural Environmental Regional Monitoring Network – river and stream channel monitoring) was to suspend any extraction within the active channel over the reach from about 1 kilometre upstream of the Tauranga confluence (cross-section 33) to Rūātoki Bridge (cross-section 47) until adequate recovery of the river bed is achieved.
