Waioeka-Otara Rivers Scheme Advisory Group Meeting

**Wednesday 25 March 2020
at 10:30am**

To: Waioeka-Otara Rivers Scheme Advisory Group

From: Tony Dunlop
Flood Restoration Engineer/Area Engineer

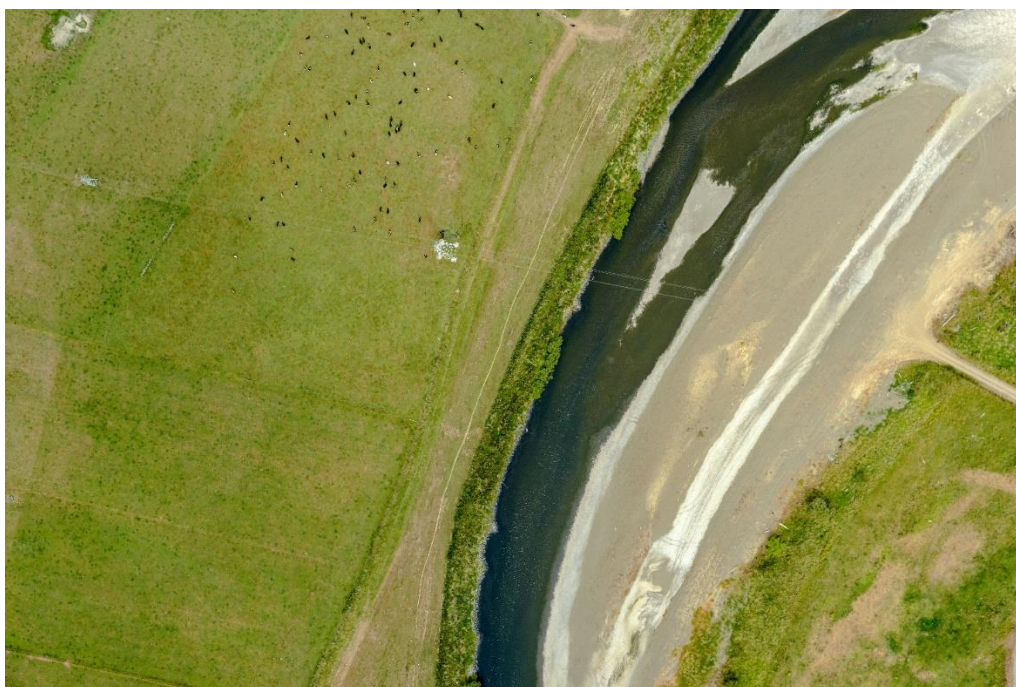
Photo 1 – Robbie's Pit overflow depression

- Establish and maintain overflow diversions to ease/reduce velocities on river bank protections, reducing the possibility of river channel degrading and causing river bank slumping at Robbie's Pit, Beatties/Nicols and Riverloch/Maxwells.

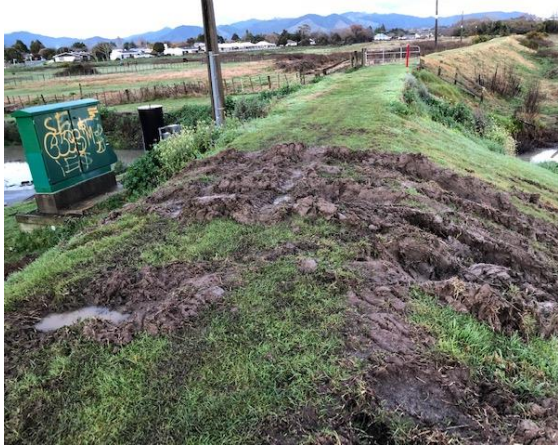
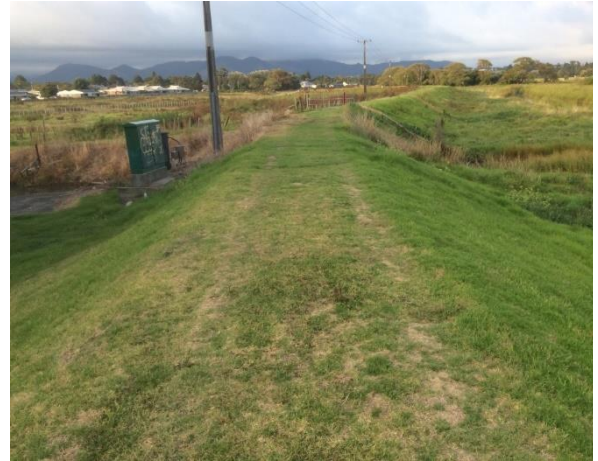
Photo 2 and 3 - Stopbank damage at Tarawa Creek outlet (before and after)

At the September 2019 meeting we showed pictures of damage to the stopbank and berm at Tarawa Creek caused by a vehicle getting stuck and having to be towed out. Restoration of this site has now been completed.

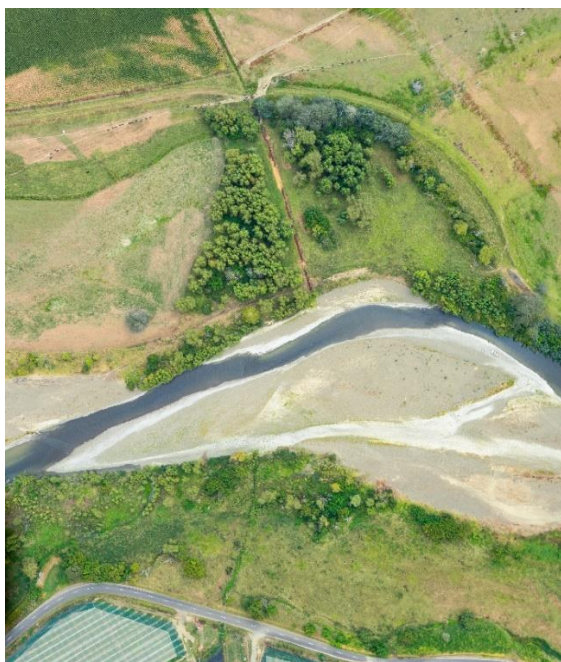
Photo 4 – Carters overflow diversion required

Establish and maintain overflow diversions to ease/reduce velocities on river bank protections reducing the possibility of river channel degrading and causing slumping at Carters lower site, Carters top site and Rewa Hill site.

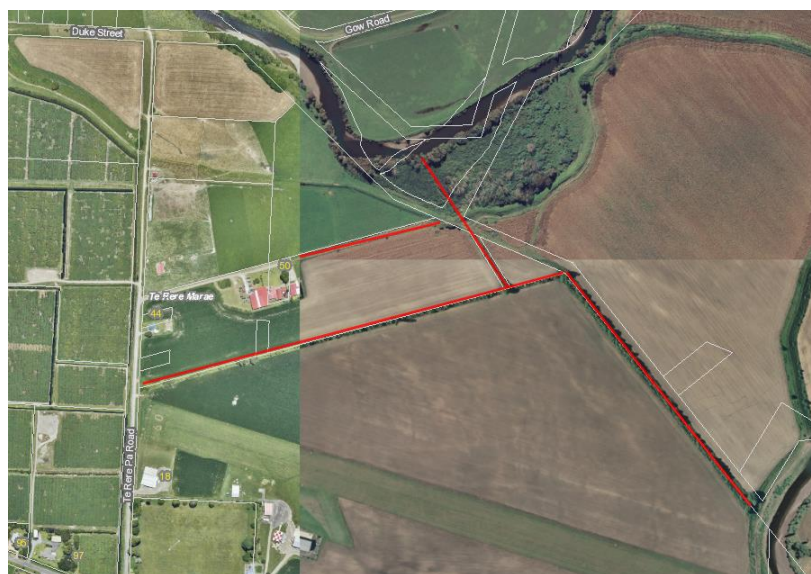
Photo 5 – Te Rere Pā drainage improvements

- 9.7 km of beach weed spraying targeting pampas grass and other invasive weeds. **In Progress**
- Te Rere Marae drainage - upgrade Aerodrome drains (marked in red in Photo 5 below) to ensure they operate more effectively in heavy rain fall events and prevent frequent flooding around the Marae. **Programmed for March/April 2020**

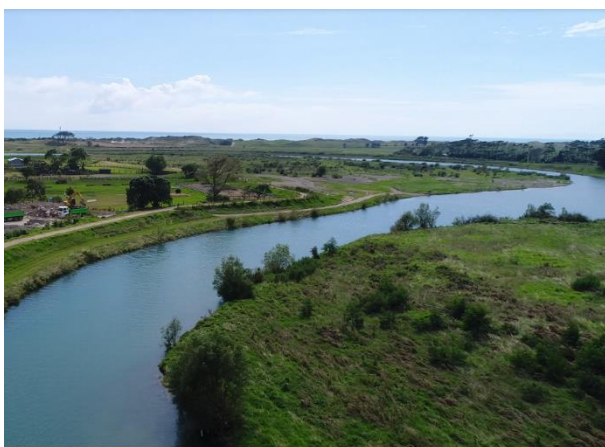
Photo 6 – Ōpōtiki Pony Club site on RHS

- Otara River berm area Ōpōtiki Pony Club – mulched vegetation and trees to allow for a more effective floodway. **Completed**

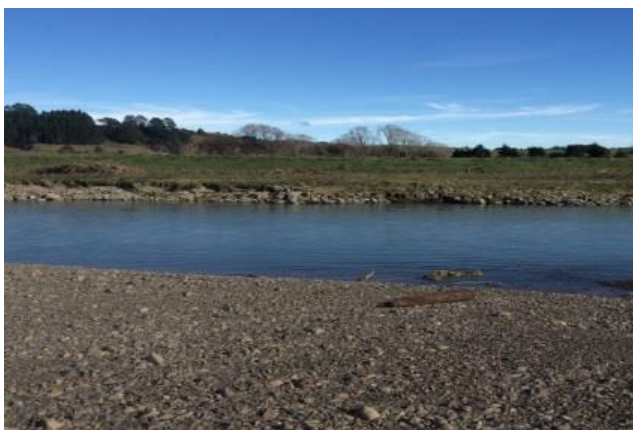
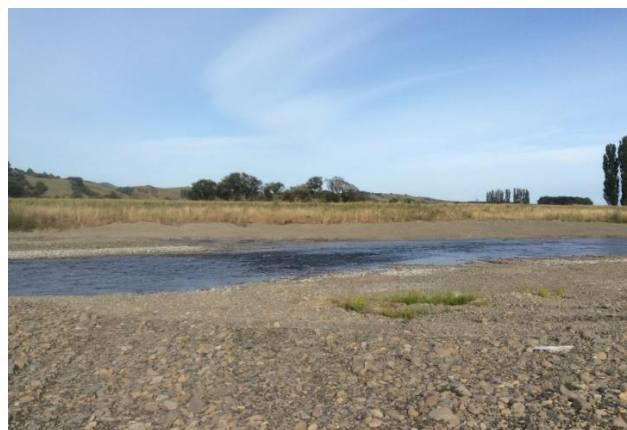
Photo 8 and 9 – Ernest rock slumping – before and after

- Carters/I Brown Pit - 80 metres of rock slumping repairs caused by gravel build up on beach, narrowing channel. **Completed**
- Ernest site - 80 metres of rock slumping causing channel degradation. **Completed**

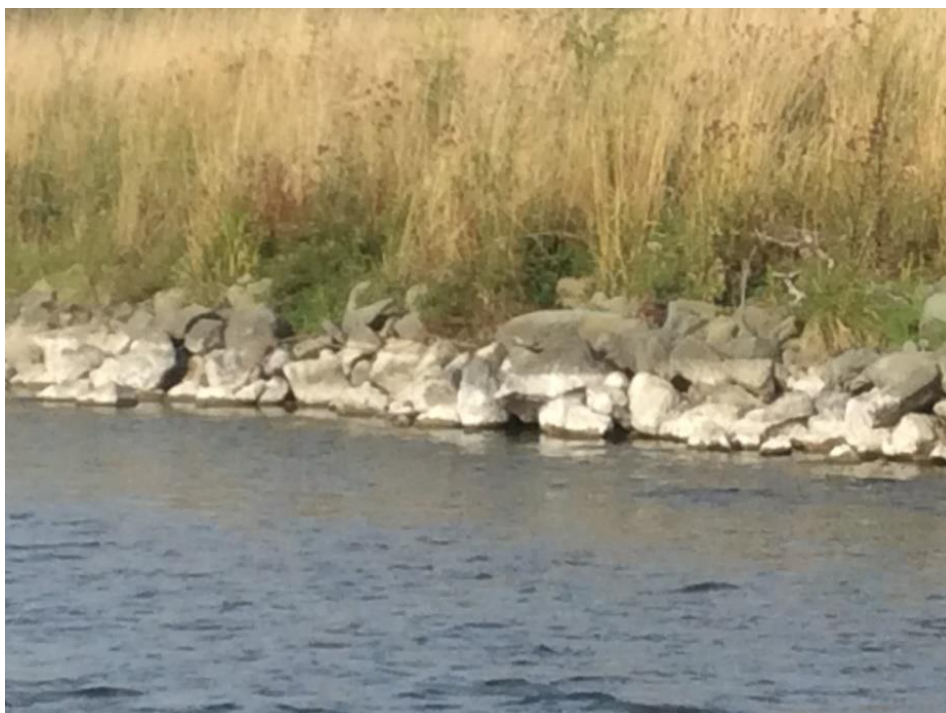
Photo 10 - Ernest rock works – note vegetation growth and gaps in rock (eel habitats)

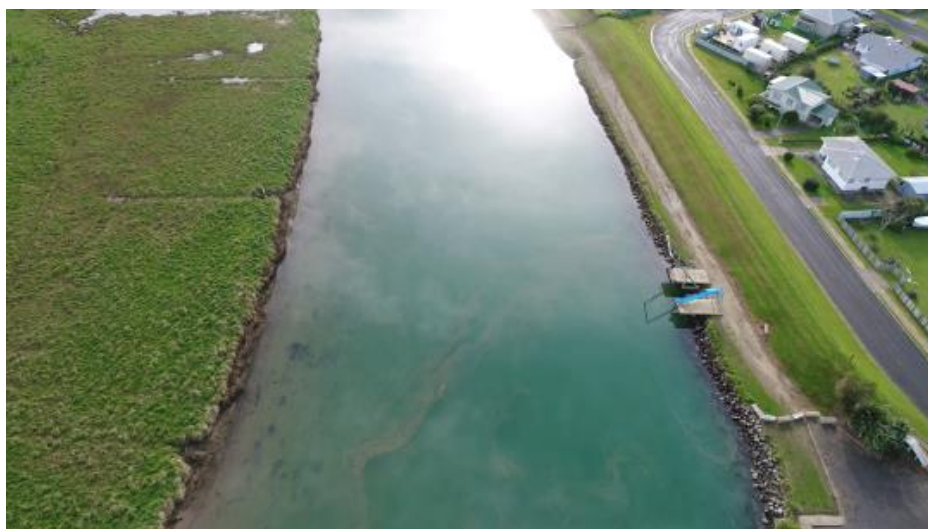
Photo 11 – Ōpōtiki wharf rock movement

- Ōpōtiki Wharf - 200 metres of rock movement requiring topping up/replenishment. **Programmed March 2020**

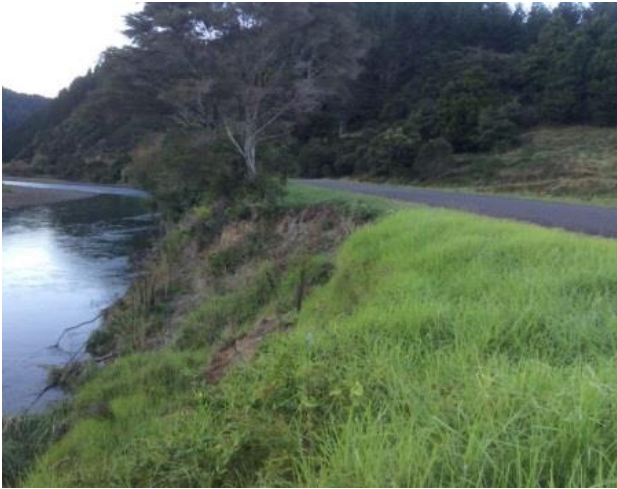
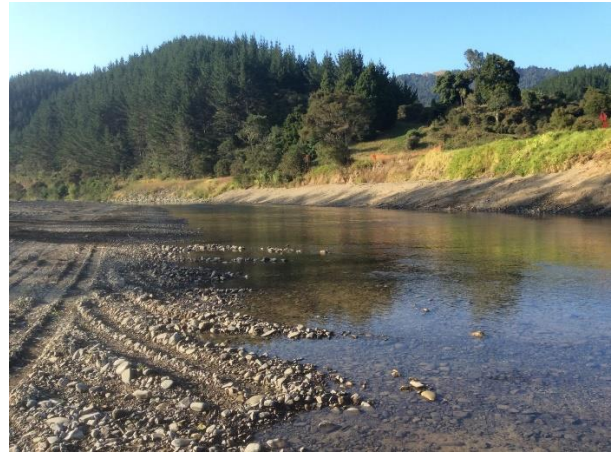
Photo 12 and 13 – Pakihi Road (before and after)

- Thornton Orchard – right bank, 50 metres of raw bank erosion threatening existing rock work and stop bank. **Pending on suitable rock supply**
- Pakihi Road - damage from February 2018 flood threatening security of the road. **Completed**

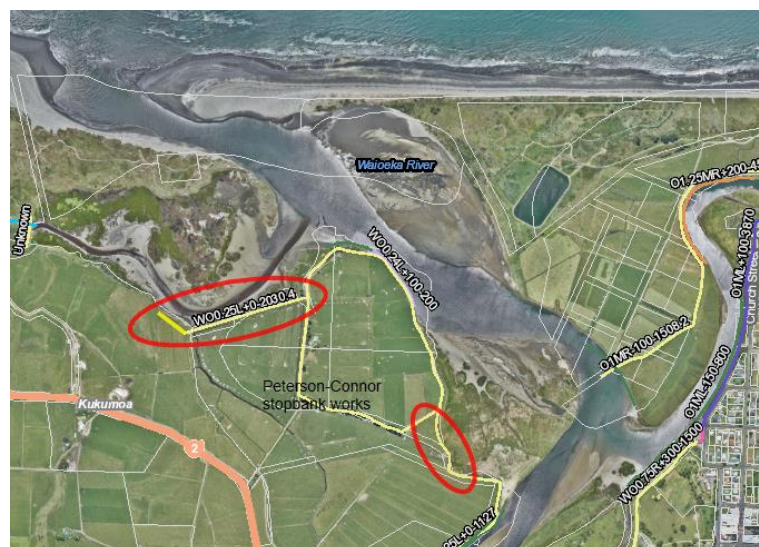
Figure 2 – Areas of proposed work Peterson-Connor

Resource consent is being processed for this stopbank raising/reinstatement work that is mainly for improving protection against sea storm surges. Discussions have taken place with affected land owners and initial discussions have begun with some hapū contacts.

Additional culverts are planned in the proposal to improve discharge of floodwater on occasions when the floodway is in use. Strengthening and protection of Baird's Drain outlet structure will also be incorporated in the proposed works. Concurrently, there is a high level assessment of alternative options being considered.
