# Whakatāne-Tauranga Rivers Scheme Advisory Group Meeting

Wednesday 16 September 2020 at 10am

Subject: Engineering update

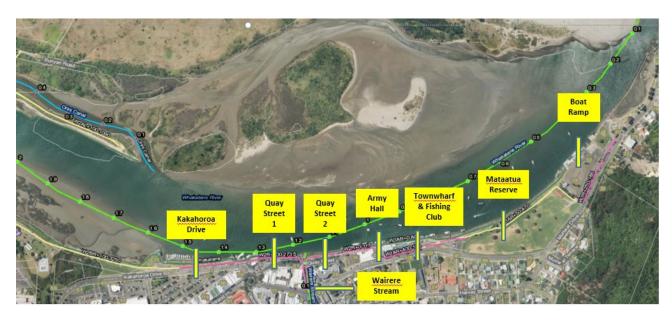
Figure 1: Proposed stopbank raising extent and stages

No	Zone	Objective	Progress
1	Kakahoroa Drive	Seepage Control, Flood levels	Stage 1
2	Quay Street 1 & 2	Seepage Control, Flood levels	Stage 1
3	Wairere Stream	Flood levels, slope stability	Stage 2
4	Army Hall	Flood levels	Stage 2
5	Townwharf & Fishing Club	Flood levels	Stage 2
6	Mataatua Reserve	Flood levels	Stage 3
7	Boat Ramp	Seepage Control, Flood levels	Stage 3

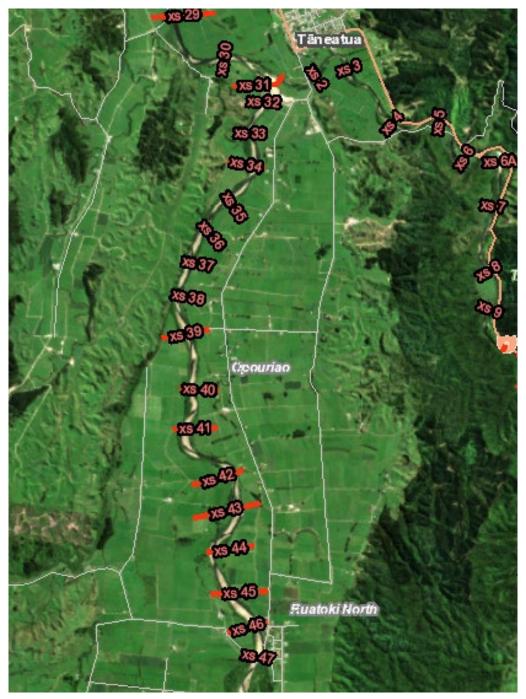
Photo 1:Cross section locations

From the most recent assessment of mean bed levels, using Waterscape's (Gary Williams) active channel definition, it can be seen that bed levels appear to have recovered over the reach with the mean bed level now within or above the guideline envelope (with the exception of cross-section 40). Extractions should now be limited to locations where mean bed levels exceed the guideline envelope, particularly in the lower reach around Peketahi Bridge up to cross-section 35.

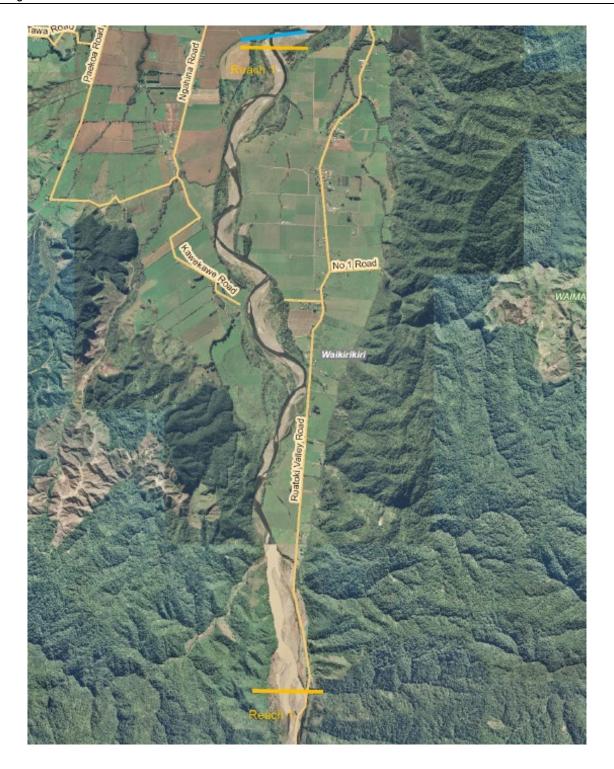
Photo 2: Resource Consent Application RM19-0257 – proposed extraction locations

Central Freight Lines Ltd (CFL) owned by Paki Nikora has applied for consent to extract up to 20,000m3 pa from the Whakatāne River in two areas as per below aerials. Submissions closed Friday, 28 August.

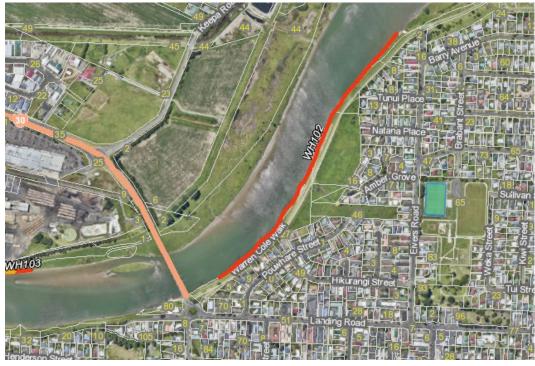
Photo 1: Eivers Road site - Warren Cole Walkway

Site reference	Comment
WH 102 Eivers Road, Warren	Extensive area of rock slumping and asset damage
Cole Walkway

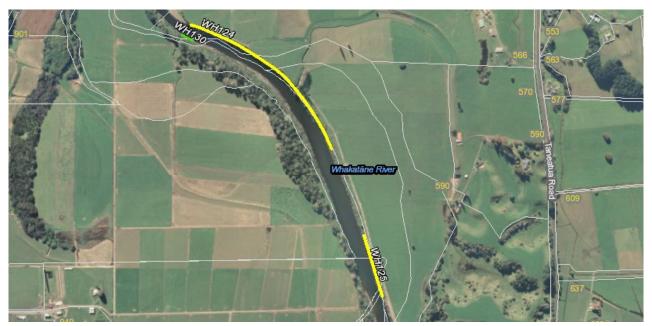
Photo 2: Dunstan and Studer sites

Site reference	Comment
WH124 Dunstan	Extensive area of eroded bank with trench willow
	damage
WH125 Fowell/Studer	Area of eroded bank with trench willow damage
WH192 Falkner	Eroded river bank
