Examples of Works Completed Under Consent 64684

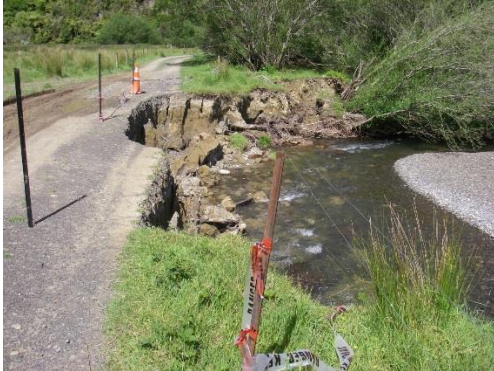
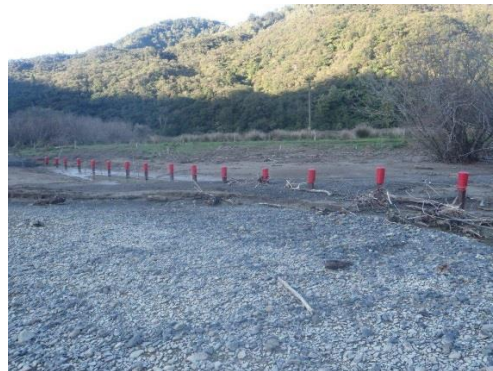
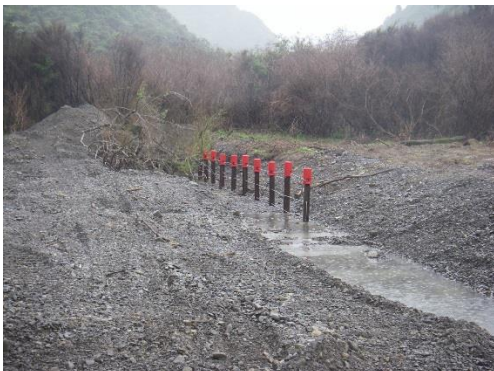
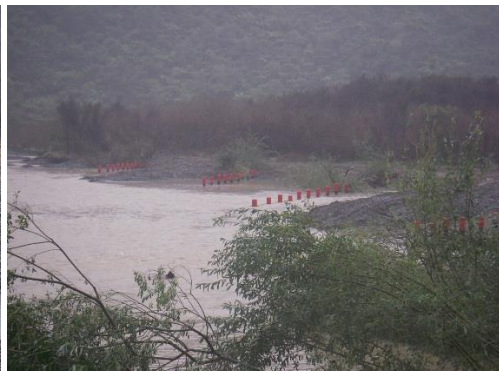
EXAMPLE 1: PAKIHI RIVER – EROSION CONTROL – DEPARTMENT OF CONSERVATION LAND – MOTU TRAILS

This work involved returned the watercourse back into its original course. Sediment discharges were minimised during the operation by working in the dry part of the bed until the final cut was made to put river back into original flow path. Permeable training groynes were constructed from railway iron and wire rope. This helped reclaim sediment and redirect main flows of water within the channel.

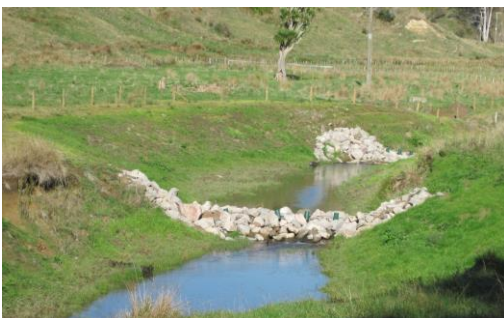
EXAMPLE 3: NGATI AWA FARMS – MARAETOTARA STREAM

This work involved the construction of a series of 10 drop structures in the bed of the Maraetōtara Stream to help minimise the degradation of the stream bed. This minimised the erosion of sediment downstream into the ocean and helped to reduce stream bank erosion.
