Whakatāne-Tauranga Rivers Scheme Advisory Group

Wednesday 17 March 2021 10am

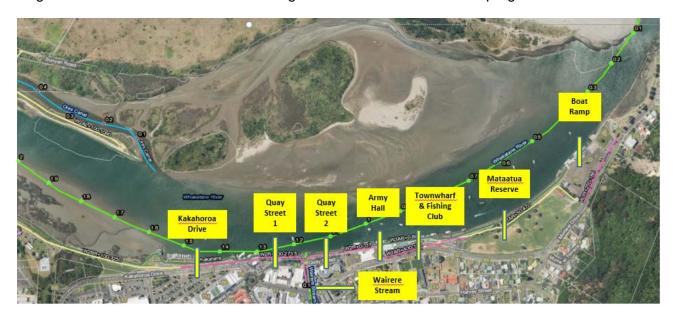
| No | Zone | Objective | Progress |
| 1 | Kakahoroa Drive | Seepage Control, Flood levels | Stage 1 |

Investigation and assessment of the remaining river sections continues and progress is on track.

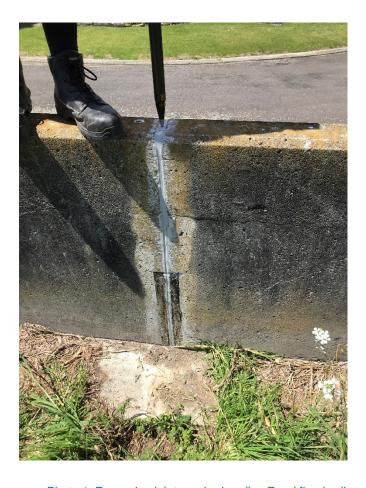
Photo 1: Expansion joint repair - Landing Road floodwall

Geotechnical and structural investigations have now been completed by Tonkin and Taylor. Staff are reviewing the report provided. This will confirm what remedial work will be required. In the meantime, with reference to the draft investigation report, joint repairs have been completed by the Rivers and Drainage Operations team on the existing expansion joints.

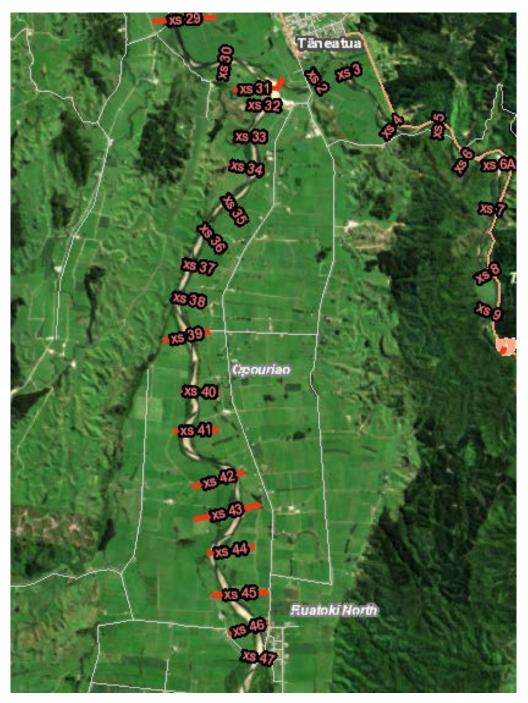
Photo 1: Cross section locations 29-47

The recommendation in the last published NERMN report (Natural Environmental Regional Monitoring Network – river and stream channel monitoring) was to also suspend any extraction within the active channel over the reach from about 1 kilometre upstream of the Tauranga confluence (cross-section 33) to the Ohotū Bridge (cross-section 47), until adequate recovery of the river bed is achieved.

From the most recent assessment of mean bed levels, it can be seen that bed levels appear to have recovered over the reach with the mean bed level now within or above the guideline envelope (with the exception of cross-section 40). Extractions should continue to be limited to locations where mean bed levels exceed the guideline envelope, particularly in the lower reach around Pekatahi Bridge up to cross-section 35.

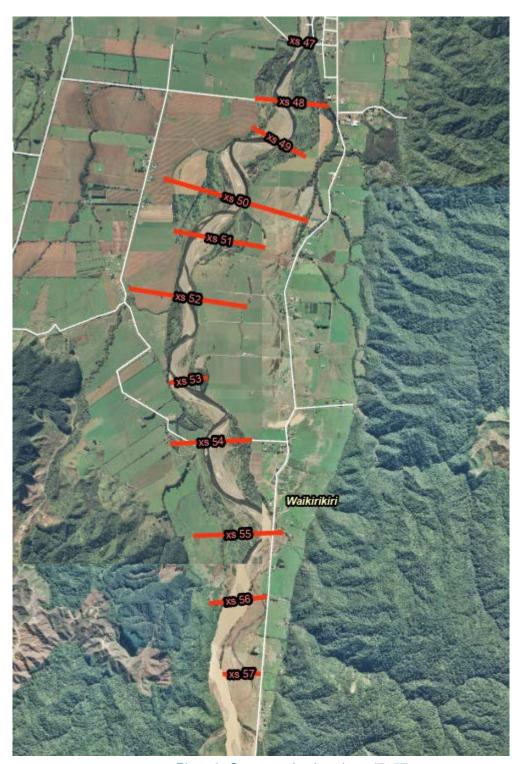
Photo 2: Cross section locations 47 -57

Central Freight Lines Ltd (CFL) owned by Paki Nikora has applied for consent to extract up to 20,000m3 pa from the Whakatāne River in two areas; firstly between cross-sections (XS) 45 and 49 and secondly between cross-section 49 and up to and beyond cross-section 57. Submissions closed Friday, 28 August and a hearing was scheduled for 25th November 2020 however this was adjourned at the request of the applicant. A new hearing date has yet to be confirmed.

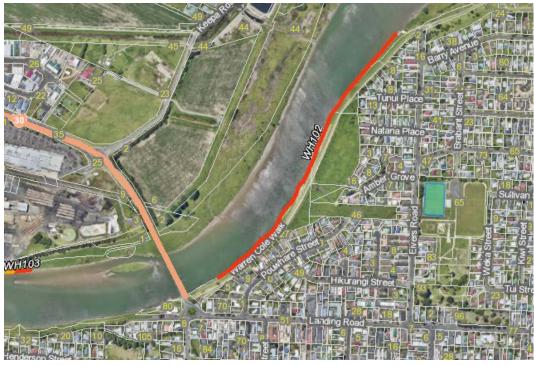
Photo 1: Eivers Road site - Warren Cole Walkway completed Dec 2020

| Site reference | Comment |
|---|--|
| WH 102 Eivers Road, Warren | Extensive area of rock slumping and asset damage |

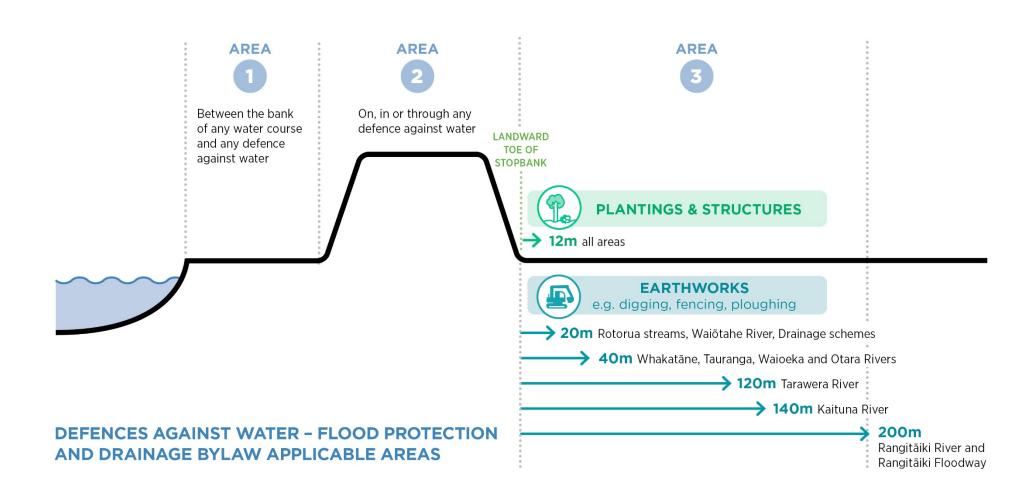
Appendix 1 - Bylaw applicable areas for defences against water (stopbanks, floodgates, pump station) and drains without stopbanks

Floodway and Drainage Bylaw applicable areas

- drainage scheme drains without stopbanks
