Ōhiwa Harbour and Catchment

Interim Report 2020

Bay of Plenty Regional Council
Environmental Publication 2020/06
November 2020

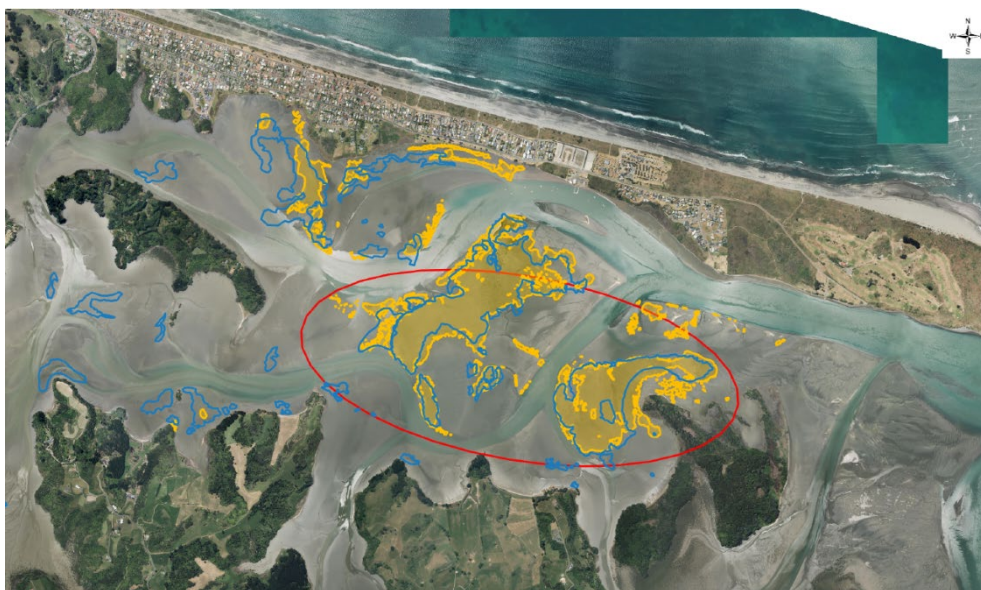
Figure 6 Red ellipse shows area where black swans have been sighted since 2019. Yellow shading shows current seagrass extent.

Bay of Plenty Regional Council staff have regularly monitored black swan numbers in Ōhiwa Harbour since 2019 (Figure 5). Swans are consistently observed in the area between Ohakana and Uretara islands (Figure 6), which is also the main seagrass bed in the harbour.

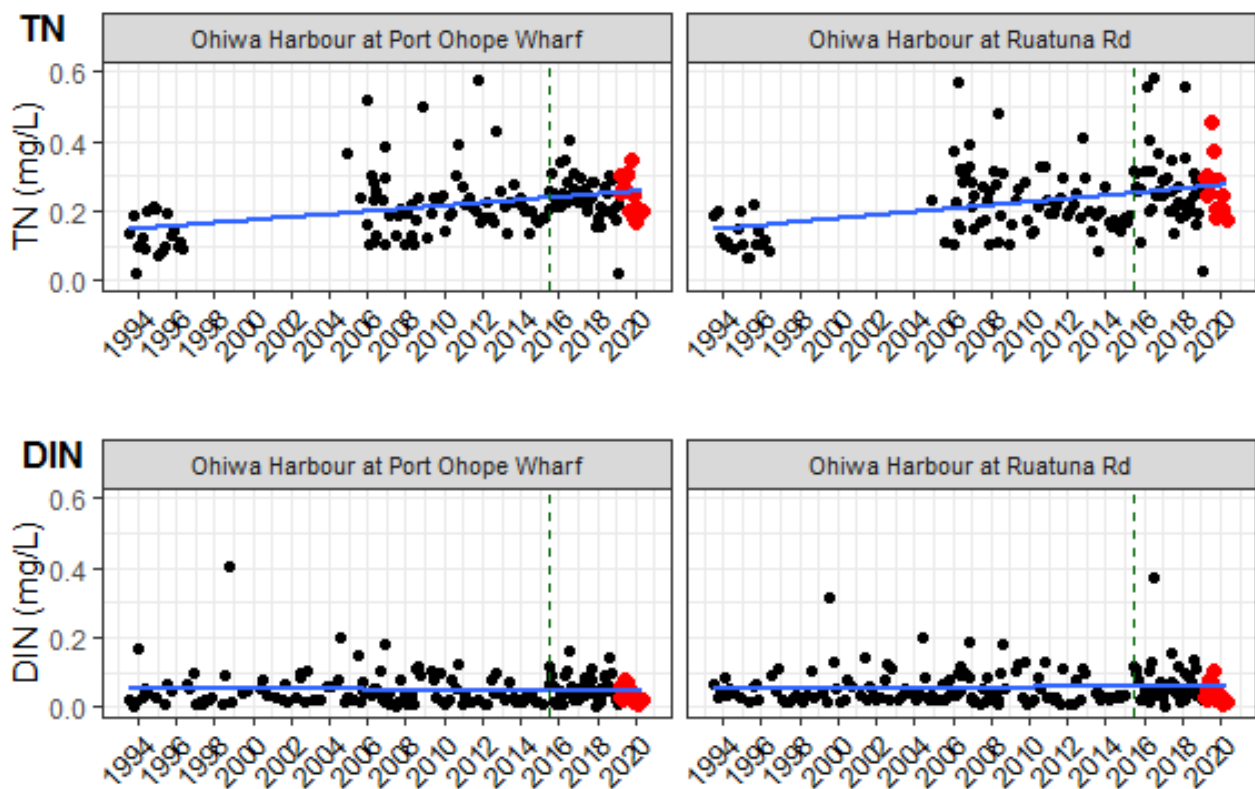
Figure 7 Concentration of total nitrogen (top) and dissolved inorganic nitrogen (bottom) over time. The blue line represents a fitted linear model. The vertical green line represents the change in sampling time from high tide to an outgoing mid-low tide. The red data points are samples taken over the last year (2019/2020).

Nitrogen results show that total nitrogen (TN) has increased at both sites since 1994 but levels appear to have stabilised over the last 10 years (Figure 7). Inorganic nitrogen (DIN – total of nitrate-nitrite nitrogen and ammoniacal nitrogen) remains fairly stable.

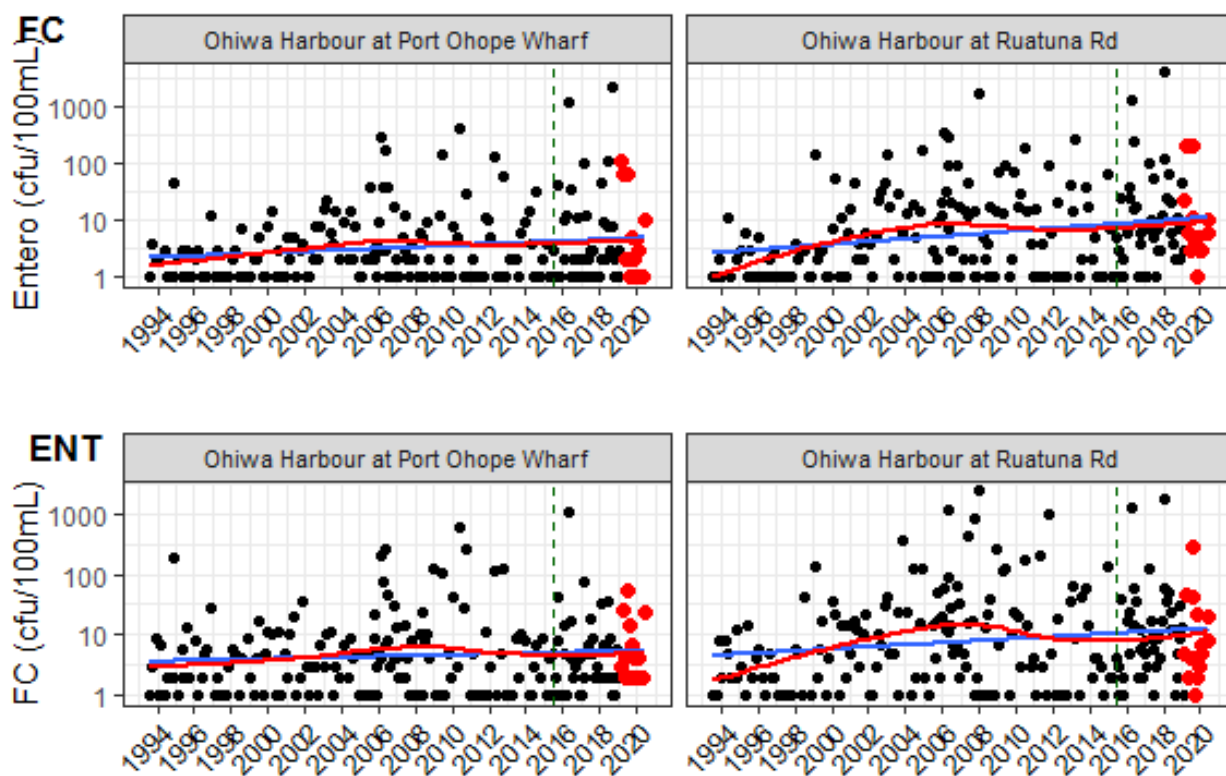
Figure 10 Concentration of faecal coliforms (top) and enterococci (bottom) over time. The blue line represents a fitted linear model, while the red line is a fitted loess model. The vertical green dashed line represents the change in tidal timing.

Faecal coliforms (FC) and enterococci (ENT) are two indicators of faecal contamination. Both indicators have continued to increase at the Ruatuna Road site since 1994, however, no trend is apparent at the site over the past 10 years (Figure 10).

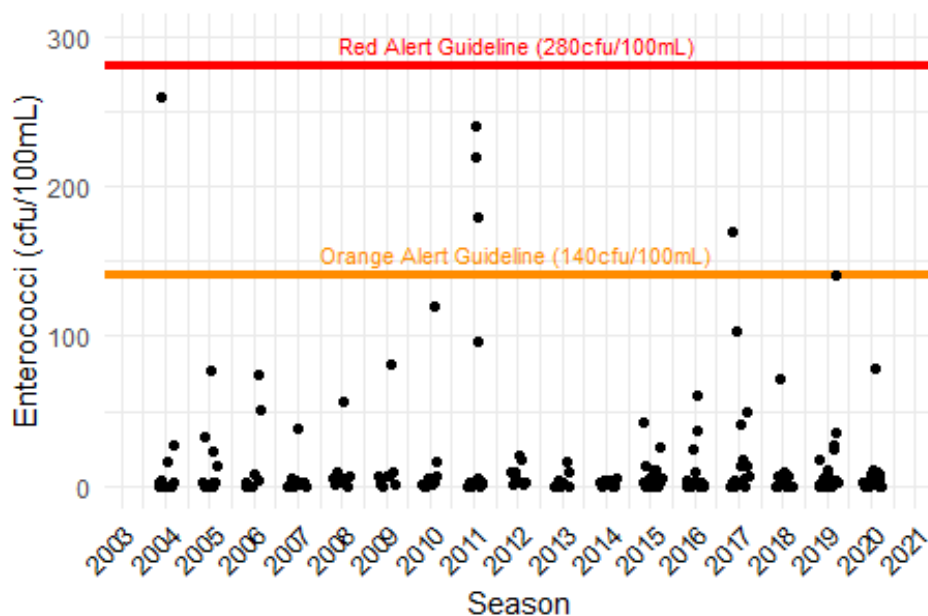
Figure 11 Enterococci results for Ōhiwa Harbour against safe swimming guidelines.

The MFE system has three categories, and two thresholds. A site can be defined as being in: an acceptable 'green' state if the number of enterococci per 100 ml is lower than 140; an 'orange' alert mode if numbers of enterococci are between 140 and 280 per 100 ml; or a 'red' action mode if enterococci numbers of two consecutive samples exceed 280 per 100 ml.

Figure 11 shows a summary of enterococci data collected at this site since 2003. Results for the most recent 2019/2020 season show that 100% of samples were in the green category, 0% were in the amber category, and 0% exceeded the red threshold.
