# Lake Tarawera

## CULTURAL MAPPING REPORT

*Prepared by Te Arawa Lakes Trust*

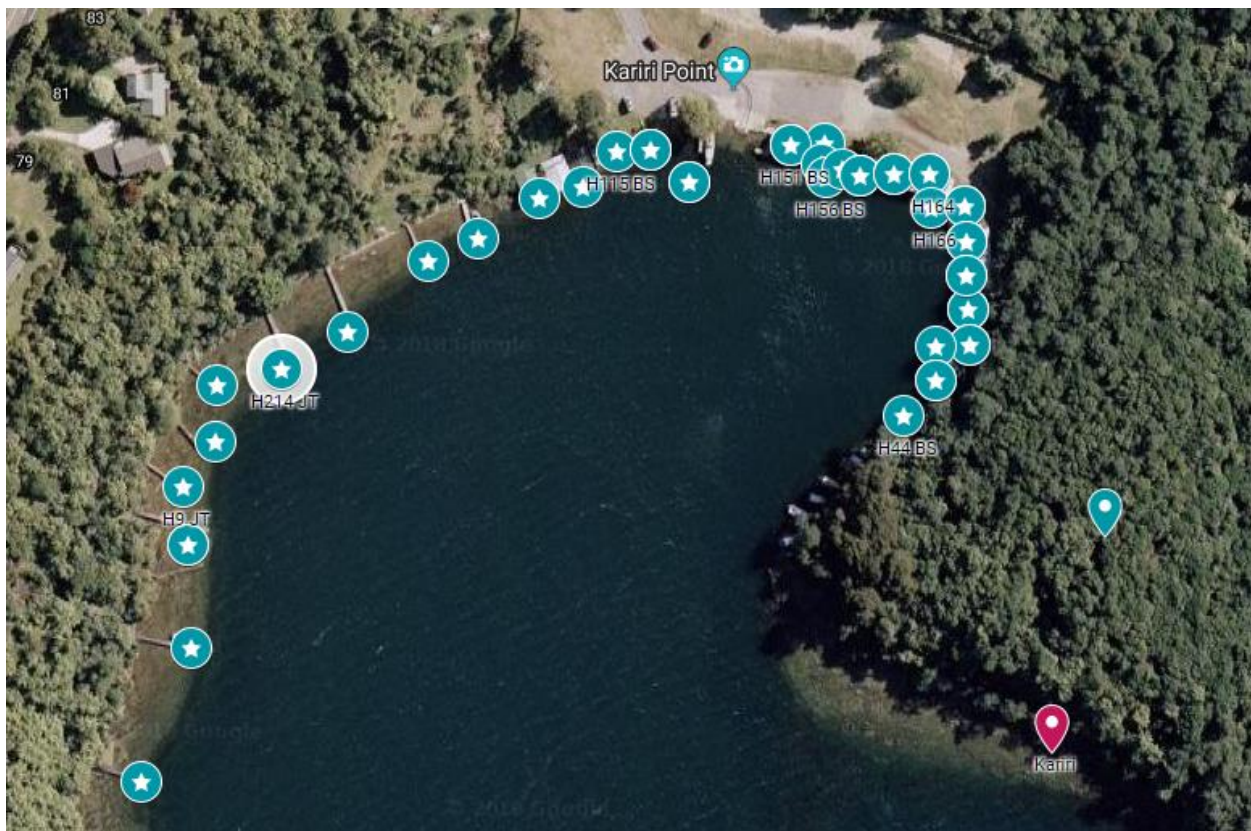
### Map 4. Kariri (Tawaroa/Boatshed Bay)

The traditional name for this pa kāinga is Tawaroa which later became known as Kariri, transliteration of 'Galilee'. This pa kāinga belonged to Tuhourangi and is the site of traditional urupā (burial sites). Existing boat sheds at Kariri Point on Lake Tarawera are probably the most culturally sensitive and inappropriate. Although

not registered with the NZ Historic Places Trust as such, the site is regarded as waahi tapu by the Tuhourangi people. The offending boatsheds are attached to the waahi tapu, which was set aside as 'an inalienable cemetery reserve in 1895'. Boatshed owners trespass over waahi tapu land whenever they use the boatsheds. The cultural impact of structures in this area is high and incompatible with the cultural values. Trustees of the land block, Rotomahana Parekarangi 6G2B, could file court proceedings to pursue the aim of having existing structures removed. Freshwater inanga and koura flourished around its shoreline as well as rauipo.

Boatshed	H167 BS	 	Spencer Road Lake Tarawera	<b>More than Minor adverse effects.</b> Based on current information sources, the structure is located less than 100m of a cultural site of significance and within 100m of an existing structure
Boatshed	H169	 	Spencer Road	<b>More than Minor adverse effects.</b> Based on current information sources, the structure is located less than 100m of a cultural site of significance and within 100m of an existing structure

Refer above assessment and recommendation for all existing structures located on Kariri Point. Please also note there appears to be unconsented/unauthorized structures with no plate number. Request stock take/ further information. From H166/167 to southern mooring area.
