# **ARCHAEOLOGICAL ASSESSMENT**

# PROPOSED AWAITI PLACE STORMWATER REMEDIATION PROPOSAL.

# Ohauiti Tauranga

**MARCH 2020**

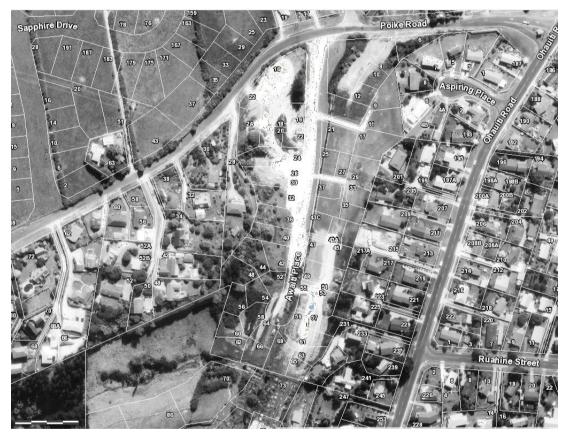
Ground disturbance associated with proposed works within Awaiti Road Reserve and storm water pond are located within an area that was extensively modified by the construction of Awaiti Place in the mid 1990s and the subsequent formation of the storm water pond in the early 2000's. The formation of Awaiti Place in 1992 involved major earthwork including topsoil removal and levelling of the natural topography. The construction of the dam and storm water pond in 2005 also involved extensive earthwork.

Figure 4. 1992. Aerial photo taken in 1992 showing the construction of Awaiti Place underway.

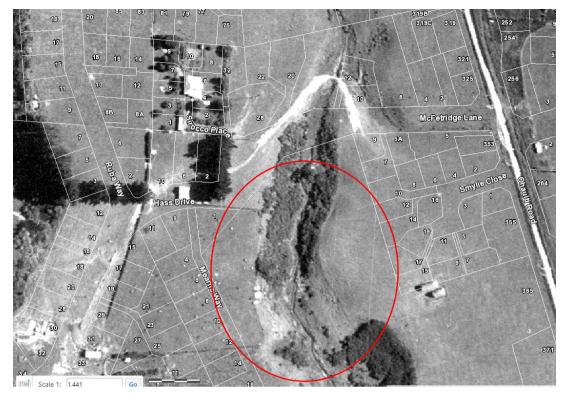
Land affected by the proposed dam and storm water pond on the southern side of the McFetridge Lane causeway survives largely unmodified. The gully and surrounding slopes were used for stock grazing up until the 1980s when the surrounding area was planted in avocado and kiwi fruit orchard. Many of the orchard trees remain in the affected area which is now encompassed within the Ohauiti Reserve accessed by public walking tracks.

Figure 5. Aerial photo taken in 1943 showing unmodified landscape in the vicinity of the proposed McFetridge Lane Dam (circled red)

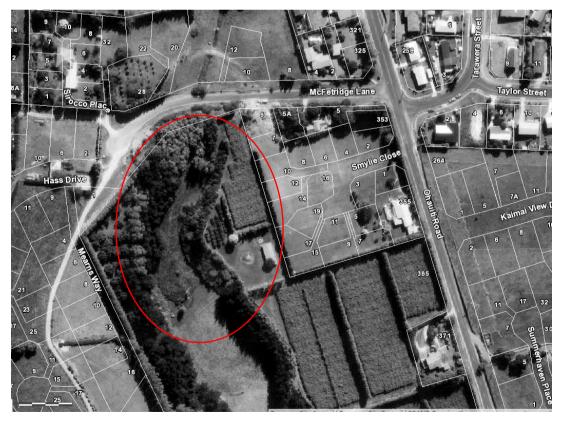
Figure 6. Aerial photo taken in 1992 showing the location of the proposed McFetridge Lane dam in a combination of pasture in the valley floor and orchard on the surrounding high ground.
